# **Introduction of A Methodology to Mitigate Tsunami Disaster by The Pre-evaluation of Tsunami Damage Considering Damage Investigation of 2004 Tsunami Disaster in the Indian Ocean**

## **1. Damage Investigation of 2004 Tsunami Disaster in the Indian Ocean**

### **1.2 Road Damage in Sri Lanka**

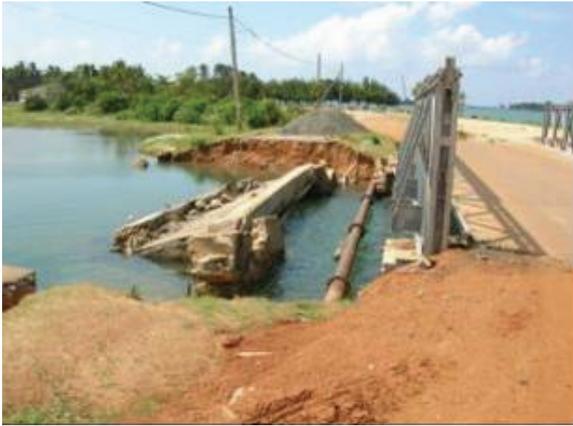
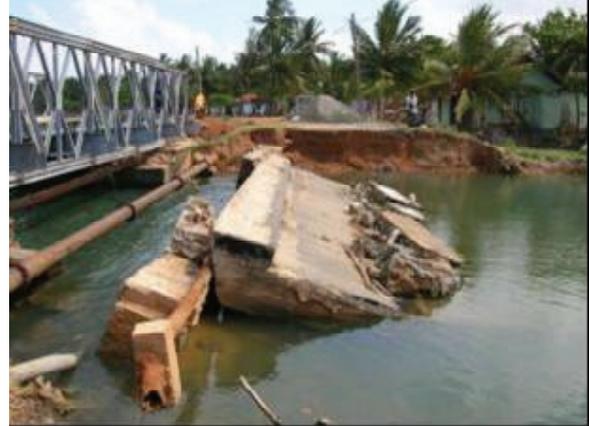
A single span bridge, 8 meters long and 4 meters wide on Bar Road which runs along the Batticaloa Lagoon and connects with the East Coast Highway, collapsed and fell into the water (see Photo-1). The right-hand side of the photo is the lagoon and the left-hand side is a small inlet. As shown in the photo, the abutments were displaced and parts of the approaching fills were scoured. The mechanism that caused the damage is deduced from our observations: (1) The approaching fills were first scoured by the backflow of tsunami water. (2) The abutments lost their stability due to the scouring of the fills and foundation soils. (3) The abutments displaced outward. (4) The bridge lost support which caused it to fall into the water. Photo-1(2) was taken from the opposite side of the bridge.

(1) Batticaloa Lagoon on the right.                      (2) The fallen bridge girder  
 Photo-1. Collapsed simple digit bridge (Bar Road)

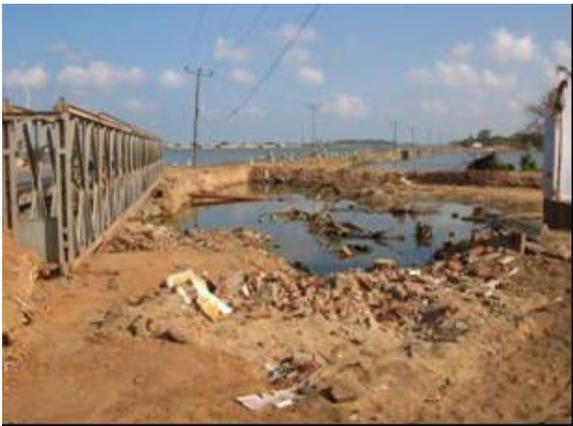
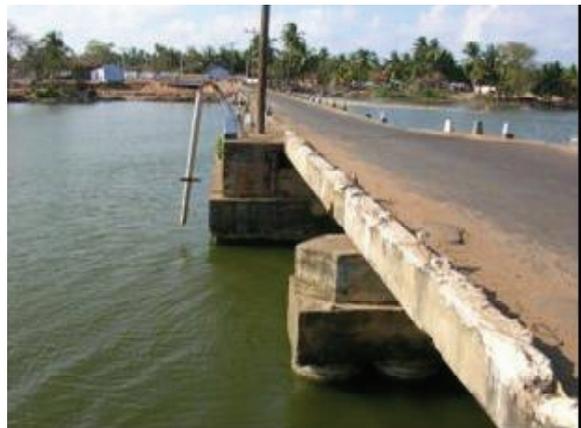
b) Koddaiikkallar Causeway

(1) The scoured out causeway mound                      (2) Damage to the sign post and curb  
 Photo -2. The damage to the Koddaiikkallar Causeway

The causeway is located a few kilometers south of Batticaloa Bridge. The total length is about 200 to 300 meters, and the most parts consist of soil fill supported by vertical concrete block retaining walls. At the central part is an opening for water with a width of about 5 meters (see Photo-2). Both ends of the causeway were scoured by the tsunami as shown in Photo-2(1). The central part of the causeway was less severely scoured. Photo-2(2) shows concrete poles that were completely folded down and roadside concrete blocks (curb) broken at the bottom. These suggest that the height of the tsunami was at least 3 meters from the road level and some floating debris in the back flow of the tsunami collided with the concrete poles and roadside blocks.

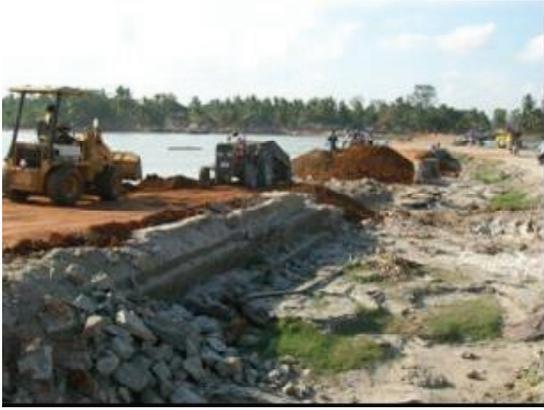
Photo-3. Periyakallar Causeway

This causeway is located a few kilometers south of Koddakkallar Causeway. There was an opening for water flow at the central part of the causeway. Unlike the damage to Koddakkallar Causeway, the sections near the opening were completely scoured out by the tsunami. In Photo-3 taken from the south looking north, the left-hand side is a lagoon and the right-hand side is the sea. The opening had been at the far end of the temporary detour seen on the right that merges the causeway. In the rebuilding work that was proceeding when we visited, a mixture of concrete debris and sea sand was used in the lower part of the fill and well-graded soil with gravel was used in the upper part. These are considered to be proper usage of fill materials since the concrete debris from demolished structures was recycled as it was suitable as sub-grade material.

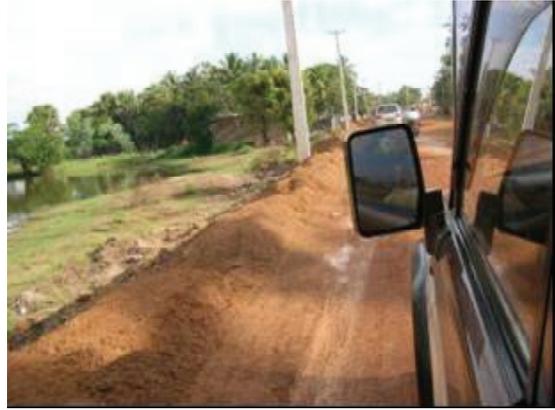
Photo-4. A Road in Kalmnai

As was mentioned, the tsunami washed up over the road in sections within the city. In the road sections where there were houses alongside, no damage was observed. However, in the embankment road sections with a height of around one meter over marshlands or paddy fields, damage was observed. It included the erosion of the road shoulders (see Photo-4) and the erosion of embankments at culverts. This damage tends to have occurred at locations where the land was lower than the surrounding area. It is presumed that the back flow of the tsunami was concentrated on the relatively low lands, causing erosion or the scouring out of embankments and culvert backfills.

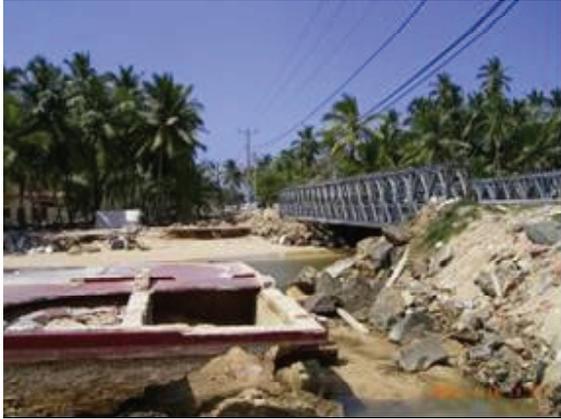
Photo-5. The Akurala bridge (91Kp)  
(① in the map)

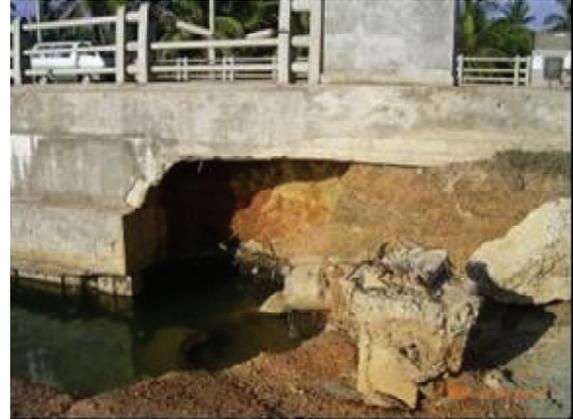
Photo-6. Scouring of a bridge (103Kp)  
(② in the map)

With regard to collapsed bridges, Erosion at the piers were observed. It is considered that bridge collapse was caused by erosion of pier, but direct impact of wave force is not cause of collapse. In addition, generally the damage to the roads was small even though damage along the road was serious. For example, in Kahawa where a train was washed away, the damage was enormous; however, there were some roads and a bridge in the area that went undamaged.

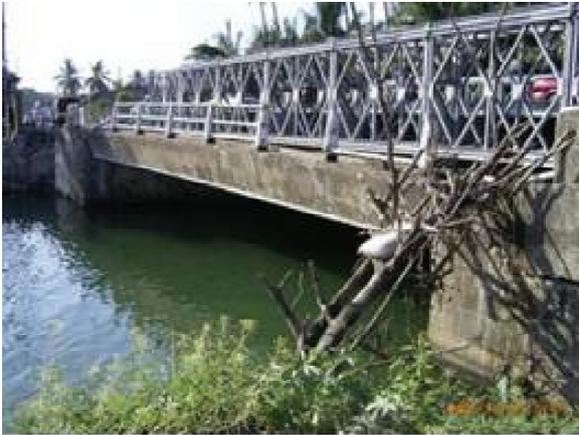
Photo-6. Restored bridge near to downtown Galle (91Kp, ③ in the map)

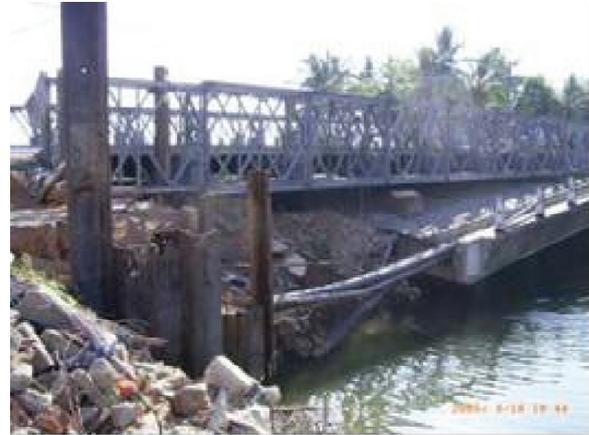
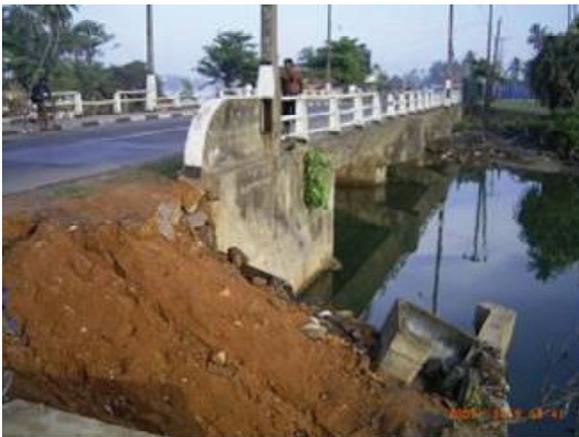
Photo-7. Erosion at approach  
(near 120Kp, ④ in the map)

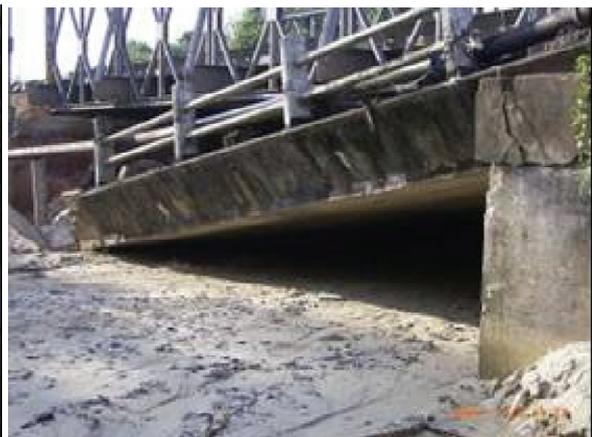
Photo-8. Bridge collapse due to erosion  
(137Kp ⑤ in the Map)

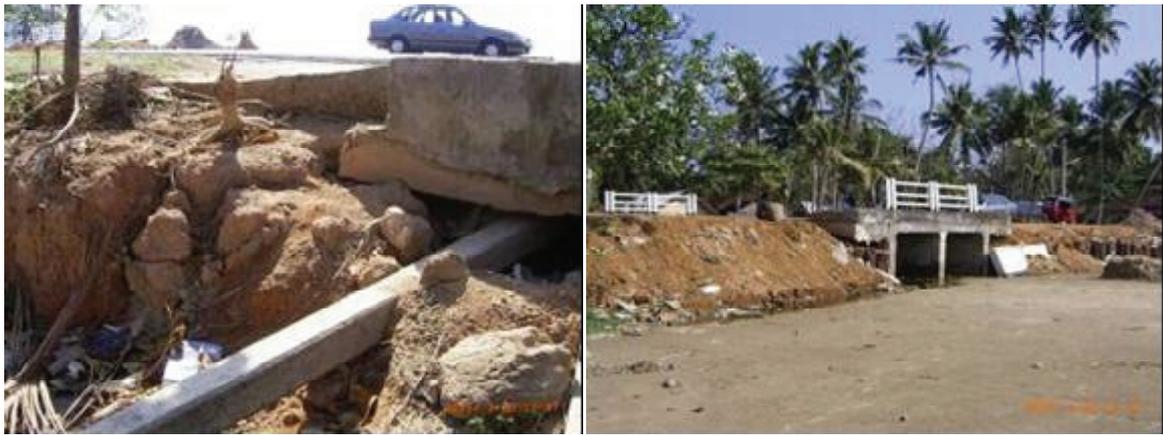
Photo-9. Culvert damaged (144Kp ⑥ in the map)

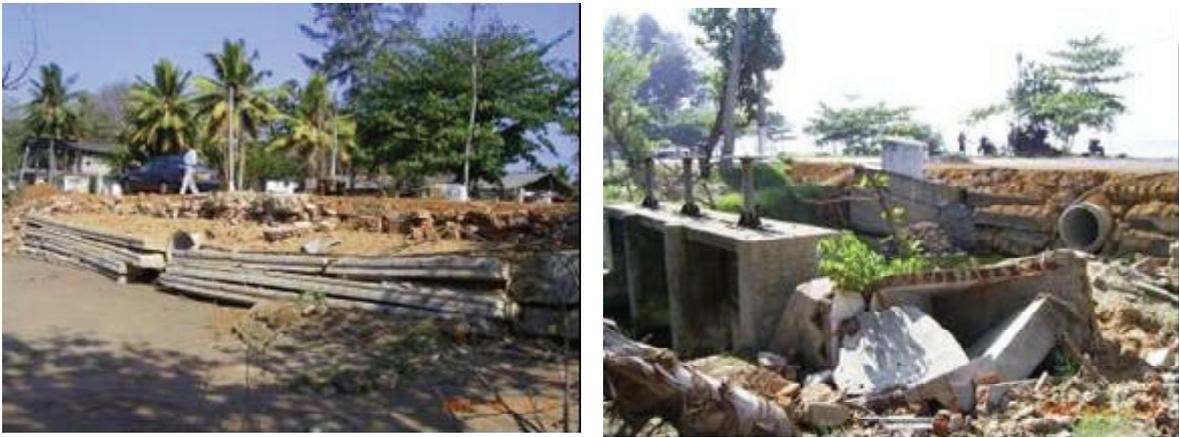
Photo -10. Damaged causeway with water pipes (145Kp ⑦ in the map)

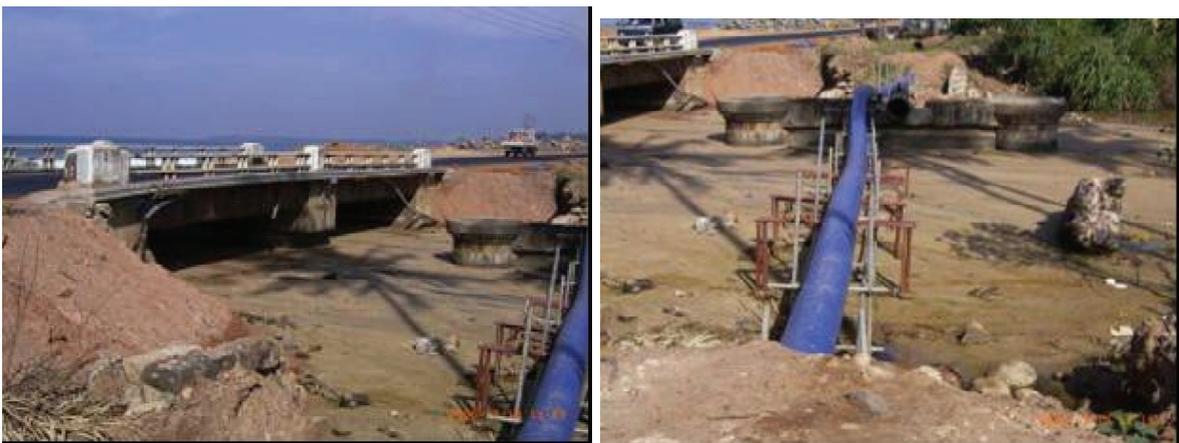
Photo-11. Undamaged bridge and recovered facilities in the upper stream (166kp, ⑧ in the map)

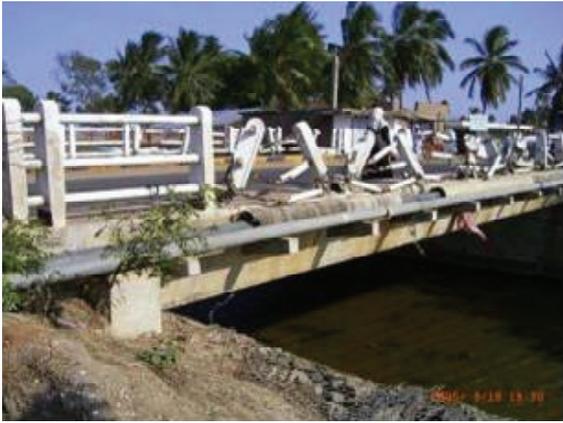
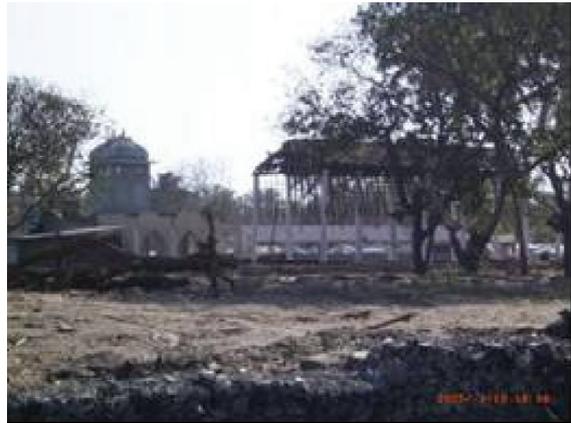
Photo-12. A bridge in Hambantota and damage around the bridge (⑨ in the map)
