## **REPAIR OF A SCOUR-DAMAGED PIER ON THE HISTORIC ROGUE RIVER (GOLD BEACH) BRIDGE**

### **Abstract**

This paper describes a foundation problem on a major historic coastal bridge in Oregon. The solution was to use an innovative contracting method of design-build for the pier repair, within a normal design-bid-build bridge rehabilitation project. The paper describes design solution using large diameter drilled shafts to underpin the damaged pier foundation.

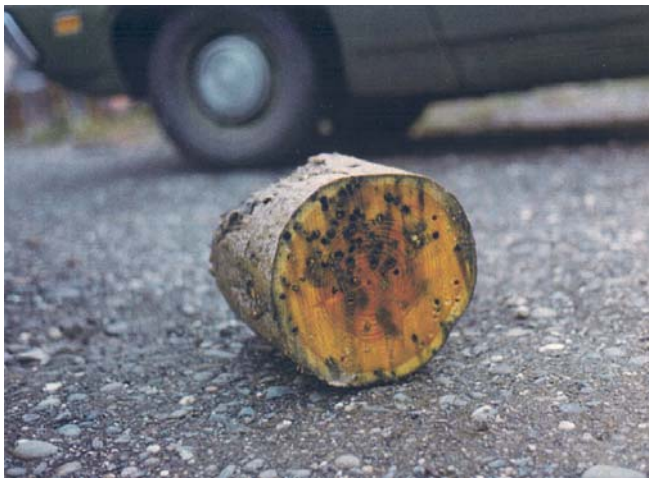
A dike built upstream of the bridge channelized the river flow and the channel began to migrate towards Pier 2. The channelization caused scour at Pier 2 severe enough to expose the outside rows of timber piles on the northwest corner of the pier. Marine borers (*Bankia*) had infested the exposed portions of the piles, weakening them.

The sheet piles installed during the 1975 repair were in poor condition with numerous areas that have corroded away completely. Further migration of the channel had exposed the bottom of the new seal along the north side of the pier. Up to 15 timber piles were exposed around the perimeter and had been damaged by marine borers (see Photo 3). Large voids were seen in the areas under the old seal where grout had been pumped during the first repair. Apparently, the grout was not installed effectively.

Photo 3 – Marine Borer damage to timber pile at Pier 2.

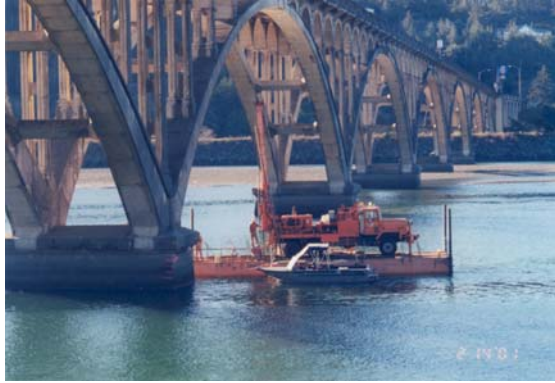
Existing boring information was inadequate for design purposes. The borings drilled for the original bridge were done with a cable tool drill, so no information on soil strength was available. The borings on the north and south side of the river revealed sand and gravel over rock, but none of the other borings, including the boring near Pier 2, which penetrated to an elevation of -21.3 meters, encountered rock. Obtaining new geotechnical information was necessary. (See Photo 4)

Photo 4 – Drilling subsurface borings at Pier 2.

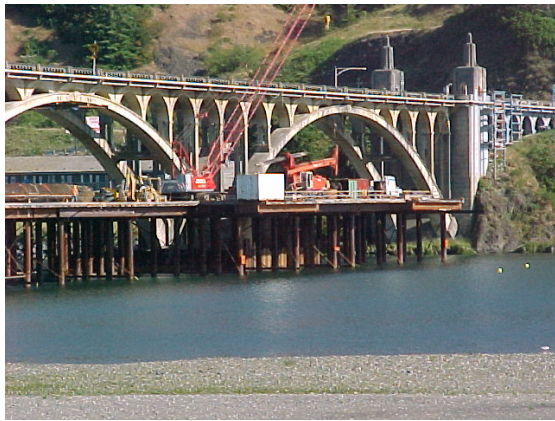
Photo 5 – Pier 2 Drilled Shaft Construction from Temporary Work Bridge

Hamilton Construction Company was awarded the contract and selected OBEC Consulting Engineers to perform the Pier 2 repair design and Golder Consultants to perform the geotechnical portion of this design. The final design was similar to ODOT's conceptual design. A collar would be installed around Pier 2 and attached to Pier 2 by post-tensioned members extending through the Pier 2 seal and anchored to the collar on both sides of Pier 2. Foundation support would be provided by six drilled shafts with diameters of about 2.13m (7 feet). (See Photo 5)

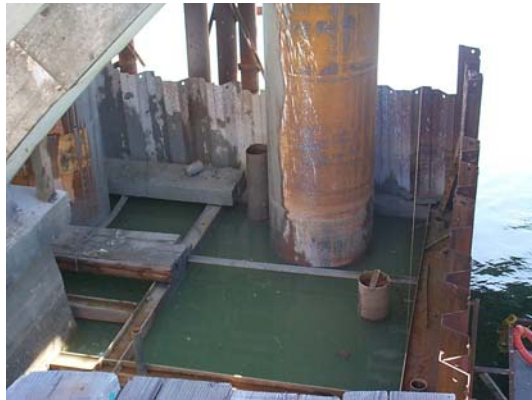
Photo 6 – New footing underpinning has 6- 2.5 m drilled shafts.

Three of the shafts would be installed on both the east and west sides of Pier 2. This arrangement was chosen because the north and south sides of Pier 2 are under the bridge, and it was felt that the limited vertical clearance under the bridge at Pier 2 would make installing shafts very difficult. The shafts were to be socketed well into the rock below the scour elevation of -27 meters. They were designed to be able to carry the design axial load wholly in the rock socket below scour elevation through both skin friction and end bearing. Originally, two tip elevations were planned, one for the more

intact rock, one for the softer rock, but all shafts were installed to the lower of the two elevations, -42 meters. (See Photo 6)

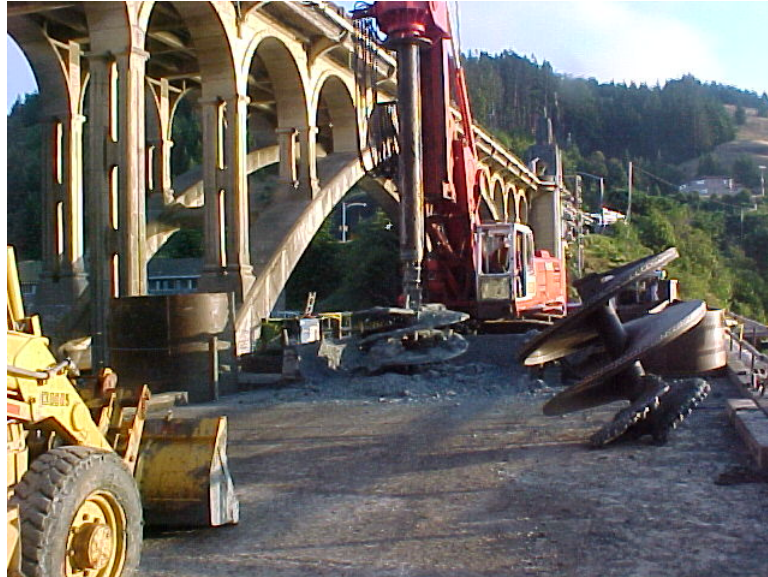
Photo 7 – Drilled shafts were drilled in full length casings 2 m into rock.

There were many challenges that had to be overcome almost from the beginning of the Pier 2 repair. Obstructions were encountered while installing the cofferdam. The available workspace around Pier 2 was extremely limited. The cofferdam surrounding Pier 2 was limited to maximum dimensions of about 21 by 23 meters. Access to Pier 2 was from the south, so equipment, supplies and spoils from drilling had to be moved almost the entire length of the work bridge to get to or from the worksite. The drilled shaft contractor had difficulty refining the shaft drilling and installation methods to efficiently complete the work during installation of the first shafts. The environmental permits did not allow any material to be deposited into the river, so special care had to be taken with the spoil excavated from the drilled shafts. There wasn't sufficient room to operate a crane large enough to install full length reinforcement cages for the drilled shafts. Therefore, the cages had to be installed in two sections. The first section had to be lowered into the shaft and braced, then the second could be lifted up and spliced to the first, then finally the entire unit lowered to its final elevation. When the horizontal holes for installing the post tensioning elements that connected the drilled shaft supported collar to Pier 2 were drilled, the holes were positioned to miss the existing timber piles. Unfortunately, not all of the piles were positioned where the original plans showed them to be, and the piles had to be drilled through, causing work slowdowns. All during this time the cathodic protection segment of the project was under way, the Rogue River (Gold Beach) Bridge was open to traffic, and tour and sport fishing boats were traveling below it. (See Photos 7 & 8)

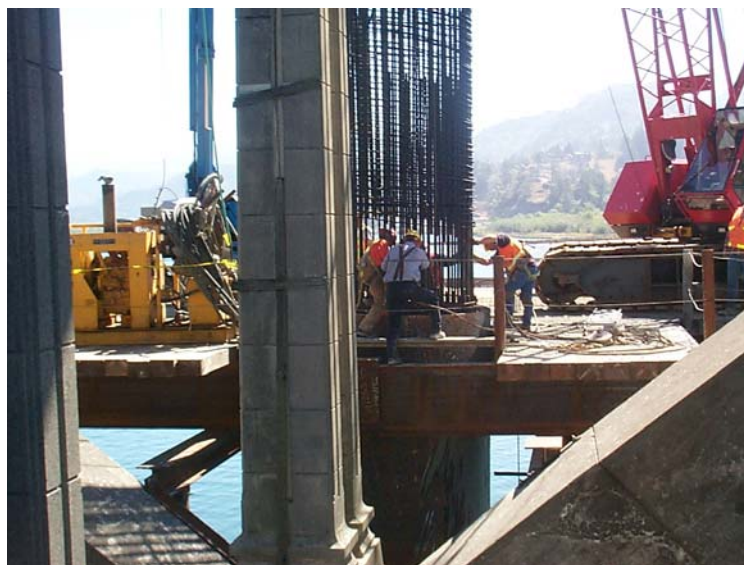
Photo 8 – Rebar cage is lowered into place just prior to tremie concrete placement.
