POST-EARTHQUAKE EVALUATION OF THE ALASKAN WAY VIADUCT

Jugesh Kapur¹, David Goodyear², Tim J. Ingham³

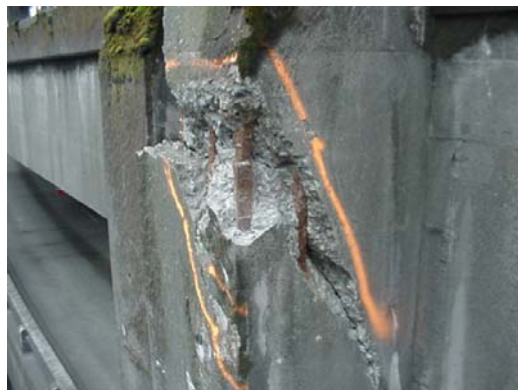
Figure 2, Damage to Bent 100, East Column, Upper Deck Joint

The damage to the structure consists of cracking of the transverse floorbeams and joints within each bent, and of the longitudinal edge girders [7]. The cracking of the joints was the most severe damage. The upper, east knee joint of Bent 100 was badly cracked and spalled and the reinforcement within this joint was exposed. Some of this reinforcement was fractured. The damage to the joint is shown in Figure 2. The upper, east knee joint of Bent 97 was also cracked. The damage to this joint is shown in Figure 3.

Table 1, Damage to Joints			
Bent	Joint	Joint	
		West	East
100	Upper	No cracking	Severe cracking and spalling of concrete; some fracture of reinforcement; see Figure 2
	Lower	No cracking	Minor cracking

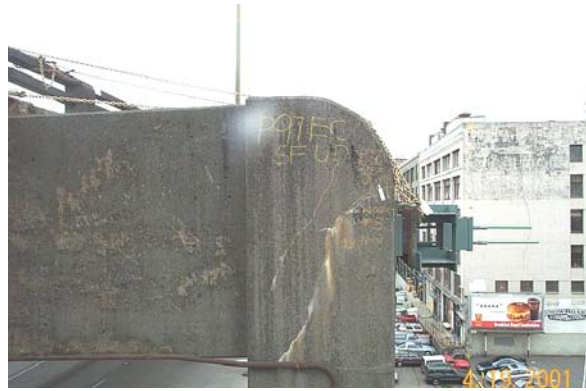
Figure 3, Damage to Bent 97, East Column, Upper Deck Joint

Table 1, Damage to Joints			
Bent	Joint	Joint	
		West	East
97	Upper	No cracking	Moderate cracking, see Figure 3
	Lower	No cracking	Minor cracking
98	Upper	No cracking	Moderate cracking
	Lower	Minor cracking	No cracking
99	Upper	Minor cracking	No cracking
	Lower	No cracking	No cracking

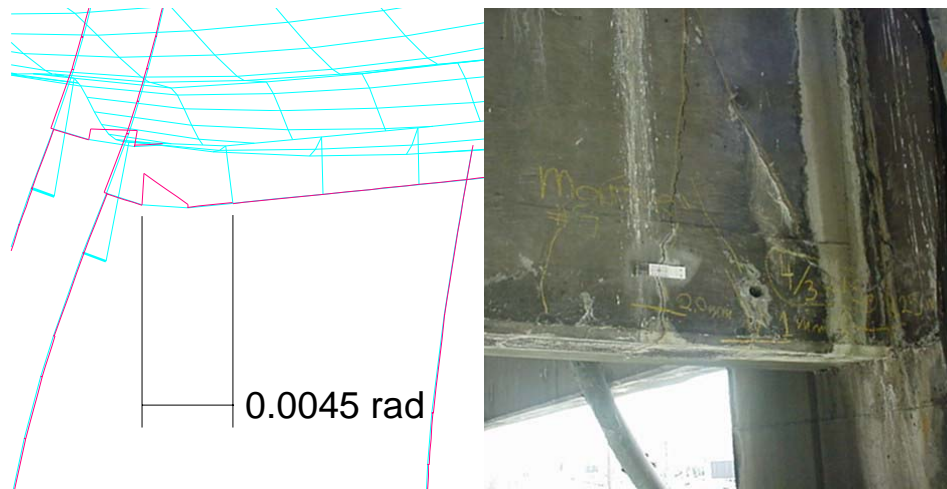
Figure 7, Curvature of Bent 100, Lower Crossbeam, in Damaged Condition

Figure 7 shows the curvature of the lower crossbeam in the damaged condition (after removing the lateral load), plotted on the deflected shape of the structure. The curvature is greatest in the element nearest the column since this is the weakest section (in positive bending). The curvature particularly tends to concentrate at the face of the column, where the moment is largest. A more reliable measure of the damage is the total rotation of the plastic hinge, which is 0.0045 radians. The average curvature of the crossbeam is then about 0.000075 /inch, which is consistent with significant cracking of the crossbeam. The observed cracking of the crossbeam is shown in Figure 7 also.

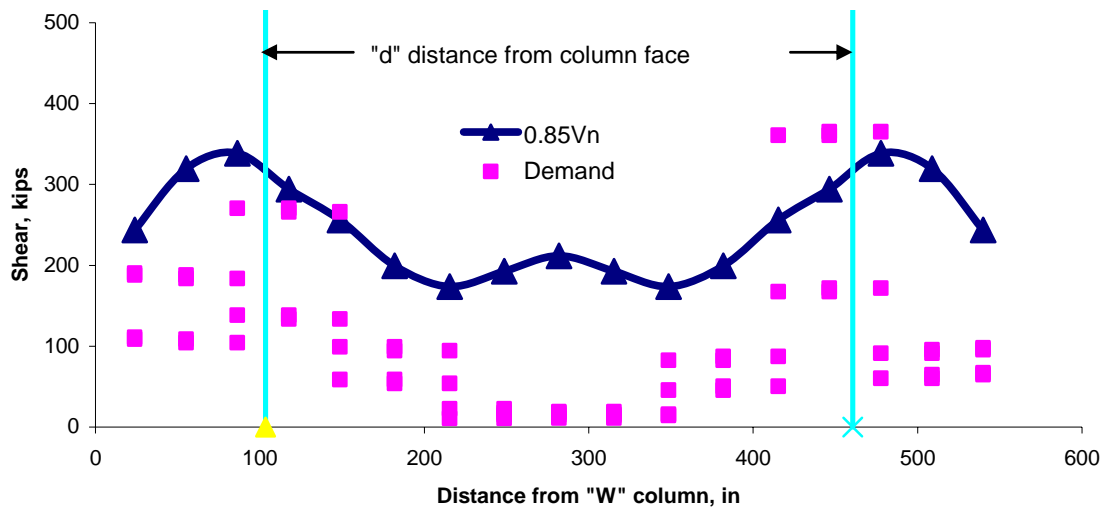
Figure 8, Bent 100, Upper Crossbeam Shear Diagram

In all cases the flexural demands were less than the calculated capacity. This was not the case for shear, however. Figure 8 compares the shear demands on the upper crossbeam of Bent 100 with the capacity of that element. The cross-beam is overloaded in the vicinity of the failed hinge—on the east side of the structure.

$$RF = \frac{(0.85)(301) - (1.2)(91) - 49}{(1.8)(95)(1.3)} = 0.44 .$$

This result strongly suggests that trucks should be prevented from using the structure until the earthquake damage is repaired and other general rehabilitation measures are completed.
