## **DAMAGE CHARACTERISTIC OF BRIDGES DUE TO 2010 CHILE EARTHQUAKE**

Kazuhiko KAWASHIMA<sup>1</sup>, Shigeki UNJOH<sup>2</sup>, Jun-ichi HOSHIKUMA<sup>3</sup> and Kenji KOSA<sup>4</sup>

This paper presents damage of bridges during the 2010 Chile earthquake based on site investigations. Damage feature of bridges including the effect of in-plane rotation of bridges, insufficient seat length, absence of anchor between superstructure and substructures at bearings and lack of bearing capacity of foundations is presented. Design practice of bridges in Chile is also introduced.

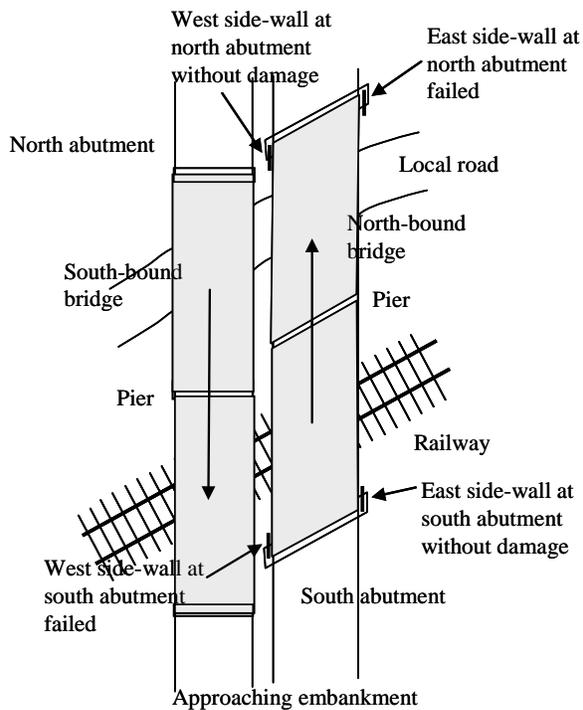
There were several skewed bridges which collapsed primarily or partially due to the rotation of bridges. One of the most typical examples of collapse due to rotation of skewed bridges was Hospital Overcrossing along the Highway No. 5 at crossing over railways, about 43 km north of Rancagua City. It was a two span simply supported PC I-girder bridge. The north-bound overcrossing collapsed while the south-bound overcrossing did not collapse as shown in Fig. 5 and Photo 1. Note that the north-bound overcrossing was constructed in the concession while the south-bound overcrossing was designed based on the original Chile design practice. There was another two span simply supported steel girder overcrossing beside the Hospital Overcrossing, however since it was a very old bridge, it is not described here. This old bridge was demolished after the earthquake. The north-bound overcrossing consisted of three PC I-girders with a skew angle of about 60 degree. Transverse beams were not set to I-girders. Piers and abutments of both the north- and south-bound bridges did not suffer serious damage although slight cracks were found. Photo 2 (a) shows seat at the north abutment of the north-bound overcrossing. The seat was 1.2 m wide in the longitudinal direction, so it was 0.85m wide in the skewed longitudinal direction. Neoplane pads were used to support PC girders without anchor. It is known from failure of the front wall at the south abutment shown in Photo 2(a) that a PC I-girder supported at the pedestal dislodged from this point. This shows that the north bridge of the north-bound overcrossing rotated in the clockwise direction. This is the direction anticipated to occur due to rotation of the north bridge. On the other hand,

Fig. 5 Collapse of North-bound Hospital Bridge

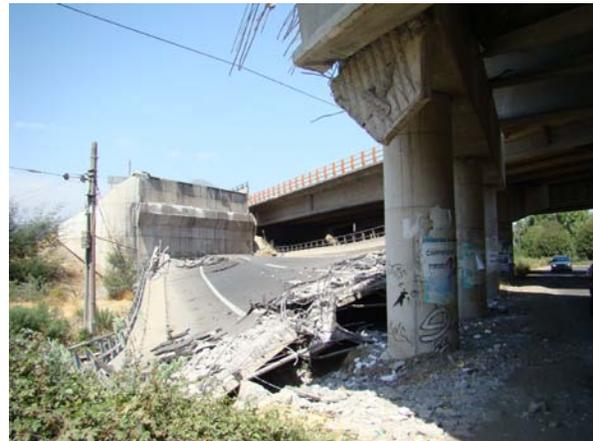
Photo 1 Collapse of north-bound Hospital Overcrossing (Courtesy of Ministry of Public Works)

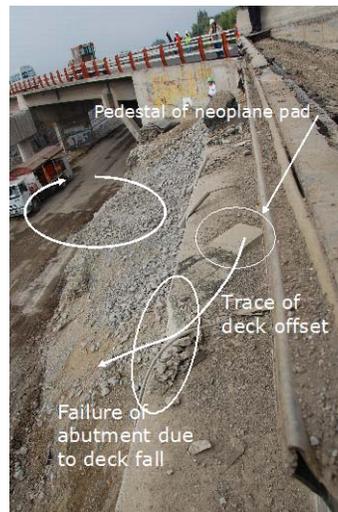
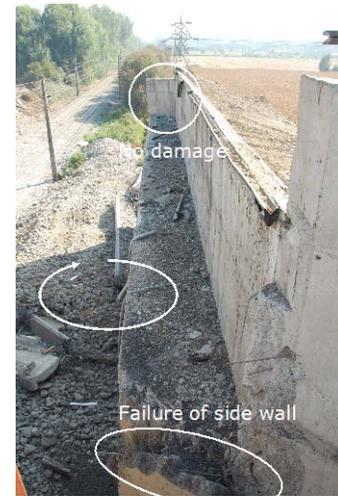
Photo 2 Evidence of rotation of the north-bound bridge

Photo 2(b) shows failure of the west side wall at the south abutment of the north-bound overcrossing. Note that the east side wall did not suffer any damage. This is in agreement with the anticipated direction of rotation. Consequently, this is also evidence that the south bridge of the north-bound overcrossing collapsed significantly affected by rotation of the bridge in the clockwise direction. Because transverse beams were not set to I-girders in the north bound bridges, it is likely that connection of I-girders by concrete slab deck could easily deteriorate once one of the three I-girders dislodged from its support, which in turn resulted in total collapse of the bridge.

(a) North abutment

(b) South abutment

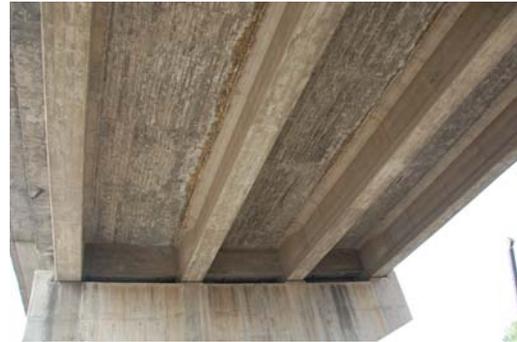
On the other hand, Photo 3 shows the south-bound overcrossing which did not suffer damage. It was an almost straight overcrossing and this was in contrast to the north-bound overcrossing. Transverse beams were set between four PC I-girders. Side stoppers were also set at both ends on the top of lateral beam for preventing excessive

superstructure drift in the transverse direction. It is considered that these countermeasures contributed to better performance in the south-bound overcrossing than the south bound bridge.

Photo 3 South-bound overcrossing which suffered almost no damage

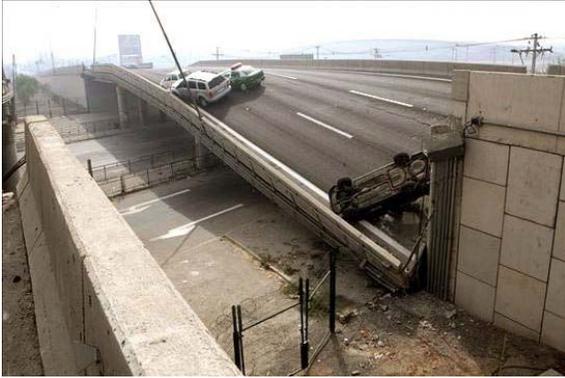
Both outer and inner bounds of Mira Flores Overcrossing collapsed as shown in Photo 4. It is obvious that deck rotation contributed to the collapse of this bridge. It had 22.5m+28m+22.5m long spans with a skew angle of about 70 degree. Two sets of moment resisting reinforced concrete pier consisting of a cap beam and five 0.9 m diameter columns supported a superstructure. The column suffered only minor flexural cracks, but bearing supports on two piers suffered extensive damage as shown in Photo 5. Photo 6 shows a side stopper for restricting drift in the transverse direction and uplift of I-girders. A pair of two side stoppers was set at both sides of an I-girder at the lower flange as shown in Fig. 6. Two anchor bolts with a diameter of about 13 mm were used to set a side stopper in position. However the anchors were too weak to limit lateral offset of the I-girders. Four abutments at both ends of two overcrossings did not suffered damage, however four side walls which were located beside the acute corners of the four collapsed bridges were destroyed. This is an evidence of the bridge rotation. The seat  $S_E$  was about 0.5 m at the two abutments.

Photo 4 Collapse of Mira Flores Overcrossing along Americo Vespucio Freeway (After AP)

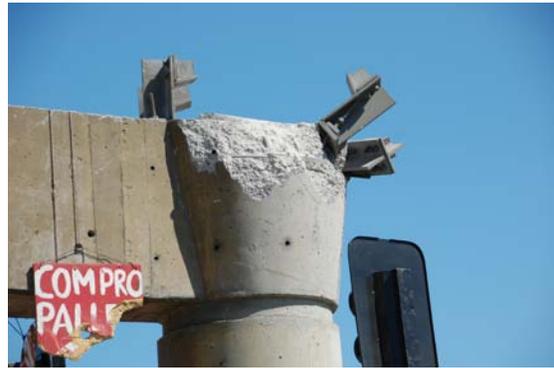
Photo 5 Failure of supports, Mira Flores Overcrossing

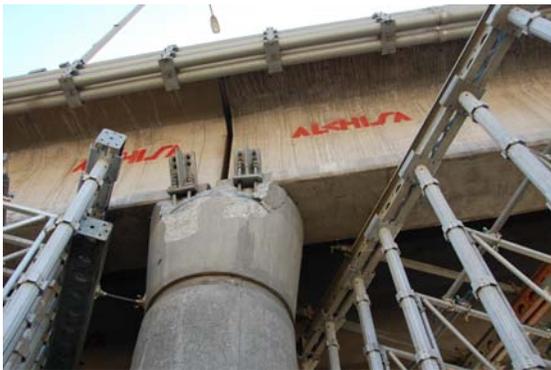
The inner bound of Lo Echeveres Overcrossing collapsed while the outer bound bridge did not collapse but it was shored due to damage of supports. They were 26.5 m +34m+26.5m long bridges with skew angle of about 60 degree. The deck slab was continuous at the joints between adjacent decks. Photo 7 shows damage of supports as well as two side stoppers of the outer bound bridge. The side stoppers were weak to limit offset of the I-girders in the transverse direction.

Photo 7 Damage of supports, Lo Echeveres Overcrossing

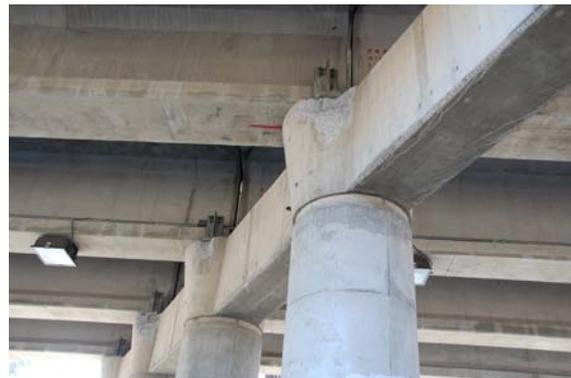
On the other hand, San Martin Overcrossing did not collapse but suffered damage at their supports as shown in Photo 8. This provides a good understanding how the girders unseated due to failure of supports in Mira Flores and Lo Echeveres Overcrossings.

Photo 8 Damage of support of San Martin Overcrossing

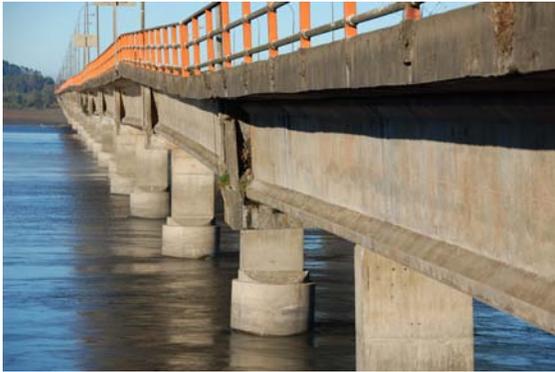
Photo 9 Settlement of girders of Juan Pablo II Bridge (from right dyke)

Juan Pablo II Bridge is a 2310 m long, 21.9 m wide, 70 span simply supported bridge crossing Biobio river in Concepcion City as shown in Photo 9. It was built in 1974. This is a bridge with major importance for transportation in Concepcion. The decks are supported by moment resisting piers. As shown in Photo 9, extensive settlement of decks as high as 0.5 m was observed. Damage could be investigated only at an approaching span at the right river dyke. Only at this approaching span, three reinforced concrete columns collapsed in shear and a lateral cap beam suffered extensive damage due to shear. Photo 10 shows shear failure of one of the three columns at the right dyke. Because this bridge was built in the days when the importance of shear capacity was not recognized, the damage was resulted from insufficient shear capacity. The failure of the column resulted in extensive settlement of the bridge as shown in Photo 9. It is likely that the settlement was also developed due to insufficient bearing capacity of foundations.

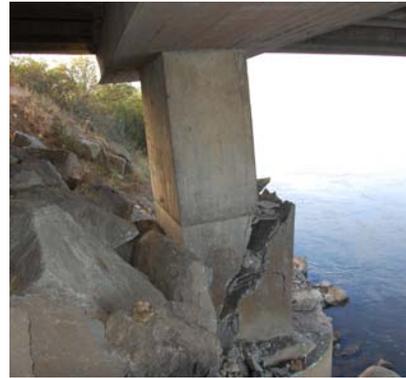
Photo 10 Shear failure of a column at the right dyke, Juan Pablo II Bridge

Major structural components including columns and cap beams failed in shear and flexure in the bridges which were unreinforced or constructed in the early days as shown in Photo 10. In the damage shown in Photo 10, the shear capacity of concrete was probably overestimated in those days. Except those bridges built in the early days, bridges built in

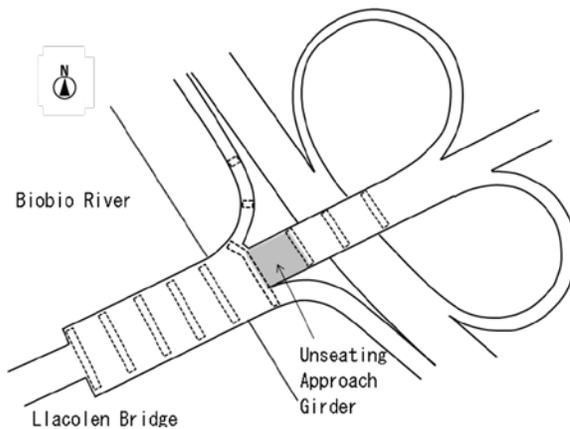
Fig. 7 Approach structure for Llacolen Bridge

Similar to Juan Pablo II Bridge, this is also a critically important bridge crossing Biobio river at the center of Concepcion City. Main spans of the bridge did not collapse, but an approach span at the right collapsed as shown in Fig. 7 and Photo 11. It is obvious that seat length was very short, and this resulted in unseating of the approaching span. Photo 12 shows failure of concrete slab of the collapsed span. It is likely in the above mentioned PC I-girder bridges that similar failure due to its insufficient capacity of concrete slab resulted in collapse of a whole bridge once an I-girder unseated from its support.

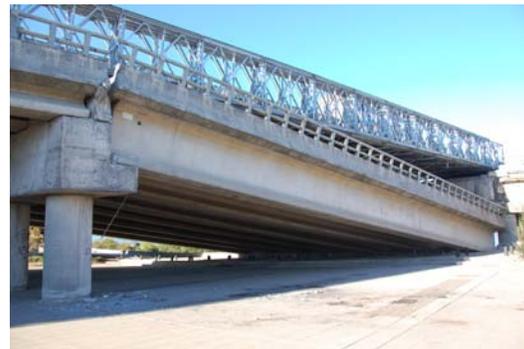
Photo 11 Collapse of an approaching span

Collapse of some bridges could be prevented if the seat of support was much longer. Because cost increase for extending seat is generally limited, it is recommended to adopt more redundant seat so that unseating of a superstructure from its supports could be avoided. Connection between adjacent superstructures or connection between a superstructure and its supporting substructure are also effective.

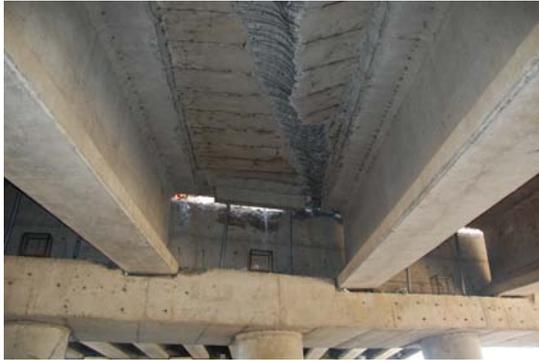
Photo 12 Failure of concrete slab

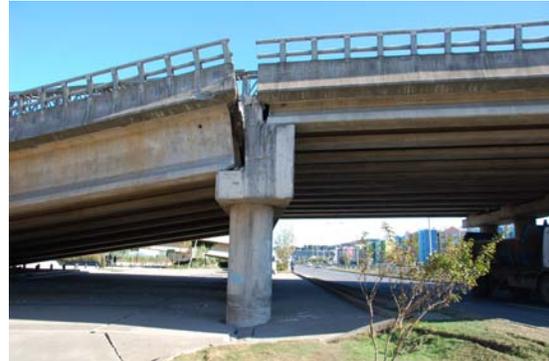
Photo 13 Lateral drift of the pier supporting the span which unseated at the other end

Photo 13 shows inclined pier which supported the other end of the collapsed span. Around the bottom of the pier, 0.6 m deep 0.4 m wide settlement of soils was observed underneath the concrete pavement as shown in Photo 14. It is likely that sand liquefaction occurred around the span, and this developed excessive lateral displacement of the pier, which in turn resulted in dislodgement of the approaching span.

In the bridges in Arapco and Concepcion, several bridges collapsed due to excessive relative displacement between or lack of bearing capacity of foundations as shown in Photos 13 and 19. It is important to correctly consider the effect of soil liquefaction.

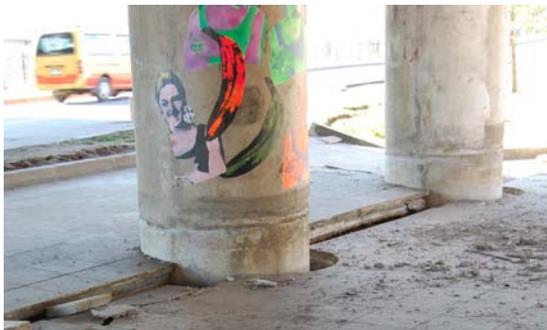
Photo 14 Settlement around a pier

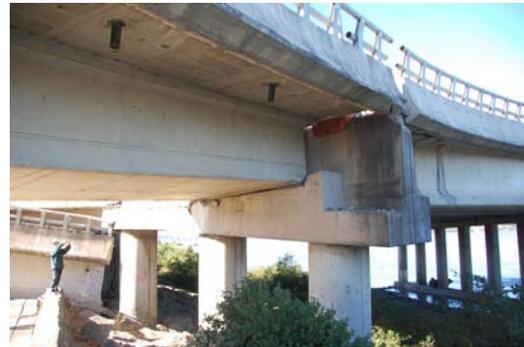
Photo 15 Uplift and outward drift at an inner end support

Photo 15 shows damage of an on-ramp curved three-span continuous box girder bridge close to the above mentioned collapsed approaching span. Curved bridges tend to

have larger response in the outward direction than the inward direction due to the arch action [Kawashima and Penzien 1979]. Furthermore inner corners are likely to subject to uplift due to warping of the bridge. It is seen in Photo 15 that outward drift of the bridge as well as uplift at the inner corner are observed.

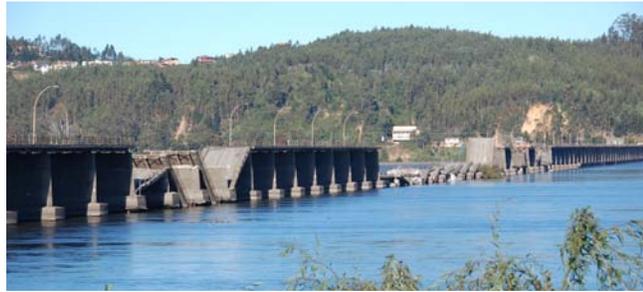
Photo 16 Collapse of Biobio Bridge

Biobio Viejo Bridge was a 1646 m long 98 simply supported steel girder bridge built in the 1930s. It was an important bridge for crossing Biobio River in Concepcion City. It was repaired after partly damaged due to the 1960 Chile earthquake. It was known based on the investigation of Japan International Cooperation Agency (JICA) that this bridge was insufficient for normal transportation due to superannuation of structural members. So it was used only for pedestrian bridge. As shown in Photo 16, several spans each collapsed at three locations.

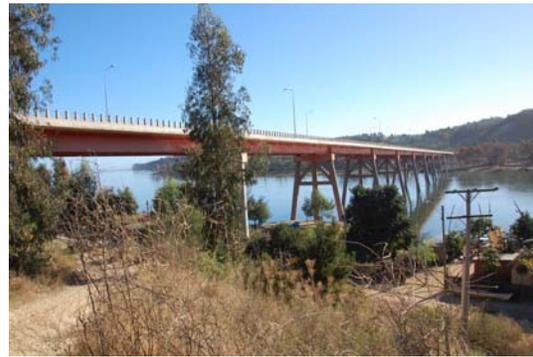
Photo 17 Maule Bridge

Maule Bridge was a 913 m long plate girder bridge consisting of two eleven span continuous bridges as shown in Photo 17. Three steel girders were supported by neoprene pads at columns while they were supported by steel fixed bearings at abutments in both ends. Consequently large inertia force of superstructures concentrated at the fixed steel bearings on the abutments in the longitudinal direction. This resulted in rupture and buckling of web plates, flanges and stiffeners as shown in Photo 18. Because rupture of lower flange had already propagated to the web plate, it was very critical for collapse. As well as large inertia force of eleven spans, incoherent response between the abutment and neighboring columns developed large lateral force at the fixed bearings on the abutment. Buckling of diagonal braces and offset of steel girders in the transverse direction also occurred.

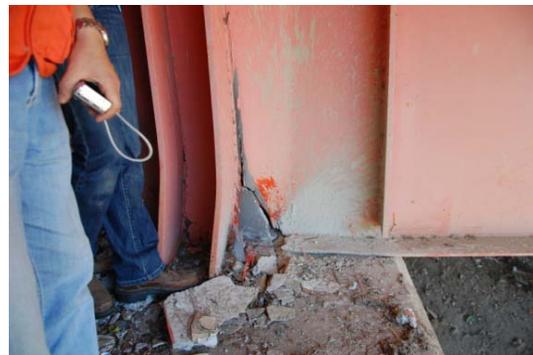
Photo 18 Rupture of web plates, flanges and stiffeners of girder at fixed bearing

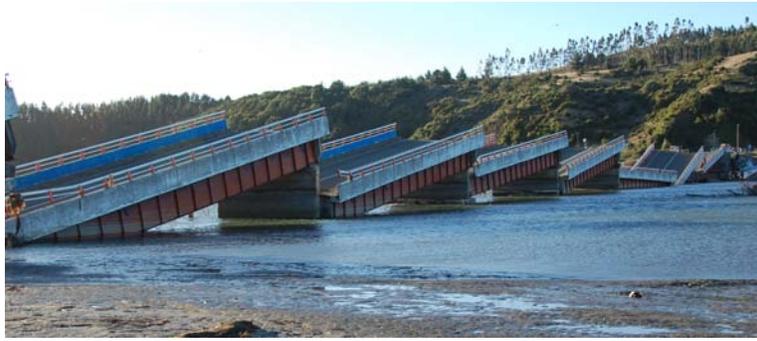
Photo 19 Collapse of Tubul Bridge

There were bridges which suffered damage due to soil liquefaction in the coastal region. Tubul Bridge was an eight span simply supported plate girder bridge in Arauco. All eight spans collapsed as shown in Photo 19. Because piers extensively tilted and approaching road embankments slid and settled sideways, it is considered that extensive soil liquefaction occurred all around the bridge. Seat length was only 0.38 m at both abutments. Raqui II Bridge was a four span simply supported plate girder bridge located very close to Tubul Bridge. Two spans collapsed in a similar way with Tubul Bridge.
