DAMAGE OF HIGHWAY BRIDGES DUE TO THE GREAT EAST JAPAN EARTHQUAKE

Jun-ichi Hoshikuma¹

Abstract

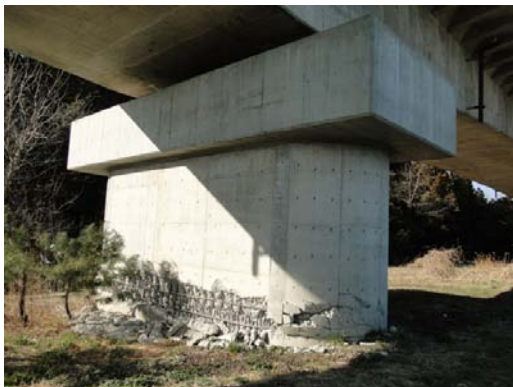
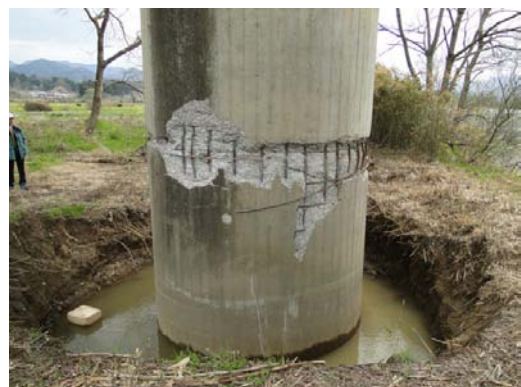
Intensive damage due to the ground motion was developed in many unretrofitted bridges designed in accordance with pre-1980 design specifications. Almost of damage modes of those bridges have ever been observed in the past earthquakes. Photos 1 to 3 show the damage to reinforced concrete piers, steel bearing supports and the attachment of the bearing support to pier top or the superstructure, respectively. Although some bridge columns collapsed during the 1995 Kobe earthquake, the only one bridge collapsed during the 2011 Great East Japan earthquake. As shown in Photo 4, an old steel girder bridge supported by steel pile-bent columns (Rokko Ohashi Bridge) in the local roadway was collapsed due to the ground motion of the earthquake. Rokko Ohashi is to be replaced a new bridge and the new one was being constructed at the time of the earthquake.

Photo 1 Damage of Reinforced Concrete Columns at Cut-off Section of Longitudinal Reinforcement

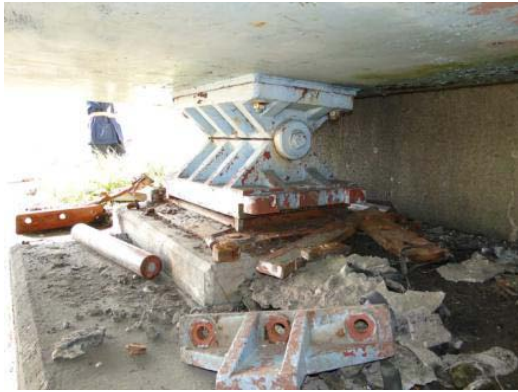
Photo 2 Damage of Steel Bearing Support

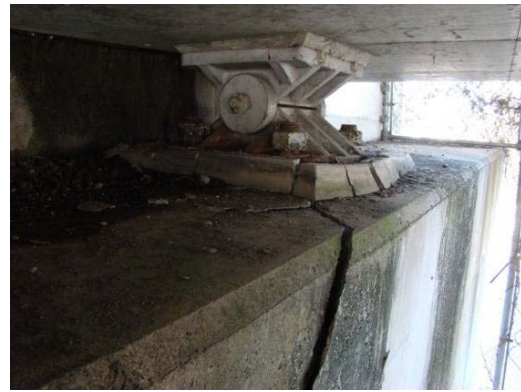
Photo 3a Damage of Pier Top

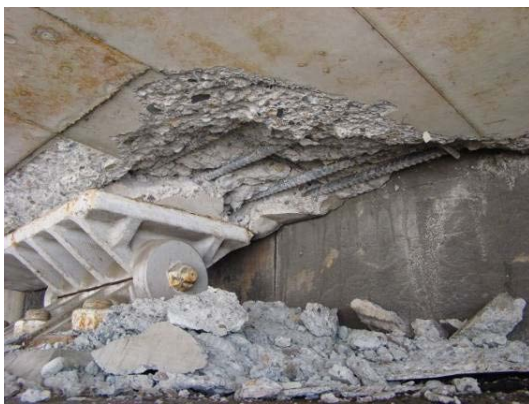
Photo 3b Damage of Attachment of Bearings to Superstructure

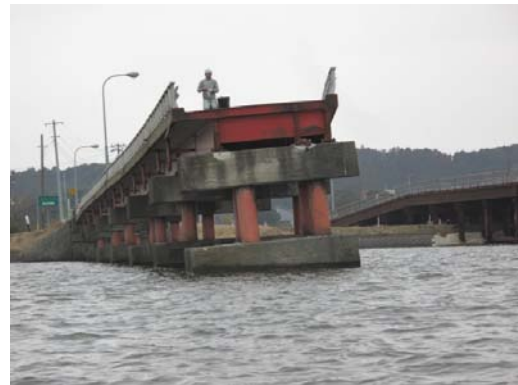
The ground motion effect to damage of bridges was less significant than the tsunami effect. One bridge (Rokko Ohashi Bridge, an old steel girder bridge supported by steel pile-bent columns located in Ibaraki prefecture) was collapsed due to the ground motion of the earthquake. Although the collapsed bridge was observed at the only Rokko Ohashi in the highway bridges, it was found in the bridge designed in accordance with pre-1980 design specifications that damage to RC columns at section of cut-off of longitudinal rebars, damage to RC pier-wall with small amount of reinforcement, damage to steel bearings and attachment of bearings, damage to bracing and steel members, and subsidence of backfill soil of abutment. These damage modes have already observed in the past earthquakes. However, rupture of elastometric rubber bearings were observed at the Sendai-Tohbu viaduct designed based on Post-1995 design specifications.

Photo 4 Collapse of Steel Pile-bent Columns

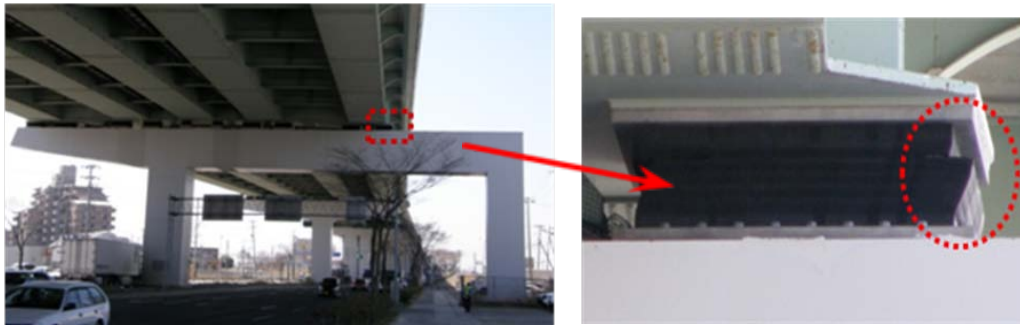
However, as shown in Photo 5, it should be noted that elastometric rubber bearings ruptured at the Sendai-Tohbu viaduct designed based on Post-1995 design specifications. Fig. 2 illustrates the structure of the Sendai-Tohbu viaduct and the positions of the elastometric rubber bearing with the rupture. As seen in Fig. 2, bridge structure in this junction is very complicate. Bridge width changes significantly in the 4-span continuous box girder with the change of the section. Span length of the section from P52 to 56 is around 70m, while that from P56 to P58 is 39m. P52 and P53 are single-column hammerhead steel piers, while P54, P55 and P56 are two-column steel frames. Rupture of the elastometric rubber bearings in the transverse direction was observed at the deck-end of P52 side in 4-span continuous box girder, though there are few damaged elastometric rubber bearings at the other deck-end side of the box girder on Pier 56. Photo 6 shows failure mode of the elastometric rubber bearing with the rupture. Comparison of the failure mode with the result of the shear loading test should be made, to estimate the capacity of the elastometric rubber bearing and the applied seismic force combination.

Photo 5 Rupture of Elastomeric Rubber Bearings in Sendai Tobu Viaduct (P54, Two-column Steel Frame)

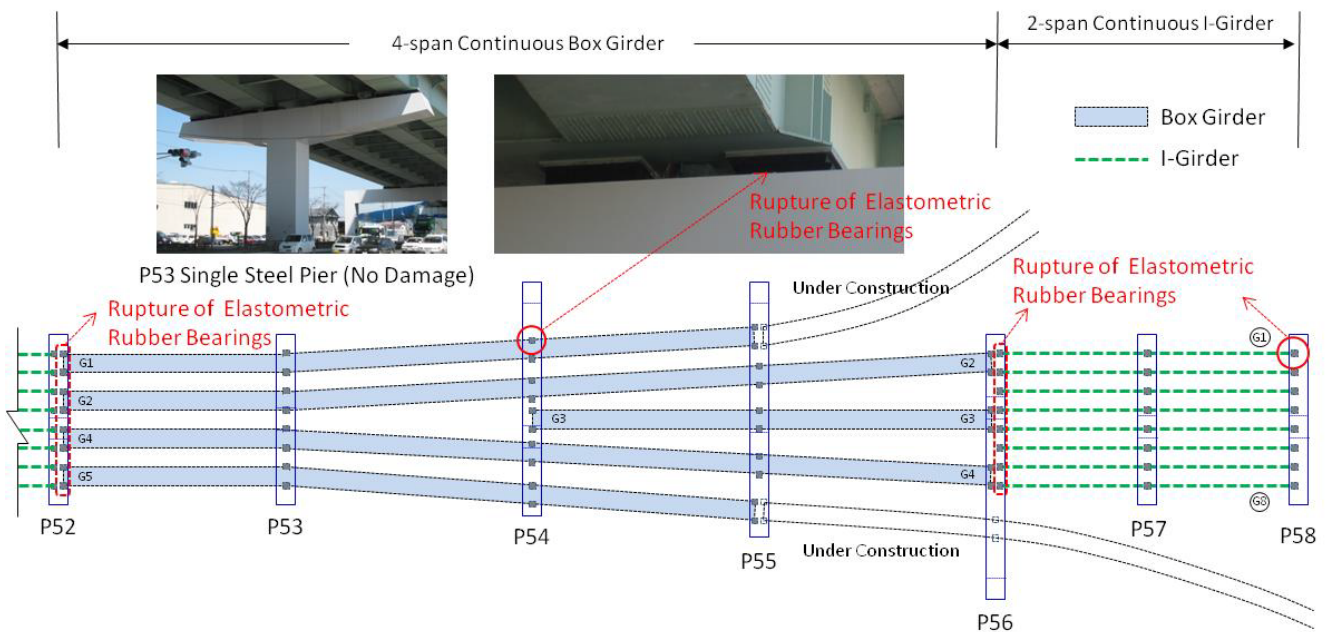
Fig. 2 Bridge Structure of Sendai-Tobu Viaduct and Position of Elastomeric Rubber Bearing with Rupture

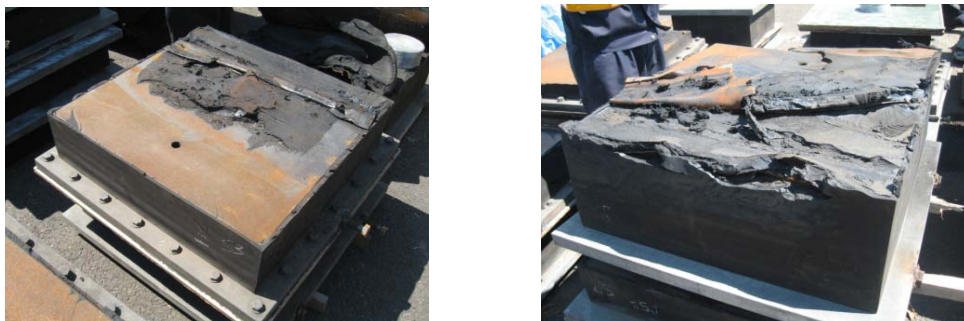
Photo 6 Details of Rupture of Elastomeric Rubber Bearings

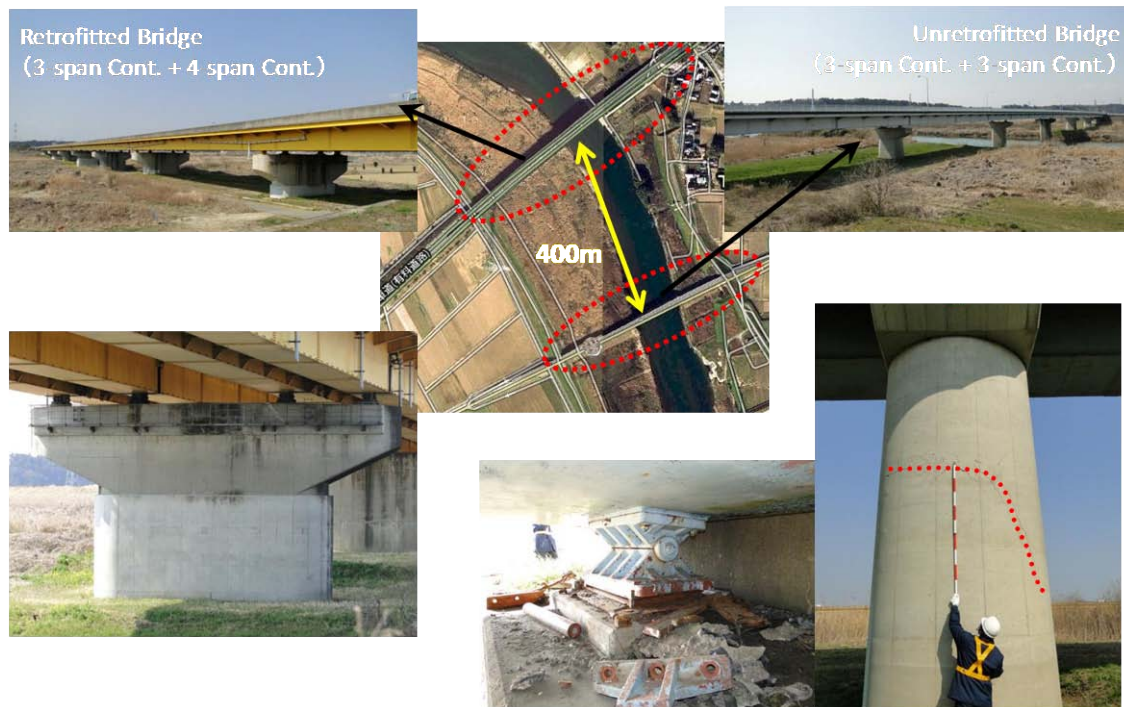
Photo 7 exemplifies the effectiveness of the seismic retrofit for bridge columns. As seen in Photo 7, there are two adjacent river-crossing bridges. Since one bridge (Nakagawa Bridge) is on the designate emergency route, bridge columns designed with the pre-1980 specifications have already been retrofitted by reinforced concrete jacketing. The other bridge (Kunita Ohashi Bridge) is on the local roadway and the bridge columns have not yet been retrofitted at the earthquake. Although Kunita Ohashi Bridge suffered from the vulnerable damage and thus lost the serviceability for the bridge, Nakagawa Bridge did not suffer from the damage and kept the serviceability soon after the earthquake. Seismic performance shown in these two bridges clearly exhibits the effectiveness of the seismic retrofit.

Photo 7 Comparison of Seismic Performance between Adjacent Two Bridges
(Nakagawa Bridge and Kunita Ohashi Bridge)

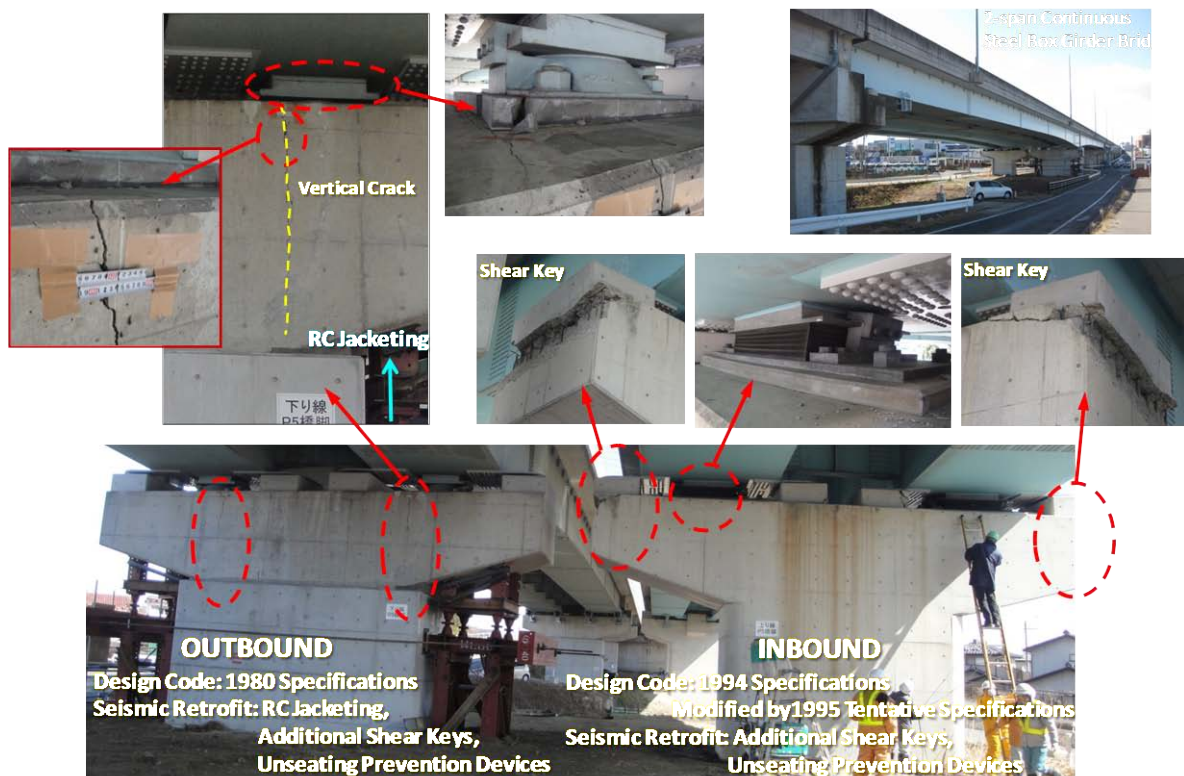
On the other hand, there are a few remarkable damage examples in the retrofitted bridges. Photo 8 shows adjacent two reinforced concrete columns in Kameda Ohashi Bridge. Each column supports 2-span continuous steel box girder at the middle. The outbound column was designed with 1980 specifications and retrofitted by reinforced concrete jacketing for strengthening the cut-off section without increasing the flexural strength of the column base. Furthermore, additional shear keys were anchored to column top to supplement the strength of the existing bearings. Although no damage was found to the steel bearings and shear keys, vertical cracks of nearly

10mm width were observed at the beam section as shown in Photo 8. The inbound column was designed with 1994 specifications basically and some modifications were made based on the 1995 tentative specifications (published soon after 1995 Kobe Earthquake). In the inbound column, elastometric rubber bearings were deformed in the transverse direction and the side stoppers were failed. Concrete of the beam edge portion attaching the supplemental shear keys also spalled off (see Photo 8) due to the transverse seismic force induced by the inertia of the superstructure, while vertical crack observed in the beam of the outbound column was not developed in the inbound beam.

Photo 8 Comparison of Damage Mode between Adjacent Two Bridge Columns

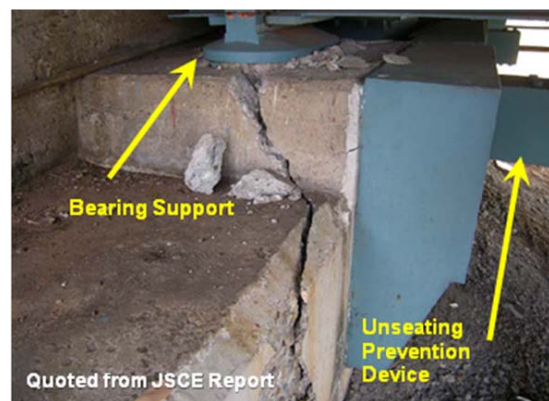
Photo 9 shows the failure of pier top. This type of damage has ever observed in the old bridge columns since the past earthquakes. Bearing capacity of the pier top was insufficient to transmit the seismic force to column. It should be noted in this bridge that the crack reaches the portion of the anchor bars of the steel bracket for attaching the unseating prevention devices. Since the unseating prevention devices should work at the unexpected situation of failure of bearing supports.

Photo 9 Crack to Pier Top Affects Attachment

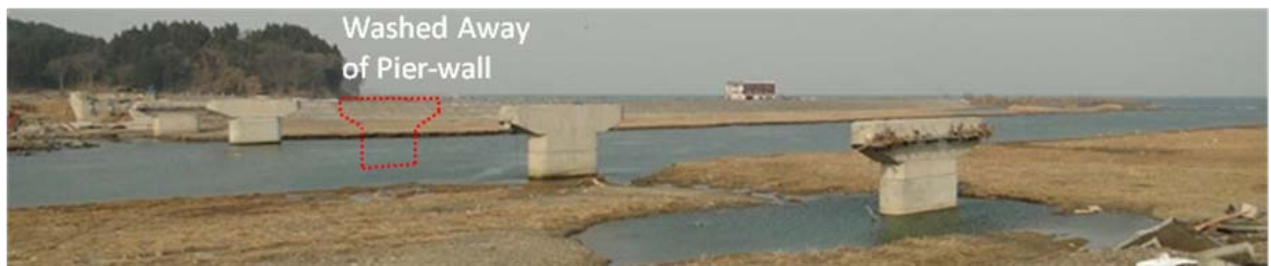
The bridge shown in Photo 10a is a 6-span steel girder bridge (twin three-span-continuous girders), namely Koizumi Bridge. The steel girder was supported by RC pier walls with steel pipe piles. The pier walls with the fix bearings (P2 and P4) were retrofitted by FRP sheets, furthermore viscous dampers were installed to the deck-ends. The height of tsunami has been estimated exceeding 10 meter high in this area, which means the steel girder was completely inundated with tsunami. Tsunami effect was so significant to Koizumi Bridge that the whole girder were washed away upstream and one RC pier-wall (P3) was also washed away. The pier-wall of P3 supported two girders with movable bearing supports was found about 50m away from original position, while the pile foundation and the footing for P3 remained at the original position. The pier-wall failed at the bottom section as shown in Photo 10b. The probable reason for only P3 being washed away was due to smaller ultimate strength than the other pier-walls. It is also noted that backfill soil of abutment was also washed away at both sides.

Photo 10a Washed Away of Steel Superstructure and Pier-wall (Koizumi Bridge)

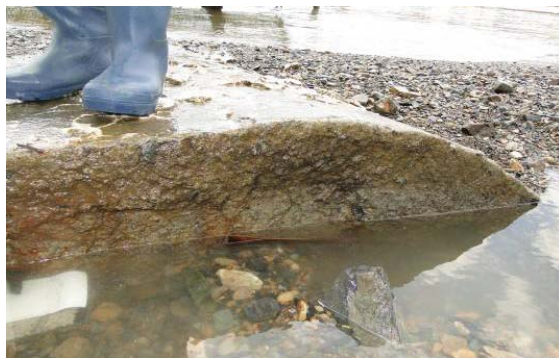
Photo 10b Failure Section of Pier-wall (P3)

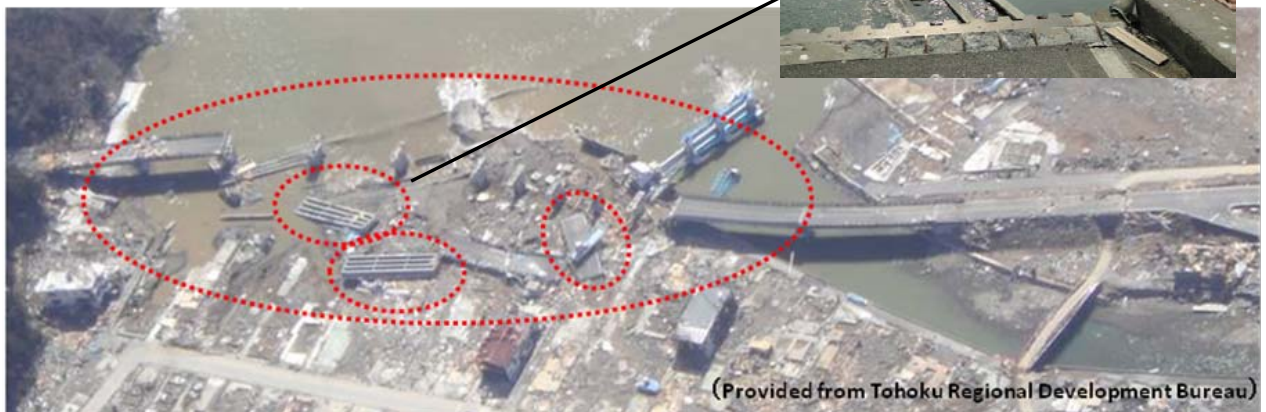
Photo 11 shows a 12-span PC single girder bridge, namely Utatsu Ohashi Bridge. Piers consisted of circular RC column (P1 and P2) and rectangular RC column with PC piles. Bridge columns were retrofitted by RC jacketing and the seat length was extended at the top of pier. Total of 8 spans (from P2 to P10) were washed away to the inland direction. It was found that additional concrete/steel shear keys, installed at the pier top for the seismic retrofit of existing bearings, were damaged and some hammerhead beams of piers in the inland side were cracked. A lot of diagonal cracks were also observed at both unseated and survived PC girders.

Photo 11 Washed Away of PC Superstructure (Utatsu Ohashi Bridge)

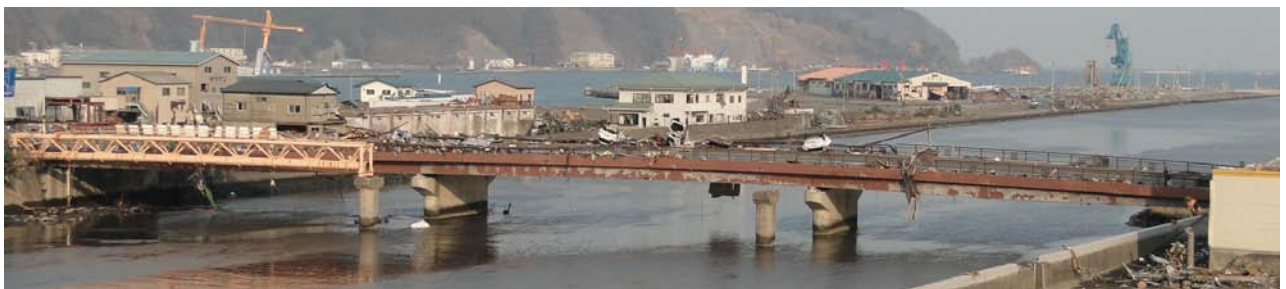
On the other hand, it is interesting to note that there are many survived bridges even though the superstructures of these bridges must be inundated with tsunami. Photo 12 exemplifies Yanoura Bridge survived washed away of superstructure due to the tsunami, while two spans of the water pipe bridge located adjacent to Yanoura Bridge were washed away. These survived bridges will hint the mechanism of resistance to the tsunami effect.

Photo 12 Bridge Survived Washed Away Due to Tsunami (Yanoura Bridge)
