# DAMAGE ANALYSIS OF BRIDGES AFFECTED BY TSUNAMI DUE TO GREAT EAST JAPAN EARTHQUAKE

Kenji Kosa<sup>1</sup>

Many bridges were washed away by Tsunami caused by the 2011 Great East Earthquake. We carried out the field survey and investigate the detailed damage to a lot of bridges in Tohoku Region. Utatsu Bridge, a prestressed concrete bridge, suffered enormous damage from the destructive tsunami. The detailed damage and the possible mechanisms of Utatsu Bridge have been conducted. Furthermore, from the study of the relation between  $\beta$  values (ratio between girder resistance and wave lateral load) and bridge damage extents of bridges in Tohoku Region and Sumatra Island, it is noted that ratio  $\beta$  is a significant indicator to judge the damage extent of bridge girders.

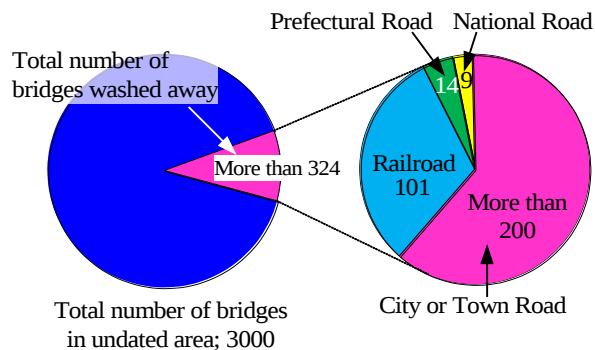
**Fig. 1** Amount of bridges washed away

During the Great East Earthquake, the outflow and excessive scour occurred to more than 300 bridges. **Fig. 1** illustrate the bridges which suffered damage Rank A (bridge is incapable). More than 300 bridges, including 9 national roads, 14 prefectural roads and 101 railroads, suffered serious losses. Despite a lack of official data about the damage to city and village roads, by the use of Google Earth, it is noted that at least 200 bridges suffered serious losses.

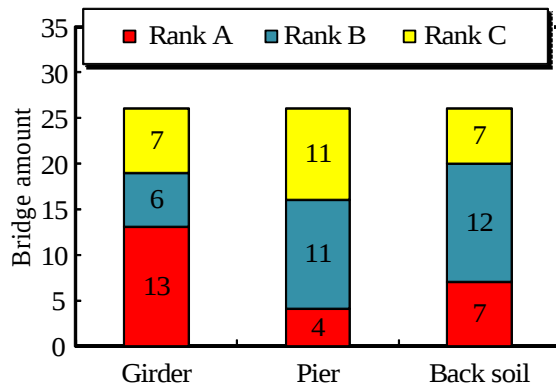
**Fig. 2** Damage to bridge due to Sumatra Earthquake

Furthermore, the damage extent of the injured parts (girder, substructure, foundation) of bridges in Tohoku region is compared with the damage of bridges in Sumatra Earthquake by authors. **Fig. 2** shows the damage extent to the 26 bridges in the western coast of Sumatra and **Fig. 3** plots the damage extent to the 12 bridges in this tsunami attack. Based on **Fig. 2** and **Fig. 3**, many girders suffered damage Rank A, namely they were washed away entirely due to tsunami action. For substructures, although partial piers flowed out, comparing with girders, the occurrence rate is smaller.

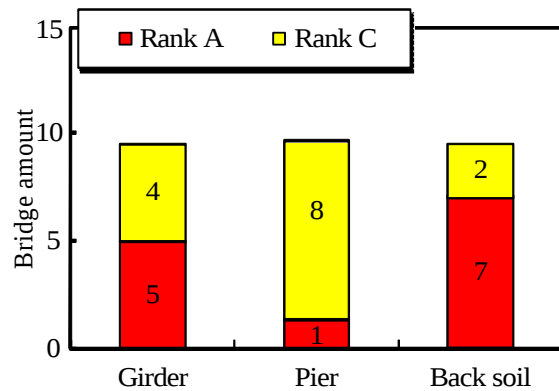
**Fig. 3** Damage to bridge due to Great Japan Earthquake

Besides that, it is frequent that foundations inflicted damage Rank A. The soils behind abutments were scoured. According to above data, the bridges in the 2 locations, where the wave heights were in excess of 10m, have many common points. The outflow of girders and the scour of foundations are the main damage to bridges.

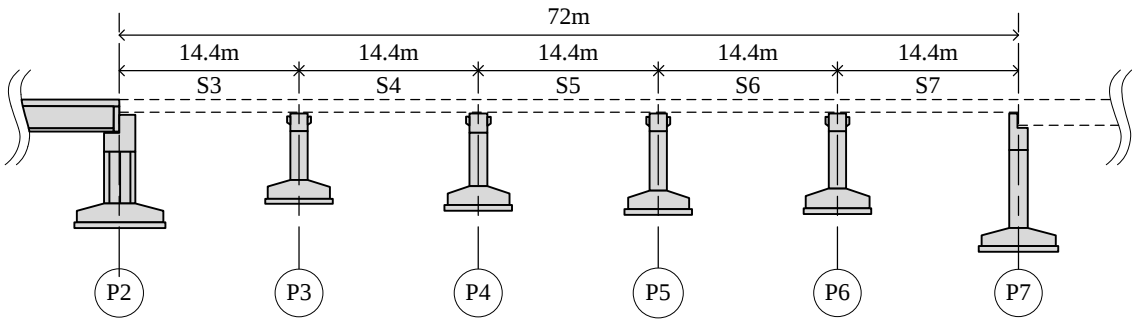
**Fig. 9** Side view of damaged superstructures (S5~S7)

Based on the detailed survey, superstructures S3~S10 moved off their supports under the wave-induced lateral load while the superstructures of S1, S2, S11 and S12 did not flow out. In the flowed spans, S3~S7 and S8~S10 have different types and the details of them are shown in **Fig. 9** and **Fig. 10**. The displacements of S3~S10 have been illustrated in **Fig. 11**. The directions of displacements are transverse to the bridge axis. The characteristic of outflow condition is that the central spans such S5~S7 and S8 experienced long displacements (28m and 41m).

It was also observed that S3~S4 and S5~S7 flowed out with no separation. And due to a great wave-induced uplift force, S8~S10 were inverted when they flowed out.

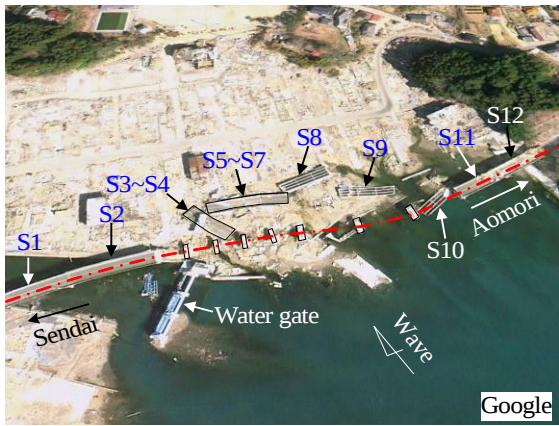
**Fig. 12** Outflow condition

However, contrary to the damage of superstructures, all piers of Utatsu Bridge withstand the wave action and did not collapse (**Fig. 12**, **Fig. 13**). The main damage to the piers is that the concrete surfaces of beams dropped due to a collision with girders and most of bridge collapse preventions were crushed or flowed out.

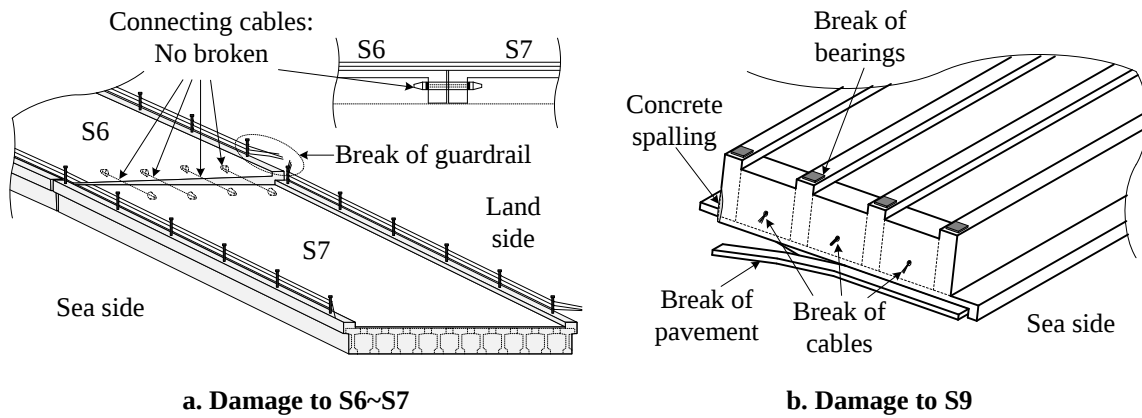
**Fig. 14** Detailed damage to superstructures

The damage to S3~S7 is one of the typical ones, which flowed out connecting with each other, and the damage of S6~S7 was selected as an example to state in the following content. Under the wave action, S6 and S7 experienced a displacement of 28m together thus it is proper to regard them as a whole. When the bridge was retrofitted, 4 cables, which were used to prevent the relative movement in axis direction of superstructures, were installed between S6 and S7. The details of cables are plotted in **Fig. 14-a**. These cables played an important role to keep S6 and S7 flowing out together. Besides, the damage to guardrails between S6 and S7 was observed as well.

S9 is one of the inverted superstructures, the damage to which is shown in **Fig. 14-b**. S9 experienced a displacement of 23m and was inverted by the wave-induced uplift. At the end surface of S8 side, different from the damage to S6 and S7, all of the cables which connected S8 and S9 were broken by the force between superstructures and the fracture traces could be found. Moreover, at the supporting area of girders, the remains of bearing plates were noted. In light of this, it is obvious that during the tsunami attack the bearings fractured. Besides that, at the connection of the 2 decks, the debris of pavement connection was observed.

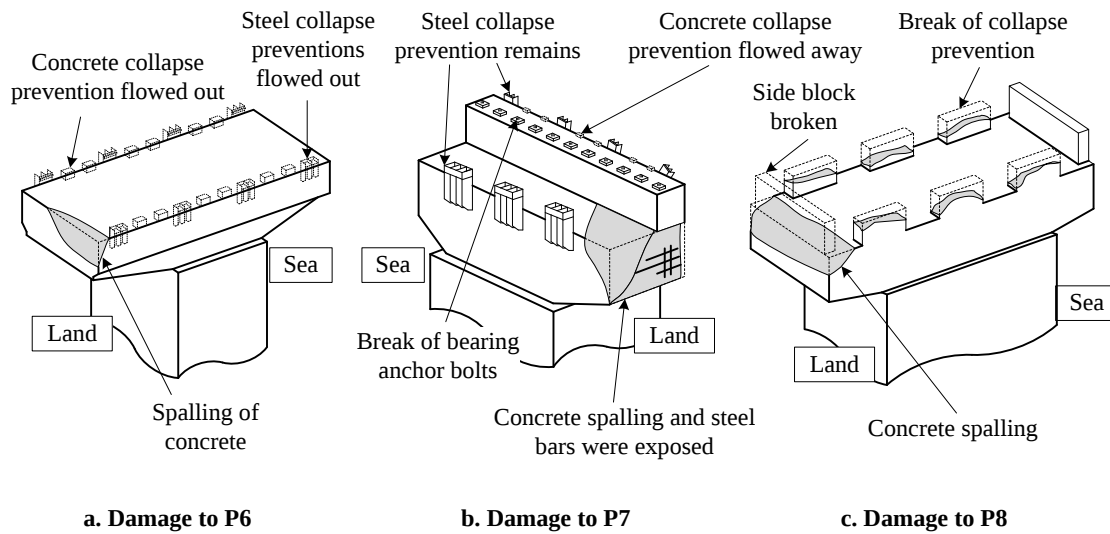
**Fig. 15 Detailed damage to piers**

It was found that the 11 piers supported 3 types of superstructures. In this section, 3 piers were selected basing on their different supporting superstructures. Pier 6 and Pier 8 respectively supported the type 2 and type 3 and in contrast, P7 supported both of these 2 types of superstructures (**Fig. 9, Fig. 10**). Therefore P6~P8 were selected to analyze. For P6 and P7, except for the concrete collapse preventions, they also had been installed steel preventions. Different from P6 and P7, only concrete collapse preventions were set up at the top of P8. These collapse preventions not only limit the superstructure's movement along the axis direction but also the transverse direction of bridge.

The detailed damage of P6 is shown in **Fig. 15-a**. When S6 and S7 were separated from P6, they imposed a horizontal collision on the concrete collapse preventions. Therefore, on the supporting plate of P6, 12 concrete collapse preventions were crushed. And for the same reason, the 8 steel collapse preventions, anchored on the sides of the beam, flowed out as well. Apart from the damage to the collapse preventions, the concrete surface of the beam which was located at the land side was crushed as well.

**Fig. 15-b** illustrates the detailed damage of P7 which supported 2 types of superstructures: S7 and S8. At S7 side, the installing details of superstructure collapse preventions were same as P6. Although the 6 concrete collapse preventions were crushed, the 4 steel ones were left. However, due to the girder-induced impact, the steel ones tilted. At S8 side, different from P6, only 3 larger steel collapse preventions were anchored and they did not flow out. The damage condition of steel collapse preventions demonstrates that when the superstructures, located on P7, displaced they were elevated by a wave-induced uplift. Because of this, the superstructures flowed from the top of the steel collapse preventions and did not impose a sufficient impact to make them separate from supports. Besides that, at the land side, the concrete surface of the beam was crushed and some steel bars could be observed.

The damage of P8 is plotted in **Fig. 15-c**. On the top of beam, 6 concrete collapse preventions and 2 side concrete blocks were set up. By the same force situation as the preventions of P6, the 6 concrete collapse preventions and one side block, which was at the land side, were crushed. Besides, it was found while the side block flowed out, a damage of the concrete surface, which under the side block, occurred.

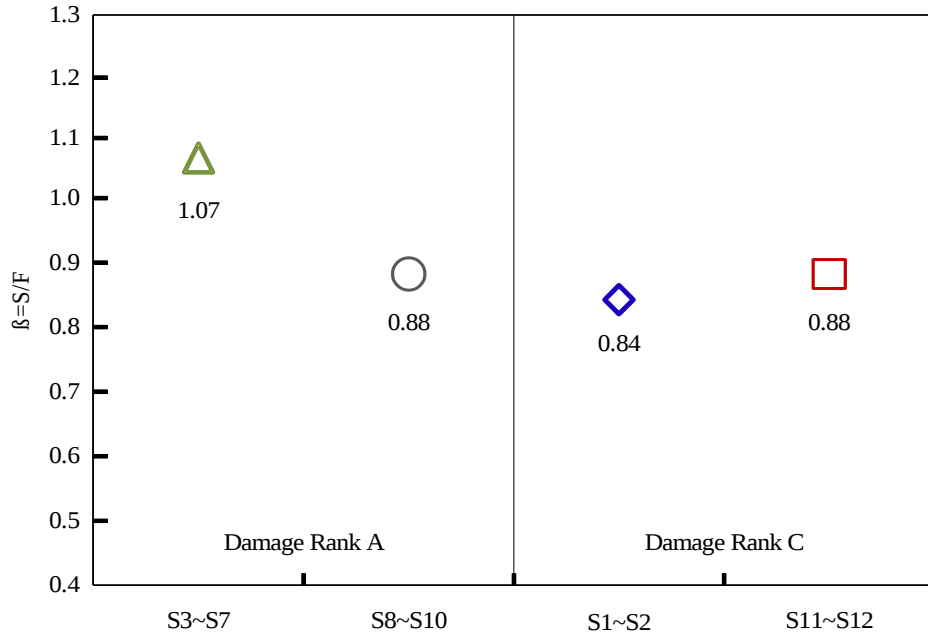
**Fig. 16** β result of Utatsu Bridge

The  $\beta$  result is illustrated in **Fig. 16**. Based on **Fig. 16**, it is known that S3~S10 suffered damage Rank A and the remaining girders suffered damage Rank C. Most  $\beta$  values are smaller than 1.0 except for the  $\beta$  values of S3~S7 which is 1.07, slightly larger than 1.0. This trend of  $\beta$  values illustrates, comparing with wave lateral load, superstructure resistance is not sufficient to make S3~S10 survive, which is attributed to the relatively small girder width causing the comparatively small girder weight.

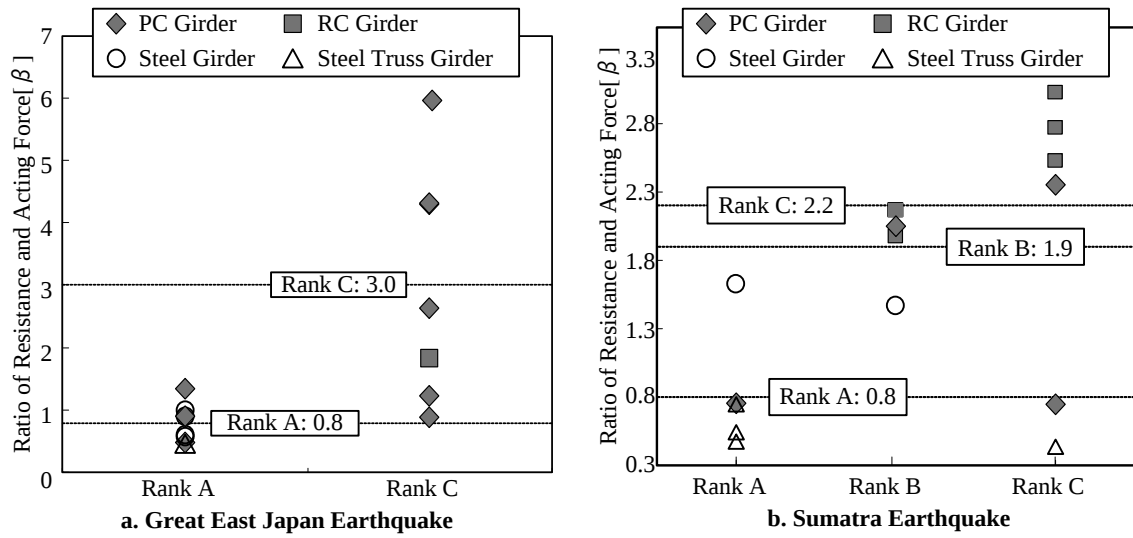
**Fig. 17**  $\beta$  result of Sumatra and Great East Japan Earthquake

**Fig. 17-a** and **Fig. 17-b** illustrate the  $\beta$  values of damaged bridges in Tohoku

region and the bridges damaged in Sumatra Earthquake respectively. In terms of the relationship between damage extents and  $\beta$  values, according to the former research as shown in **Fig. 17-a**, during the Sumatra Earthquake, the average  $\beta$  values of Rank A, Rank B and Rank C are respectively 0.8, 1.9 and 2.2 and the average  $\beta$  value of Rank A is around 2.5 times larger than Rank C. By the same method, for the situation of bridges in Tohoku region, refer to **Fig. 17-b**, the average  $\beta$  values of Rank A and Rank C are 0.8 and 3.0 respectively. And the average  $\beta$  value of Rank A is around 3.75 times larger than Rank C. Therefore, from the above result, it is noted that the  $\beta$  value is a significant indicator to judge the damage extent of bridges.

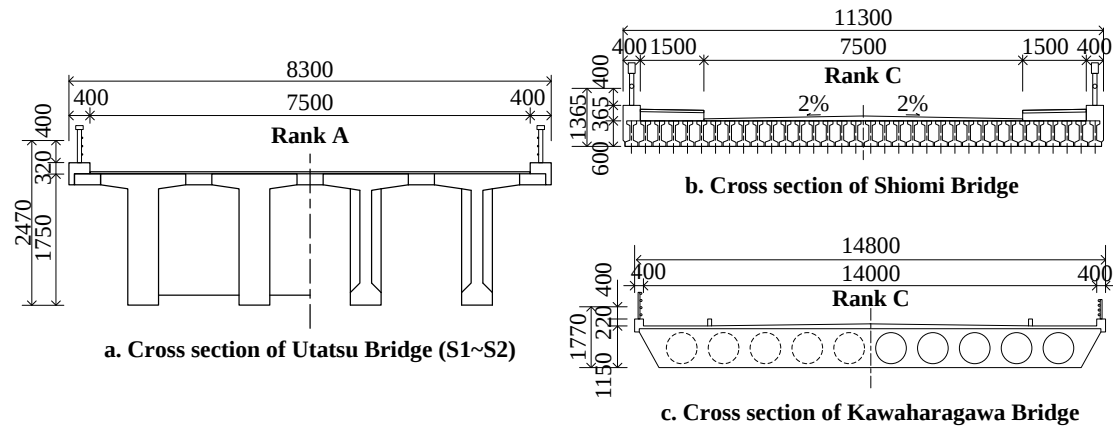
**Fig. 18** Comparison of cross sections

**Fig. 18** is applied to describe the difference of typical girders of Rank A and Rank C. It is obvious that the ratio to girder width and height of Rank A (3.36) is smaller comparing with the girder of Rank C (b: 8.28, c: 8.36), which led to insufficient resistance and greater wave pressure area. Therefore, in future design, it should be

considered to increase the ratio to girder width and height for tsunami resistance.
