New Attempt to Maintenance of Steel Bridge Coating in Expressway

Shuhei Sakai¹, Dai Wakabayashi²

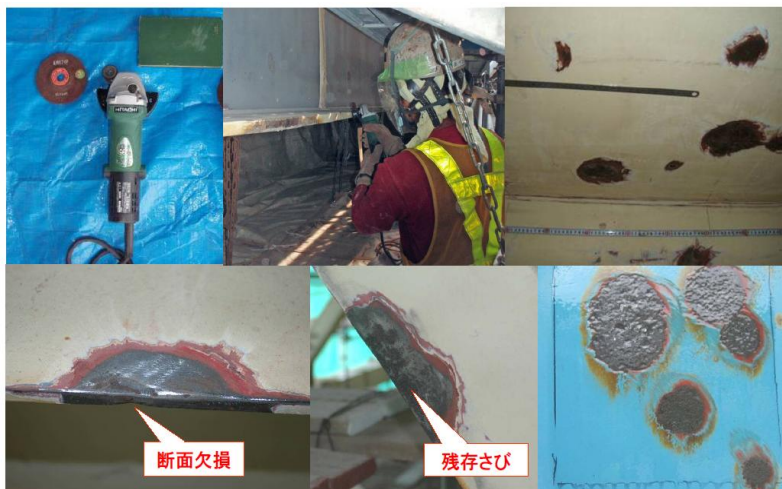
Fig.5 Grinding by power tool such as disk sander (According to ISO 8501-1 St 3)

This reason is that deteriorated coating have been grinded by disk sander (According to ISO 8501-1 St 3) and general painting system have been painted repeatedly (Fig.5).

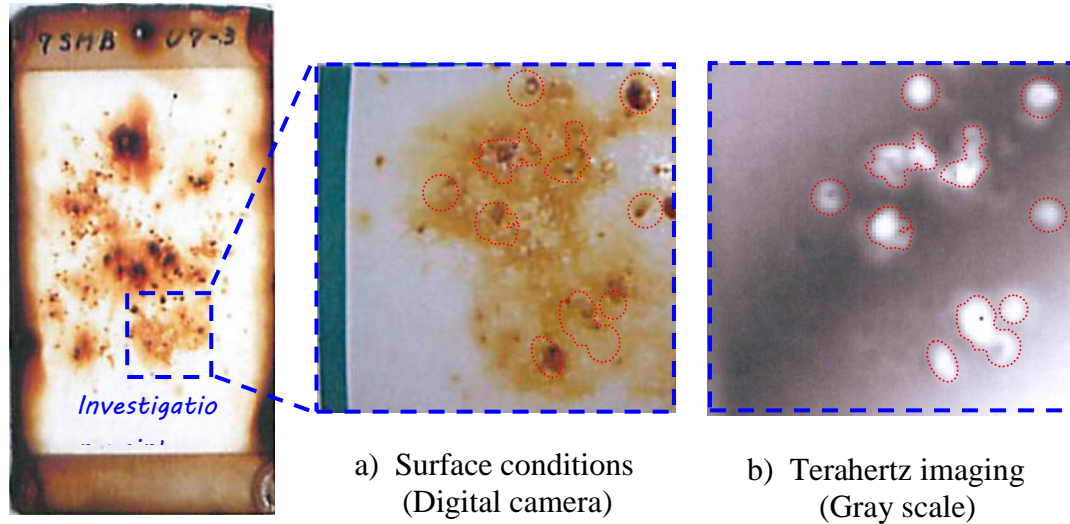
Fig.9 Investigation result by the deterioration coating specimen

Fig.9 is the result of a measurement. The back side of exposed specimen gets

rusty on the coating surface because of existing dew including the rust juice for a long time, and as for the rust spreads through the coating appearance and a real rust area becomes indistinct.

Terahertz imaging can be detected only a rust and corrosion point removing dirt with the rust juice in the coating surface.

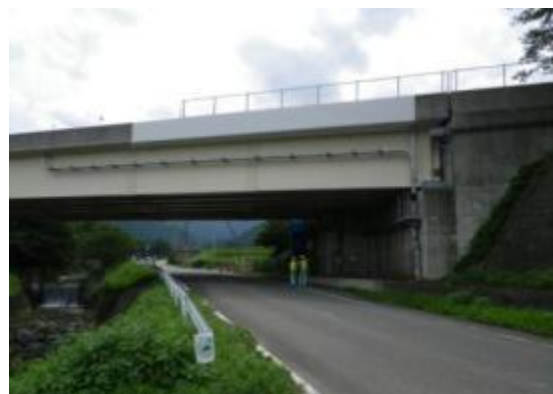
Fig.16 Horisaka Bridge (Ise Expressway in Mie Pref. conventional general paint 23years)

The test construction carried out at the steel bridge of Ise Expressway in Mie Pref. The bridge had the local deteriorated coating at the end of girders, because of the influence of leakage water in deicing salt from the expansion joint (Fig.16). In the test, we investigated the surface roughness, dust, noise, cleanliness performance at the web, corner, gusset plate and the corrosion surface, and processing time on the bridge repair construction site.

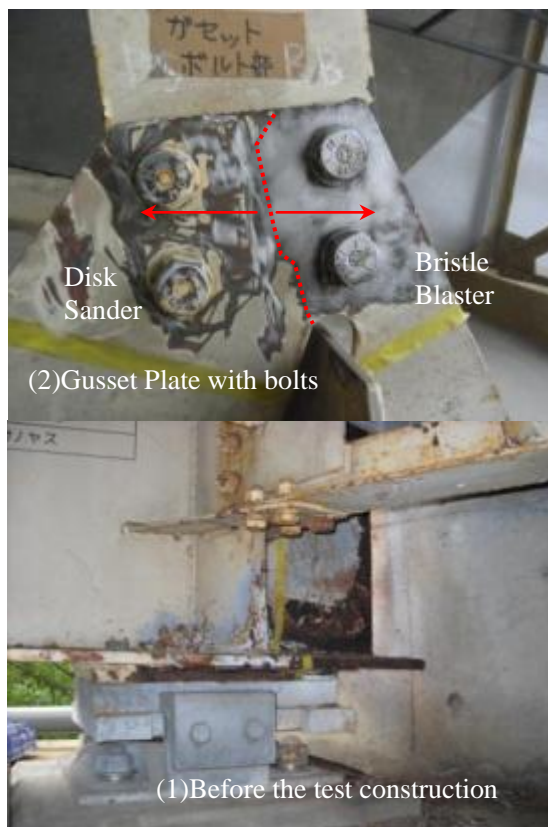
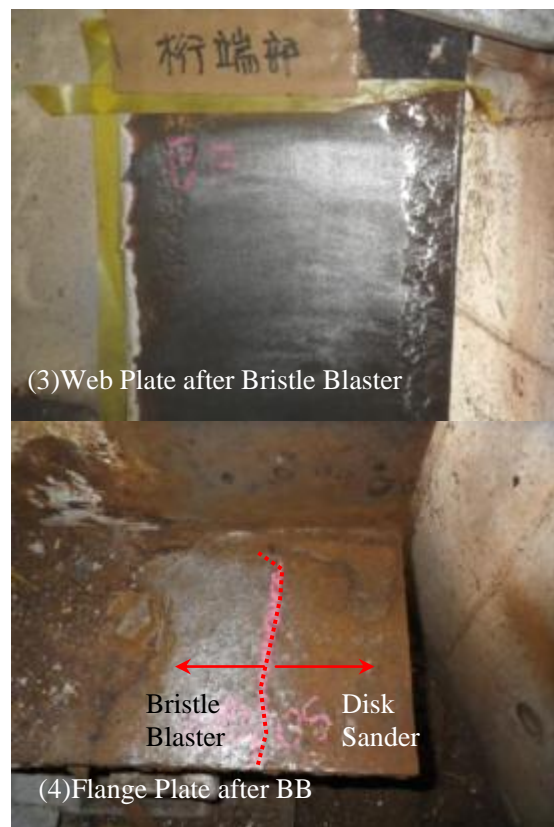
Fig.19 Treated Surfaces after the tests

Fig.19(1) to (4) shows the treated surfaces after the work. This method is not worrying about cutting down the steel, the variations of surface cleanliness treatment is not much. Also, it can be good at the corner and around the bolts. Grinding with disk sander cannot be so. In addition, it can clean all the sever rusts (partial layered) on the corroded steel surfaces.

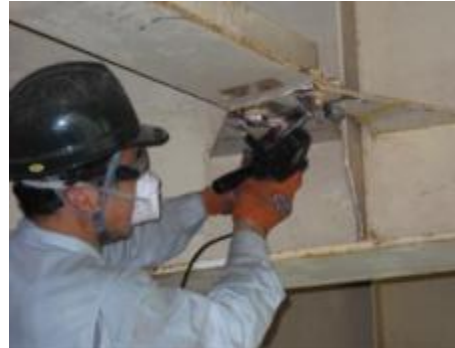
Fig.21 Construction by new tool

As mention above, this method is reasonable, environmental and efficient than conventional grinding method with DS. And in case of repair at local deteriorated coating, the blasting with abrasives, this method is superior.
