# **RESEARCH AND REPAIR OF REINFORCEMENT BY OVERLAYING FLOOR SLAB METHOD IN EXPRESSWAY**

## **Abstract**

NEXCO has been reinforcing floor slabs by overlaying for about 15 years as a measure against deterioration and increasing live load on steel bridges. However, re-deterioration has become noticeable on repaired bridges. This document is a summary of the measures taken to cope with the issue.

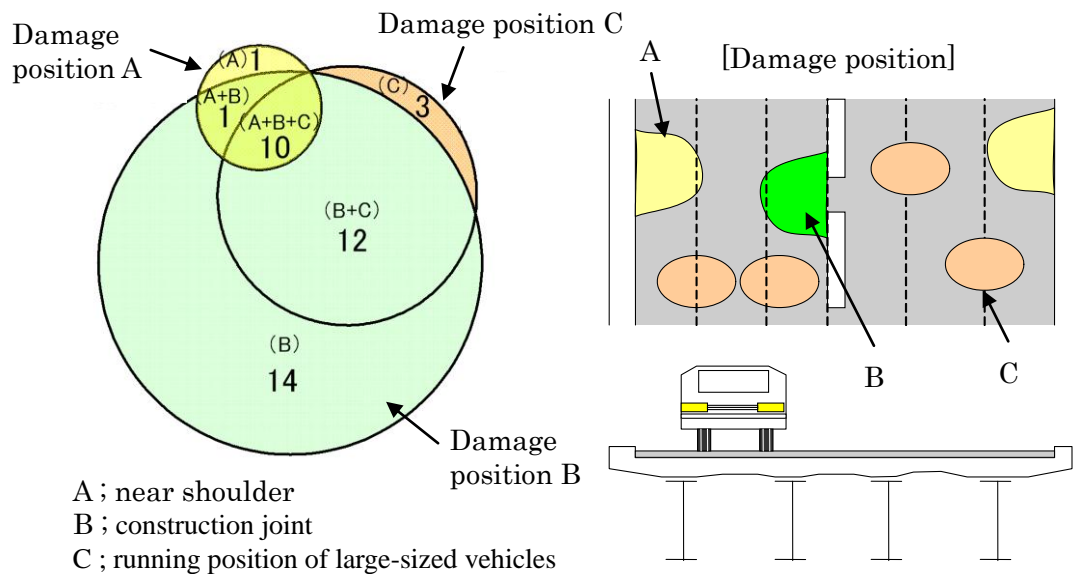
Fig.2 Damage position of overlaying floor slab

We did a questionnaire survey, in 2006, for about 400 bridges repaired by overlaying. The survey showed that re-deterioration occurred in 12% of bridges. When we studied the record of damage and analyzed damage positions, we found that potholes occurred most at the construction joint between lanes (Fig.2) and tended to be near the shoulder next to running position of large-sized vehicles. Fig.3 shows the cross section of floor slab where many potholes were found. The damage state indicates infiltration of water from the construction joint and staying of slag at the boundary between existing floor slab and overlaying.

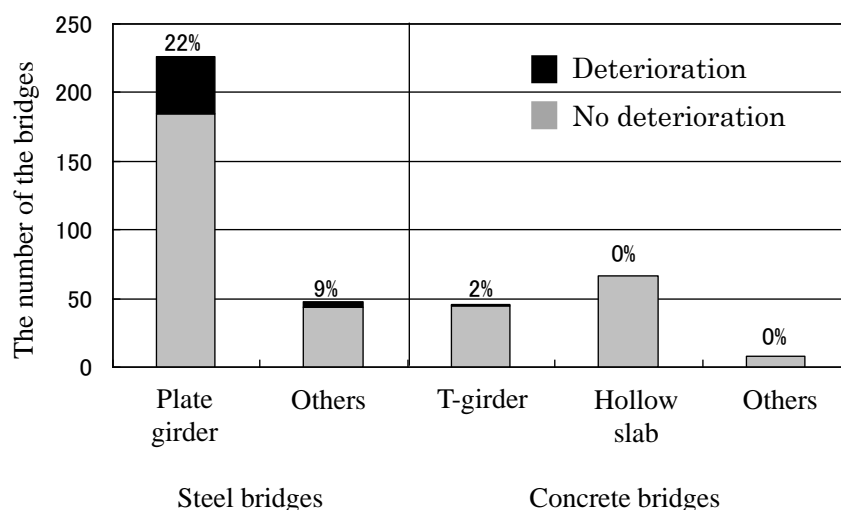
Fig.4 Relations of structure and deterioration

**Structural factors:** Steel bridges accounted for 70% of the bridges reinforced with the overlay method and re-deterioration was noticeable in plate girder bridges (Fig.4). In addition, much of the deterioration was found in bridges designed between 1971 and 1979 — design standards used for these bridges are not much different from the current standards.

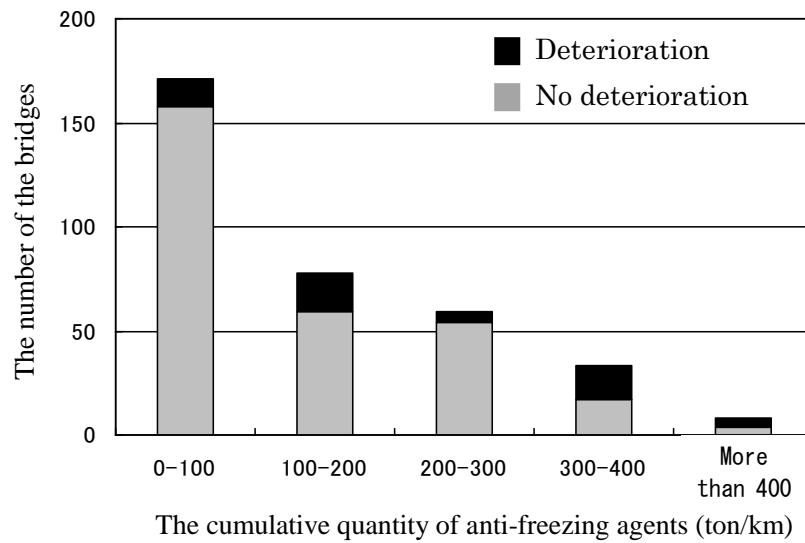
Fig.5 Number of deterioration caused by anti-freezing agents

**Environmental factors:** Re-deterioration tended to become noticeable when the cumulative quantity of anti-freezing agents used and the cumulative days of when minimum temperature is lower than zero degrees exceed a certain quantity (Fig.5, 6).

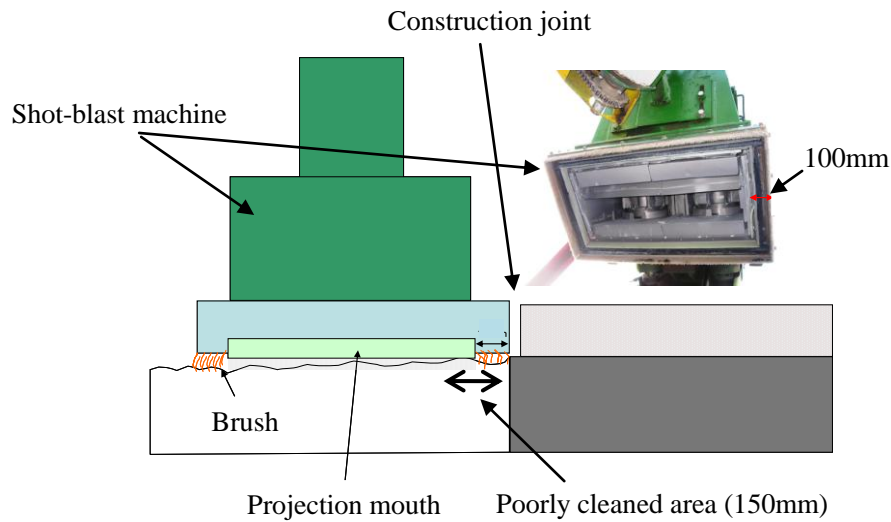
Fig.7 Position of a shot-blast machine at edge

We found that in many cases re-deterioration begins from the construction joint. A standard procedure in the overlay method is to polish and sweep the existing floor slab with a shot-blast machine after milling. Although the shot-blast machine is placed along the construction joint, the area which is 150mm from the construction joint cannot be sufficiently polished and swept. We also found that although a sweeper cleans after milling, chips were not fully removed and tended to remain at the edge (Fig.7). Poor adhesion may occur when concrete is casted in this state. Therefore, vibrators are used for tamping by hand.

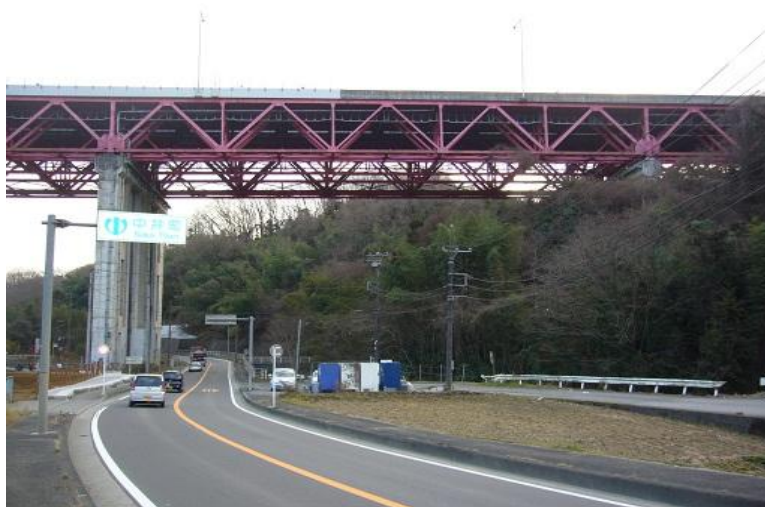
Fig.8 The bridge repaired by overlaying floor slab

In 2002, we repaired a re-deteriorated floor slab of a steel truss bridge which was reinforced by overlaying in 1990 (Fig.8). As some ten years had passed since the repair, potholes were often found in the pavement. Inspections showed that there was separation between the existing floor slab and overlaying concrete. It was assumed that this separation caused the damage to the pavement. Thereupon, we tried injecting resin in the interface of the re-deteriorated floor slab. This method was selected considering safety of road users and so that roadwork restrictions to control traffic are held down as much as possible as traffic on the bridge was more than 80,000 vehicles per day.

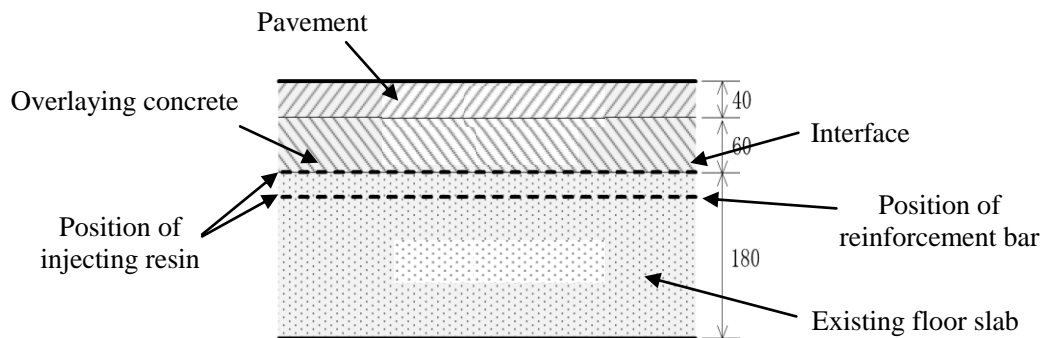
Fig.9 Section where resin was injected

Fig.9 shows a section of the bridge actually repaired by injecting resin. After cutting the pavement, injection holes 100mm deep and with a diameter of 10mm were drilled, and the resin was injected. The resin was partly injected from the pavement surface as traffic control requirements restricted the work that can be carried out (Fig.10). In either case, the holes were cleaned by air (compressed air infusion) after drilling. But places where the concrete have turned to gravel were washed with water. Resin was injected every 1m in both longitudinal and perpendicular directions. Core sampling was performed after injection, and it was confirmed that filling was satisfactory in most of the repaired locations.

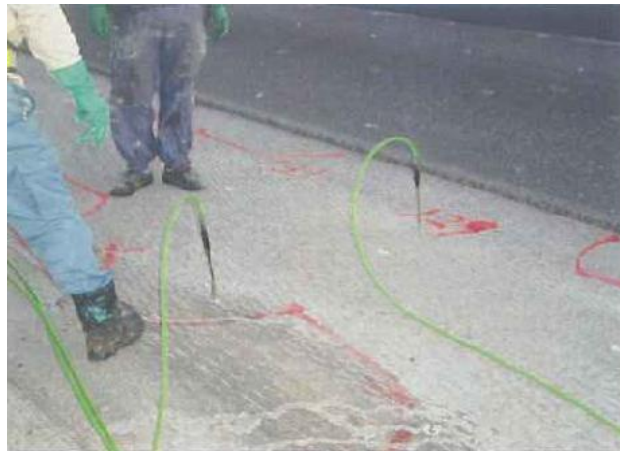
Fig.10 Shows resin being injected

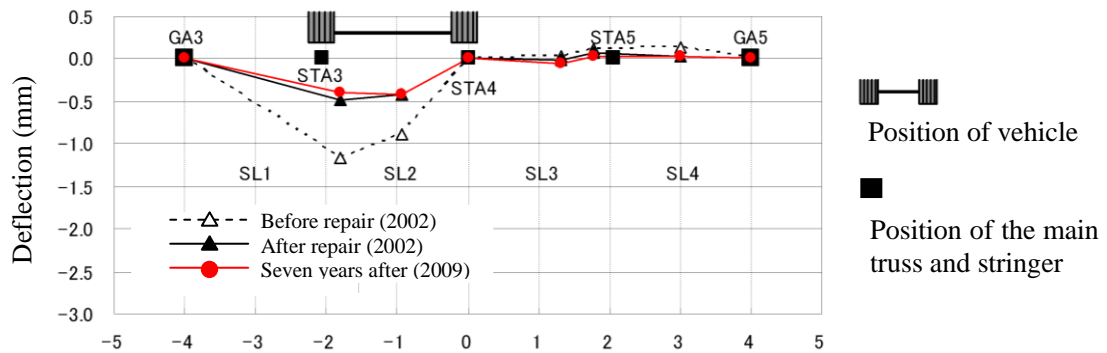
Fig.13 Distribution of relative deflection of floor slab

Fig.13 shows the maximum measured deflection. The deflection decreased after repair. We found that the deflection measured "seven years after" repair is equal to the value measured immediately "after repair" and assumed that the load bearing capacity increased by the repair lasts.

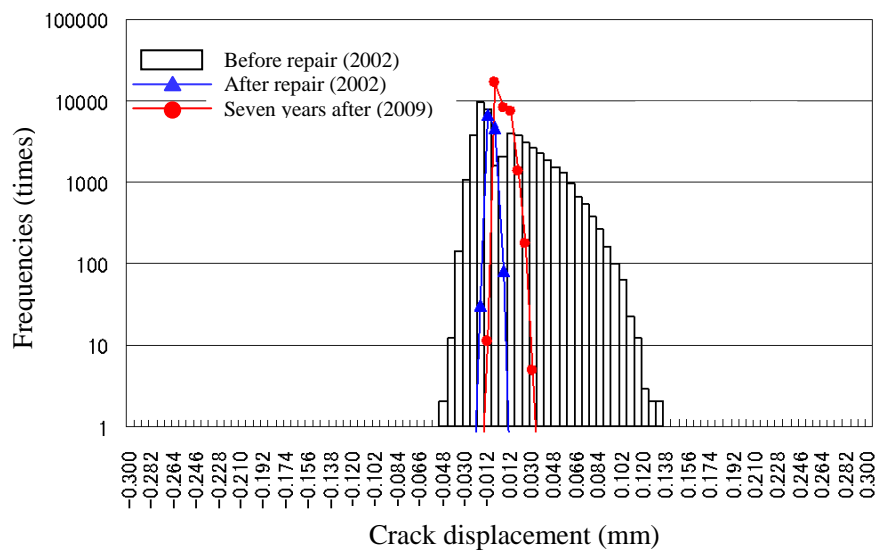
Fig.14 Frequency distribution of crack displacement

Crack displacement was measured for cracks in the longitudinal and perpendicular direction of the bridge axis. Fig.14 shows the measurement of a crack in the perpendicular direction. The crack displacement shows the range of crack displacement caused by vehicles travelling on the bridge. Though the displacement of “seven years after” repair is approximately 2 times that of immediately “after repair”, the displacement is low and is half that of “before repair”. Because the remaining crack width was between 0.10-0.20mm, we assumed that the crack did not tend to noticeably progress.
