# **REPAIRING FATIGUE CRACKS IN A STEEL DECK PLATE GIRDER BRIDGE OF UNUSUAL STRUCTURE**

Haruhiko Nakata<sup>1</sup>, Yoshiyuki Takamura<sup>1</sup>, Ken Tokumasu<sup>2</sup>

## **Abstract**

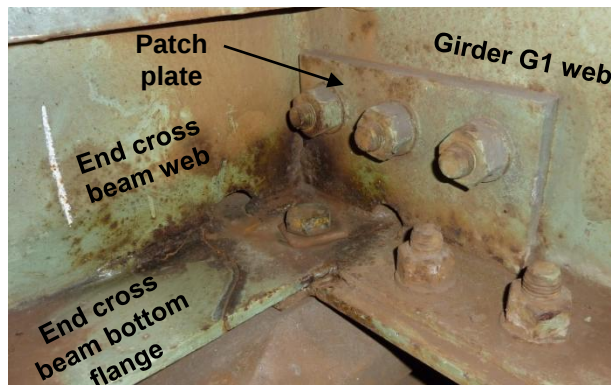
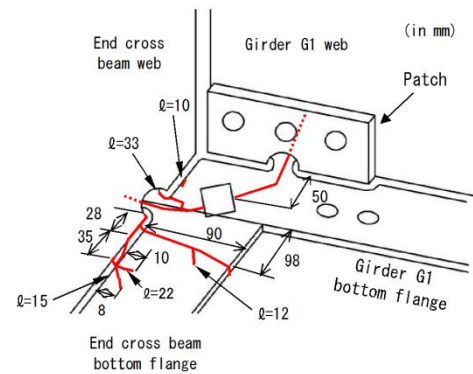
Cracks in girder G1 initiated in weld beads between the sole plate and the end cross beam bottom flange and grew penetrating through the flange and partly propagating further into the weld between the flange and the web of the end cross beam. Cracks were also found in the main girder bottom flange, originating at around the bearing set bolt. None of them was propagating into the main girder web which had a patch plate on it.

PHOTO 1 CRACKS IN GIRDER G1

- (1) To improve fatigue durability, the main girder and end cross beam bottom flanges were unified in the new replacement part.
- (2) The planar dimensions of the sole plate were made larger to reduce stress concentration in the support area.

- (3) The ends of the sole plate were tapered to alleviate stress concentration due to drastic change in cross-section around the sole plate.
- (4) High tension bolts were used for the connection with the sole plate, main girder bottom flange and end cross beam bottom flange, to improve fatigue durability.

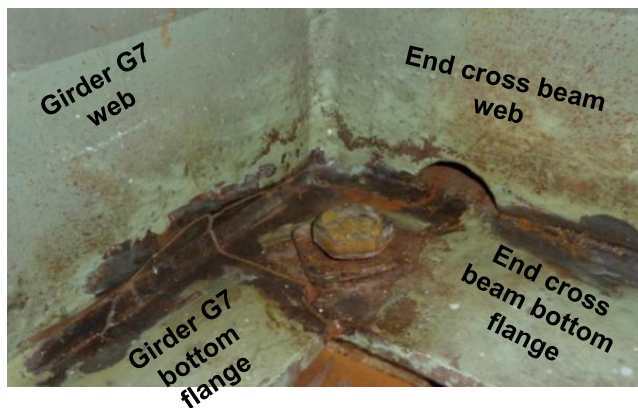
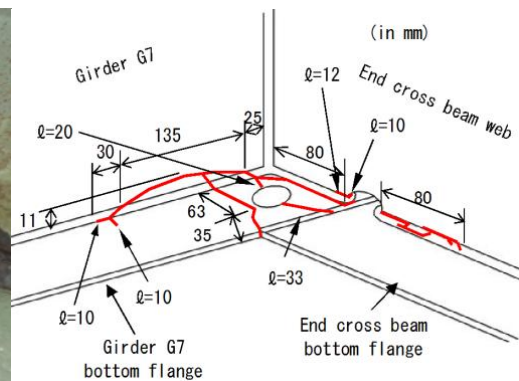
Cracks in girder G7 initiated in weld beads between the sole plate and the main girder bottom flange and penetrated through the flange. They propagated into the weld between the flange and the web of the main girder, and partly further into the web.

Gap was found between the sole plate and the top shoe in both girders G1 and G7. The girders were found to move in the vertical direction with every passage of vehicle, generating metal sound.

PHOTO 2 CRACKS IN GIRDER G7

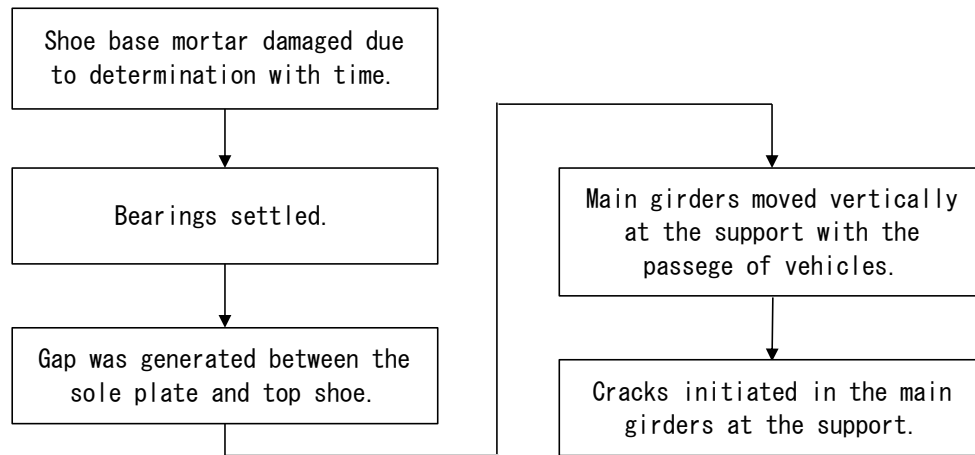
The focus was then moved to the damage to the shoe base mortar on girders G1 and G4. The assumption was that deterioration of the shoe base mortar with time caused settlement of the bearings, which resulted in vertical movements of the main girders, giving impacts to the damaged parts (Figure 6).

FIGURE 6: COURSE OF DAMAGE EVOLUTION

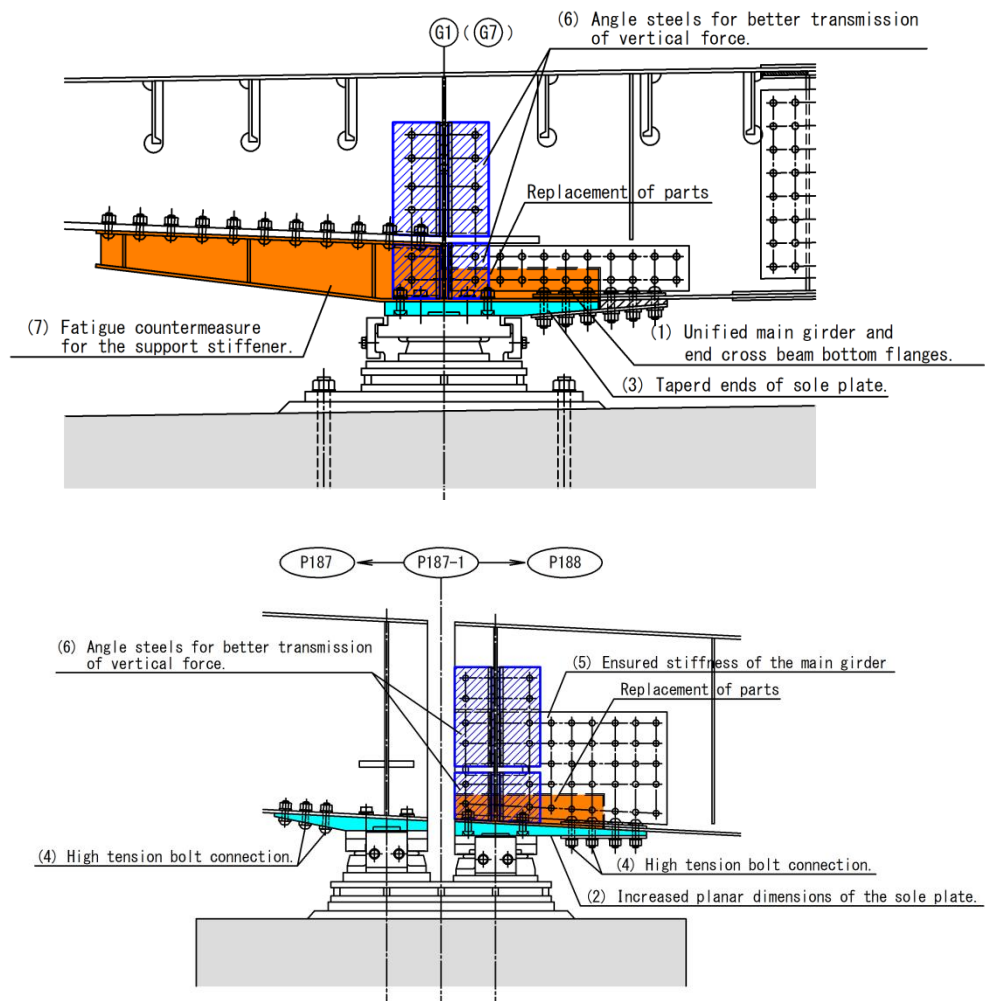
FIGURE 7 SCHEMATIC DIAGRAMS OF THE REPAIR

- (5) In order to assure stiffness in the main girders in the support areas, splice plates were installed on the main girder web to a height one half the girder height which was the effective buckling length above the support point.

- (6) Angle steels were installed where the main girder web met the end cross beam web, to ensure transmission of vertical force between the new and existing parts above the support point.

- (7) As a fatigue countermeasure for the support stiffener, stiffness of the overhang bracket was enhanced to control deflection.

Figure 7 shows the schematic diagrams of the partial replacement plan. The numbers in the diagrams correspond to the numbers in the above list. The parts marked with red color are those to be replaced, and the blue-colored part is the new sole plate to be installed.

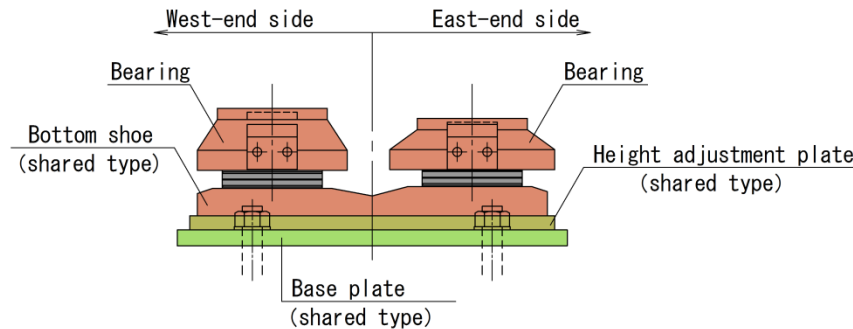
The damage found in the existing shoe base mortar on girders G1 and G4 suggested influences on the capacity to carry reaction force. On the other hand, the limited headway required the existing bearings to be temporarily removed for the emergency repair work to create a sufficient work space. However, fine height adjustment was difficult with the existing bearing system in which the higher bearing on the west-end side and the lower bearing on the east-end side were mounted on the same block, sharing one base plate, one height adjustment plate and one bottom shoe (Figure 8).

FIGURE 8 SIDE VIEW OF THE EXISTING BEARINGS

Consequently, it was decided to replace the bearings at the same time with the emergency repair work. Steel bearings were employed to replace the existing rubber ones so that reaction force would be carried more properly. In order to make height adjustment in the field easy, the height adjustment plate was divided into two parts for the two bearings.

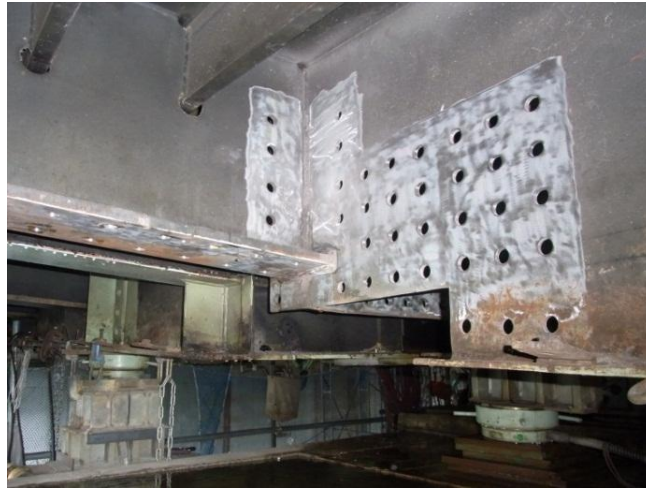
PHOTO 3 GIRDER G7 IMMEDIATELY AFTER REMOVAL OF THE PARTS WITH CRACKS

The emergency repair project described in this paper has just been completed. Photo 3 shows girder G7 after removal of the damaged parts. Photo 4 shows the same girder after the partial replacement, with the bearings also replaced.

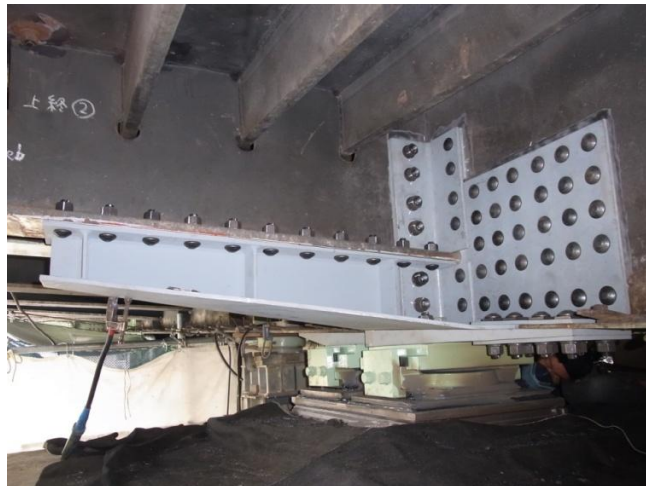
PHOTO 4 GIRDER G7 AT THE COMPLETION OF EMERGENCY REPAIR
