EXAMPLES OF BRIDGE DAMAGE ON METROPOLITAN EXPRESSWAY DISCOVERED BY EMERGENCY STRUCTURAL INSPECTIONS AFTER THE TOHOKU EARTHQUAKE

Tsuyoshi KOSUGI¹
Takehiko HATSUKU²
Masaru SHIMONISHI³

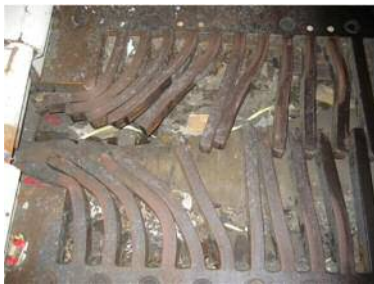
Figure 4-1(left) Joint Damage
Figure 4-2(center) Road Surface Damage
Figure 4-3(right) Water Leakage in Tunnels

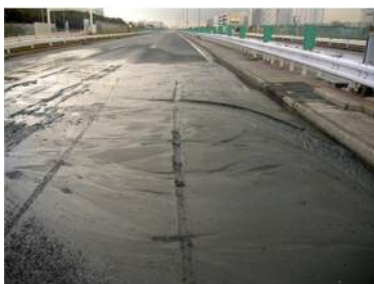
Figure 4-4 (left) Pavement Damage due to Liquefaction
Figure 4-5 (center) Missing Bridge Bearings
Figure 4-6 (right) Truss Component Damage

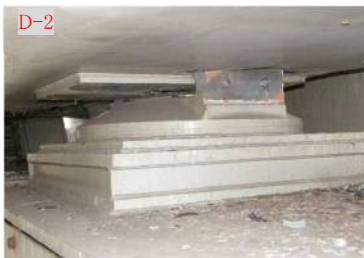
In the Kanagawa area, damage around bearings of steel bridges became an issue due to the surface difference in level that occurred in the joints on the D-2 bridge pier of the Daikoku Junction. The displacement limiters for the upper bearing of spherical bearings and the earthquake-resistance reinforcements fell from that bridge pier, and dropped below the elevated structure (Figures 5-1 through 5-4). In addition, the bolt attached to the side block of bearing fractured on the nearby D-1 bridge pier, and the side block dropped below the elevated structure (Figures 5-5 through 5-6). Based on this damage at the Daikoku Junction, emergency inspections were conducted on the bridge piers that make up the steel bridges in the Kanagawa area targeting bearings, earthquake-resistance reinforcements and the like.

Figure 5-1 (left) Missing Upper Bearing
Figure 5-2 (center) Fallen Upper Bearing
Figure 5-3 (right) Missing Displacement Limiter

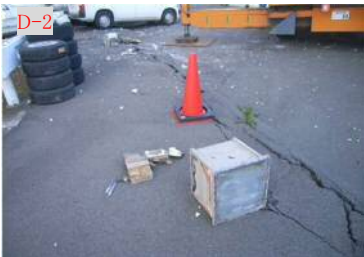
Figure 5-4 (left) Fallen Displacement Limiter
Figure 5-5 (center) Missing Side Block
Figure 5-6 (right) Fallen Side Block

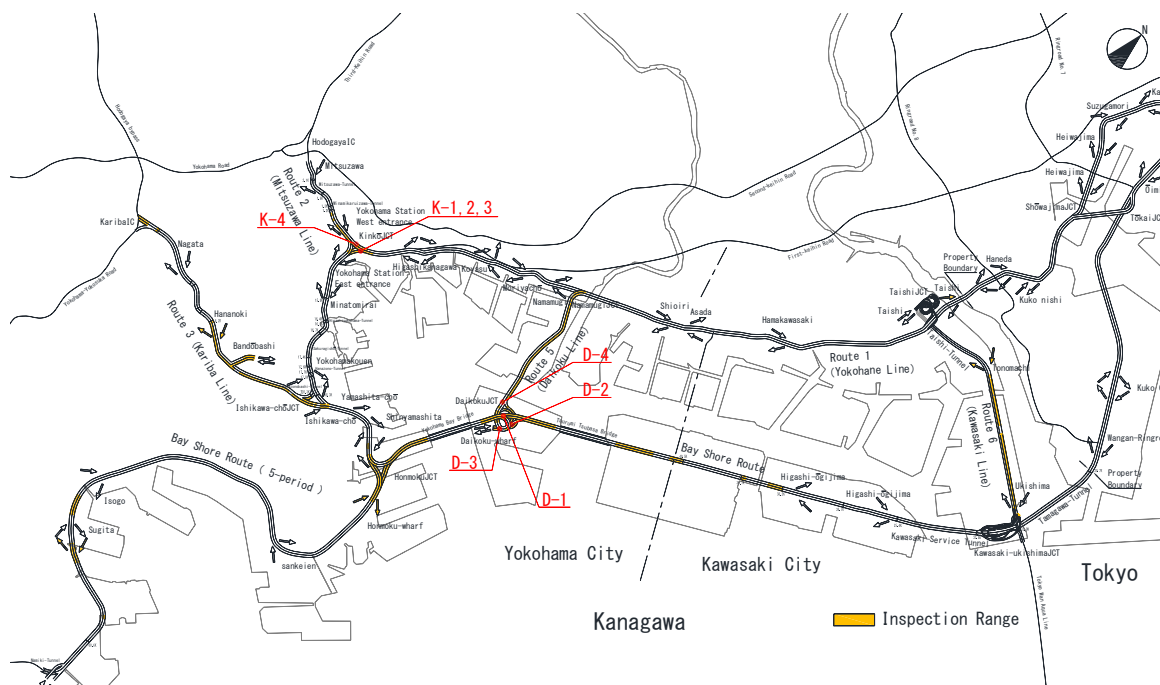
Figure 5-7 Bridge Pier Inspection Range and Damaged Locations

Places thought to have the greatest influence from the earthquake were selected, and the results of the inspections of approx. 350 bridge piers confirmed damage on 6 new bridge piers. Together with the D-2 and D-1 piers, these inspections brought the total to 8 bridge piers. The inspection results are shown in Figure 5-7 and Table 5-1, and the main damage is shown in Figures 5-8 through 5-10.

The results of these emergency inspections show that damage around bearings is concentrated near junctions. Since the curvature and incline of the superstructure is comparatively large in the vicinity of the junctions, it can be presumed they exhibit unforeseen behavior due to the earthquake. In addition, the bridge piers where damage was found were all steel structures. High-rise bridge piers are generally steel structures, and the difference in rigidity is thought to be one of the primary factors in steel bridge piers more easily swaying than reinforced concrete bridge piers.

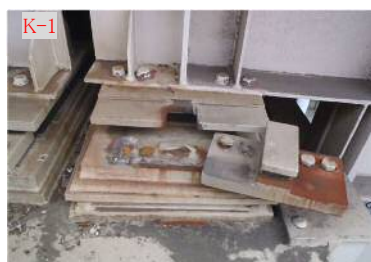
Fractures of bolts attached to side block in the rubber bearings, and cracks of upper bearings and fractures of setting bolts in the spherical bearings were discovered. In the 6 new bridge piers where damage was confirmed, luckily the components did not drop below the elevated structure, but it can be said the effect of the earthquake to bridges was remarkable.

Figure 5-8 (left) Fractured Bolts

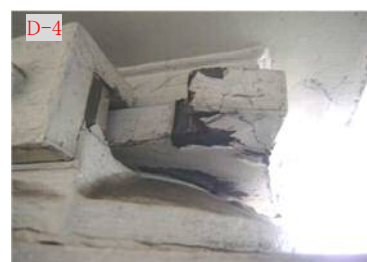
Kanagawa No5. Daikoku Route	D-3	Daikoku JCT	Separate	Double-layer rigid frame steel structure	33.95	BP-A	Spherical Bearing	Fracture of bolt setting bearing
Kanagawa No5. Daikoku Route	D-4	Daikoku JCT	Separate	Double-layer rigid frame steel structure	26.54	BP-A	Spherical Bearing	Deformation of upper bearing

Figure 5-10 (right) Deformation of Upper Bearing

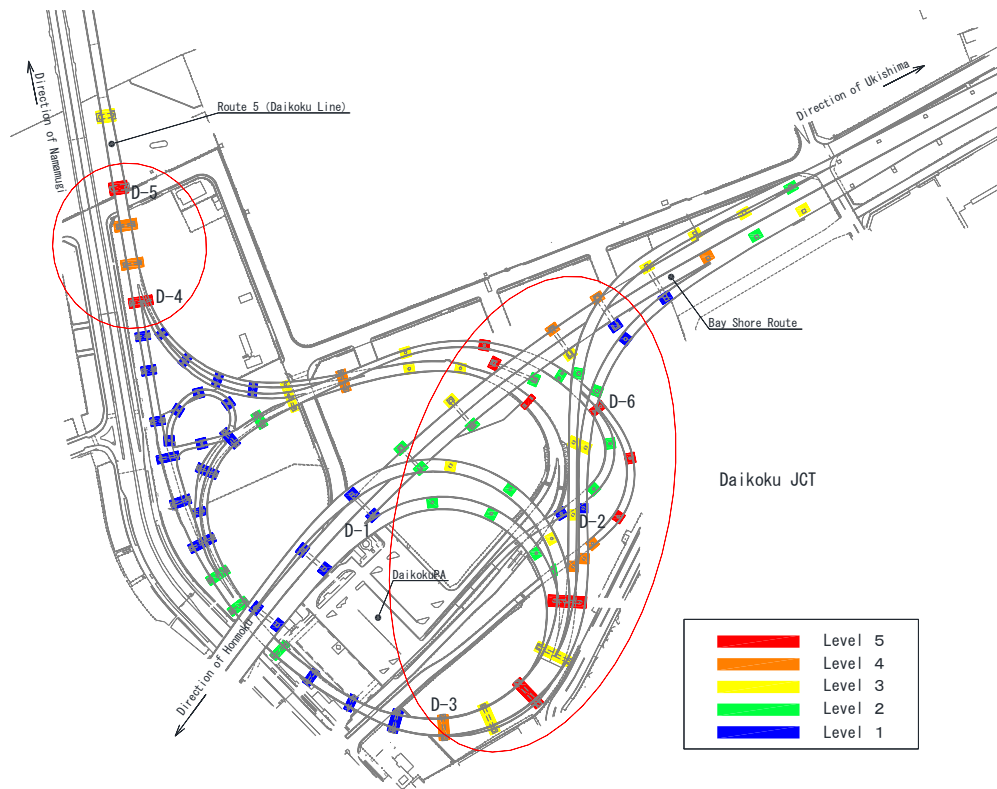
Figure 6-1 Ground Subsidence Investigation Findings and Main Deformation

The results of the investigations of approx. 90 bridge piers of the Daikoku Junction are that deformation of level 4 or greater, which is thought to have an influence on the use of the area, has occurred in 20 locations. The investigation findings and the main deformations are shown in Figure 6-1. Large deformations are gathered near the ramps on the side outside the harbor from the Bay Shore Route or the K5 Daikoku Route heading towards Namamugi, and there are trends towards slight scattering in some locations.

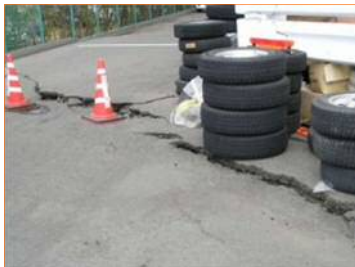
D-3 (left) Surface Difference (Level 4)

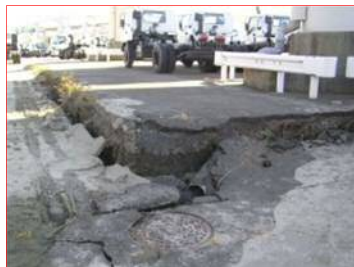
D-4 (center) Surface Difference, Opening (Level 5)

Among the 4 bridge piers at the Daikoku Junction that took damages around bearings, major surface difference in level occurred around the foundation for the D-2 and D-4 bridge piers. The relationship between these is not definite, but if hypothetically there were cavities under the footing or at the side of the footing, then it can be thought the tremor amplitude of such bridge piers becomes bigger due to degradation in the ground resistance that the footing received, as compared with sound bridge piers of same height. The influence of ground subsidence on the behavior of elevated bridges is not clear, but it may be necessary to study this relationship to prepare for future earthquakes.

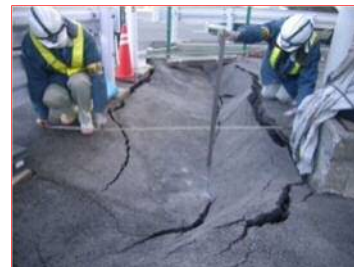
D-5 (right) Cave-in (Level 5)

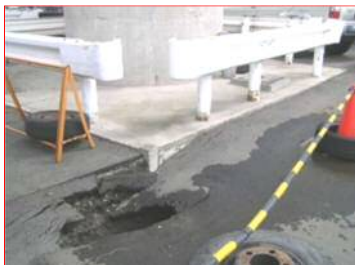
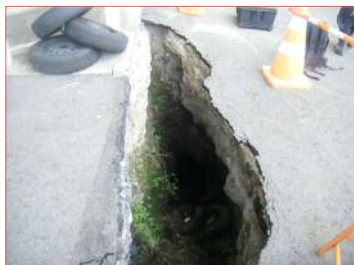
D-6 Ground Fissures, Pavement Collapse (Level 5)

The deformation around bridge pier D-6 is considerable with a large cavity occurring around the foundation of the bridge pier, and the pavement has collapsed. It is possible there was a cavity under the footing from before the earthquake, and earth and sand is filling in the area around there. Accordingly, an observation well was set up by boring in a position 2.5 m from the bridge pier, and after surveying the underground situation with a video scope (Figure 6-2), partial cavities were confirmed at a depth of 6.5 m directly below the footing and again under that at a depth of 7.3 m. The findings and an image of the cavity occurrences are shown in Figure 6-3. In line with the conjecture, there is a possibility earth and sand around the bridge pier was filling in the area under the footing from before the earthquake and there already was a cavity under the pavement surface. In these investigations, detailed situation around the foundation was not manifested, but it is thought these deformations such as surface difference and the like are the results of the effect that the earthquake extended latent conditions.
