# **Non-Destructive Bridge Deck Assessment using Image Processing and Infrared Thermography**

Masato Matsumoto<sup>1</sup>

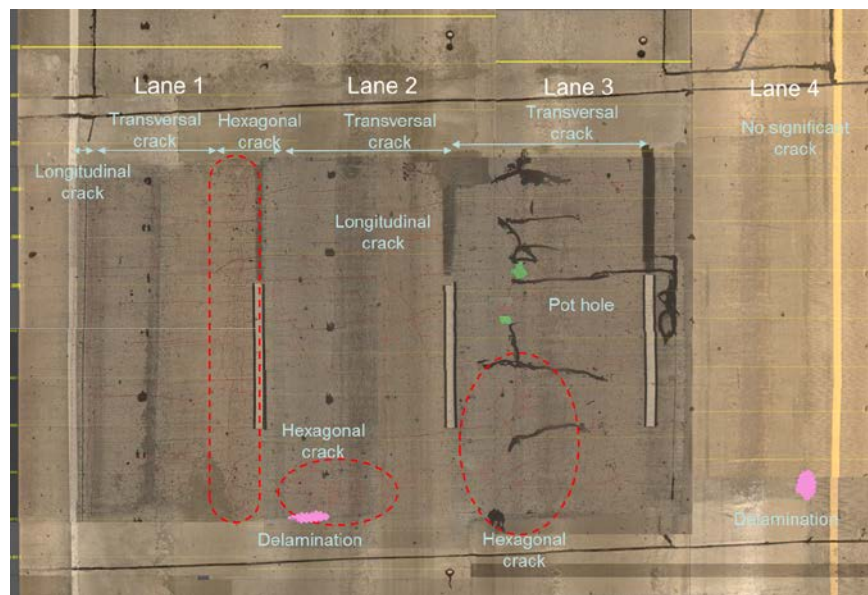
including “Moderate,” or “Severe” cracks. Most of the detected cracks on this bridge deck shall be categorized as ‘Insignificant’, and these cracks could not be detected by the traditional visual inspection that is typically performed by the bridge inspectors overlooking the deck surface defects from the shoulder. The infrared thermography camera successfully detected the possible delamination in deck concrete as shown in Fig.5 (hatched in pink colour). In order to find such deck subsurface defects traditional technique using chain dragging method (Fig.1- left) requires lane closure during the inspection period.

Fig.5: Overall Condition of the Deck at Downtown Orlando

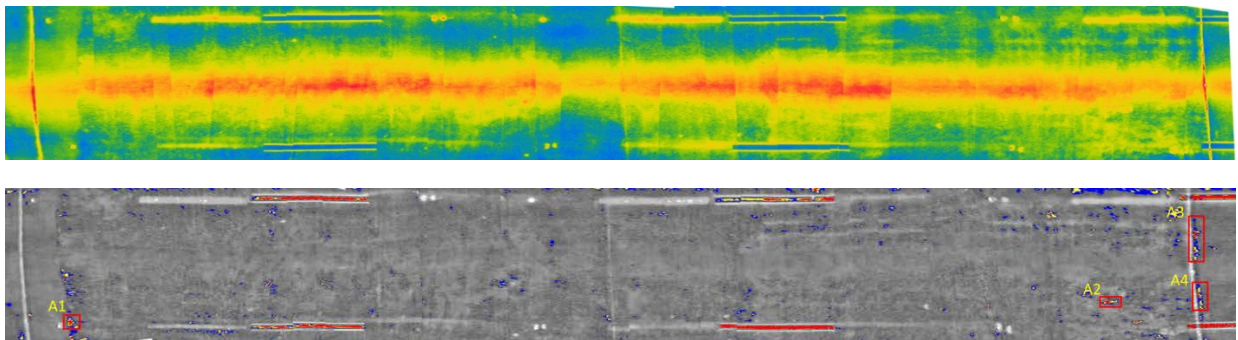
voltage or current when heated by infrared radiation, thus requiring longer exposure time to take the IR image. In this study, raw infrared images were further analyzed based on algorithm developed and tested in Japan on many bridges. The proprietary IR software applied in this project can classify the damage rate into three categories; the classification categories being “Critical” (crack caused by delamination reaches on concrete surface and immediate attention is required), “Caution” (crack exists within 2cm from the concrete surface and close monitoring is recommended) and “Indication” (Currently satisfactory) (see Fig.6). Raw infrared (IR) image data is filtered and rated into three categories by the software to indicate and evaluate the severity of the subsurface defects in concrete structures. The real time monitor shows the raw thermal image and filtered/rated images at the field (Fig.7). Fig.8 is an example of the thermal image and software output for a scanned bridge in downtown Orlando.

Fig.8: Thermal Image and IR Software Output for the Scanned Bridge

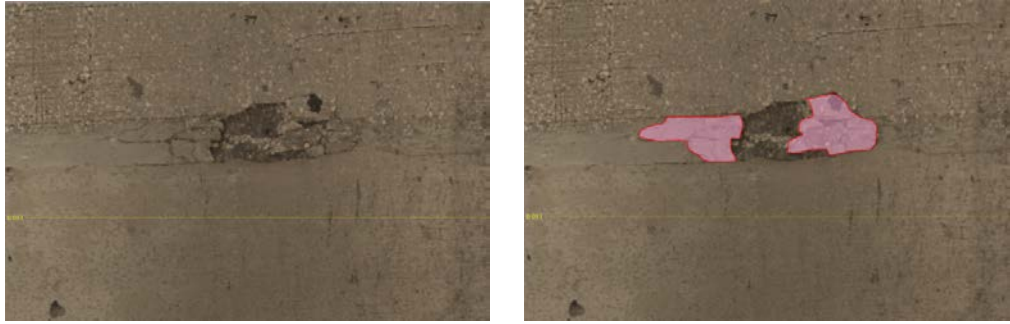
Fig.9 shows an example of detected pothole and possible delamination. Typically, perimeter of the pothole becomes vulnerable to further cracking and delamination due to the concentrated loading, causing the pothole area expanding to the surrounding area. Patching the potholes before it starts growing is a good maintenance strategy to increase the level of safety to the motorists and reduce the total maintenance cost for the bridge owner. Fig.10 shows the visual image and infrared software output at the third lane of the bridge deck. Some potholes and possible delaminated areas were found along the longitudinal construction joint between the widened and existed decks, especially at the shear key locations. Fig.11 shows an example of the visual image and infrared software output close to the expansion joint. Delaminated areas in concrete were found at the boundary of existing deck concrete and the concrete placed after the settlement of expansion joint. These ‘boundary’ areas between the concrete placed in different time period can be the possible weak spots to initiate potholes and delaminated areas.

Fig.9: Detected Pothole and Possible Delamination

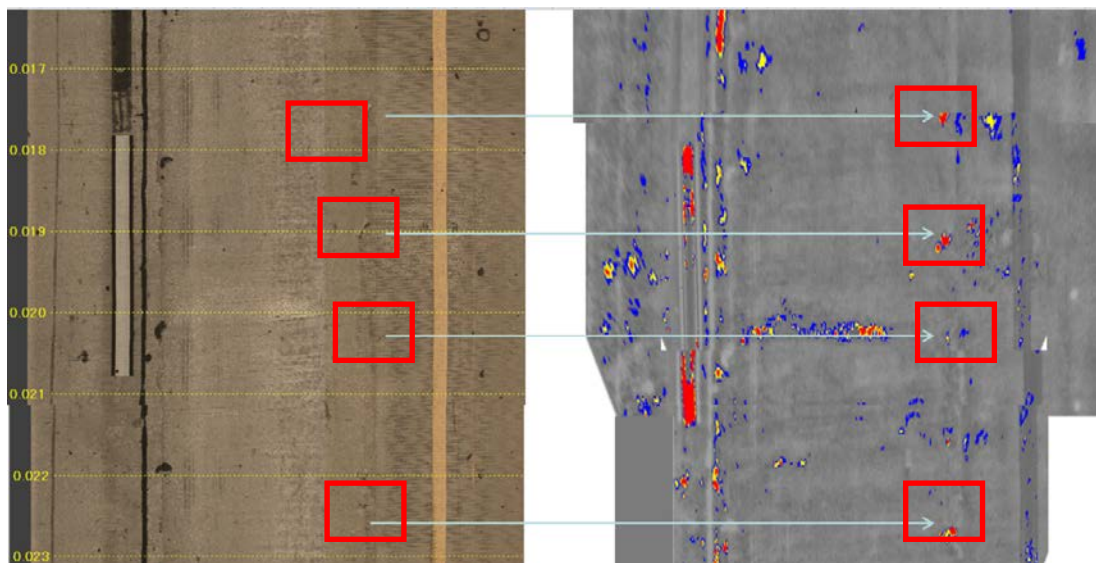
Fig.10: Visual Image (left) and IR Software Output (right) at Longitudinal Construction Joint

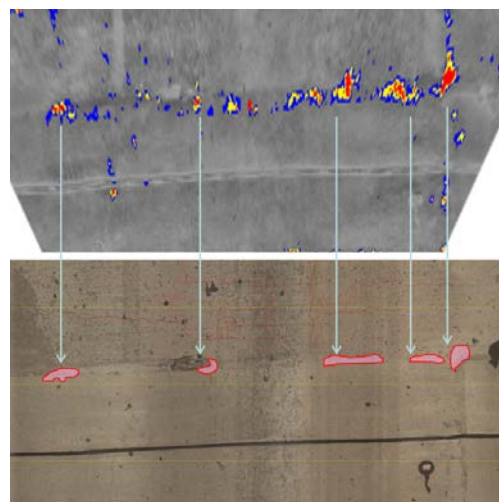
Fig.11: Visual Image (bottom) and IR Software Output (top) at Expansion Joint

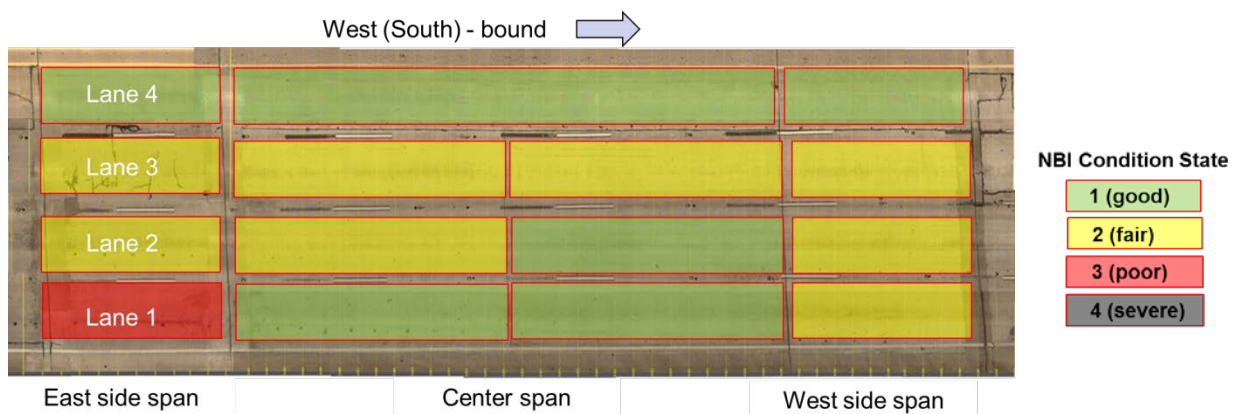
Table 2 describes the four condition states defined in the AASHTO Guide Manual for Bridge Element Inspection (AASHTO, 2011). Based on the AASHTO Manual, the condition states for each span/lane of the bridge deck were determined and summarized in Fig.12. Cracking significance and patterns varies for each span/lane of the bridge deck. If we could apply this deck scanning system to the corridor level inspection and determine the condition state for each span/lane of each bridge in the network, the bridge owner can use this information to prioritize the bridge deck repair/rehabilitation program and efficiently allocate the limited budget to obtain the maximum return on investment for the network level bridge management.

Fig.12: Determining the Condition States for Each Span/Lane of the Bridge Deck

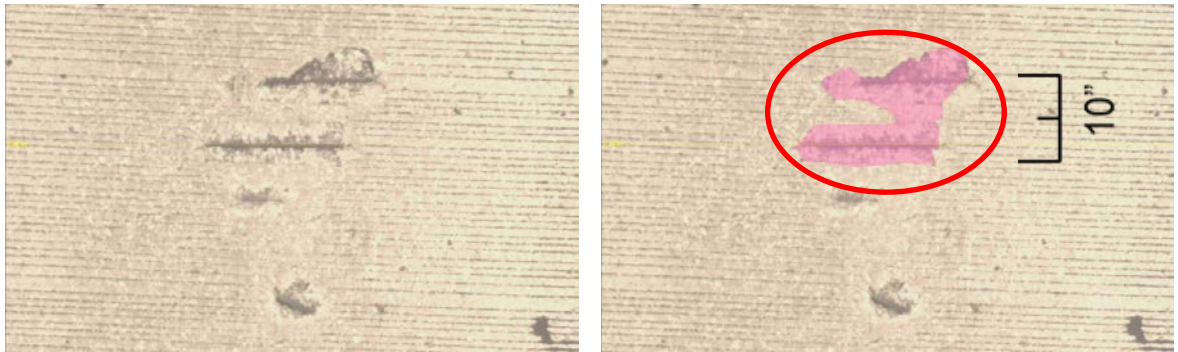
Fig.13 shows an example of potholes with corroded rebar exposed on the deck top for another bridge on I-4. The cause of the spall in deck top concrete could be lack of cover thickness and/or corrosion of rebar. The infrared software shows some potential delamination around the spalled concrete and other potential deck subsurface delamination as shown in Fig.14, indicating the possible rebar corrosion and occurrence of future pothole. The red line in Fig.14 is estimated re-bar location on the deck top side (interval of rebar estimated to be approximately 8" from the two exposed rebar shown in Fig.13).

Fig.13: An Example of a Pothole with Corroded Rebar Exposed

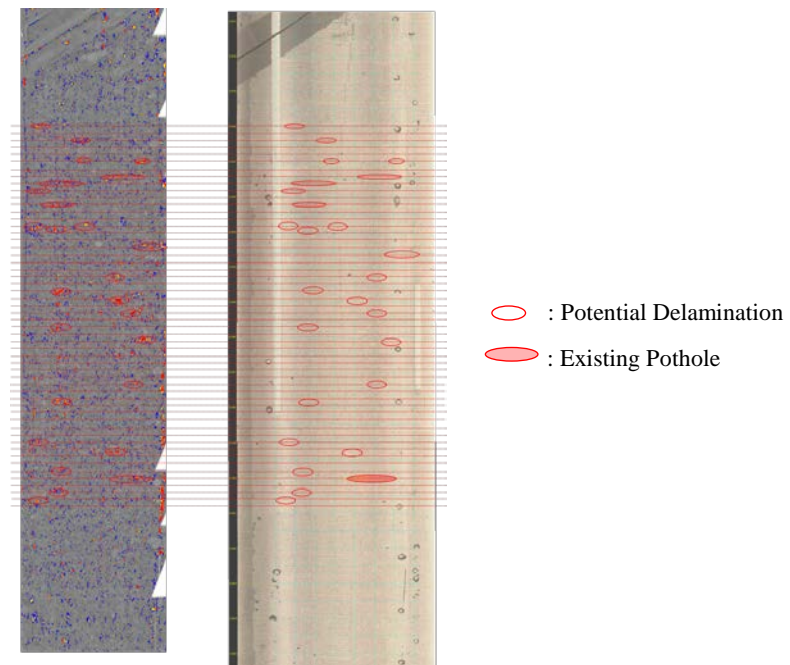
Fig.14: Visual Image (right) and Infrared Software Output (left)
