Repair Works on a Composite Girder Cable-Stayed Bridge damaged by Ship Collision (Binh Bridge in Vietnam)

Tomonobu Tokuchi, Shinji Kaifuku, Satoshi Kawabata, Tatsuya Idani

The Binh Bridge, a 3-span cable-stayed bridge with composite girders and a center span of 260m, was opened to traffic in 2005. In 2010, 3 ships swept upstream by a typhoon collided with the bridge, resulting in serious damage to the main girder and several cables. Repair and rehabilitation works on the bridge were awarded to IHI Infrastructure Asia Co., Ltd.

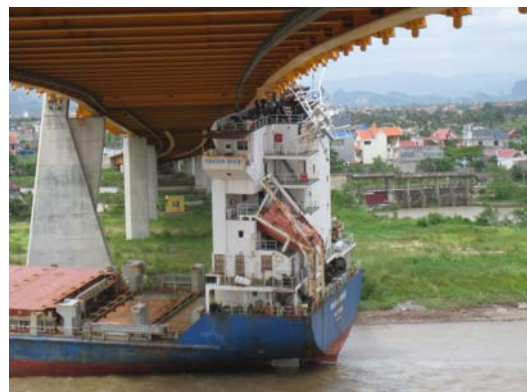
Figure 2 Ship Collision of Main Girder

Binh Bridge, located in Haiphong City, Vietnam, is a 3-span cable-stayed bridge with composite girders and a center span of 260m that was completed in 2005. Figure 1 shows a complete view of the Binh Bridge at completion. In July 17th 2010, three cargo ships that had been moored for repair at a shipyard near the Port of Haiphong were carried approximately 600 m upstream by typhoon No. 1 and collided with the composite girder of the Binh Bridge. Fig. 2 shows a general view of one of the ship's bridge stuck onto the composite edge girder after collision.

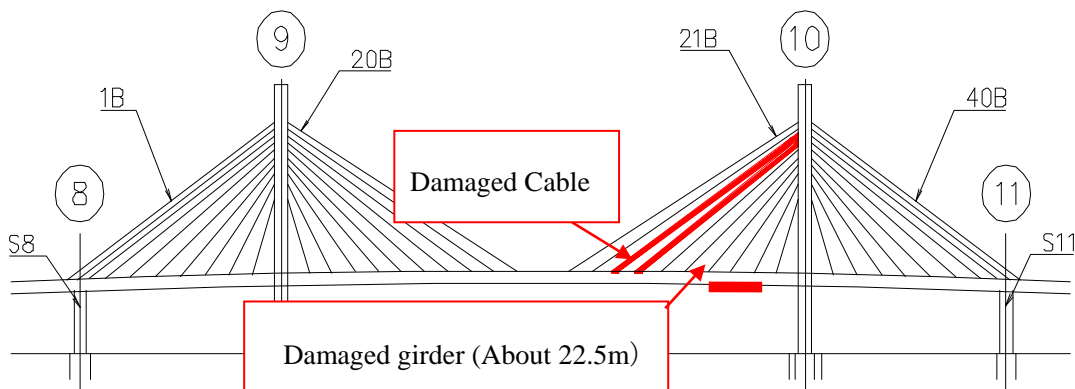
Figure 3 Damage locations on bridge

The main areas of damage were; lower-flange of the main girder (22.5m), two stay cables, the guard railing and a navigation sign board in downstream side. (Figure 3)

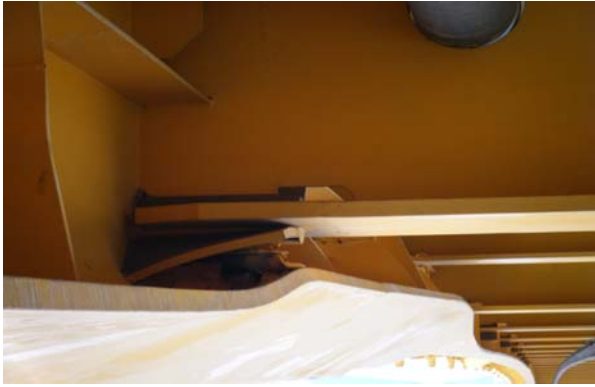
Figure 4 Damaged Edge Girder (Inner side)

The main girder lower-flange was deformed in the out-of-plane direction with the vertical stiffeners exhibiting complete buckling. Figure 4, 5 show the damaged edge girder. However, the floor beams and concrete deck slabs were undamaged and sound.

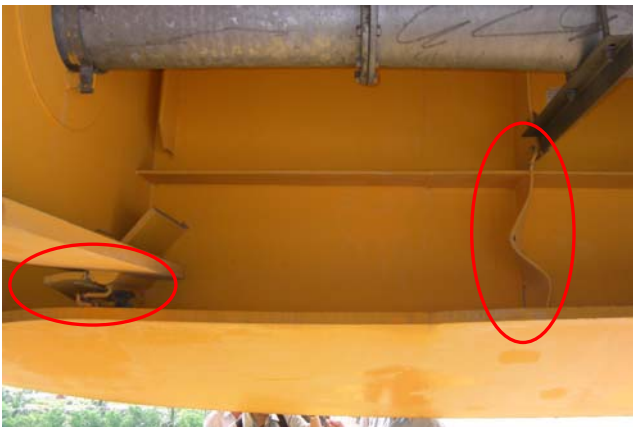
Figure 6 Buckled Stiffeners

The main girder was significantly bent on the bottom flange side by the collision and had residual plastic deformation. A web was pulled by the bottom flange until it developed out-of-plane deformation. Webs had cracks in places near cable anchorages and were shifted by a distance nearly equal to the plate thickness (20 mm) in an out-of-plane direction. Stiffeners on the inner side of the main girder were pushed upward by the bottom flange until they were buckled, and it was impossible to replace the stiffeners. Figure 6 shows the buckled stiffeners.

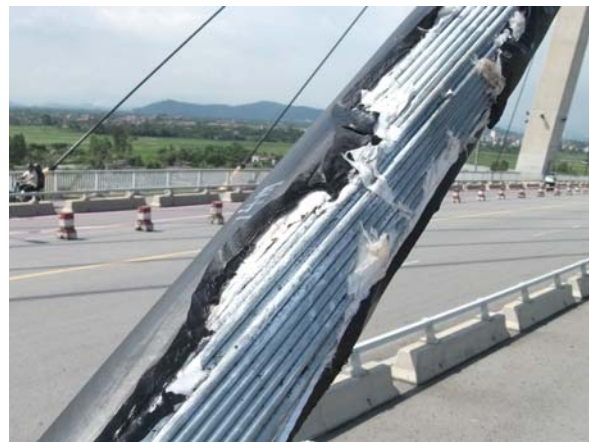
Figure 7 Cable Damage

The polyethylene cover (PE cover) of the two stay cables was peeled off completely exposing the wire strands which had partial damage to the galvanizing cover. Figure 7 shows the damaged cable. “White rust” of the zinc coating was also observed. From the damage condition, it was obvious that salty water had gone into the stay cable and thus the stay cable would require replacement.

It was difficult to accurately evaluate the durability of the damaged cables, so it was impossible to guarantee their quality for the future. Therefore, we determined to replace the damaged cables with new cables.

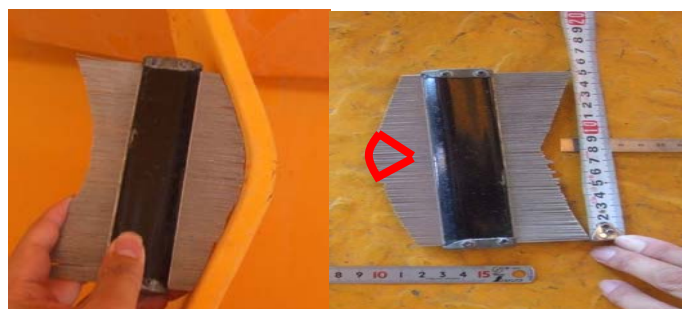
Figure 8 Surface curvature of bent plate

We conducted evaluation in terms of the strain of the plates with the aid of Expression (1) below. In the evaluation, we used cold bending radius $5t$ ($\epsilon = 10\%$) that is stated in the Specifications for highway bridges as a guide, in order to achieve Charpy absorbed energy higher than or equal to the required performance⁽²⁾ of steel materials from the viewpoint of ensuring the toughness of steel plates. Figure 8 shows the surface curvature of bent plate being measured.

The simple strain evaluation by this method revealed that most portions had a strain of 3% (corresponding to a load of $15t$) or lower. The strains were at levels that would not cause problems. However, we determined to replace portions with cracks and those with apparent residual deformation anyway. The bridge portion that would be replaced is approximately 22.5 m long in the longitudinal direction and 1050 mm

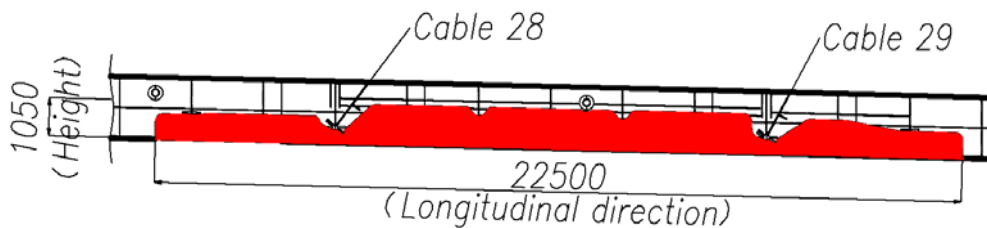
Figure 9 Replaced main girder range

from the bottom of the main girder, which is slightly higher than half of the girder height. Figure 9 shows the portion that would be replaced in the main girder.

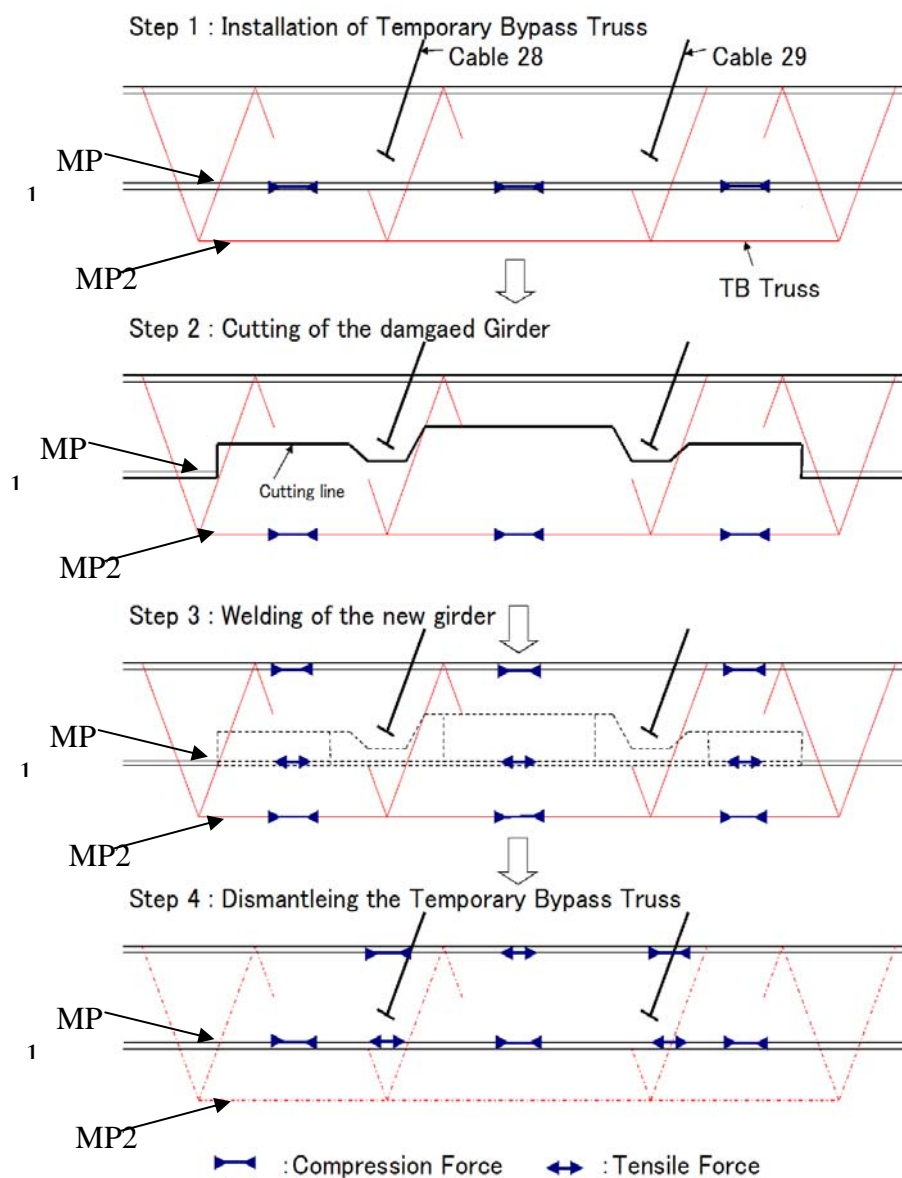
Figure 18 Stress monitoring for each construction step

In the figure 18, load flow transferring to lower flange and Temporary Bypass Truss during repair is shown. In the figure 19, the result of monitoring measuring point (MP)1 and 2 is shown by graph. For the vertical axis of this graph acting force is shown and for the horizontal axis construction step is shown. Regarding vertical bar of this graph, the changing force of lower flange and Temporary Bypass Truss per each construction step is shown. And Regarding polyline of this graph the sum total of that is shown.

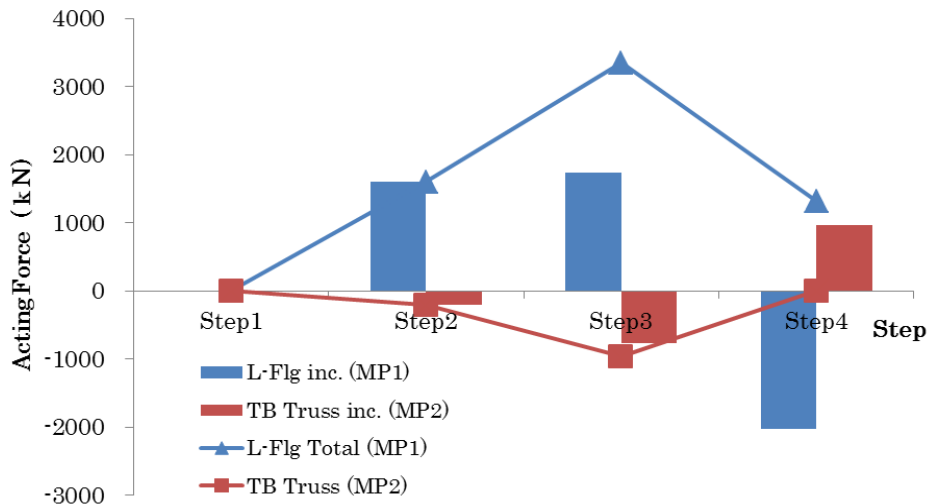
Figure 19 Force changes during construction

When cutting the lower flange deformed in the out-plain direction, the residual stress is released and the behavior which be back to non-deformed condition was confirmed. In the measuring result of monitoring, stress difference between edge girder of upstream side and that of downstream side due to out-plain deformation of edge girder was confirmed.

When Temporary Bypass Truss was installed on the girder, there is not stress in this Temporary Bypass Truss but compression force is acted on the edge girder (Step1). When cutting damaged edge girder, Temporary Bypass Truss is compressed due to re-distribution of compression force of cut edge girder (Step 2). When welding of newly parts of edge girder, Temporary Bypass Truss is compressed because of welding shrinkage. Also welded newly part of edge girder is tensioned (Step3). When dismantle the Temporary Bypass Truss, due to release of compression force acted on Temporary Bypass Truss, this force is distributed to edge girder and concrete deck slab (Step 4). Finally distributed acting force on the Lower Flange is approximately 1000 kN (for the stress, approximately 22 N/mm² (Section 900mm x 60mm)) including residual stress due to welding.

From the above result, we concluded that because Temporary Bypass Truss was transferred from the compression force acted on damaged edge girder, it is very efficient for this repair work.

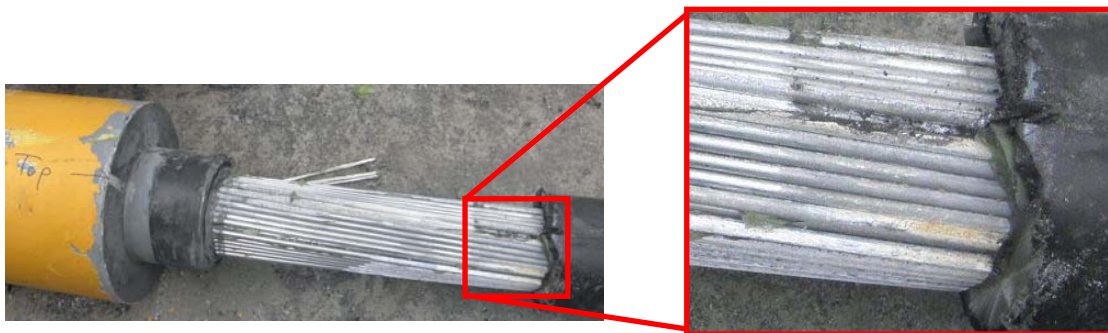
Figure 20 Opening investigation result of damaged stay cable

After replacement the damaged Stay Cable, we performed the opening investigation for corrosion situation of wire of Stay Cable 24B. About 5.7m position from cable socket was into the guide pipe of Cable Anchorage and stay cable cover of about 7.6m position apart from there was damaged and wire of stay cable was exposed. Stay Cable was exposed in the rain due to typhoon and 4 days later temporary cover of Stay Cable is covered.

In our investigation, about 1.7m area from the socket including 1.5m portion covered with polybutadiene rubber was peel. Opening investigation result is shown in Figure 20.

As a result, regarding wire from the edge of cable to 1.2m position some area is same as new product partially but the white rust could be found over the top of cable. Also in slight area the red rust could be found. As above mentioned, nevertheless it is difficult to evaluate the effect of corrosion; the replacement of damaged stay cable was decided in consideration to safety of long span. In our internal investigation, it was confirmed that wire was corroded two years later after damage Cover of Stay Cable. So if the cover of Stay Cable is damaged, the water invader should be prevented as soon as possible.
