2010 MAULE CHILE EARTHQUAKE WALL PERFORMANCE AND ITS APPLICATION TO IMPROVEMENT OF THE AASHTO LRFD SEISMIC WALL DESIGN SPECIFICATIONS

Tony M. Allen, P.E.¹

Abstract

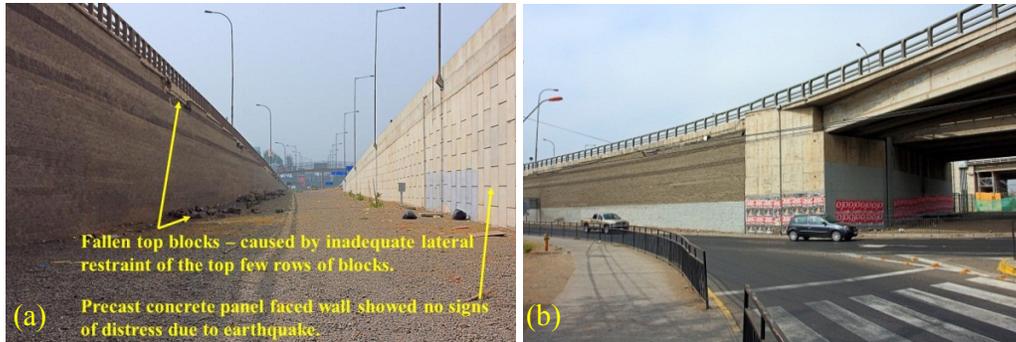
Figure 2(a) shows two walls retaining the approaches to the Americo

Vespucio/Independencia Bridges in Santiago, built in 2004. The wall to the left in the figure is a high density polyethylene (HDPE) geogrid reinforced wall with a dry cast concrete block facing, and the one on the right is a steel reinforced soil wall with concrete precast panels. Both walls are approximately 6 to 7 m in height. Figure 2(b) shows the bridges at the same interchange, which did sustain some damage that required the bridge to be shored until repairs could be made. Other than some toppling of facing blocks at the top of the block faced wall due to poor connection and coping details, the walls showed no signs of damage due to the earthquake.

Figure 2. The Americo Vespucio/Independencia Interchange Showing (a) Bridge Approach Walls, and (b) the Bridges and Abutments.

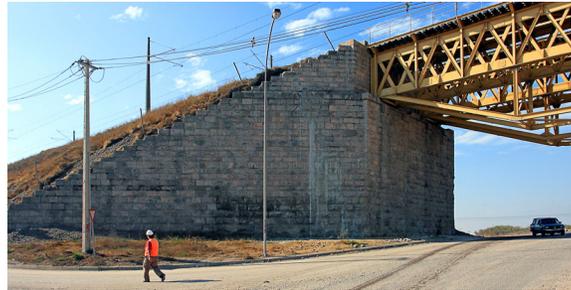
Figure 3 shows an exceptionally large (i.e., approximately 12 m high) concrete faced gravity wall supporting the Maipu River Railroad Bridge just south of Santiago. Both the wall and bridge were not damaged and were fully operational after the earthquake, yet parallel bridges at this site did suffer significant damage, but without collapse.

Figure 3. Abutment Wall Supporting the Maipu River Railroad Bridge South of Santiago.

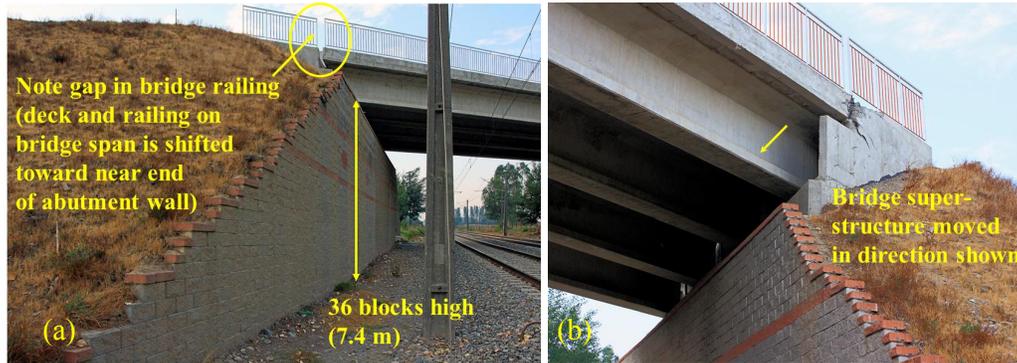
Figure 4(a) shows one of the dry cast concrete block faced HDPE geogrid reinforced soil walls that form the bridge abutments for the Avenida Independencia Bridge at Estribo Francisco Mostrazal between Santiago and Rancagua in the central valley. These walls, 7.4 m in exposed height, directly support the bridge abutment footing load of approximately 210 kPa at each abutment, the typical maximum allowed footing loading in the AASHTO design specifications. The walls were designed using the 2002 AASHTO Standard Specifications (Tensar Earth Technologies 2003). For seismic design, the acceleration coefficient used was 0.3g. Though ground motion data was not available at this particular site, based on ground motion data in the general vicinity, actual PGA's were likely in the range of 0.3g to 0.5g. Reinforcement spacing varied from 0.2 to 0.4 m, and reinforcement length varied from 80 to 100% of the wall height. Most of the reinforcement layers had an ultimate tensile strength of approximately 130 kN/m. Good quality crushed stone backfill (42° design friction angle) was used for the walls.

As can be seen in the figure, the abutment walls showed no sign of damage or permanent deformation. However, the bridge superstructure was damaged, but still functional, as shown in Figure 4(b). The bridge superstructure has both significant skew and a significant longitudinal downward slope. The combination of slope and

skew caused the bridge superstructure to move downslope and toward the acute angle in the bridge skew, resulting in the damage, yet the walls were unaffected. This case history is a testament to the ability of reinforced soil wall structures to resist large earthquake loading.

Figure 4. Avenida Independencia Bridge Geogrid Reinforced Soil Walls at Estribo Francisco Mostrazal (a) West abutment, and (b) East Abutment.

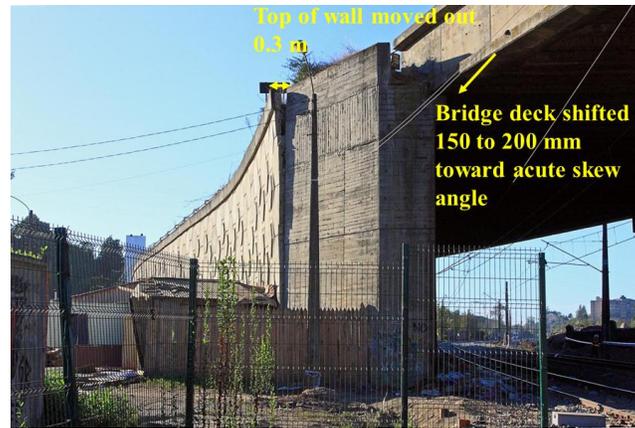
Figure 5 shows one of the first reinforced soil walls built in Chile, in 1995. This wall is located in Concepción, near one of the hardest hit areas in that location. The site is underlain by 6 to 7 m of loose sand and silt with a high water table, and some sand boils (evidence of liquefaction) were observed. One of the older bridges at the site collapsed, and the other bridges were significantly damaged (Yen, et al. 2011). The wall shown in the figure is approximately 10 m high where it makes contact with the severely skewed Via Elevada railroad undercrossing bridge abutment wall. The severe skew restricted the length of the steel soil reinforcement (bar mats) attached to the wall facing panels closest to the bridge abutment wall. Furthermore, the vertical joint between the reinforced soil wall and the bridge abutment wall was not tied together to prevent movement and separation at the vertical joint, though in all other respects, the wall was designed in accordance with the AASHTO bridge design specifications available at that time, but using a higher seismic design acceleration (0.4g) than required by Chilean design standards at that time (W. Neely, Aug. 30, 2010 personal communication). The backfill used for the wall was a uniform medium river sand. Based on testimony from the wall supplier (W. Neely, personal communication), the backfill soil used was very difficult to maintain compaction, causing difficulties in

keeping the facing panels aligned during wall construction. As can be seen in Figure 5, the wall top moved outward about 0.3 m, likely the result of the lack of connection at the vertical joint combined with the medium uniform sand backfill.

Figure 5. Abutment and Reinforced Soil Wall at the Via Elevada Railroad Undercrossing.

- Avoid uniform sand backfill, especially if it lacks angularity. While uniform sand is well drained, it can be unstable with regard to reinforced soil wall backfill, allowing soil reinforcement to slip and facing panels to separate. A more well-graded mix of soil, but with low silt/clay content, is preferred.

- Full height joints in walls can come apart during shaking. These joints should

be structurally tied together adequately to prevent separation during shaking, but not so tight that the joints attract load and differential settlement issues cannot be addressed.

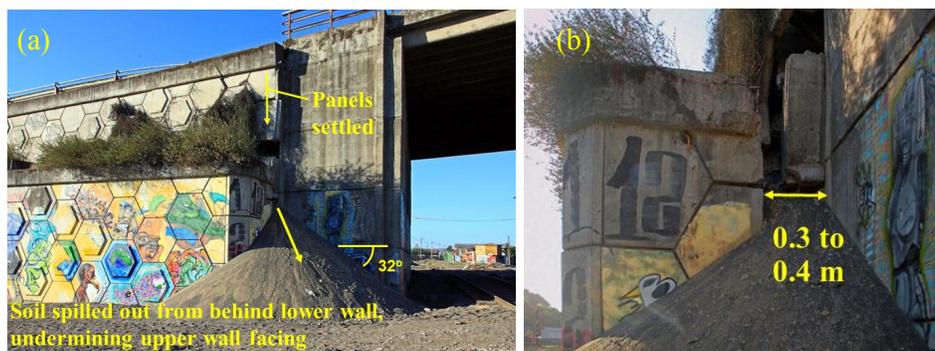
The other walls at the bridge shown in Figure 5 and other bridges at this interchange exhibited similar performance problems where the reinforced soil walls joined with the bridge abutment walls. An example of the walls at these other bridges is shown in Figures 6 and 7. In this case, the lower wall moved outward over 0.3 m, due to a combination of lateral sliding and outward rotation. It is possible that liquefaction induced weakening of the soil below the wall contributed to this movement. However, of all the walls observed in Chile, this is the only wall that exhibited what appeared to be a sliding failure. In all other cases, when wall movement occurred, it was due to rotation of the wall, or liquefaction induced displacement. As the wall moved outward, a large gap formed due to the lack of connection across the vertical joint, allowing much of the sand backfill to flow through the opening.

Figure 6. Tiered Walls at the Via Elevada Railroad Crossing (a) Overall View of Walls, and (b) Close-up Showing Movement of Lower Tier.

- Wall corners and tight radius curves in the wall alignment tend to exhibit damage more often than relatively straight sections of wall. If wall corners are not properly joined together, they can open up and allow backfill to spill through during shaking. In severe cases, shearing of panels or facing blocks can occur. Special details may be necessary at corners or sharp turns in the wall alignment to prevent separation of panels and to address the three dimensional aspects of the corner or tight radius curve.

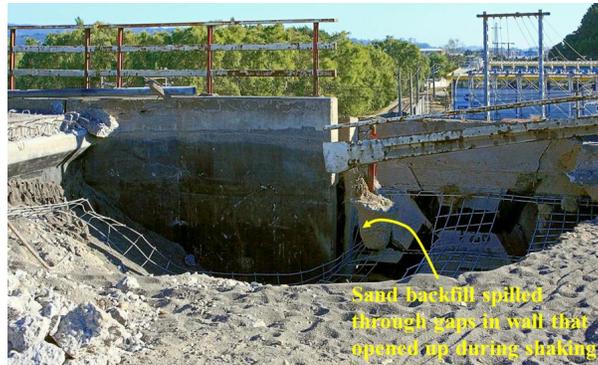
Figure 7. Wall Shown in Figure 6, but from Back Side Showing Exposed Junction between Reinforced Soil Wall and Bridge Curtain Wall.

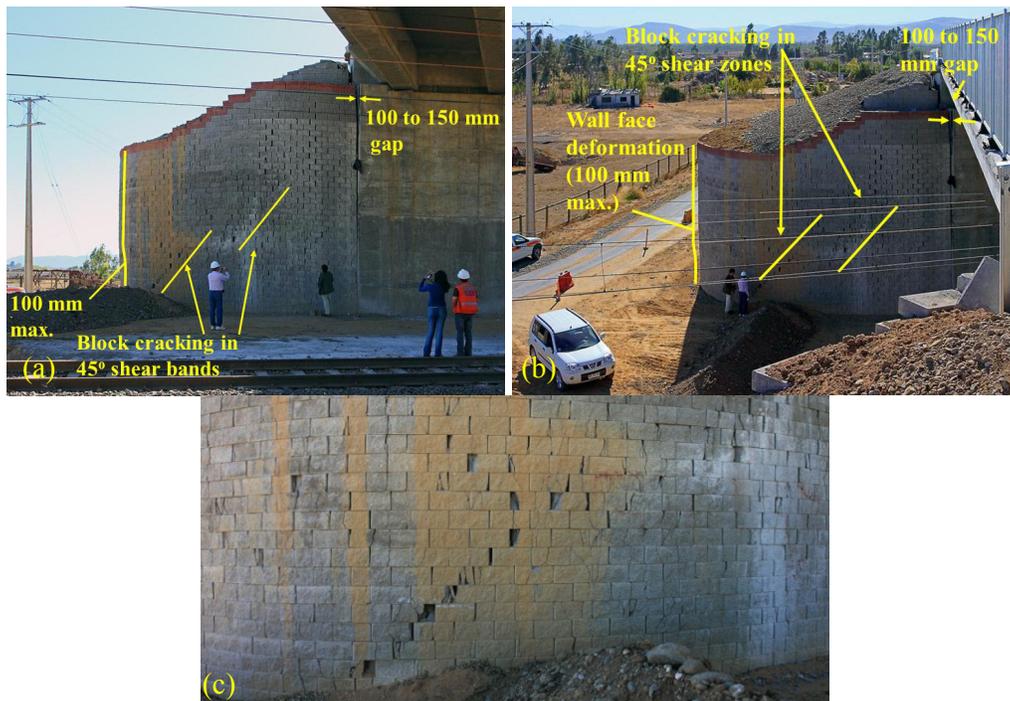
Figure 8 shows one of the four dry cast concrete block faced HDPE geogrid walls built in 2009 that retain the approach fills for this railroad undercrossing near Talca in the central valley, almost directly east of the earthquake epicenter. PGA's in

this area were likely in the range of 0.5g, based on ground motion records in the general area (e.g., Curico) and its relatively close proximity to the epicenter. The walls have a maximum height of over 9 m plus a 2 m high surcharge. Another important feature of these walls is the very tight curve in the wall alignment. Based on construction photos, geogrid strips were placed throughout the curve, requiring the geogrid strips to overlap one another through the curve. It was not clear if some soil was placed between the overlapping geogrid strips to ensure good pullout resistance, and how well the geogrid connected with the facing blocks within the curve in the wall alignment.

As can be seen in this figure, the wall shown did exhibit significant deformation, primarily through tilting, as no sliding of the wall at its base was observed. The tilting of the wall resulted in the formation of 45° shear bands (see especially Figure 8c) in the facing blocks, especially transverse to the bridge centerline and in the vicinity of the tight radius curve in the wall alignment. Some deformation and shearing also was present in the other four walls at this site, but not as severe as the wall shown in the figure.

Figure 8. Muros Talca Railroad Crossing with Dry Cast Concrete Block Faced HDPE Geogrid Walls (a) Ground View, (b) View of Wall from Bridge, and (c) Close-up of Wall Face Showing 45° Shear Bands.

- For reinforced soil walls, a minimum reinforcement length of 70% of the height or more, especially in upper part of wall, appears to prevent excessive lateral deformation of wall face. This is especially important for heavily skewed bridges where the reinforced soil wall joins the curtain wall or abutment wall.

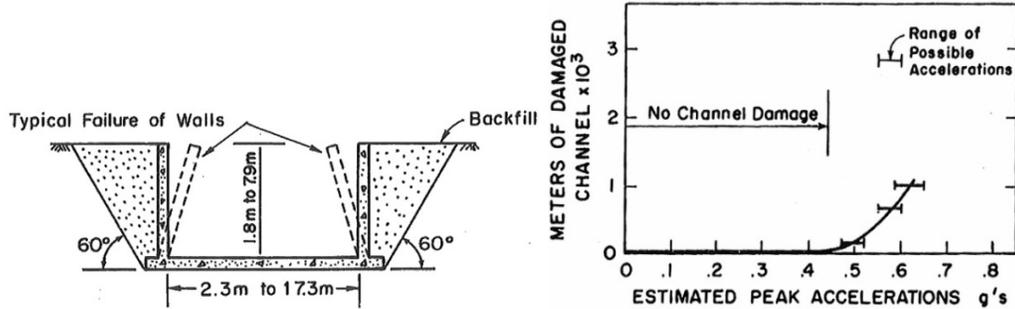
A PGA criterion can also be developed empirically from wall performance in past earthquakes, such as the 2010 Maule Chile earthquake. Clough and Fragaszy (1977) assessed damage to floodway structures, consisting of reinforced concrete cantilever (vertical) walls structurally tied to a floor slab forming a continuous U-shaped structure, due to the 1971 San Fernando earthquake. They found that no damage was observed where PGA’s along the structures were less than 0.5g (see Figure 10). However, damage and wall collapse was observed where accelerations were higher than 0.5g or where the structures crossed the earthquake fault, though in the latter case damage was quite localized. They noted that while higher strength steel rebar was used in the actual structure than required by the static design, the structure was not explicitly designed to resist seismic loads. Gazetas, et al. (2004) for concrete gravity walls in the 1999 Athens earthquake and Lew et al. (1995) for tieback shoring walls in the 1994 Northridge earthquake observed that wall performance was good for peak ground accelerations up to just under 0.5g even though the walls were not specifically designed to handle seismic loads. AASHTO (2012) provides a more complete summary of wall seismic performance in Appendix A11.

Figure 10. Floodway Walls in the 1971 San Fernando Earthquake, (a) Floodway Wall Configuration and Failure Mechanism, and (b) PGA versus Length of Walls Damaged (after Clough and Frigaszy 1977).
