# NON-DESTRUCTIVE BRIDGE ASSESSMENT TECHNOLOGY BY INFRARED THERMOGRAPHY

Masato Matsumoto<sup>1</sup>, Koji Mitani<sup>2</sup> and Necati F. Catbas<sup>3</sup>

## The pilot Project

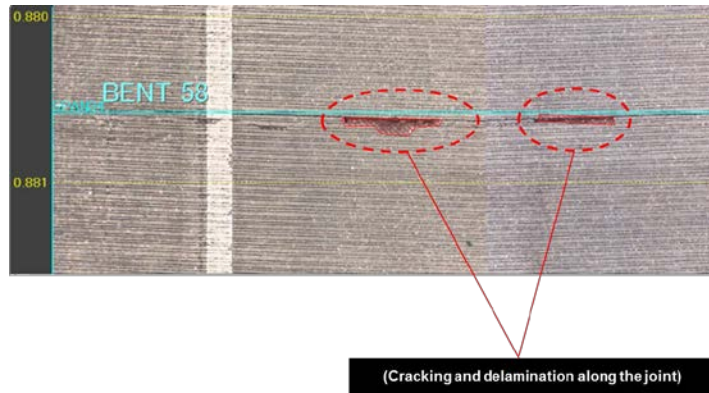
Fig.6 depicts typical delaminated areas found on the deck surface. This type of cracking and delamination were found at some of the joints throughout the entire bridge deck. These delaminated areas were detected by digital image and IR scanning results, and hatched in yellow (for CS2: Fair) or red (for CS3: Poor) depending on their sizes. According to AASHTO manual (AASHTO, 2013), areas of delamination or spall with 6 in. (15cm) or less in diameter should be evaluated as ‘CS2: Fair’, while those areas of greater than 6 in. (15cm) diameter or areas with unsound patch should be evaluated as ‘CS3: Poor’. The hatched areas were automatically summarized by the software to calculate the quantity of deck surface with each condition state. Fig.7 depicts the typical cracking found on the deck surface. The spacing of the crack was less than 1.0ft (0.3048m), and these cracking areas were evaluated as ‘CS3: Poor’. Fig.8 is an example of IR scanning results successfully detecting the spall on the deck surface. These spalls were less than 6 in. (15cm) in diameter and were evaluated as ‘CS2: Fair’.

Fig.6: Typical delaminated areas on the deck surface (near the joint area)

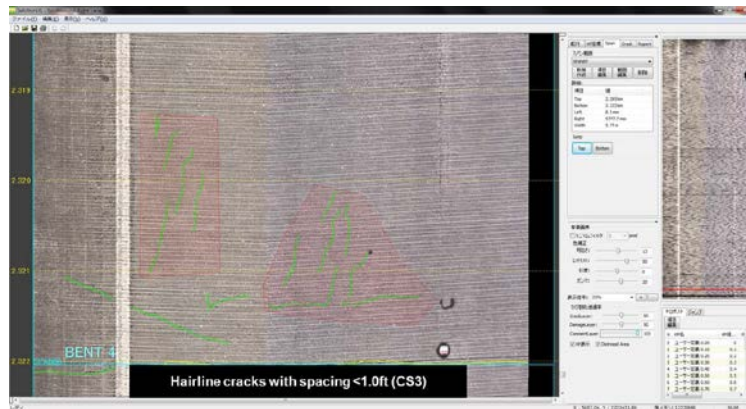
Fig.7: Typical cracking on the deck surface (hairline cracks with narrow spacing)

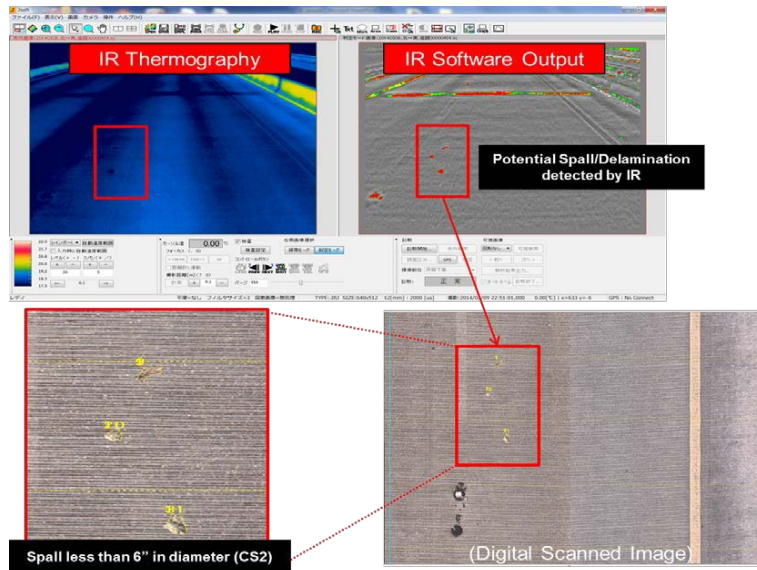
Fig.8: Typical spall found on the deck top

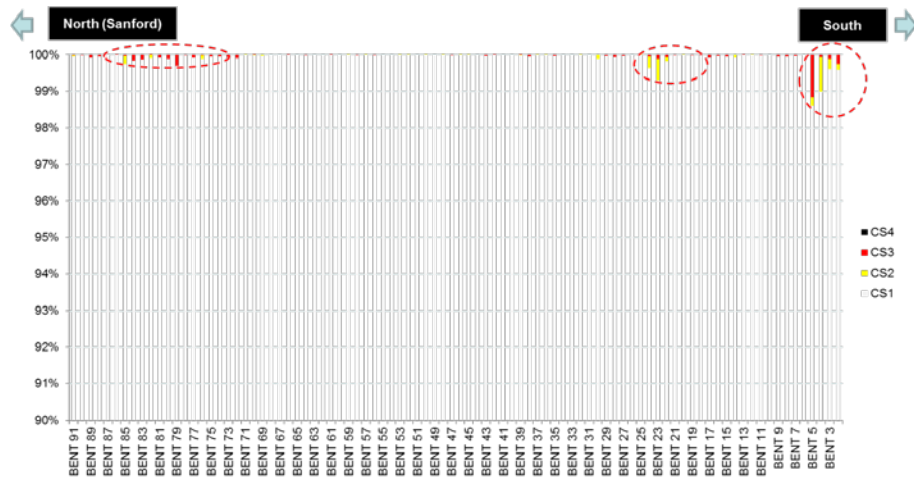
Table 2 is an example of element level inspection summary for the south bound bridge. The area of each condition state was also summarized for each span/lane of the bridge deck. Fig.9 is a graphical presentation for element level condition state distribution for each span of the south bound bridge. This kind of information can be a quantitative parameter for the bridge owner to monitor the overall deck condition over time and to prioritize future repair/rehabilitation programs.

Fig.9: Element condition state distribution (south bound bridge deck)

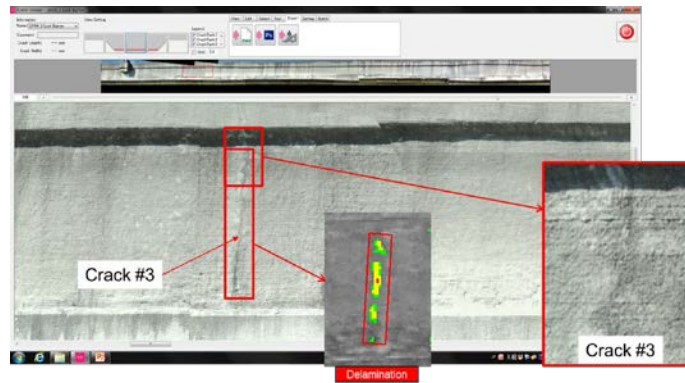
The reinforced concrete bridge railings show some cracks with efflorescence, coupled with possible delaminated areas adjacent to the cracks (Fig.11). The existence

of delaminated areas was detected by IR scanning. Areas including cracks with minor delamination and/or efflorescence should be evaluated as ‘CS2’ based on the criteria in AASHTO Manual. Table 3 is an example of element level inspection quantity summary for the bridge railings for west face of the south bound bridge. The length of the bridge railing in each condition state can also be summarized for each span of the bridge. Fig.12 is a graphical presentation for element level condition state distribution for each span of the west face of the south bound bridge. The percentage of linear footages in bridge railings in ‘CS2’ varies for each span, and this information can be a quantitative parameter for the bridge owner to monitor the overall condition for bridge railings over time and to prioritize the repair/rehabilitation program.

Fig.11: Typical cracks with delamination on the reinforced concrete bridge railing

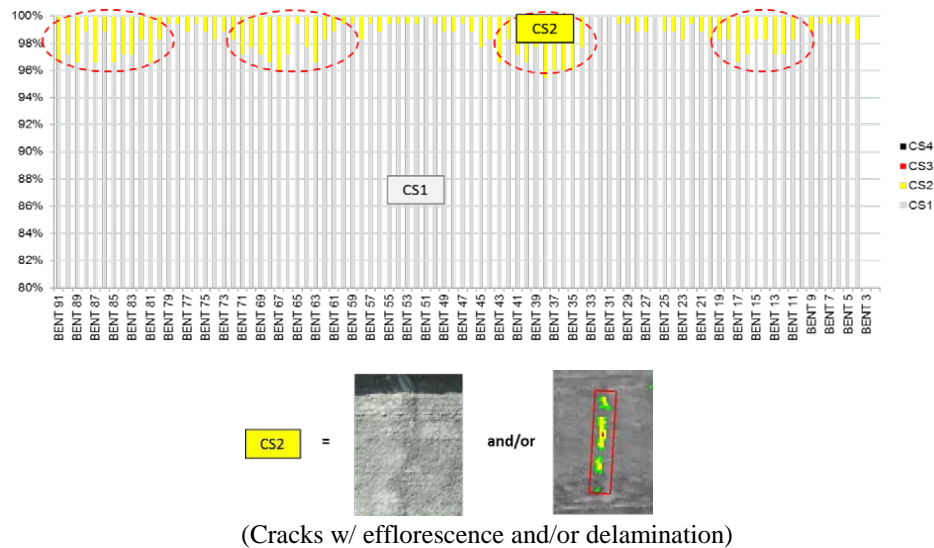
Fig.12: Element level condition state distribution for reinforced concrete bridge railings

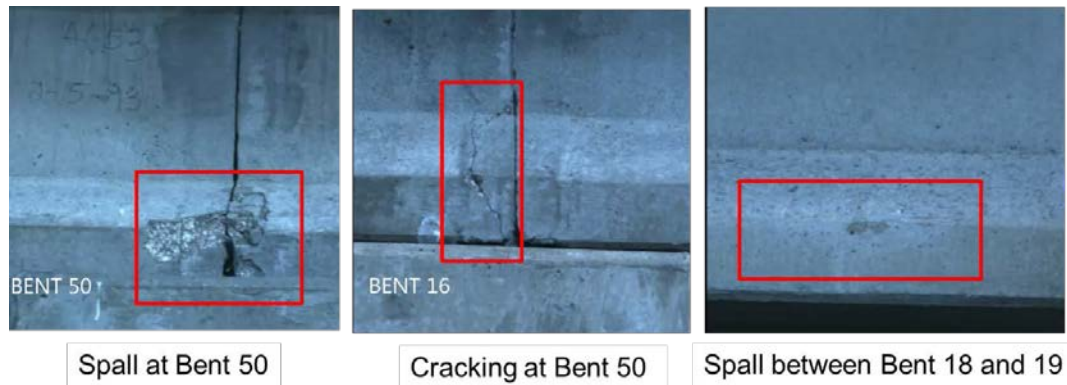
On the other hand, no significant cracks/delaminations were found in the outer faces of the prestressed concrete beams except for some minor spall and cracking at the end of the beam (Fig.13). Sections including minor cracks and delamination should be evaluated as ‘CS2’ based on the condition state criteria defined in the AASHTO Manual. Based on the information obtained by digital image and IR scanning, condition state for element ‘#109 Prestressed Concrete Girders/Beams’ for the Lake Jessup Bridge was summarized. Table 4 is an example of an element level inspection quantity summary for the prestressed concrete beam for the west face of the south bound bridge. The length of each condition state for prestressed concrete beams was also summarized for each span of the bridge. Fig.14 is a graphical presentation for element level condition state distributions for each span of the beam of the west face of the south bound bridge. The percentage of beams in ‘CS2’ (depicted in yellow color) varies for each span, and this information can be a quantitative parameter for the bridge owner to monitor the overall condition for prestressed concrete beams over time and to prioritize the repair /rehabilitation programs. Fig.15 is an example stitched image and IR scanning results for the west face of Span 7 (Bent 84- Bent 85) of the north bound bridge. AASHTO condition state distribution for reinforced concrete bridge railing and prestressed concrete beam are also shown in Fig.15.

Fig.13: Typical cracking and spalls at the prestressed concrete beams

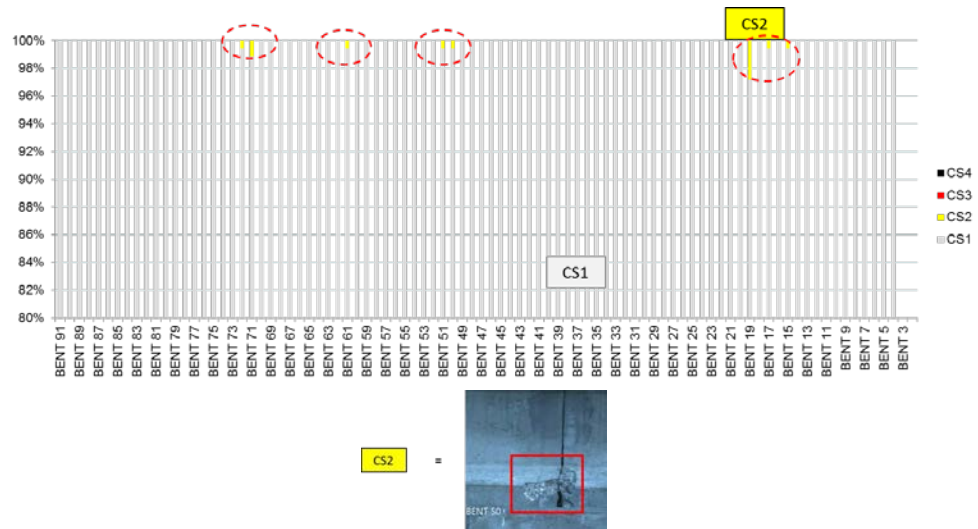
Fig.14: Element condition state distribution for prestressed concrete beams
