Investigation of Tunnel Ceiling Collapse Accident

Masahiro Shirato¹

Abstract

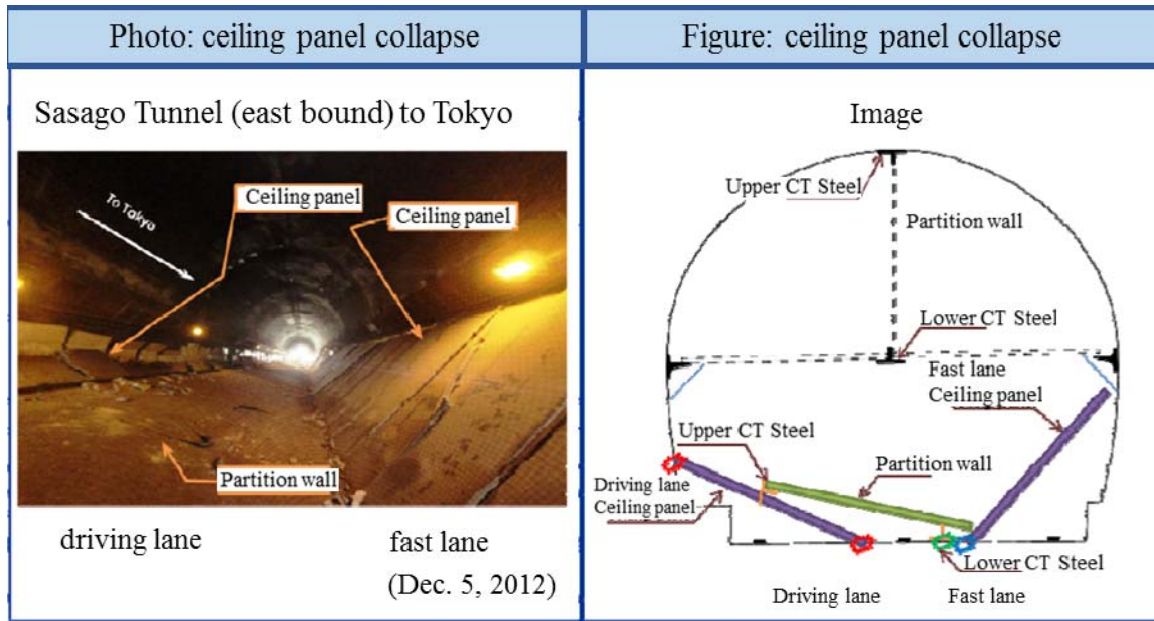
FIGURE 1 PANELS COLLAPSE

As shown in Figure 1, at about 8:03 a.m. on December 2, 2012, ceiling panels and partition walls collapsed over a continuous road section of length approximately 140 m in the east-bound lane of the 4.4 km long Sasago Tunnel. The tunnel is located about 80 km west of Tokyo and the collapse occurred at 1,150 m inside from the Tokyo-side entrance. Three vehicles were involved under the fallen ceiling panels. Two of these vehicles caught fire and burned, killing 9 people and injuring 2 people. Except for natural disasters and fires, such a severe and sudden collapse of a road structure in service has not seen before in Japan.

- 3) Finally, the ceiling adhesive bolts lost a sufficient strength to suspend the ceiling panels and partition walls and the bolts were pulled out, resulting in the fall-down of the tunnel ceiling system. Because neighboring ceiling CT-beams were bridged to each other by a partition wall, the collapse occurred over a continuous section of length approximately 140 m.

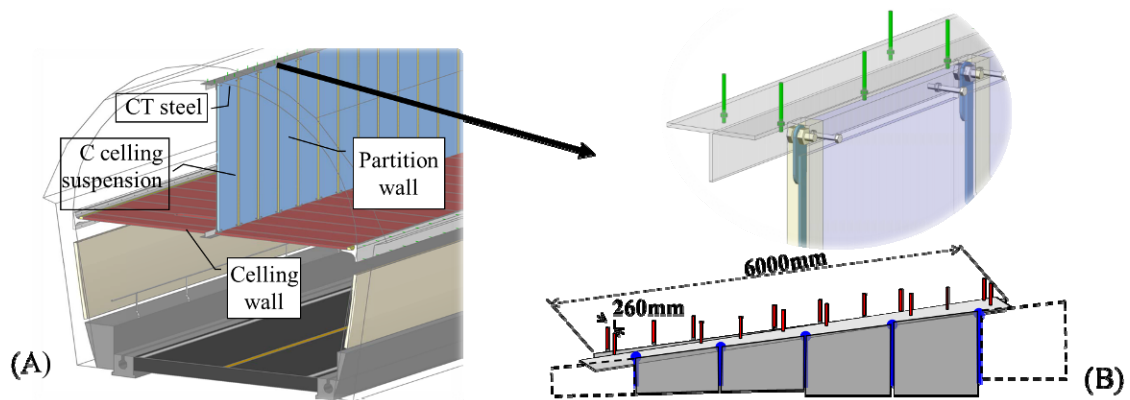
FIGURE 3 STRUCTURE OF CEILING (A) AND CT STEEL BEAMS (B)

The Sasago Tunnel is operated by the Central Nippon Expressway Company Limited and it is located in Yamanashi Prefecture. It was put in service in 1977. The overall tunnel length is approximately 4.4 km. As shown in Figure 3, due to this length, a transverse ventilation system was employed and the tunnel cross section was partitioned with ceiling panels and partition walls to use the partitioned spaces as the horizontal ventilation ducts. The tunnel cross-sections are with different dimensions of L, M and S as shown in Figure 2 to meet the prescribed values for smoke and soot visibility, maximum roadway wind speed, and duct end wind speed.

The tunnel ceiling was comprised of 6m-long CT steel beams attached to the tunnel lining concrete, partition PC walls, ceiling PC panels, hanger rods, and other components, which were supported by pedestals on both sides, and hung by 16 adhesive anchor bolts in every CT steel beam (referred to below as ceiling adhesive bolts). The adhesive material used was unsaturated polyester-based resin as shown in Figure 4.

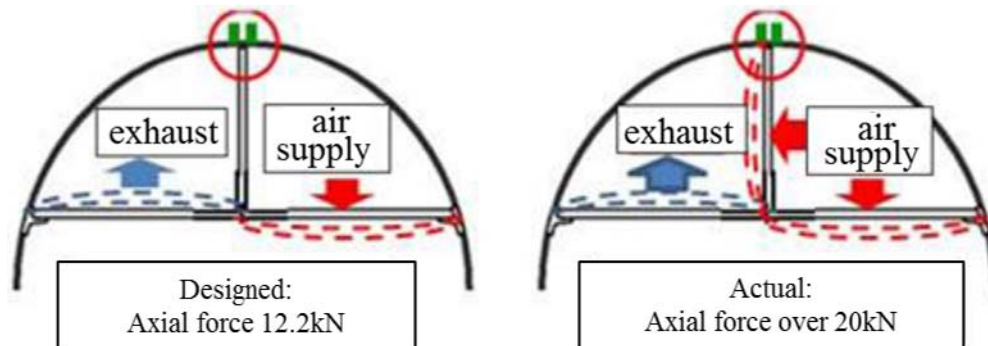
FIGURE 5 WIND LOAD OF THE DESIGN OF CEILING ADHESIVE BOLTS

Figure 5 compares the wind loads considered in the original design for obtaining the required strength of ceiling adhesive bolts to those considered by the Committee in the prediction of the order of actual reaction forces to ceiling adhesive bolts. The original design process calculated that pulling force on the ceiling adhesive bolts would be a maximum of 12.2 kN per bolt, assuming the weight of the ceiling panels, partition walls and other components, and action of a wind load in the vertical direction during operation of ventilation equipment. However, the committee pointed out that, when taking into account a lateral wind effect acting on the partition walls during the ventilation, an additional pulling force of about 8 kN per bolt was supposed to be generated, and the actual load applied was predicted as approximately 20 kN in total. This was large enough that it should have been considered in design calculation.

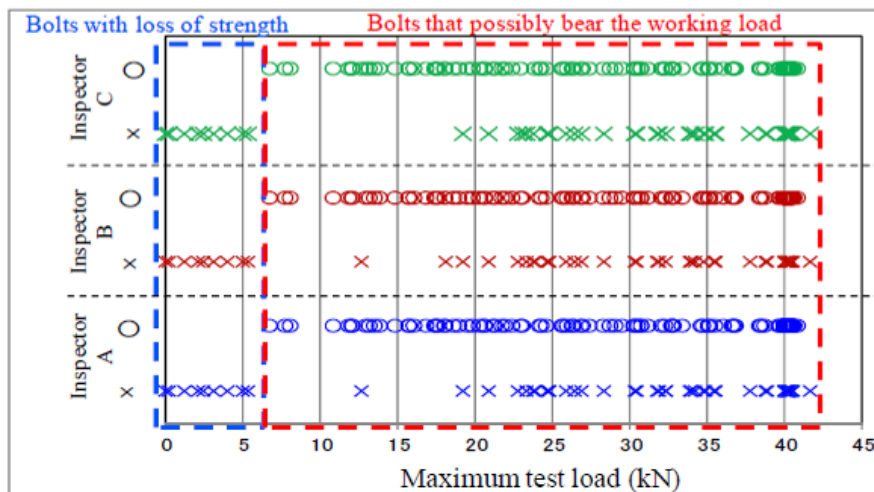
FIGURE 7 RELATIONSHIP BETWEEN HANDS-ON INSPECTION (VISUAL AND HAMMERING TEST) RESULTS AND PULL-OUT STRENGTH

Figure 7 compares the inspectors' assessments and the pull-out strengths. It was confirmed that a combination of hand-on, visual, and hammer striking inspections of adhesive bolts is effective for detecting malfunctioning bolts. However, the technique is also known to have technical limits, such as the difficulty of estimating pull-out strengths.

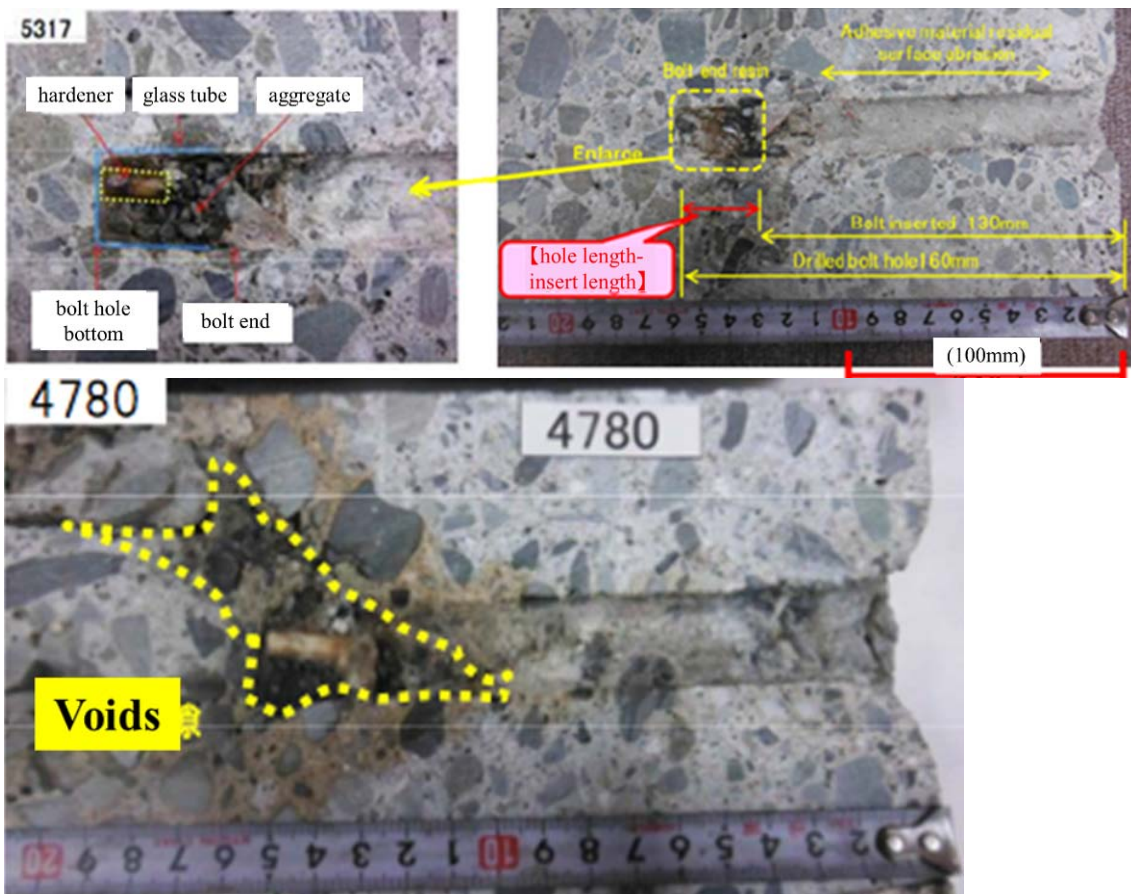
FIGURE 8 CONCRETE CORE EXAMINATION (VOIDS)

Core samples including ceiling adhesive bolts were taken from the lining concrete at the 56 bolt positions, of which 26 were taken from the accident section, and the embedding status of the ceiling adhesive bolts was checked. Figures 8 and 9 shows typical cut-out cross-sections. In a significant number of cases, the bolt tip and anchor hole bottom did not coincide, and spread adhesive, aggregate, hardener, adhesive's grass tube were left in the remaining space between the bolt tip and anchor hole base as seen near the bolt tip in Figure.8. Voids inside the lining concrete were also confirmed to be present, and in some cores, the adhesive flowed out into these voids as also shown in Figure 8.

- 1) With regard to the adhesive bolts hanging the ceiling system, there were underlying factors from the design and construction stage which influenced to this accident, such as the specified pull-out strengths were not always generated at the adhesive bolts even at the time construction was completed.
