AN INVESTIGATION OF 46-YEAR-OLD BRIDGE DECK SLABS IN SNOWY COLD REGION

Ko Kakuma¹, Shinya Okada² and Hiroaki Nishi³

Abstract

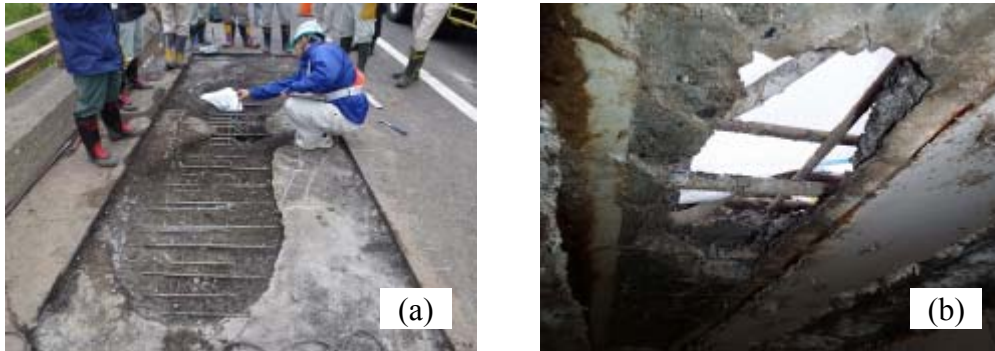
It has been generally known that the damage to RC slabs of highway bridges, which are subjected to direct wheel loading, is principally caused by fatigue from wheel load running repetition. In snowy cold regions, on the other hands, there have been several cases of deterioration and partial collapse of RC slabs, even though the bridges are located under comparative lighter traffic volume than urban areas. Such damages are attributed to freezing-thawing action caused by environmental conditions in combination with fatigue action. A previous research showed that such combined damage is found throughout Hokkaido, irrespective of the grade of road (Mitamura et al. 2009). Also, the research experimentally found that fatigue durability of RC slabs is drastically reduced when the cover concrete is reduced by even 1cm in thickness, because the effective slab thickness is reduced.

Figure 1 PARTIAL COLLAPSE OF RC SLAB IN HOKKAIDO: (a) damage condition on top surface; (b) view from bottom surface

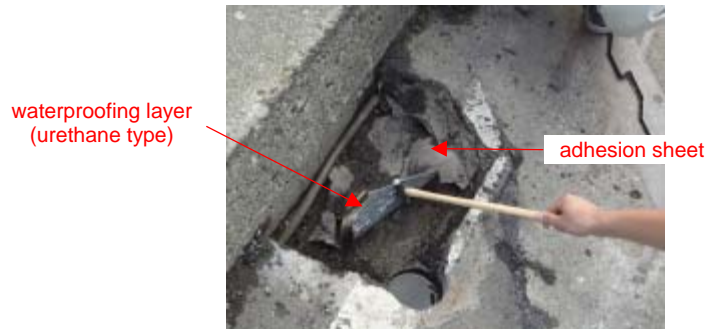
An example of the condition of the waterproofing layers is shown in Figure 4. Figure 4(a) shows the area around the wheel guard and the expansion joint. In this case, the pavement, the adhesion sheet between the pavement and the waterproofing layer, the urethane waterproofing layer and the concrete were totally detached, and water infiltration was found in the upper part of the slab. Also, sand with 1cm thick was accumulated between the pavement and the adhesion sheet around the catch basin, which was about 2m distance from the expansion joint. It is thought that the detachment of the adhesion sheet has allowed water to intrude into the slab for a long time.

Figure 4 DAMAGE CONDITIONS OF WATERPROOFING LAYERS: (a) near wheel guard and expansion joint; (b) near sidewalk

The tensile adhesion strength was 0 at 100% of the locations near the wheel guard and the catch basins. When installing the waterproofing layers near the wheel guard, it is necessary to complete the work carefully, because water tends to accumulate there. Also, the gap between the curb of sidewalk and the waterproofing layer, serving a route for water intrusion, indicates that it is necessary to extend the waterproofing layers to the wheel guard.

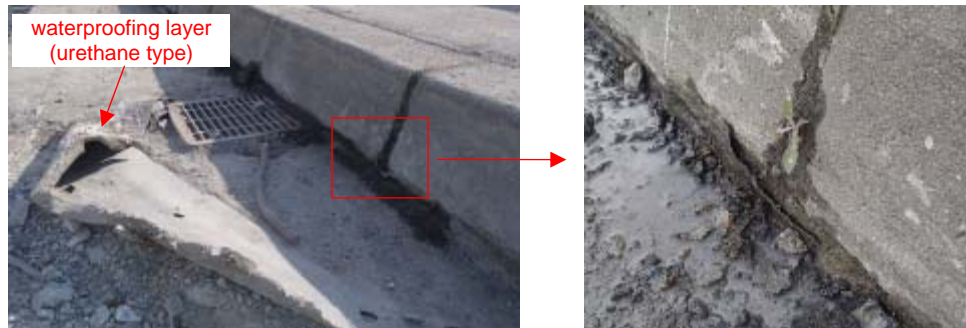
(b)

Figure 4(b) shows the condition near the boundary between the carriageway and the sidewalk. Around the photographed area, the waterproofing layer around the catch basin had lost adherence and was detached. Furthermore, a gap presence between the waterproofing layer and the surface of the curb allowed water to infiltrate under the waterproofing layer, although the waterproofing layer was raised onto the curb. The gap especially presented at curbstones joints.

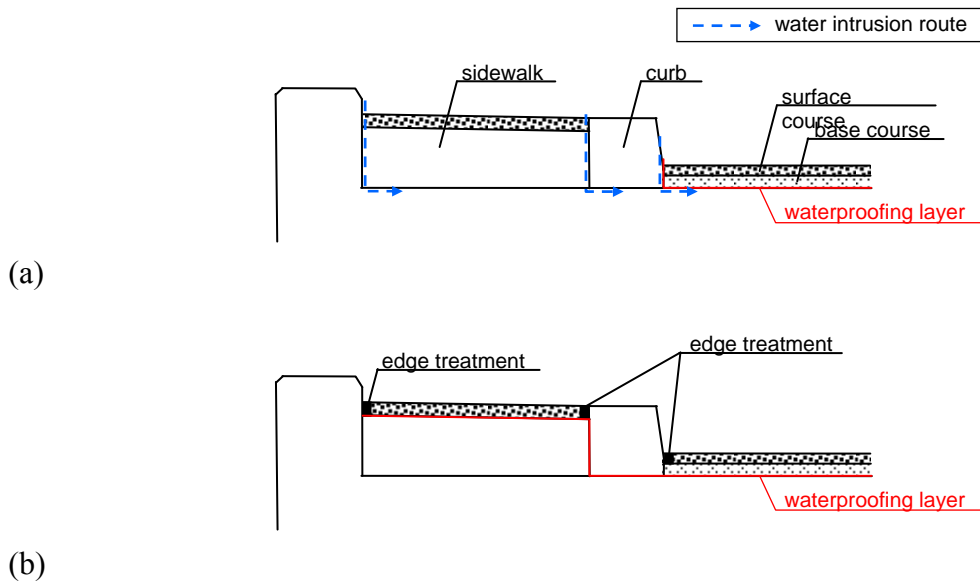
Figure 5(a) shows a schematic of the water intrusion route near the boundary between the carriageway and the sidewalk. In addition to the gap between the raised part of the waterproofing layer on the curb and the curb surface, it is possible that water intruded through the boundary between the curb and the sidewalk and through the boundary between the wheel guard and the sidewalk. To prevent water intrusion there, it is necessary to extend the waterproofing layer onto the sidewalk with edge treatment as shown in Figure 5(b), instead of just being raised to part of the height of the curb stone.

Figure 5 TREATMENT OF WATERPROOFING LAYERS NEAR CURBS: (a) current treatment; (b) desirable treatment

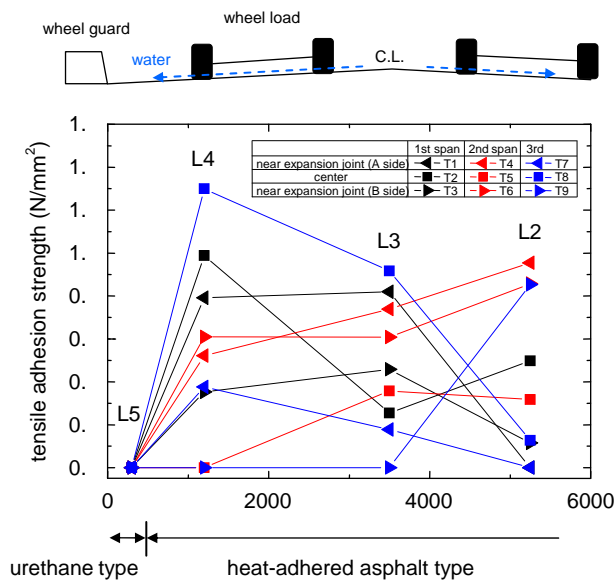
Figure 6 shows the distribution of tensile adhesion strength measured along the transverse line (T1-T9). In *Manual for Waterproofing of Highway Bridge Slabs*, 0.6N/mm^2 is specified as minimum tensile adhesion strength at a temperature of 23°C . Also, Table 3 lists the summary of tensile adhesion test results. Among the 46 test locations, 76% were below the standard value and 46% had zero tensile adhesion strength. Focusing on the tensile adhesion strength values along the transverse measurement lines (L2-L5), the values near the wheel guard and that near the catch basin (L5) are zero, meaning waterproofing was not maintained around these areas. Because the partial collapse of the slab occurred near the wheel guard, it is thought that the collapse was significantly affected by water intrusion from the side of the wheel guard. The area near the wheel guard is a part that the waterproofing layer must function properly, because water tends to gather at this area, and precise construction management has to be done for the installation of waterproofing layers. For the wheel load running line, tensile adhesion strength of less than the standard value reached 56% on the wheel load running line (L4), 64% on the center line (L3) and 70% on the area between the wheel load running lines (L2). As shown in Figure 6, the tensile adhesion strength tends to be moderately high along the wheel load running lines. This is probably caused by the increase in adhesion strength due to the roll-compacting of pavement by the wheel load running repetition.

Figure 6 TENSILE ADHESION STRENGTH DISTRIBUTION IN TRANSVERSE DIRECTION

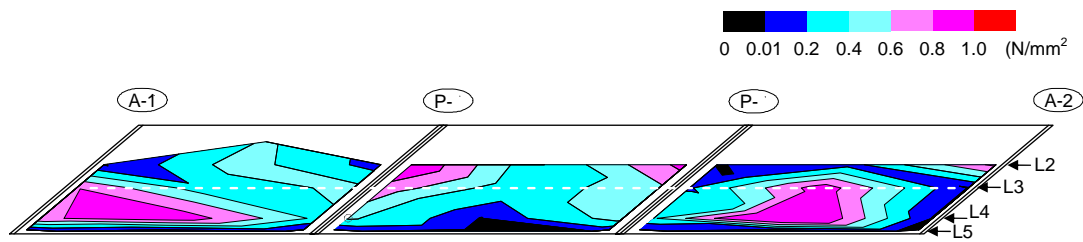
Figure 7 is a contour map indicating the tensile adhesion strength distribution in the bridge. In this Figure, the warm colors indicate areas with a standard value of 0.6N/mm^2 or greater and the cold colors indicate values lower than the standard value. The areas with values greater than the standard value are distributed locally, mainly on the A-1 side of the 1st span, P-1 and P-2 of the 2nd span and the mid-span of the 3rd span. The areas near the wheel guard on the P-2 side of the 2nd span, where the partial collapse of the slab occurred, are colored in the range of tensile adhesion strengths lower than the standard value, including zero.

Figure 7 CONTOUR MAP OF TENSILE ADHESION STRENGTH

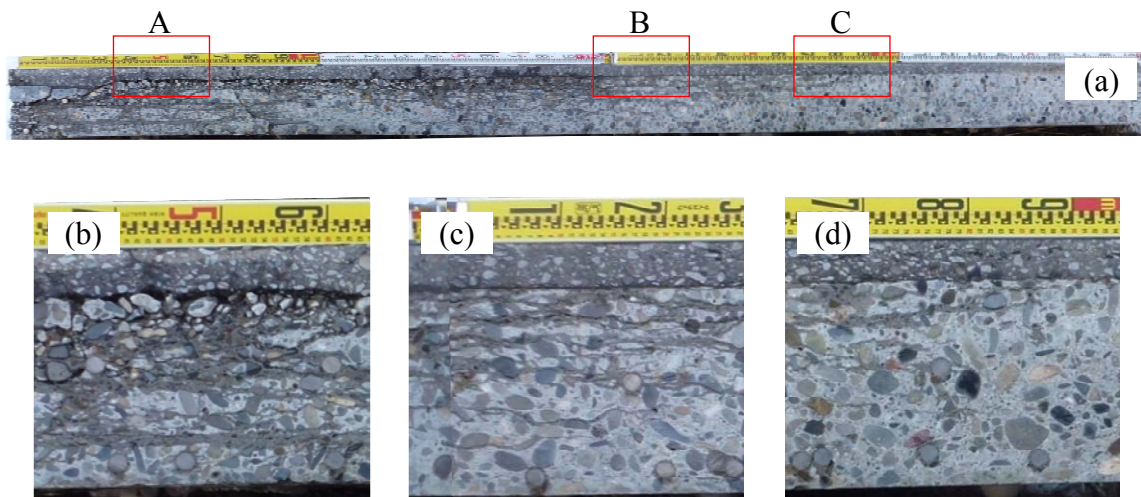
Figure 8 shows an example of the cross-section of the slab. In the whole view of the cross-section (Figure 8(a)), the concrete on the right side of the cut slab is sound without cracks. However, the concrete on the left side of Figure 8(a) shows damage. The closer to

the expansion joint (P-2), the more damage is observed, and the surface concrete on the left side area is gravelized, i.e. aggregate and mortar are separated from concrete and this damage is called “gravelization” in the following. Figure 8(b)-(d) are enlargements of parts A, B and C in Figure 8(a). In part C (Figure 8(d)), horizontal cracks dividing the concrete into exfoliation layers can be observed, this paper calls this phenomenon “laminar exfoliation”. The number of laminar exfoliation layers is greater in the area closer to part B, and numerous laminar exfoliation layers are found throughout the cover concrete, as shown in Figure 8(c). The interval of each layer of exfoliation corresponds to the almost maximum size of coarse aggregate. Also, in part A (Figure 8(b)), concrete in the 5cm depth from the top surface is gravelized in addition to laminar exfoliation reaching down to lower reinforcing bars.

From the observation of the deterioration in each part, the deterioration shown in Figure 8 are thought to have started from the left side of the figure (Figure 8(a)) toward the right side. Here, the expansion joint is farther to the left of the left side of the figure where the deterioration and damage originated, and vehicles travel from left to right in the photographed section. Namely, deterioration and damage around the expansion joint were exactly caused by impact loading of the wheels with accelerating factors: rainwater and snowmelt water which tend to collect in this area. To secure the long-term durability of RC slabs, the importance of the waterproofing layers, which prevent water intrusion in slabs, is emphasized once again.

Figure 8 DAMAGE CONDITION OF RC SLAB: (a) whole view; (b)-(d) enlargement of part A, B and C, respectively

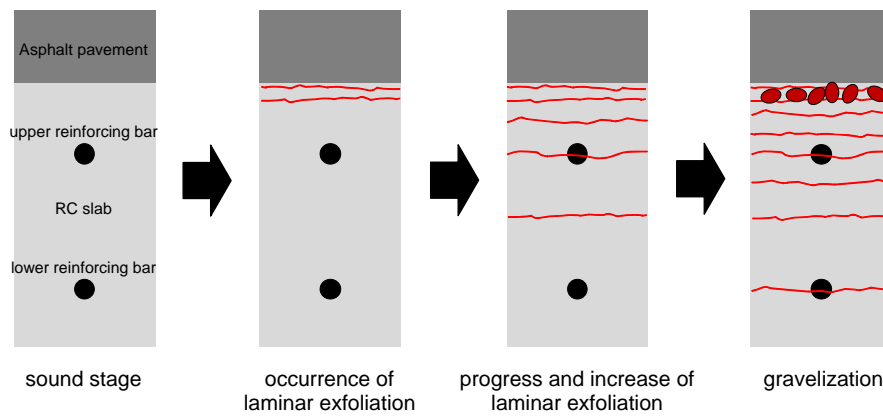
Based on the result of the cross-section observation, it is estimated that deterioration and damage to this RC slab had progressed through the stages shown in Figure 9. In sound stage, damage has not occurred in the slab, even though the slab has experienced repeated freezing-thawing and wheel load running. In occurrence of laminar exfoliation stage, laminar exfoliation occurs in the upper part of the slab, mainly in the cover concrete. In the progress and increase in laminar exfoliation stage, laminar exfoliation progresses toward horizontal direction. At the same time, new laminar exfoliation starts to occur in areas including the part below the upper reinforcing bars. However, laminar exfoliation stops increasing toward depth direction when the thickness of each layer approximately reaches the maximum size of coarse aggregate. In the gravelization stage, the aggregate and mortar in the sliced concrete layers separate in the surface of the slab concrete after the laminar exfoliation saturating exfoliation in depth direction. It is thought that the effective slab thickness decreases at this stage, as stated above, and that the fatigue durability is remarkably reduced.

Figure 9 DETERIORATION AND DAMAGE PROCESS OF SURVEYED RC SLAB
