LANDSLIDE DETECTION, MONITORING, PREDICTION, EMERGENCY MEASURES AND TECHNICAL INSTRUCTION IN A BUSY CITY, ATAMI, JAPAN

K. Fujisawa¹, K. Higuchi¹, A. Koda¹ & T. Harada²

¹ Public Works Research Institute, Japan (e-mail: fujisawa@pwri.go.jp)

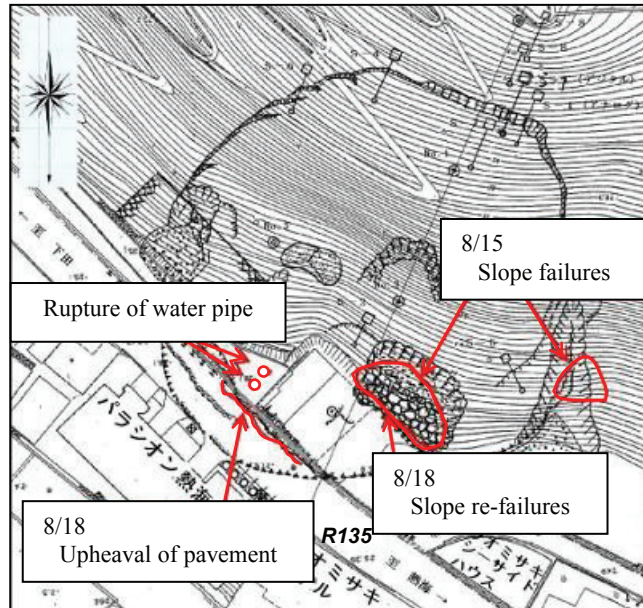
Figure 3. Location of phenomena

Regarding landslide movement, two slope failures in the landslide were observed behind a car repair factory on August 15th. Upheaval of part of the national highway was also reported on the 18th. The back of the car repair factory collapsed again on the 22nd, and the water supply pipe laid underground along the national highway ruptured (Figure 3).

These phenomena, however, were initially not recognized as triggered by a landslide, and only the car repair factory received a warning letter from the authorities. Eventually, another underground water supply pipe along the national highway ruptured on November 8th after rainfall of 41 mm on the 5th and 6th, and so a further investigation was conducted, which resulted in open cracks being found on the slope on the 17th. The scarp of the major crack located at the altitude of 92 m was 1.0–1.5 m deep. These findings confirmed that a series of phenomena (slope failures, upheaval of pavement, and rupture of water pipe) had been caused by the landslide. Subsequently, an extensometer was set up at the main scarp to monitor the behavior of the landslide, and it initially recorded continuous and slow movement of over 5 mm a day.

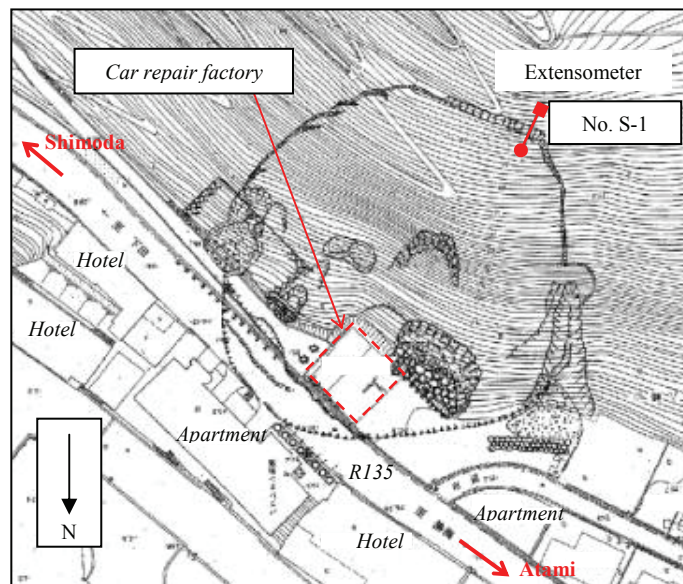
Figure 4. Ground plan of investigation

A follow-up investigation carried out by Shizuoka prefecture and Atami city, and revealed that the major crack extended continuously straight. While there were longitudinal cracks on the Shimoda side, echelon cracks were observed on the Atami side. The slope at the toe of the landslide also collapsed at several locations. The mountainside of the national highway was uplifted by the movement of the landslide, and the pavement on the seaward side of the national highway was deformed. The office of the car repair factory was leaning, the flat area of the ground was raised, and the rock mass of the scarps collapsed. This sequence of phenomena helped reveal the shape of the landslide, the size of which was 75 m long and 75 m wide (Figure 4).

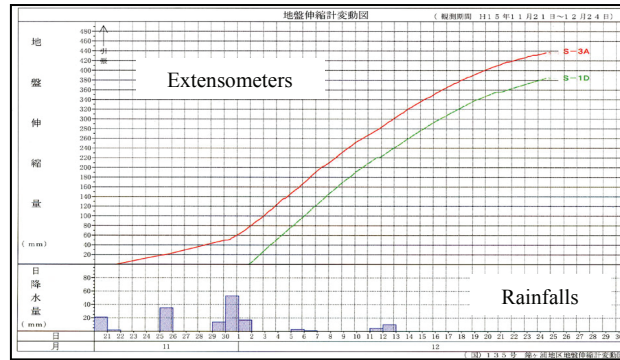
Figure 5. Displacement of extensometers

The topography of the landslide was identified in the field, suggesting the possibility of further growth. Subsequently, nine extensometers were additionally installed across the main scarp, stretching further up the slope. The movement of the landslide was also monitored on the landslide by an optical theodolite. The longitudinal profile along the national highway was measured to check the deformation induced by the landslide. Data recorded by extensometers showed that the tension displacement was accelerating, 5.2–5.7 mm/day from November 21 to 25, 6.7 mm/day on the 26th and 7.2 mm/day on the 28th (Figure 5). Continuous rainfall of 79 mm from November 29 to December 1 encouraged further displacement, which reached 24.8 mm/day (1 mm/h on average) on December 6. At this stage, further collapse of tertiary creep was predicted using the equation of Saito (1987) to occur at 12:00 on January 5.

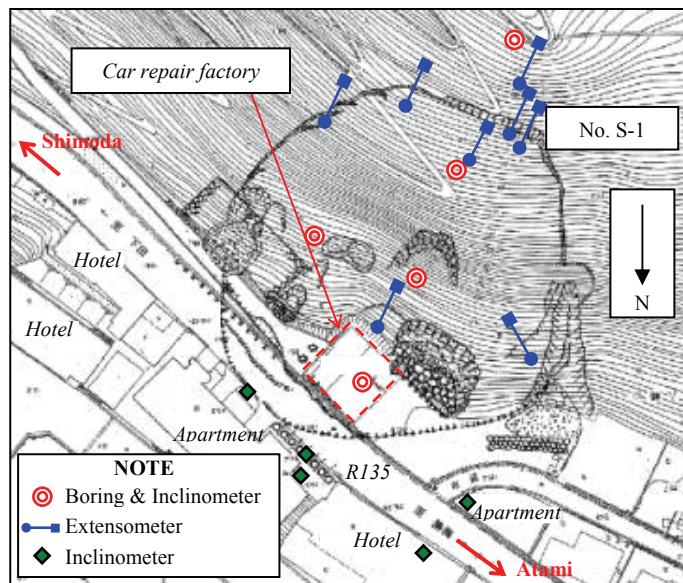
Figure 6. Locations of installations

The depth of the sliding surface as well as the rock constitution was quickly investigated by boring. The system of monitoring the landslide by extensometers and a theodolite was reinforced by increasing the number of watchmen to look for any change of the surface and toe of the landslide, thus enabling the boring works to be conducted safely (Figure 6).

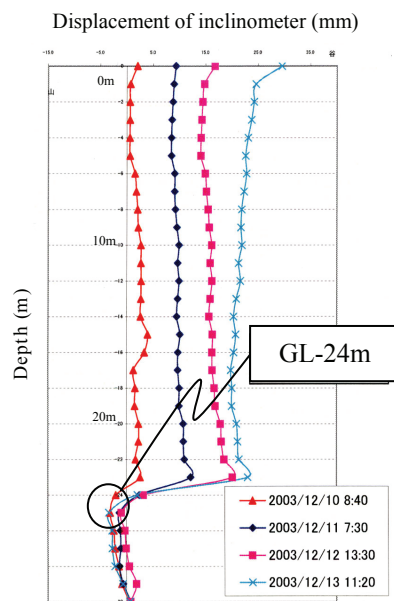
Figure 7. Depth of slide surface

The boring cores consisted of fractured clay and hollows underneath relatively fresh andesite lava that can also be observed at outcrops, indicating that weaker rock types existed in the deeper layers. The deformation of the landslide mass was also observed by an inclinometer using these bore holes 2 to 3 days after the guide pipe of the inclinometer was installed. According to this measurement and observation, the maximum depth of the slide surface was 24 m deep (Figure 7).

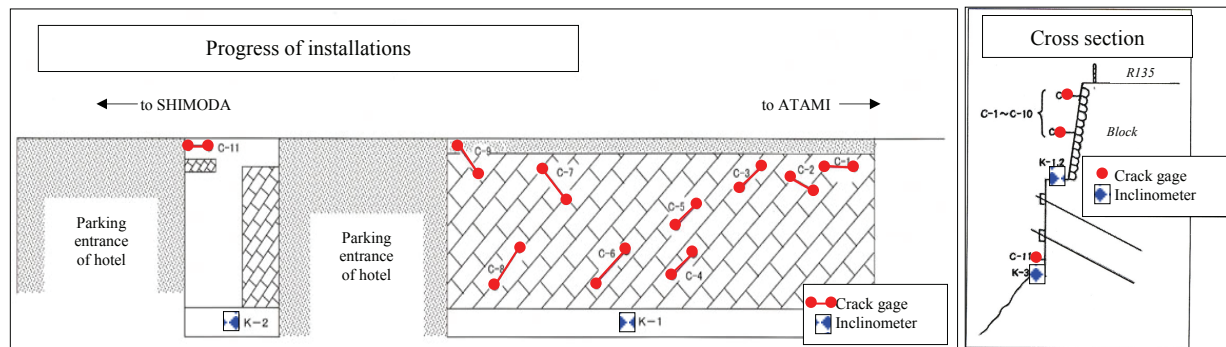
Figure 8. Location of installations for structure (concrete block wall, etc.)

Historically, part of the highway near the landslide had collapsed when resort apartment buildings were constructed in 1973. Although steel piles with two rows of anchors were subsequently installed in the shoulder of the road, a part of the upper row was not functioning in 2003.

Judging from the results of boring and the history of landslide disasters in the area, it was estimated that the counterweight filling work could be effective only in the area of weak geological soils, including the highway area, because the filling could actually trigger further movement of the landslide, possibly damaging hotels and resort apartment buildings. Therefore, inclinometers were set up over the landslide, and crack-gauges were installed on the highway, such as on the concrete block retaining wall, in order to detect the landslide movement (Figure 8). The counterweight filling work was continued step by step with careful monitoring.

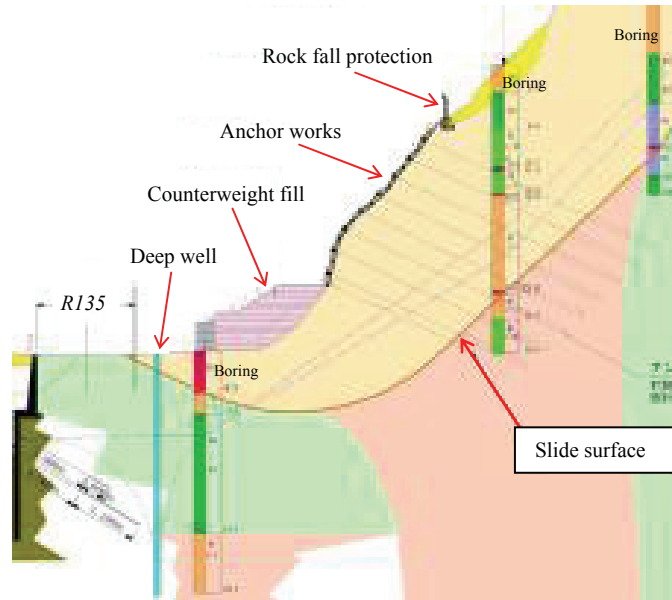
Figure 9. Section of emergency measures

The safety factor of the slope was initially estimated to be $F_s = 0.95$, and counterweight filling work was expected to increase the factor to 1.00. The factor, however, could not be measured directly, and had to be estimated based on observation while the counterweight filling and boring works were under way. Furthermore, the depth of the slide surface had to be determined by observation and monitoring using several installations. Fortunately, the counterweight filling work required only a short period by utilizing a stock of concrete wave-dissipating blocks (1 m cube) to establish the foundation of the fill (Figure 9).

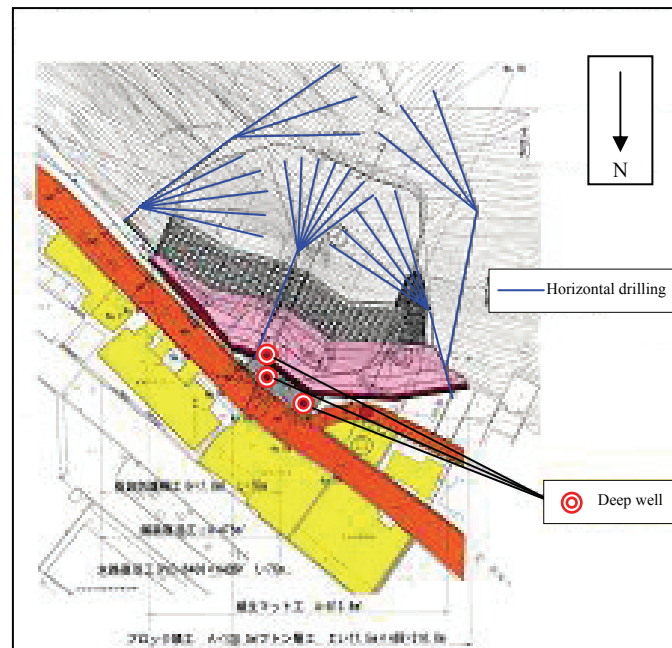
Figure 10. Location of deep well

While the counterweight filling work was carried out under careful observation and monitoring by watchmen and installations, water flow from a concrete block retaining wall on the side of the national highway started increasing. Although the water seepage was located 10 m lower than the slide surface, it was assumed that the water was related to the landslide movement. Subsequently, work for draining the underground water was planned and conducted in order to make the counterweight filling effective and reduce the water pressure against the concrete block retaining wall. Judging from the circumstances of neighboring structures, three deep wells, each of 25 cm in diameter, were set up from December 29 to 31 (Figure 10). The wells pumped up and drained water to mitigate the landslide movement. The

depth of water in each well was around 11 m and a large volume of underground water was effectively drained.

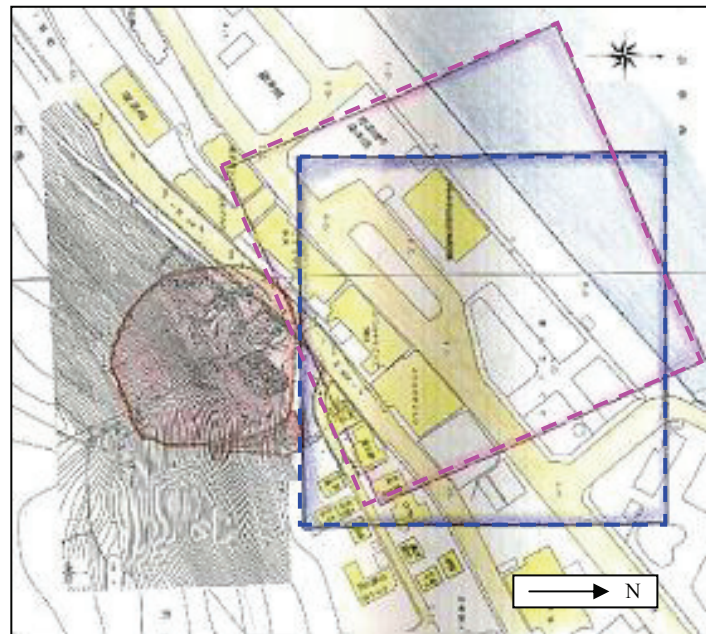
Figure 11. Region of evacuation advisory landslide

Because of the heavy traffic along the highway (15,000 cars/12 hours) as well as many hotels and resort apartment buildings in this area, a landslide would have caused huge damage to the local community. Therefore, an evacuation area was set up (Figure 11), and meetings to explain the circumstances to the residents were held to make them aware of the landslide and the evacuation system in advance (Figure 12).

- 1) In case of displacement of 2 mm/hour and continuous slope failures of small areas, an evacuation advisory and traffic closure would be implemented, and information about the landslide movement would be reported to the police.
- 2) In case of displacement of 2 mm/hour for 2 hours continuously, total rainfall of >60 mm and hourly rainfall of >15 mm, an evacuation advisory would be announced and the road would be closed. Fire alarm devices would be used to inform tourists staying at hotels and resort apartment buildings.
