**Risk management for landslide disasters
– in the case of the Higashi-Yokoyama landslide, Japan –**

Kazunori FUJISAWA¹, Joko OHARA¹, Fujihiro OKADA², Masami SHICHI²,
Takao YOSHIDA³, Youichiro HAGIWARA³

¹Public Works Research Institute, Japan

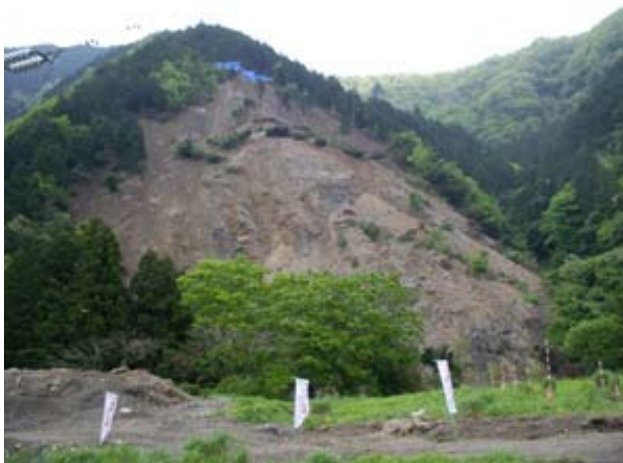
The Higashi-Yokoyama landslide occurred on May 13, 2006 along the left bank of the Ibi river near the town of Ibigawa-cho in Gifu prefecture. Figure 1 shows the location of the landslide site, situated approximately two kilometers downstream of the Yokoyama Dam operated by the Ministry of Infrastructure, Land and Transport, and approximately 3.5 kilometers upstream of the Kuze Dam operated by the Chubu Electric Power Company. The landslide measured approximately 150 m in width by 135 m in height, with a volume of approximately 250,000 m³ (see Picture 1).

Picture 1 General view of landslide site (May 14, 2006)

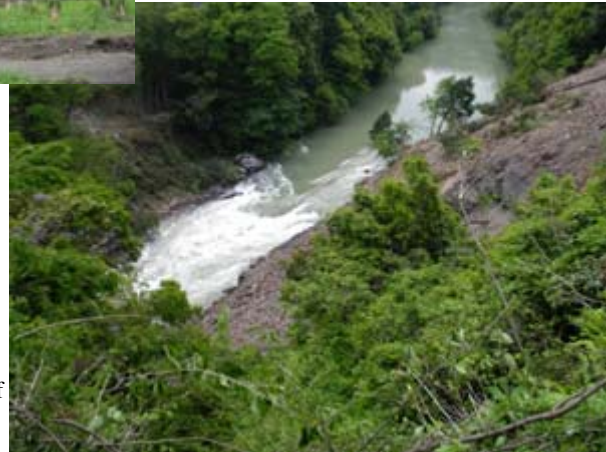
Approximately 50,000 m³ of debris was washed into the river during the landslide. As Picture 2 shows, this had the effect of blocking some two-thirds of the river across its width, and also causing damage to several local roads. Most of the moving body remained on the affected slope.

Picture 2 Rock deposits in river course at tail of landslide (May 14, 2006)

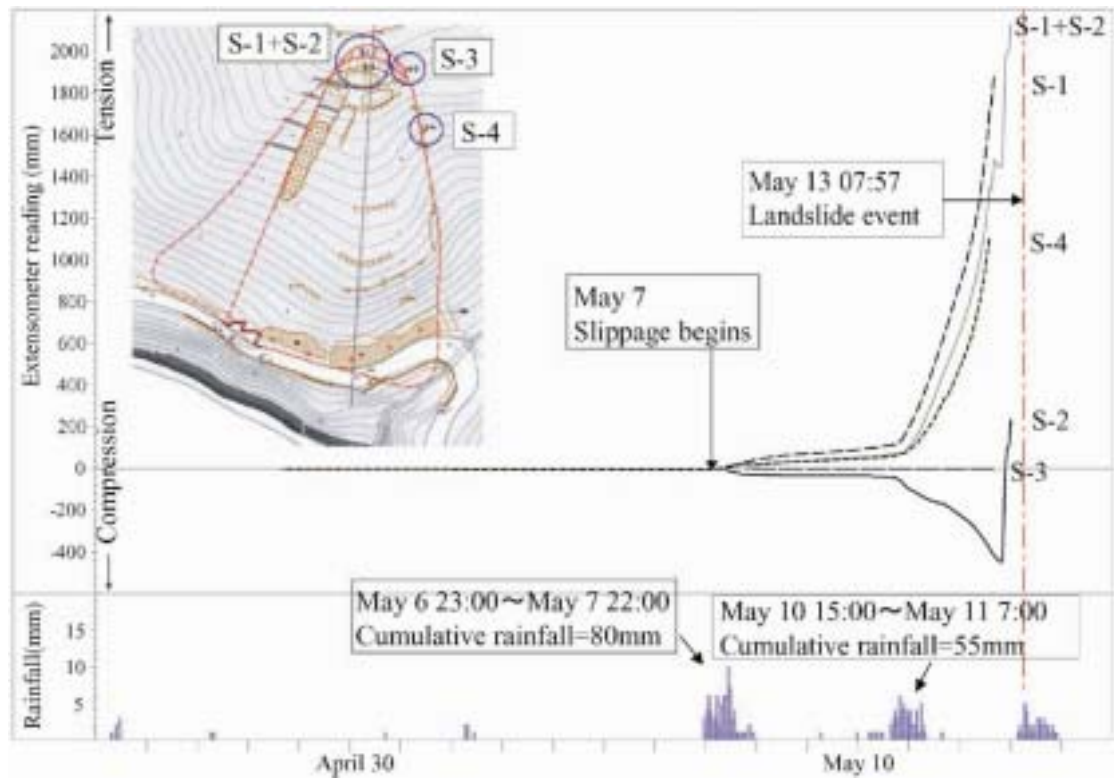
Figure 2 Extensometer observations

A site survey of the slope following the roadway slope collapse on April 11 delivered confirmation of the landslide, enabling formulation of an appropriate response tailored to the extent of the landslide. After the main scarp on the slope was confirmed on April 21, an extensometer was installed in the ground and displacement monitoring began on April 28 (see Figure 2). Analysis of observation data for May 11 using the Saito method predicted a landslide at some point after 20:00 on May 12.

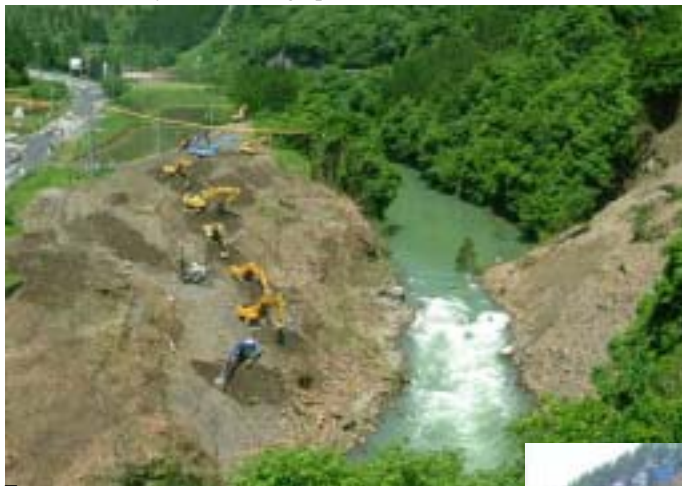
Although the landslide on May 13 blocked the Ibi river approximately two-thirds of the way across, the majority of the moving body remained up on the slope in an unstable condition. The debris which fell into the river was thought to be holding up (and therefore stabilizing) the remaining moving body on the slope. In order to prevent the effect of river erosion from washing away this debris and destabilizing the remaining moving body, it was decided to widen the river course opposite the affected slope, and also to install 1,000 foundation blocks at the tail of the landslide (see Picture 4). This work was conducted around the clock on a 24-hour shift system to ensure completion prior to the rainy season, when the rate of erosion would increase due to the higher water level in the river.

Picture 4 River widening on the opposite bank of the river

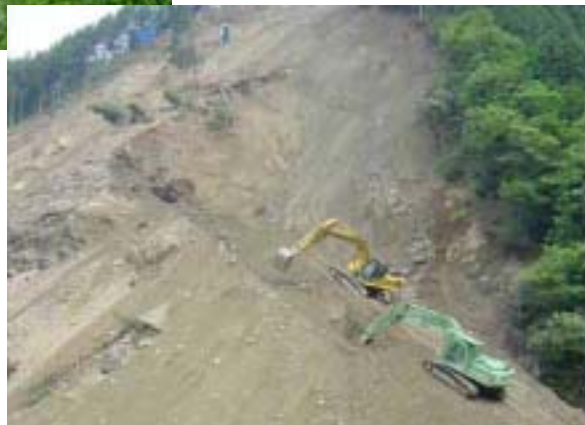
Picture 5 Emergency earth removal using remote-controlled machinery

Boring work was carried out on the moving body, together with emergency earth removal at the head of the moving body. Given that the slope had a gradient of around 40° it was considered unstable and too dangerous for workers to enter the affected area, so the debris removal work was conducted using remote-controlled backhoes and other machinery as shown in Picture 5.

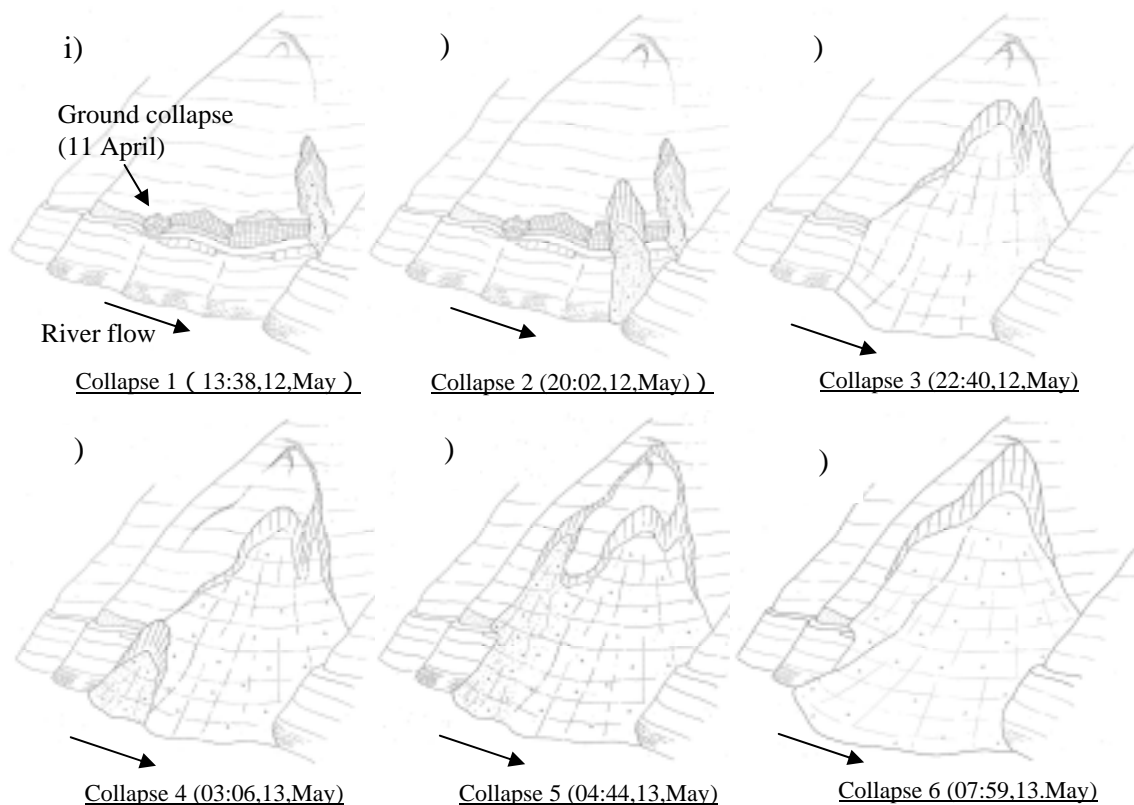
Figure 3 History of collapses

The analysis of images before and after the landslide indicated that the ground collapse involved an debris in excess of 1,000 m³, and that six separate landslide events occurred. Figure 3 shows sketches for each landslide event, numbered 1 through 6. Based on analysis of the images, the sequence of events leading to the landslide is thought to be as follows:

- 1) Ground collapse confirmed on slope next to road on mountain on April 11. Major crack identified at top of slope on April 21. Ground collapse of approx. 2,000 m³ (Collapse 1 in Figure 3) occurs in the vicinity of the downstream extension of the crack at 13:38 on May 12.

- 2) Several minor falling rock events occur in the region of Collapse 1 and a further ground collapse on April 11. Second ground collapse of around 1,000 m³ (No. 2 in Figure 3) occurs at 20:02 on May 12 a short distance upstream of Collapse 1.

- 3) A steady succession of falling rock and ground collapse events begins at 22:23 on May 12, in the vicinity of Collapses 1 and 2, leading to a major ground collapse of approximately 10,000 m³ at 22:40 (No. 3 in Figure 3).

- 4) After a brief hiatus following Collapse 3, the next major ground collapse (No. 4 in Figure 3, estimated at 1,000 m³) occurred at 03:06 on May 13 in the vicinity of the slope tail on the upstream side. Due to the camera angle and poor visibility at night, the images provide only limited detail, although evidence of localized tree shaking suggests that the crack at the head of the landslide was beginning to extend towards the upstream side of the slope at this point.

- 5) A further ground collapse (No. 5 in Figure 3, 1,000 m³) occurred at 04:44 on May 13 on the slope further up the slope from Collapse 4.
- 6) Falling rock and ground collapse events began at approximately 07:40 on May 13 on the middle and lower section of the slope and became more frequent, culminating in a major slope collapse (number 6 in Figure 3, 40,000 m³) at 07:59. This was followed by more falling rocks and minor collapses, but without any further significant topographical deformation. The slope today is thus in much the same state as it was after Collapse 6.

Thus, the sequence of events leading up to the landslide began with collapses at the periphery of the landslide area (from the head to the sides and tail), where the effect of stress caused by slippage is most apparent, followed by an increasing incidence of falling rocks and minor collapses in the area.

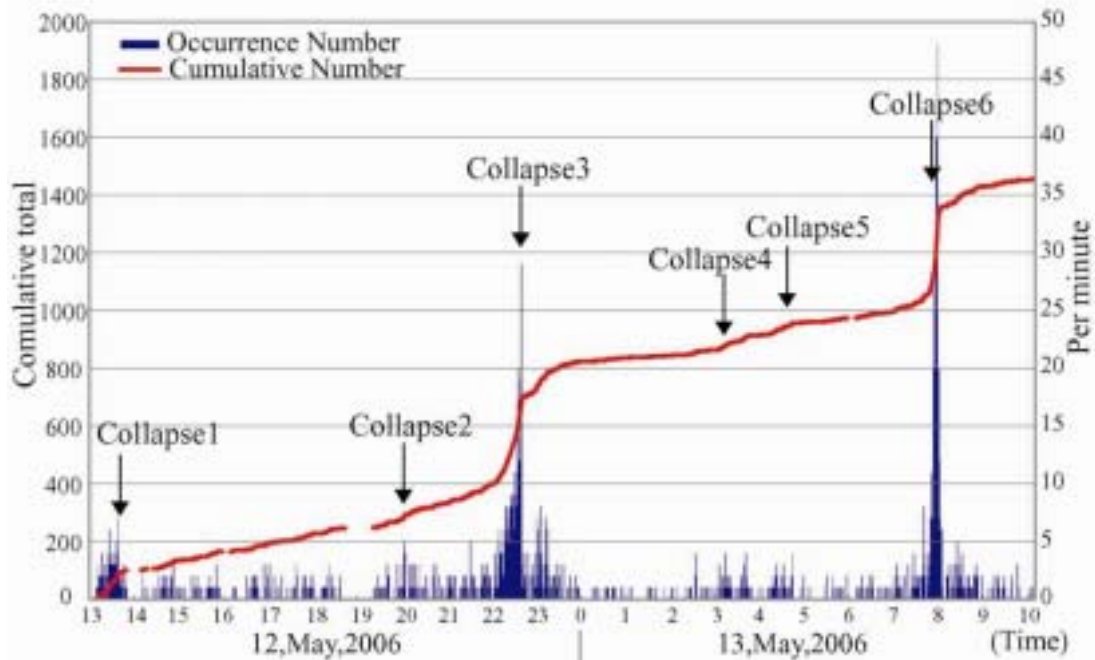
Figure 4 Other events — falling rocks, ground collapses and fallen trees

Figure 4 shows the count of falling rock events, ground collapses and fallen trees. Prior to the six major collapses, the frequency of these events steadily increased. The rate of increase was particularly pronounced prior to the two largest collapses (numbers 3 and 6).
