# INVESTIGATION OF DAM PERFORMANCE DURING THE NOTO HANTO EARTHQUAKE IN 2007, JAPAN

Tomoya IWASHITA<sup>1</sup>, Nario YASUDA<sup>2</sup>,  
Kazuhito SHIMAMOTO<sup>3</sup> and Tomoki OTANI<sup>4</sup>

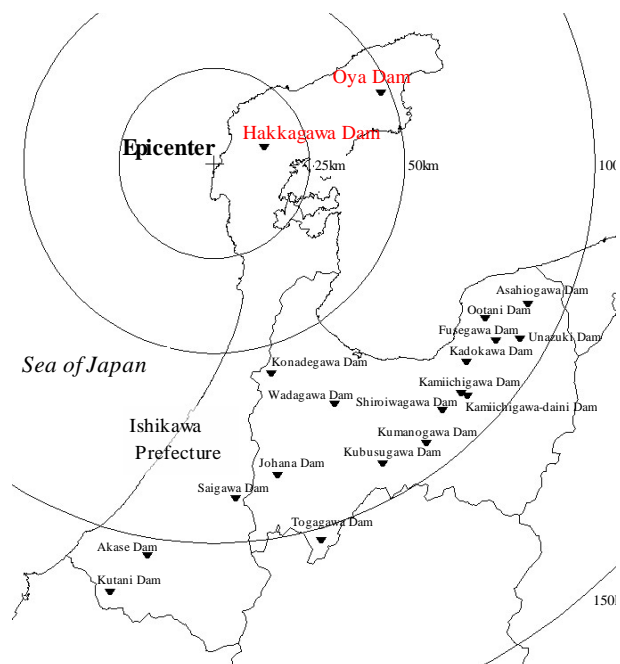
Fig. 1 Location map of dams that recorded an acceleration of over 25 gal at the dam foundation

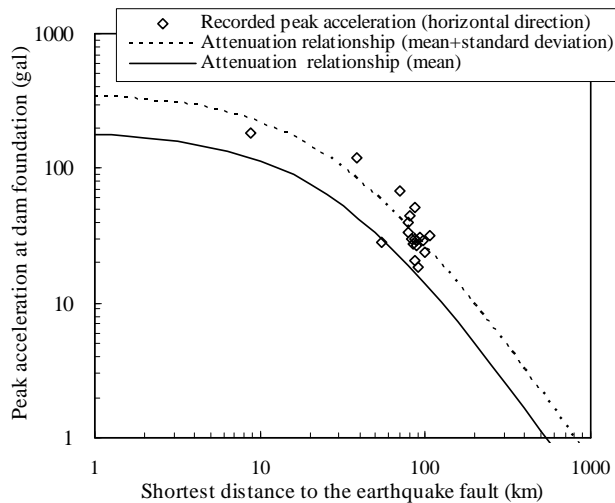
Fig. 2 Attenuation of peak acceleration recorded at dam foundations and the attenuation relationship as per the River Bureau, MLIT (2005)

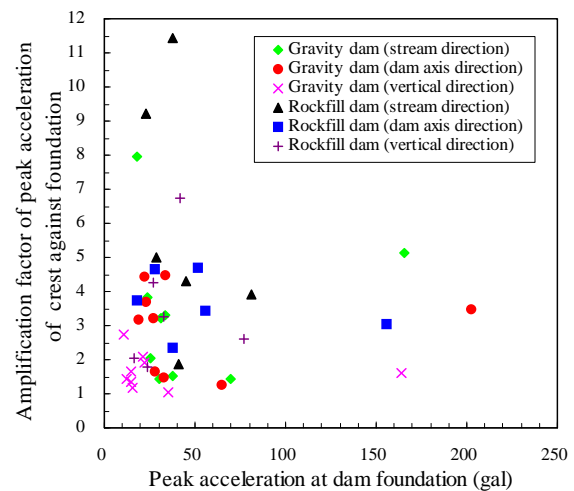
Fig. 3 Amplification factors of peak acceleration at the crest against that at the dam foundation

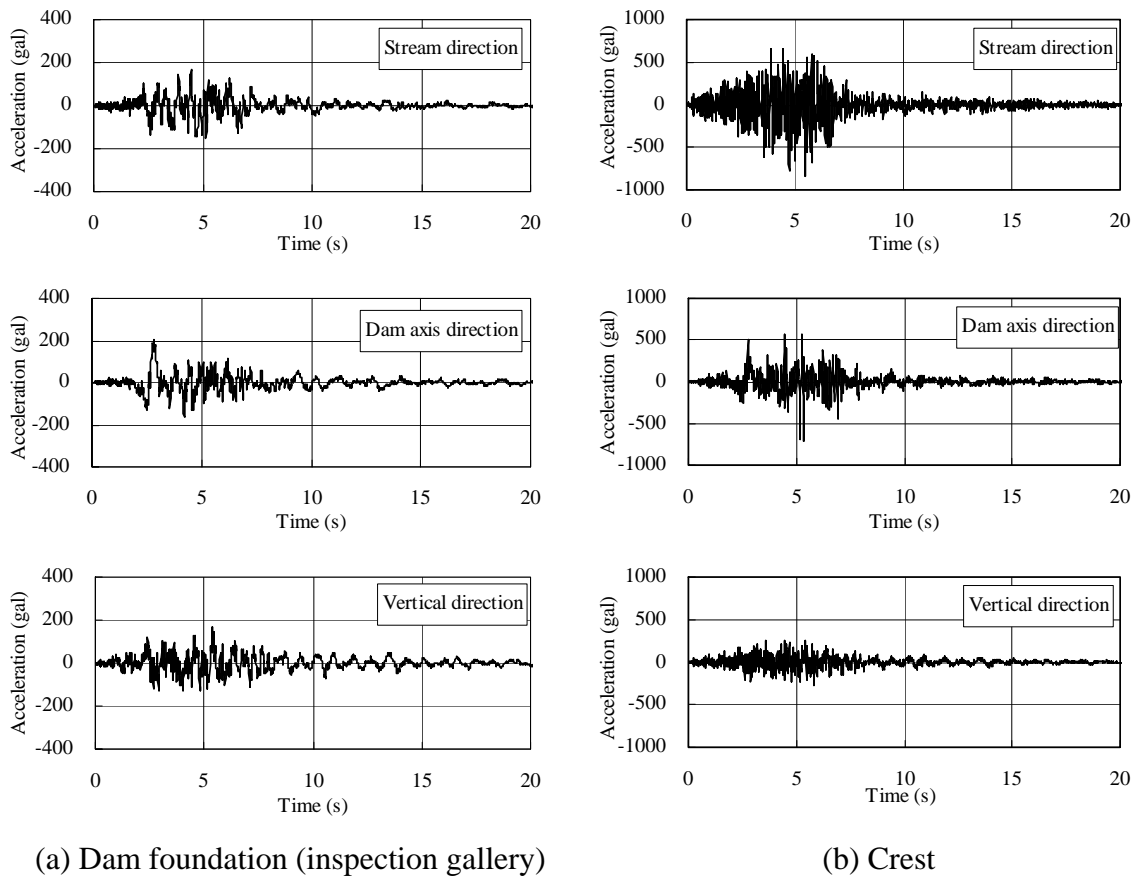
Fig. 4 Acceleration time histories recorded at Hakkagawa Dam

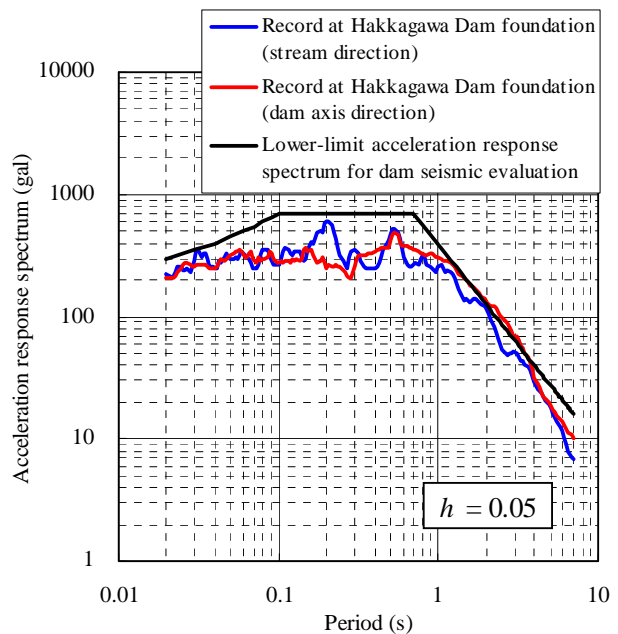
Fig. 5 Acceleration response spectra at the foundation of Hakkagawa Dam

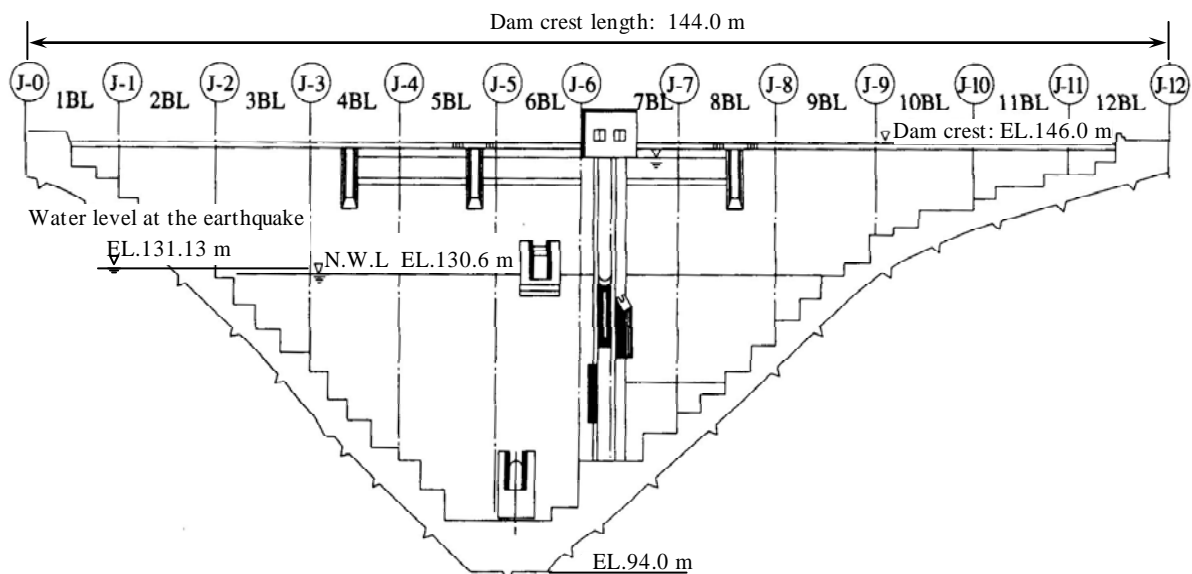
Fig. 6 Upstream face of Hakkagawa Dam

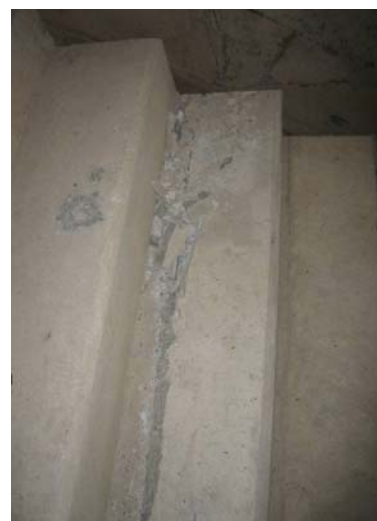
Photo. 4 Cracks in concrete steps along contraction joint J-8 in the gallery

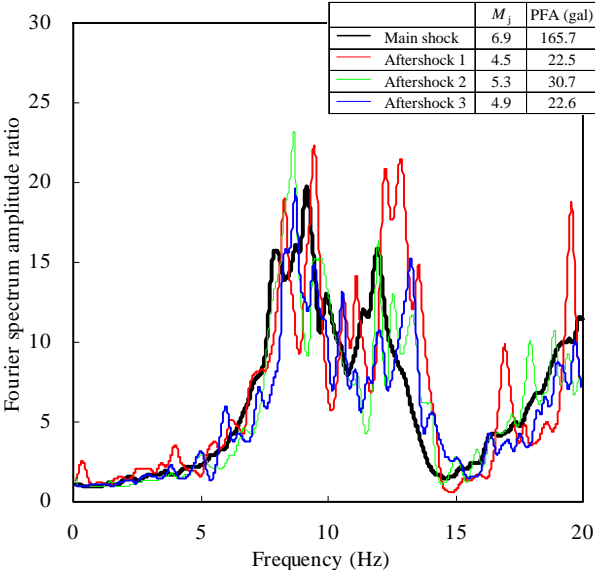
Fig. 7 Fourier spectrum amplitude ratio of crest to dam foundation during damped free vibrations after principal motions

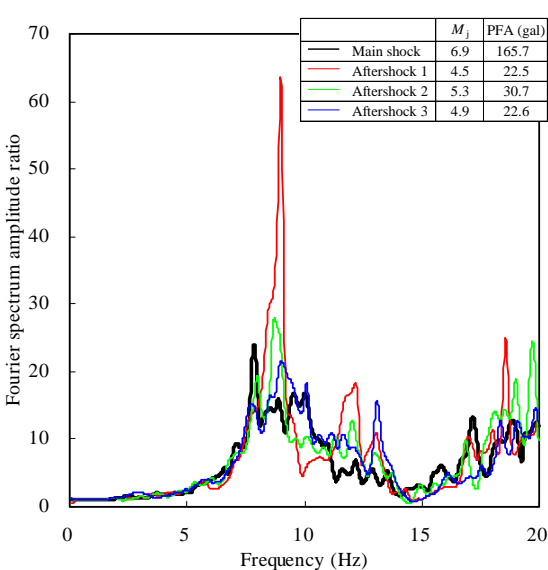
Fig. 8 Fourier spectrum amplitude ratio of crest to dam foundation during the main shock and aftershocks

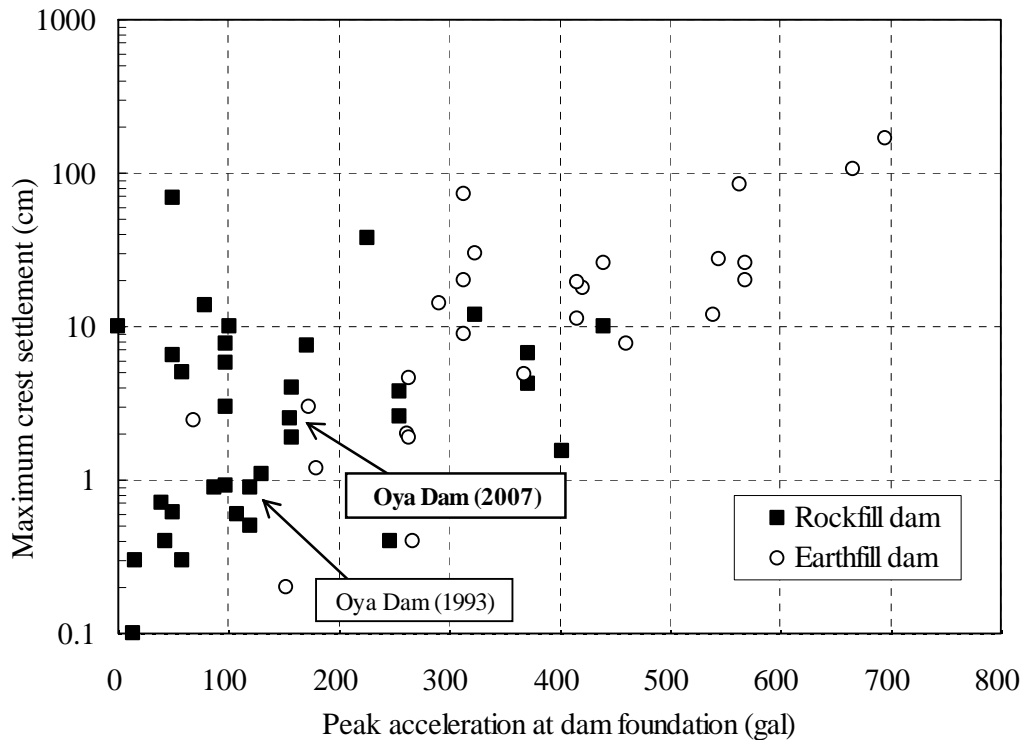
Fig. 14 Relationship between maximum crest settlement and peak acceleration at dam foundation for embankment dams in Japan and six other countries and one region (recent earthquake data added to the figure as per Iwashita (1999))
