Effects of the Mid Niigata Prefecture Earthquake in 2004 on dams

ABSTRUCT

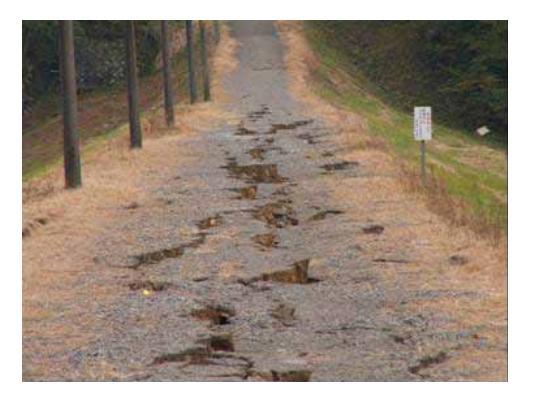
At this reservoir, a number of cracks parallel with the embankment axis have been found at the crest of the dam body. Cracks are staggered and are more or less continuous, and the crack occurred area extends almost over the entire length (292 m) of the embankment. These cracks have caused stepping so that the reservoir side of the embankment has subsided (see Photos 1 and 2). The total difference in elevation at the cracks is up to about 70 cm, and the maximum crack width of a single crack is about 40 cm. Elevation differences at the cracks and the magnitudes of crack openings are larger in the middle section of the embankment and smaller in the sections closer to both abutments, where dam height is smaller.

Photo .1 Close view of crest cracks (Asagawara Regulating Reservoir)

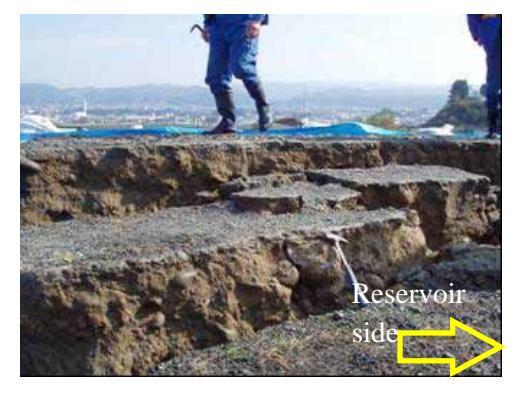
Photo .2 Stepping caused by crest cracking (Asagawara Regulating Reservoir)

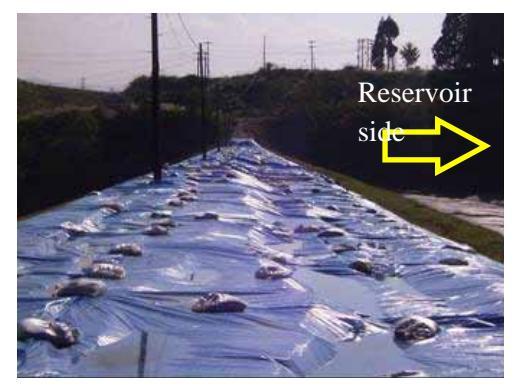
Photo .3 Vinyl sheeting to protect cracked crest (Asagawara Regulating Reservoir)

After the investigation conducted on October 25, the cracked areas were covered with vinyl sheeting, as a temporary measure, to prevent further progress of anomalous conditions caused by seepage of rainwater into the cracks (see Photo 3).

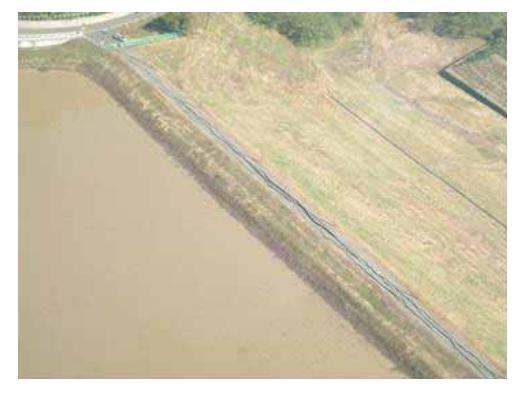
Photo .4 Water level rise after earthquake (photo by Hokuriku Regional Development Bureau) (Asagawara Regulating Reservoir)

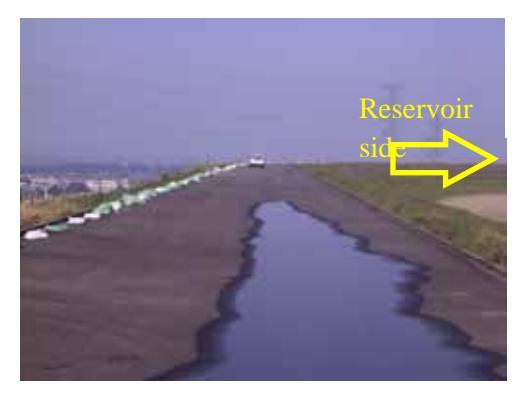
There was also an area where the crest pavement is noticeably inclined toward the reservoir (see Photo 5).

Photo .5 Inclination of crest pavement (Shin-Yamamoto Regulating Reservoir)

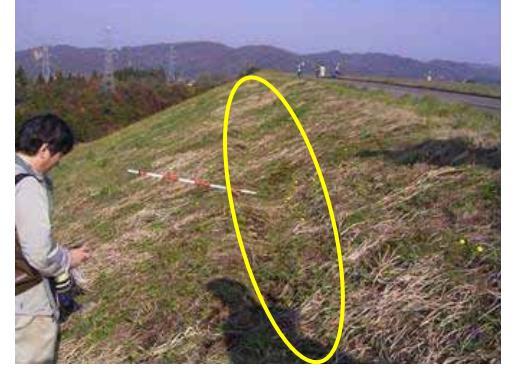
There was also a 100-meter-long crack along the embankment axis at about one meter below the outside edge of the embankment crest, and it seemed that the embankment above the fracture had subsided partially(see Photo 6).

Photo .6 Outer slope cave-in and cracking (Shin-Yamamoto Regulating Reservoir)

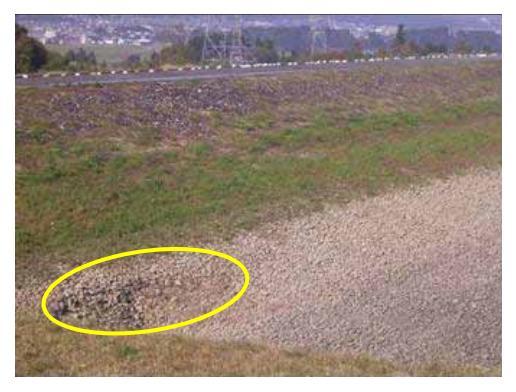
The riprap zone on the reservoir side slope has been stepping (see Photo 7). Although the depth of the fault is unknown, slip may have occurred. Overturned boulders indicating the possibility of sand boiling were found in the lower-elevation area in the riprap zone.

Photo .7 Stepping of riprap surface of reservoir-side slope (Shin-Yamamoto Regulating Reservoir)

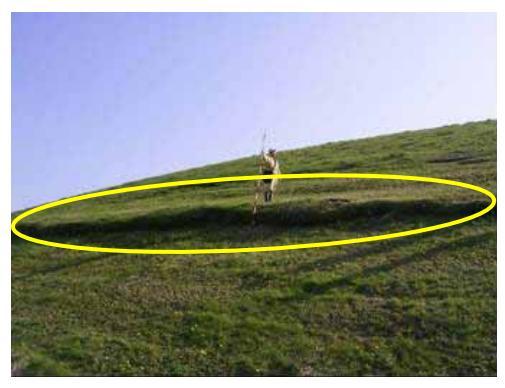
The mid-elevation region of the outside slope has a scarp zone that is thought to be the head of a sliding block and a bulging zone that is thought to be the toe of the sliding block (see Photo 8). This region measures about 5 m in the direction of the embankment cross section by several tens of meters in the embankment axis direction. From the fact that the trench at the toe of the embankment slope was not moved, it can be inferred that the slip occurred only in a relatively small mid-slope region, but more detailed investigation is necessary.

Photo .8 Bulging of outer slope surface (Shin-Yamamoto Regulating Reservoir)

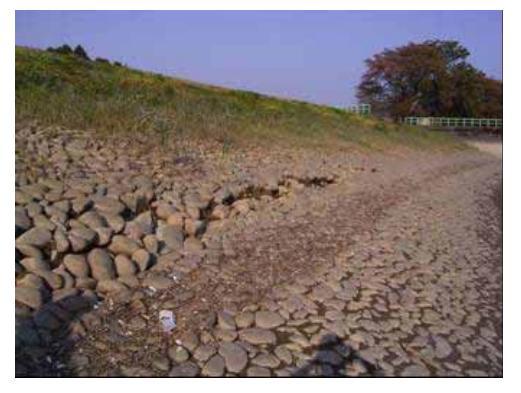
It was found that slip had occurred in the riprap zone of the reservoir-side slope, causing a vertical displacement of up to about 50 cm (see Photo 9). The slip zone measures about 10 m in the direction parallel to the embankment axis direction and about 5 m in the slope direction.

Photo .9 Slip of reservoir side slope (Yamamoto Regulating Reservoir)

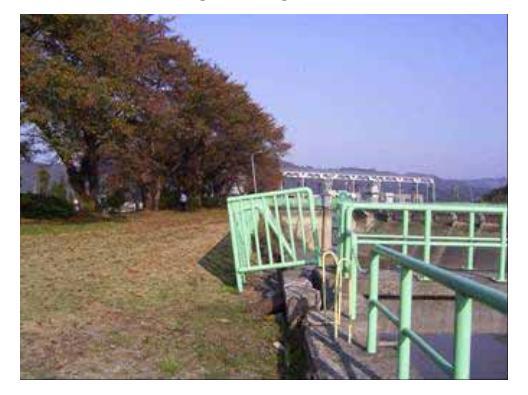
The settlement of the backfill behind the retaining wall around the water pool, which is an intake structure, was particularly large (see Photo 10). Small crest cracks were found along the joint between the backfill and the crest of embankment.

Photo .10 Ground deformation near the intake facilities (Yamamoto Regulating Reservoir)

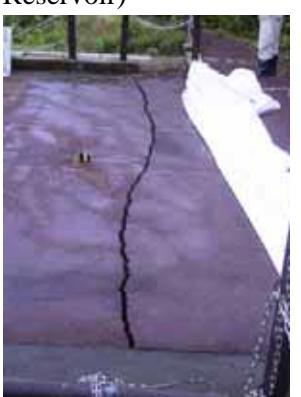
Cracks running in the upstream-downstream direction were found at the right- and leftabutments. The maximum crack opening width was about 5 cm (see Photo 11). Exploratory excavation will be conducted to collect information such as crack depth.

Photo .11 Transverse crack at the crest of the dam (Chofukuji Dam)

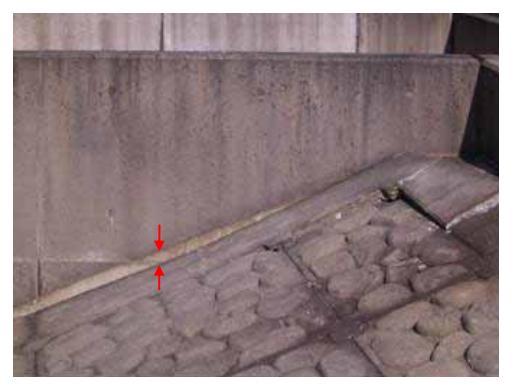
At the upstream and downstream slopes, faulting occurred between the spillway and the upstream fill on the left bank. The displacement due to faulting was about 7 cm (see Photo 12). Though it was difficult to inspect the upstream slope because it was covered with facing blocks, visual observation did not reveal any major local changes in the condition of the upstream slope.

Photo .12 Settlement of surfacing blocks relative to spillway (Chofukuji Dam)

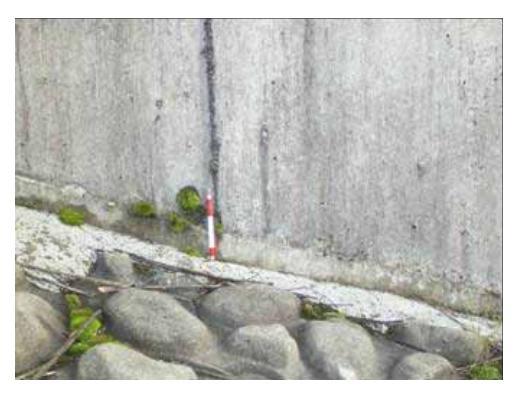
On the upstream and downstream slopes, faulting occurred between the spillway and the fill on the right bank. The vertical displacement was about 7 cm (see Photo 13). Earthquake-induced changes, such as slip and collapse-causing cracks, were found at three locations on the downstream slope (see Photo 14).

Photo .13 Settlement of surfacing blocks relative to spillway (Tsuboyama Dam)

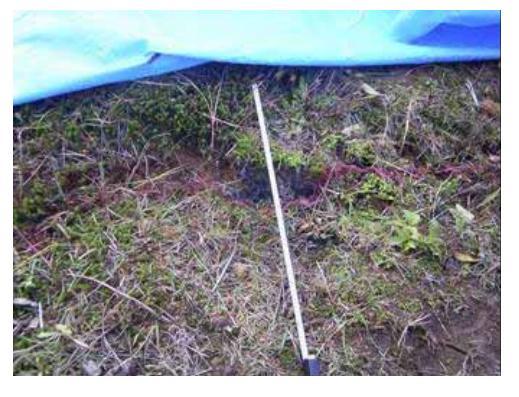
Photo .14 Crack on downstream slope (Tsuboyama Dam)

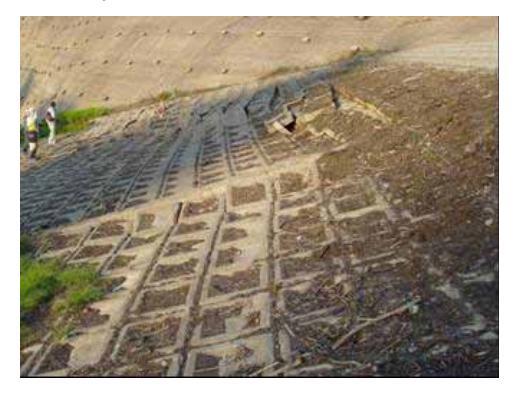
The region from the mid-elevation level to the toe of the upstream slope had been settled. Near the toe of the slope, there were some areas that had moved horizontally in the upstream direction. The earthquake-induced changes, such as subsidence with vertical displacements of about 30 cm, in the conditions of facing blocks on the left-bank region of the dam were particularly noticeable (see Photos 15 and 16). The facing blocks will be removed to investigate the changes in the internal conditions.

Photo .15 Earthquake-induced changes on upstream slope (Kawanishi Dam)

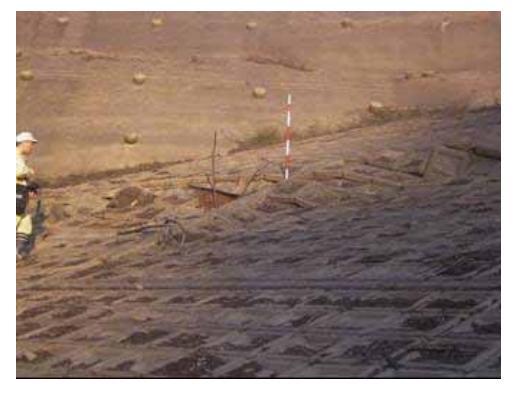
Photo .16 Earthquake-induced changes on left-bank upstream slope, viewed from the toe of the upstream slope (Kawanishi Dam)
