Quick Report on Damage to Infrastructures and Buildings by the 2007 Noto Hanto Earthquake

NILIM, PWRI, BRI and PARI Reconnaissance Team for the 2007 Noto Hanto Earthquake

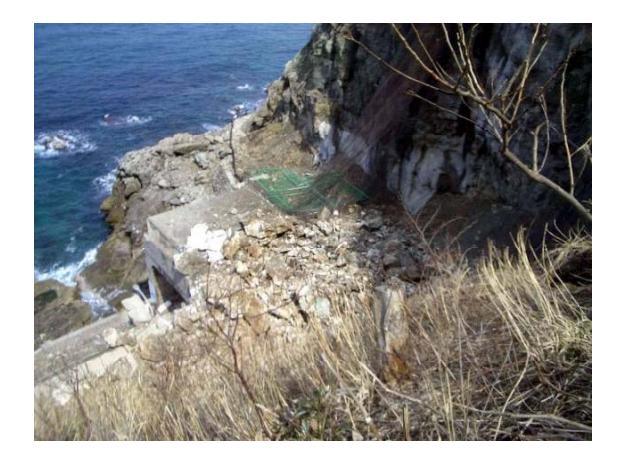
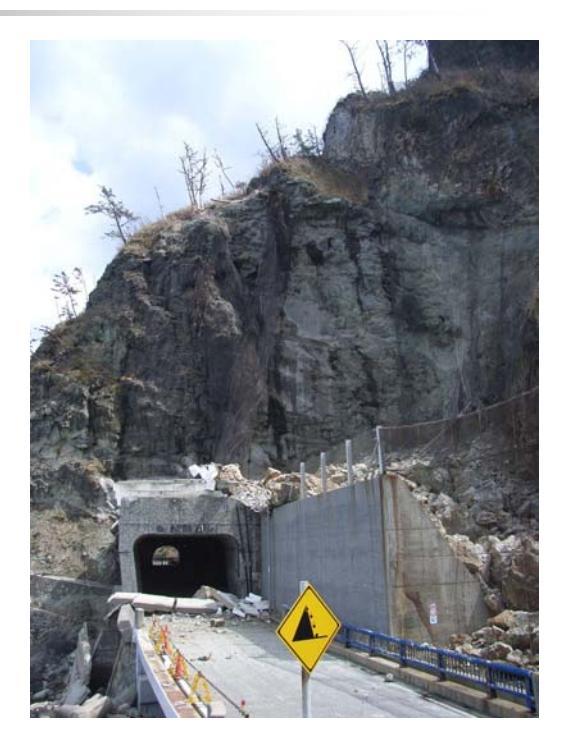
Rock Shed, Sosogi, National Highway Route 249

Rock failure: 10m long x 30m wide

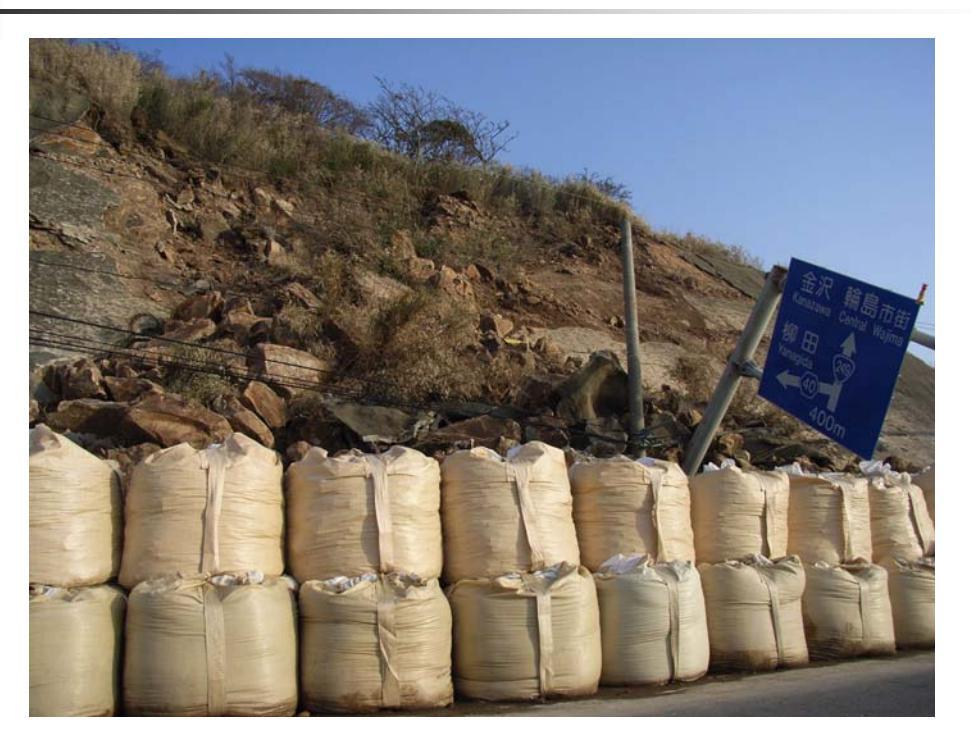
Rock Fall, Shibuta, National Highway Route 249

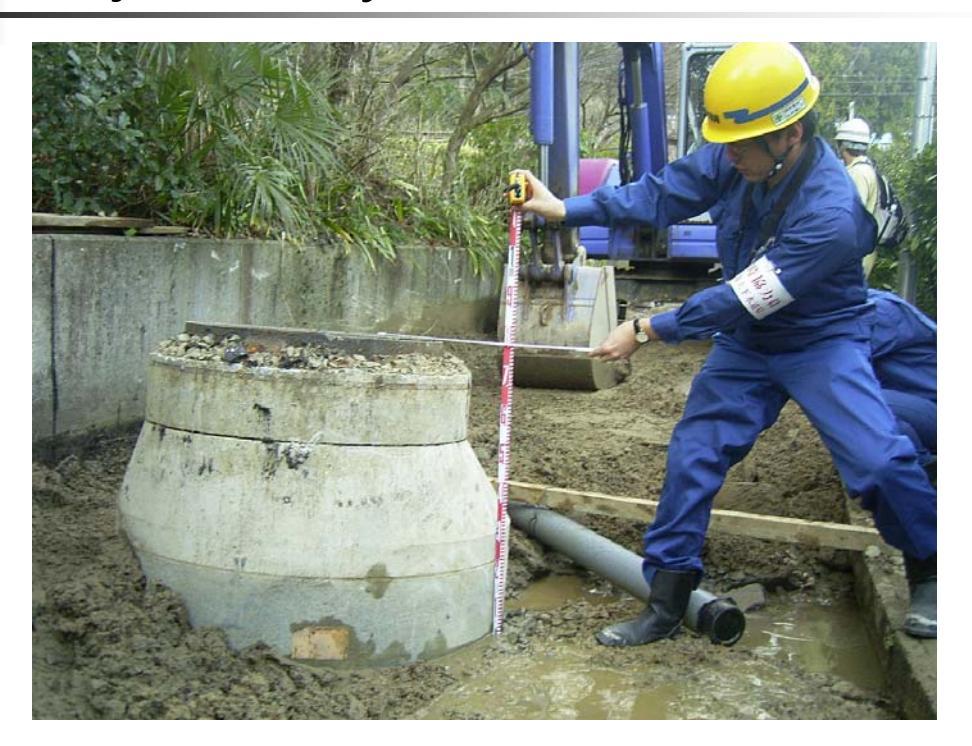
Uplift of Manhole, Monzen, Wajima City

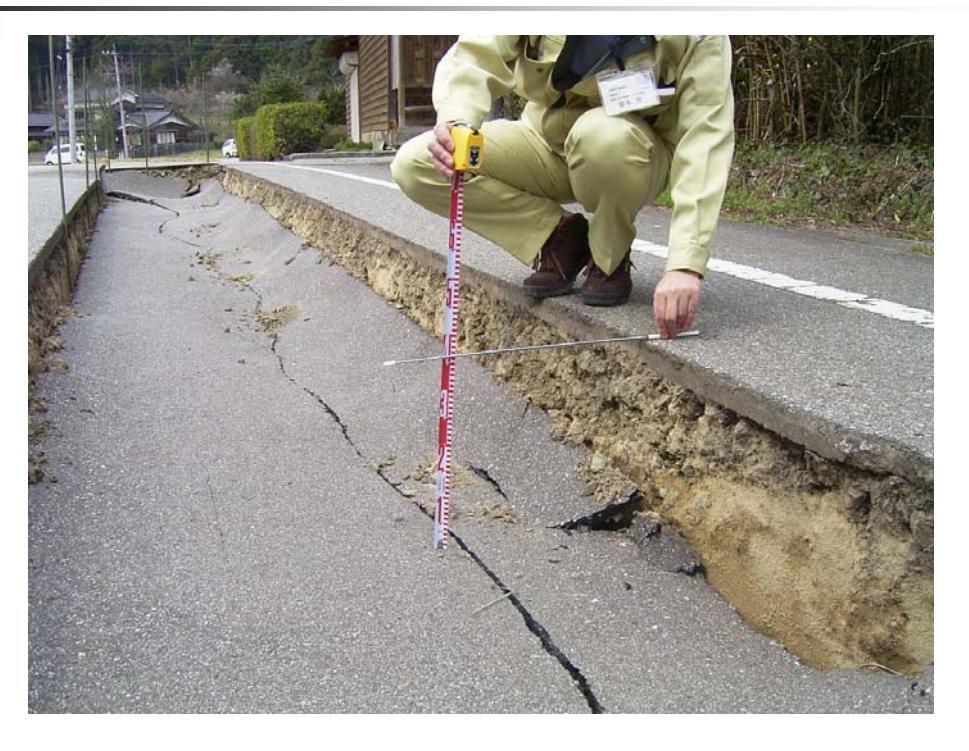
Settlement of Road Surface and Backfill of Sewage Pipe, Monzen, Wajima City

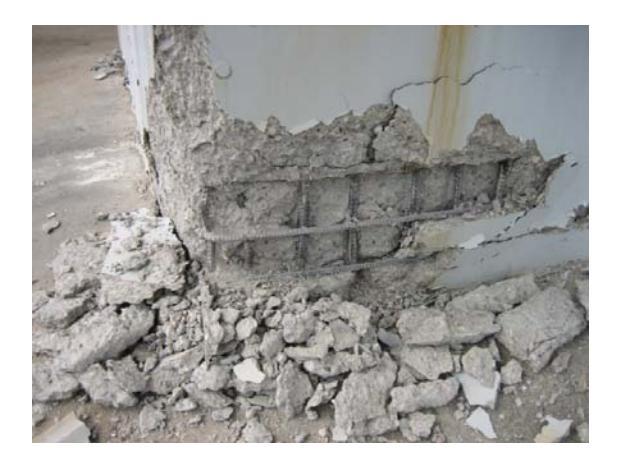
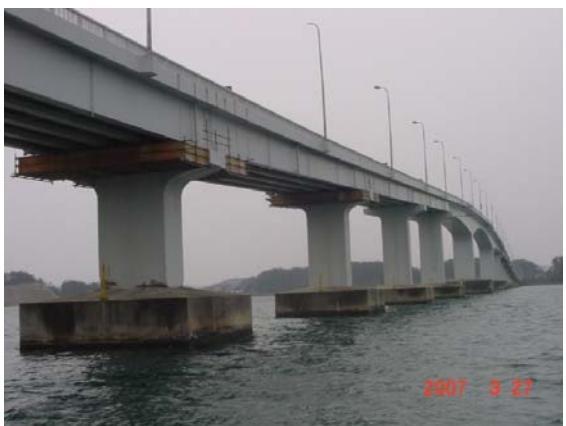
Highway Bridge Damage -Notojima Bridge

Damage at the bottom of Pier No.7

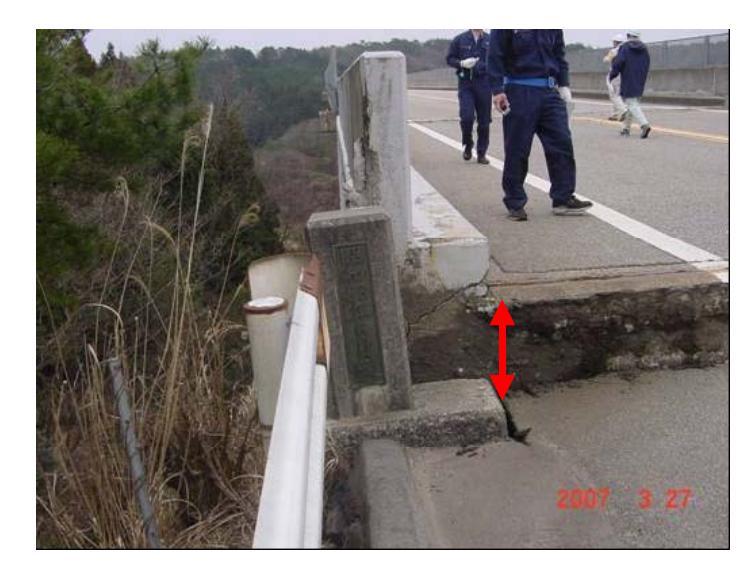
Highway Bridge Damage -Other Damage

- Settlement of backfill soil (Noto Bridge, Right)
- Damage to expansion joint

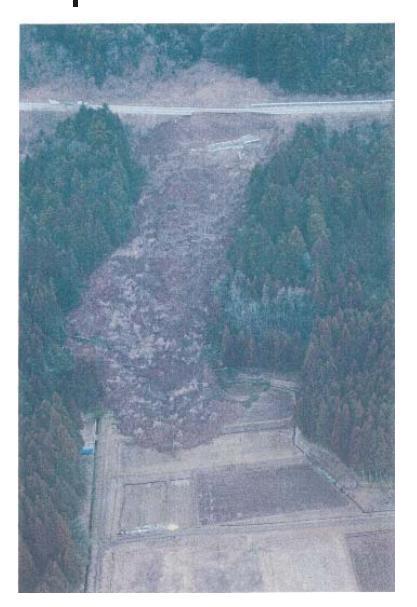
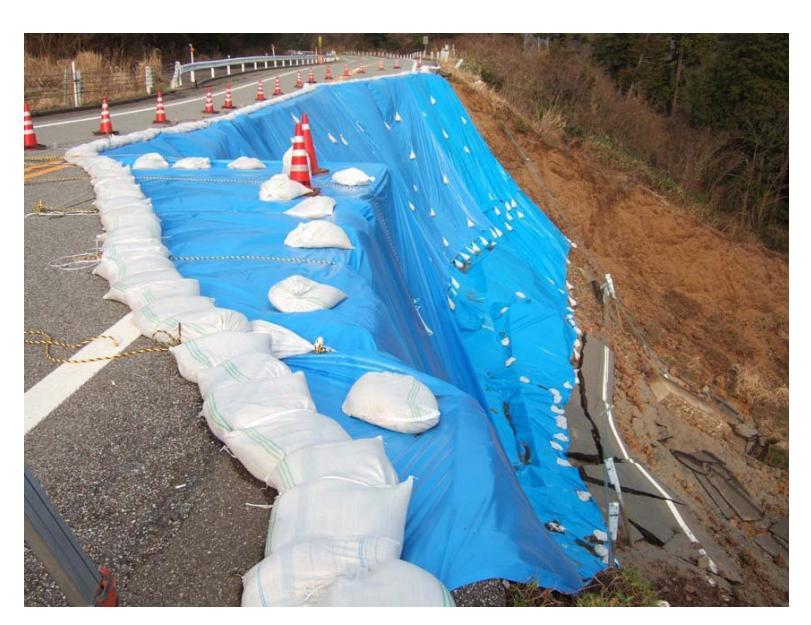
Failure of Road Embankment, Toyota (H=30m), Noto Toll Road

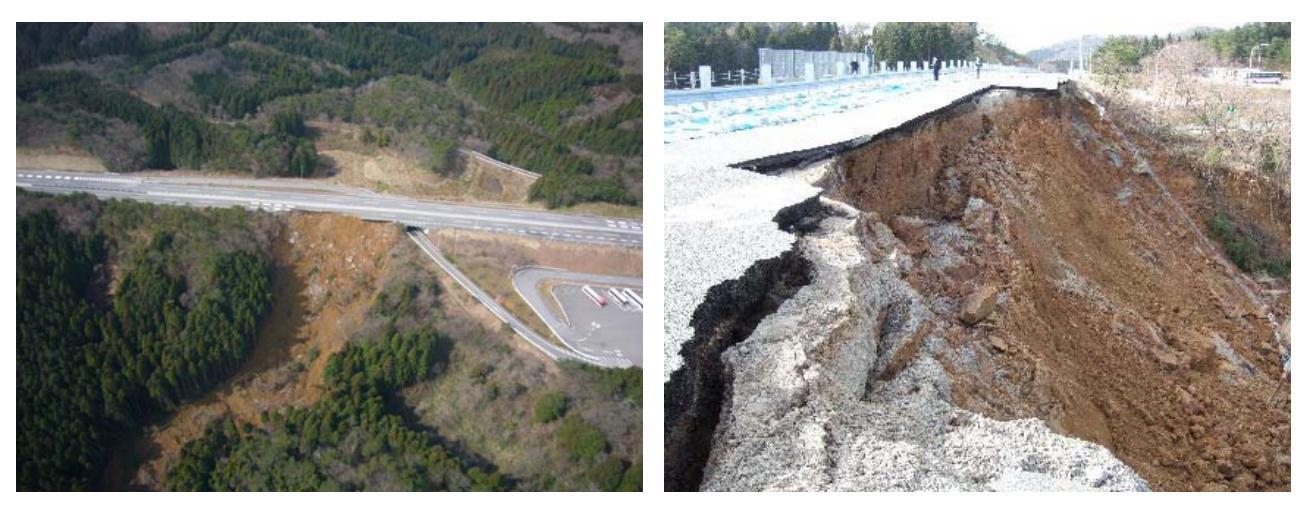
Failure of Road Embankment, Beshodake SA (H=35m), Noto Toll Road

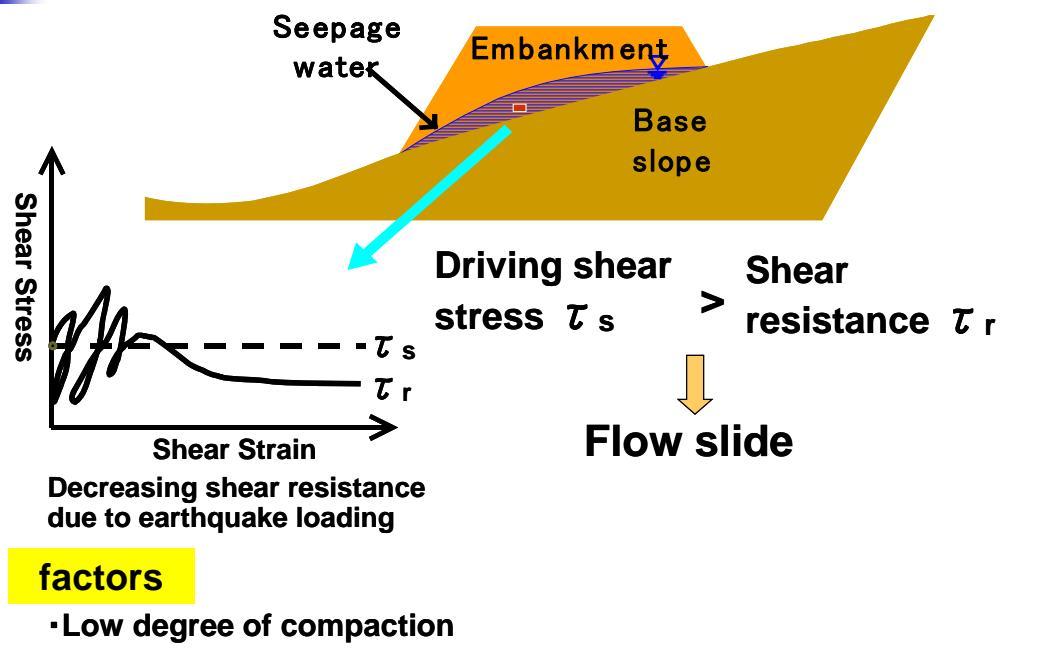
Schematic Mechanism of Earthquake-induced Flow Failure

•Existence of seepage water in embankments

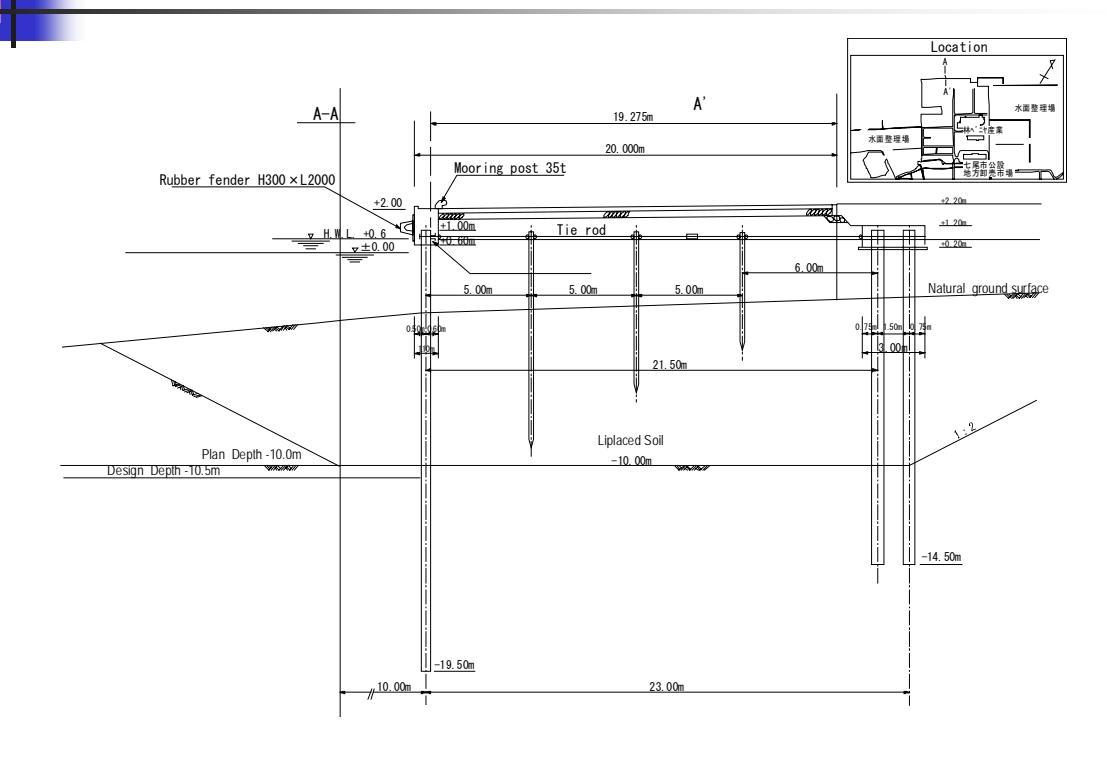
Nanao Port -10m Sheet Pile Quaywall, No.1

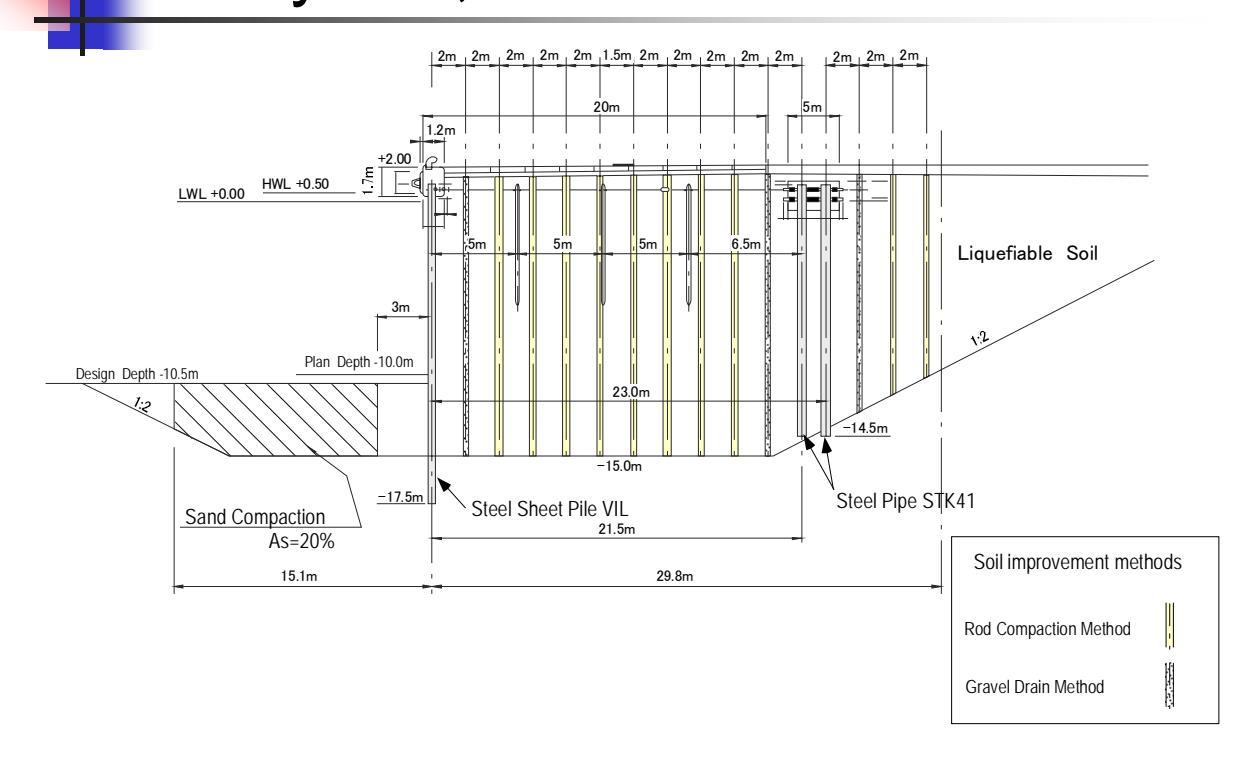
Nanao Port -10m Sheet Pile Quaywall, No.2

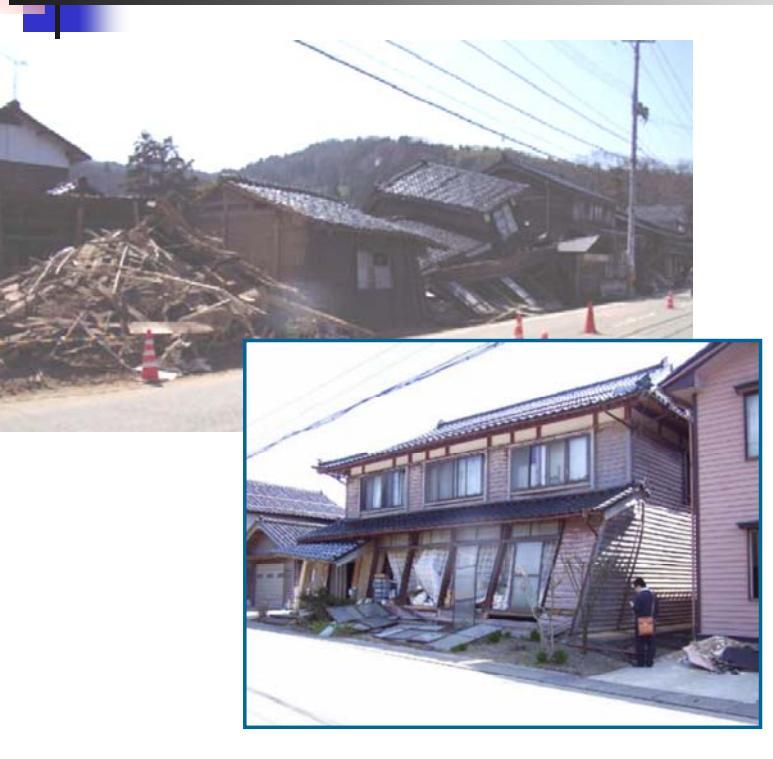
Damage to Wooden Buildings, Monzen, Wajima City

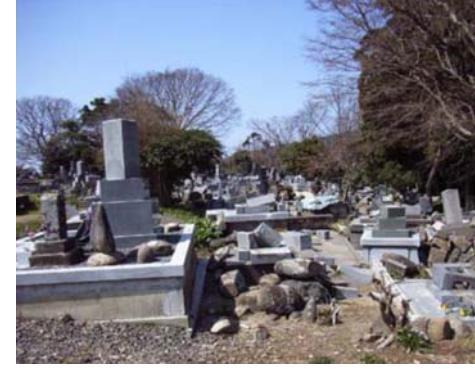
Fall of tomb stones in E-W direction

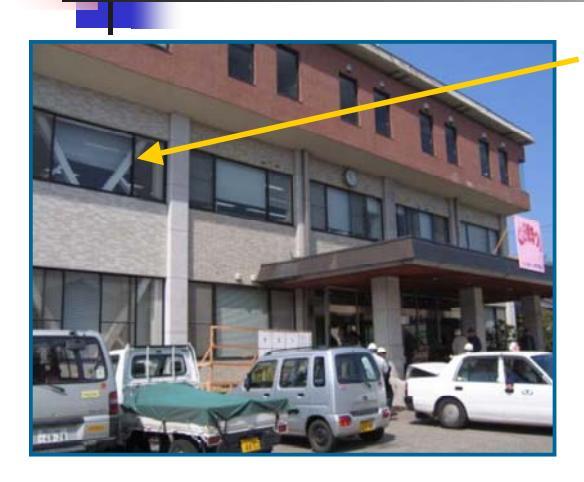
Retrofitted Monzen District Office Building, Wajima City

JMA 6+ 1304 cm/s²

Retrofitted by steel braces

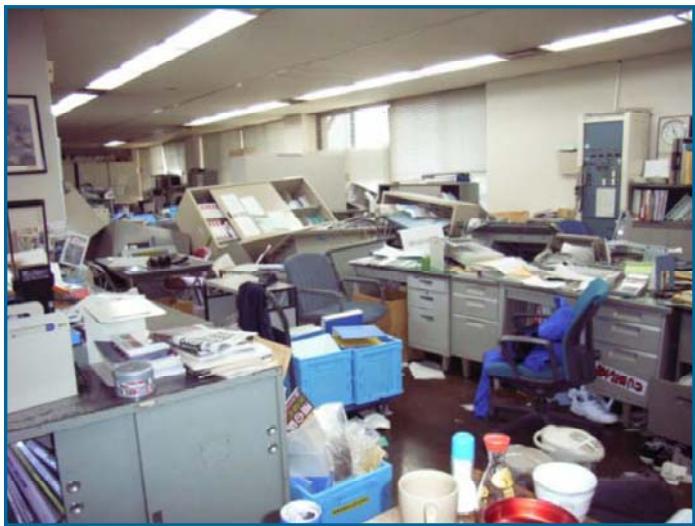
Damage in office room

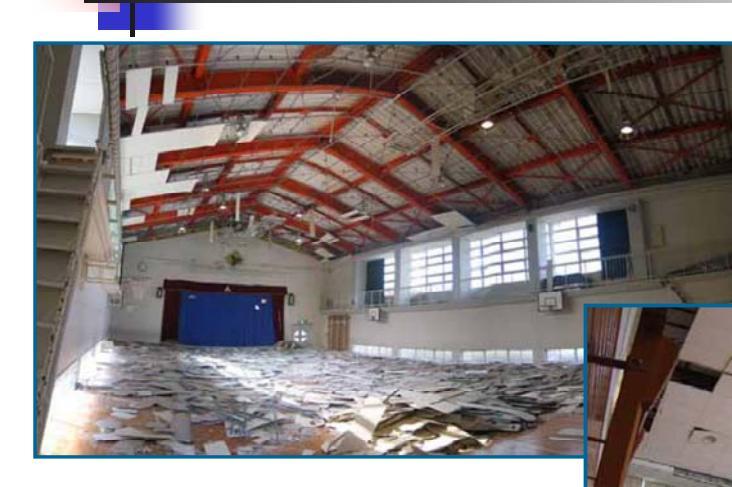
Damage to Ceiling of Gymnasium

Elementary school Noto Town S Roof girder + RC column

Elementary school Shika Town S Roof girder + RC column
