Damage to Buildings Induced by Tatsumakis in Nobeoka City, Miyazaki and Saroma Town, Hokkaido in 2006

ABSTRACT

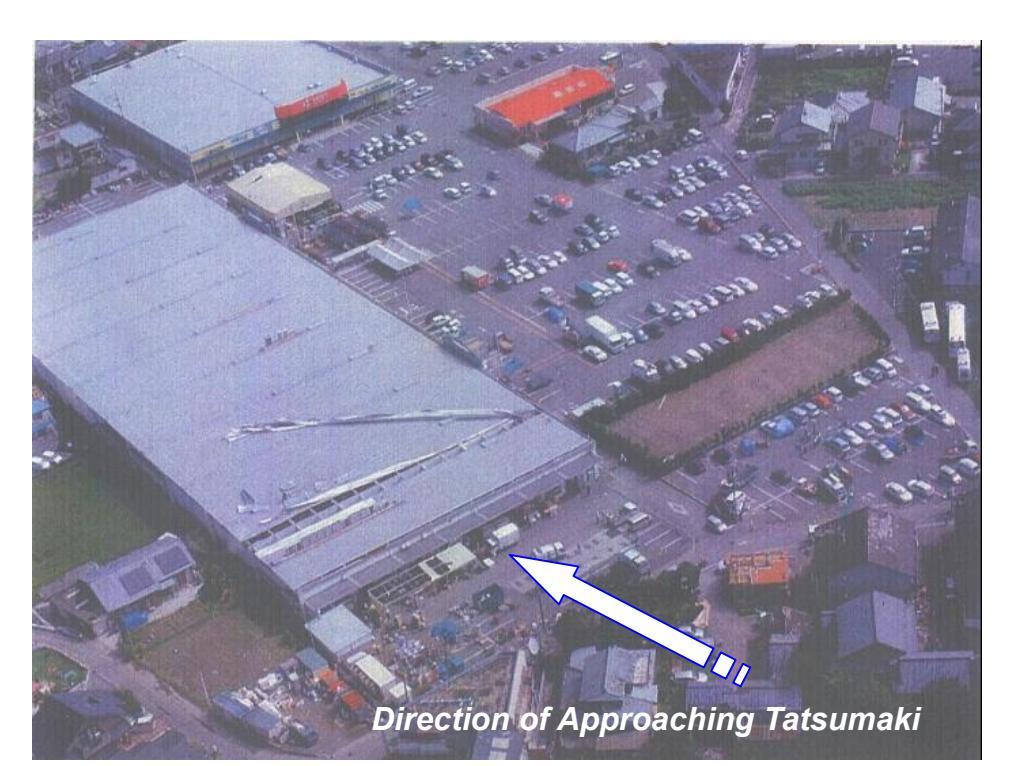
A commercial facility of mass grocery retailer in Nobeoka city experienced serious damage and which induced lots of economical loss of goods and display racks as well as external claddings. On the roofing materials, there were lots of marks of attack by flying debris. This facility is supposed to locate just in the course of the tatsumaki. Based on the observed damage state, the sudden decrease of internal pressure had generated first because of the peeled-off steel roofing materials and then the damage of indoor goods was supposed to become extensive very much.

Fig.4 Damage State after Disaster

Figs. 4 to 10 show the main damage state of this commercial facility. This retailer rapidly began repairing just after the disaster and only five days was needed for resuming business.

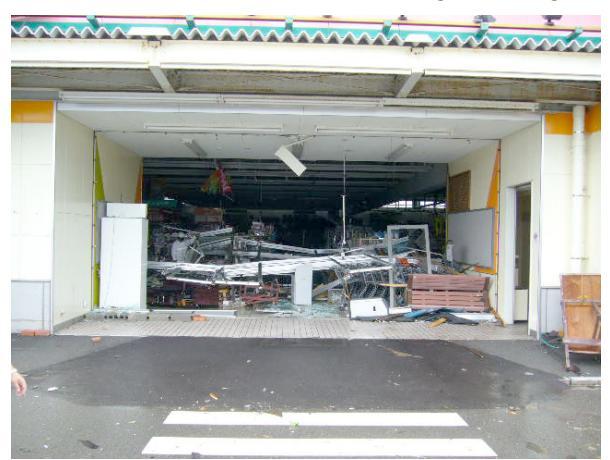
Fig.5 Overturning of Sash in Entrance

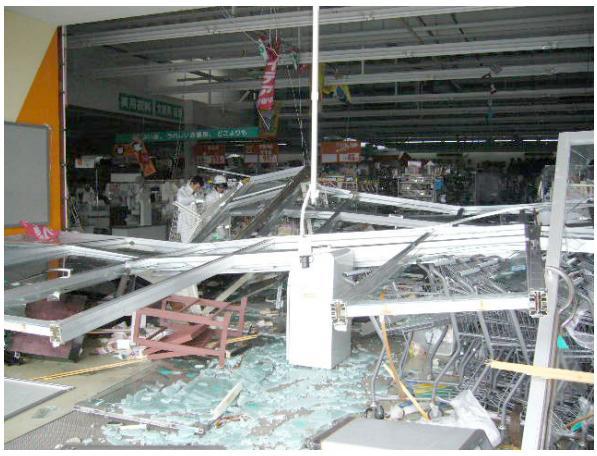
Fig.7 Damage State of Commercial Goods

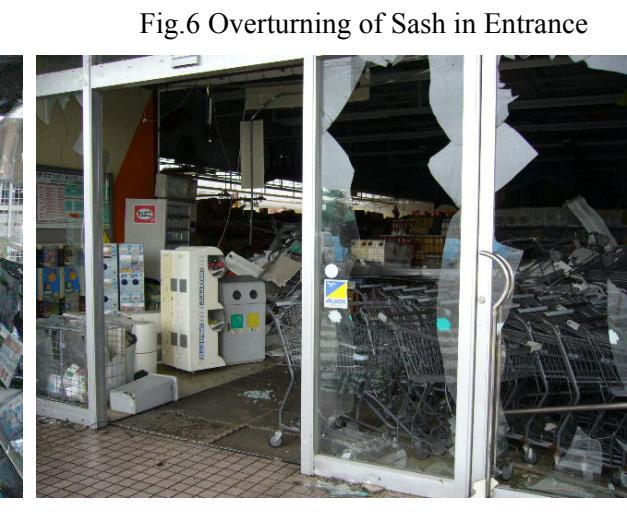
Fig.8 Breakage of Window in Entrance

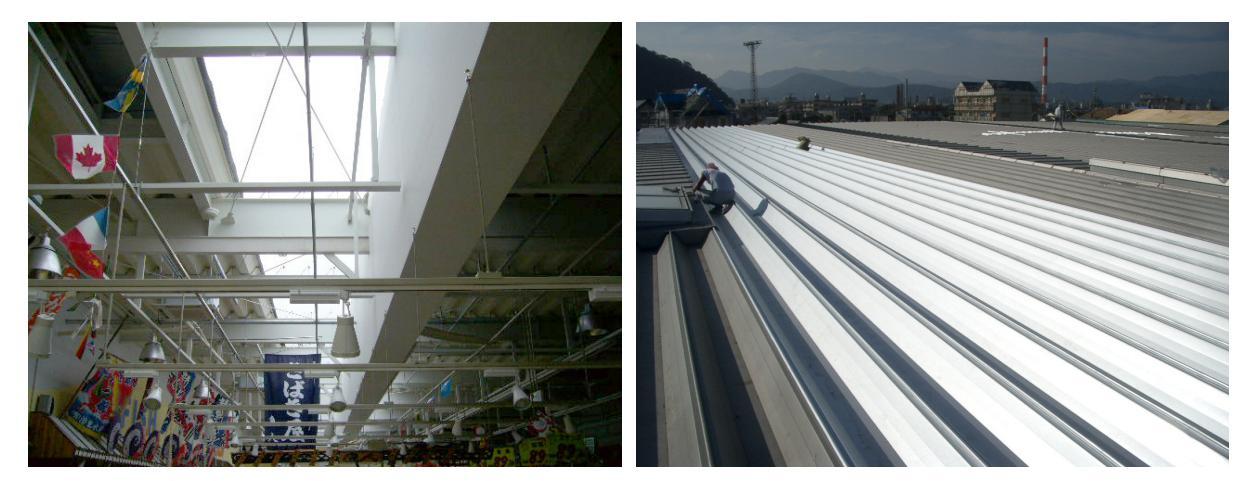
Fig.9 Peeled-off Steel Roofing Materials

Fig.10 Repaired Steel Roofing Materials

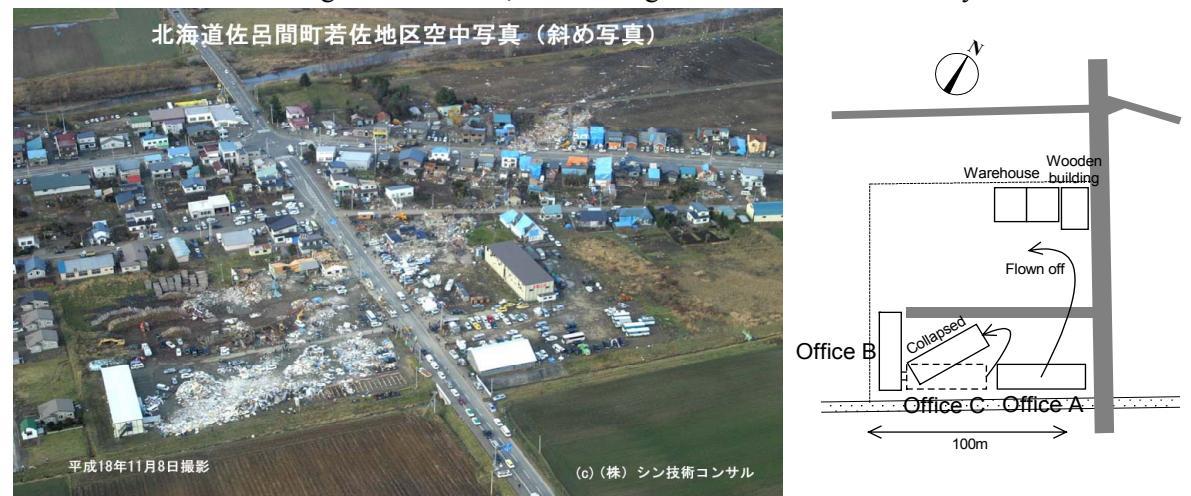
In Wakasa region of Saroma town, two of three temporary working offices were severely collapsed by the approaching tatsumaki (See Fig.11). Office A was flown off to the north direction and the other office C was collapsed to the same direction. Series of wooden piles of them were still left on these sites and lots of broken structural elements such as lattice girder were observed to be scattered in the neighboring site (See Figs. 12 and 13). The left temporary working office (office B) which was connected to the office C by connecting corridor had several breakages of windows, but

Fig.11 Damaged Temporary Working Offices

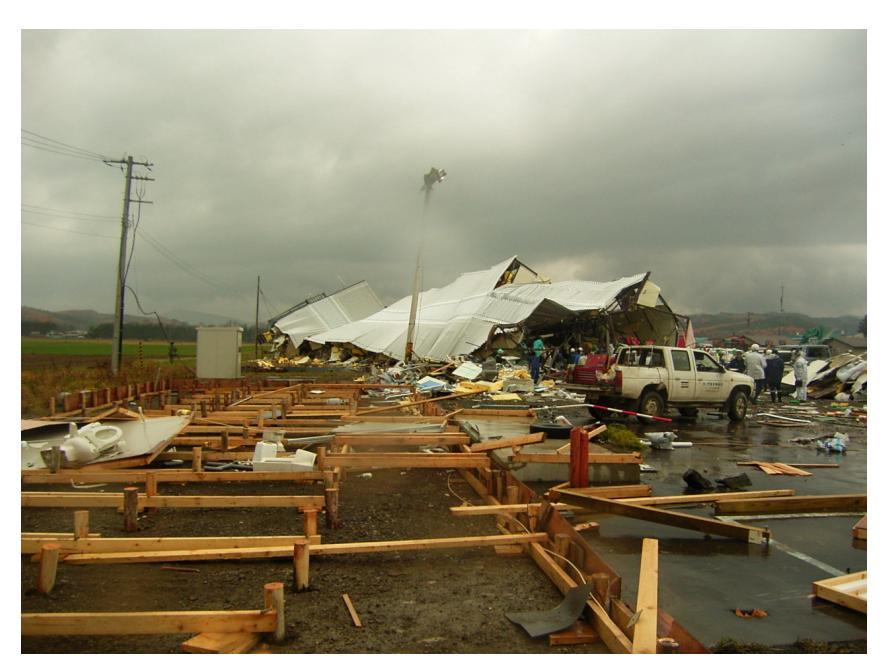
Fig.12 Collapse of Offices A and C (See Fig. 11)

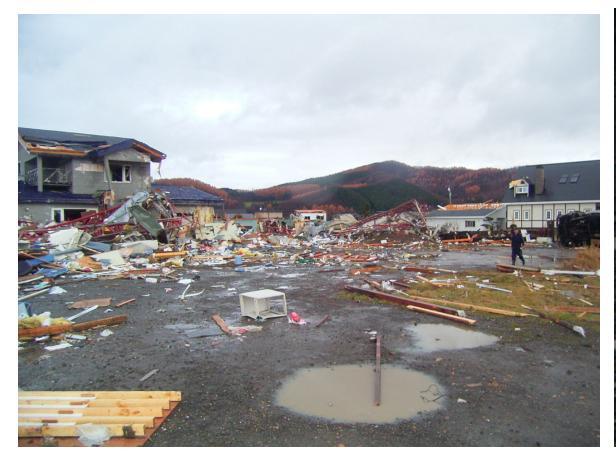
Fig.13 Scattered Structural Elements and Others

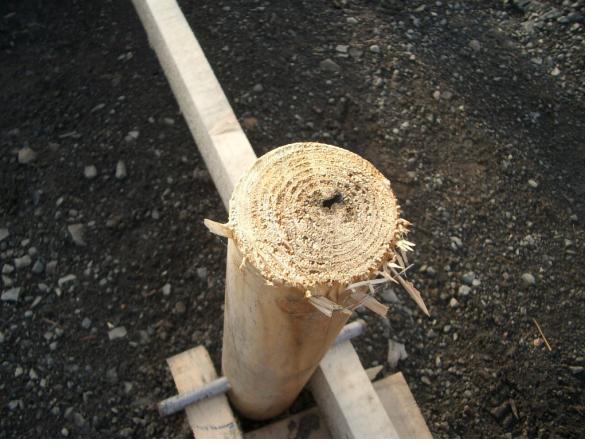
There were marks of pulled-up nails on the top of the wooden piles of offices A and C as shown in Fig.14 and these nails were considered to fasten floor joists with wooden piles. There also left crump irons on the side of the outer wooden piles as shown in Fig.16, which were considered to fasten ground sill with outer wooden piles. Based on the result of the serious damage, the pull-out performance of these fasteners with the given fastening interval is supposed to be totally inadequate against wind load induced by the tatsumaki.

Fig.14 Wooden Pile of Office A

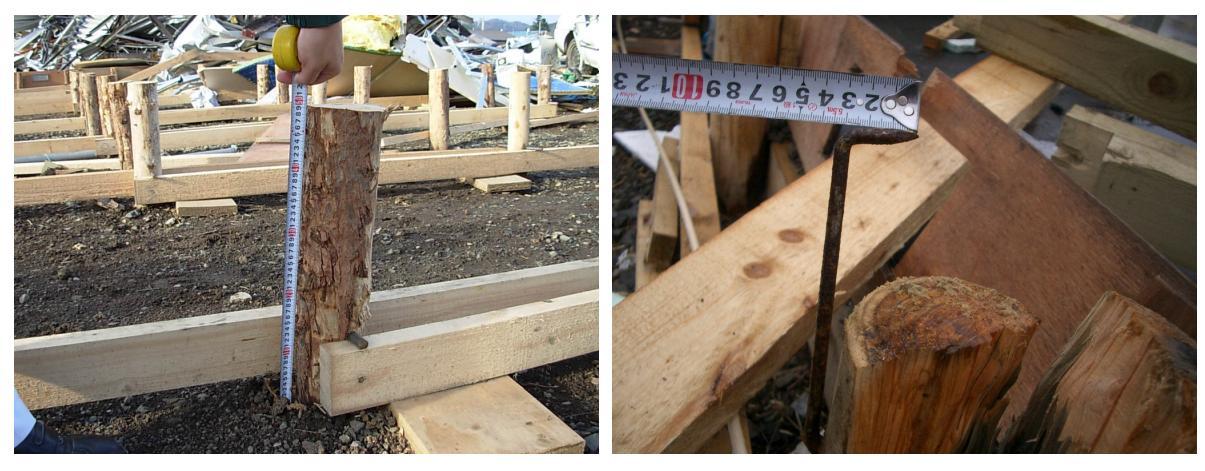
Fig.15 Wooden Piles of Office A

Fig.16 Clump Iron Left on Wooden Pile

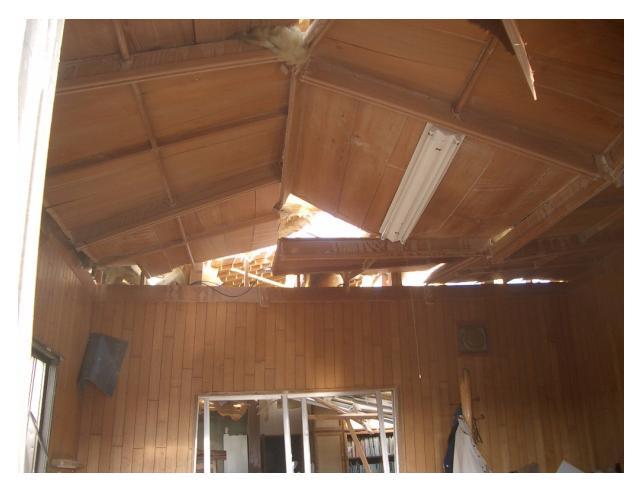
Fig.17 Damage to Ceiling

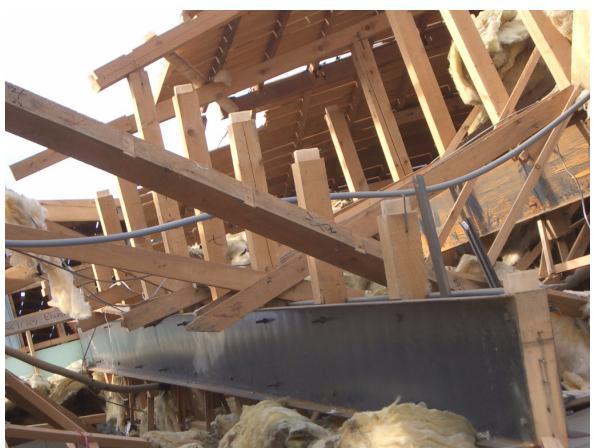
Fig.18 Out-of-joint between Vertical Roof Strut and Purline

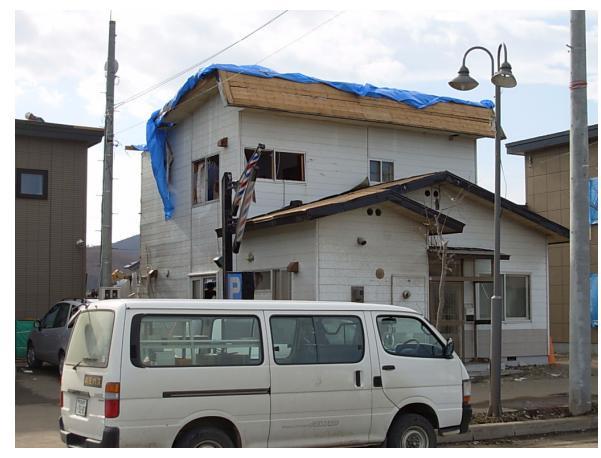
Fig.19 Damage to Roofing Materials

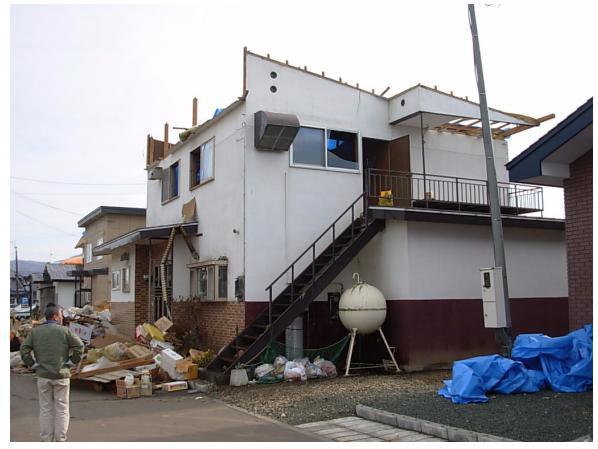
Fig.20 Damage to Roofing System and Part of Wall

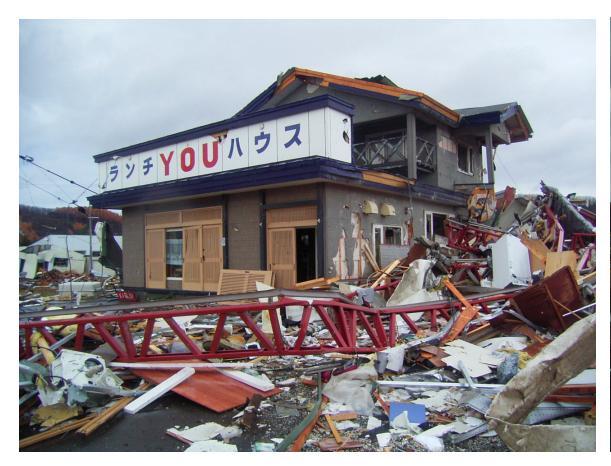
Fig.21 Severe Damage to External Cladding by Flying Debris

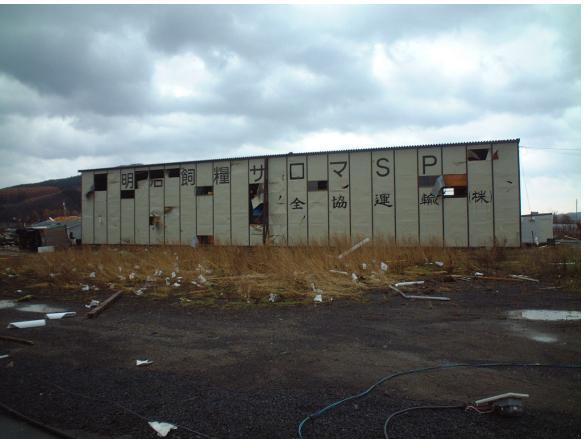
Fig.22 Damage to Wall by Flying Debris

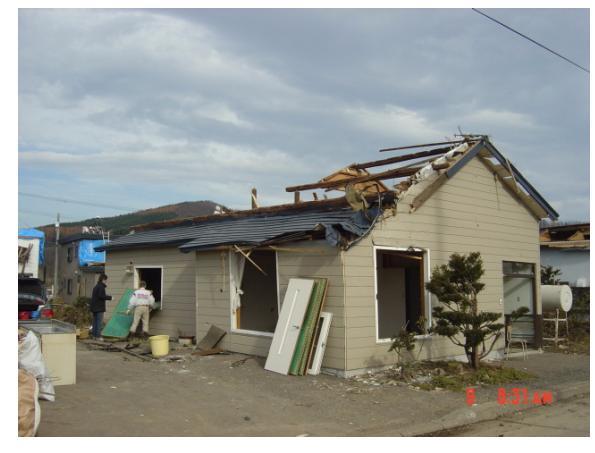
Fig.23 Damage to Roofing System

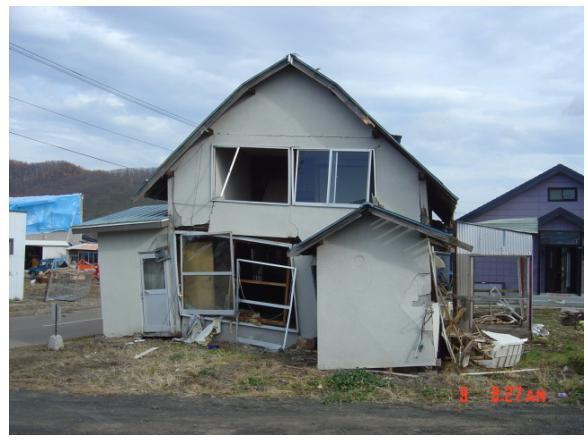
Fig.24 Residual Deformation of External Cladding

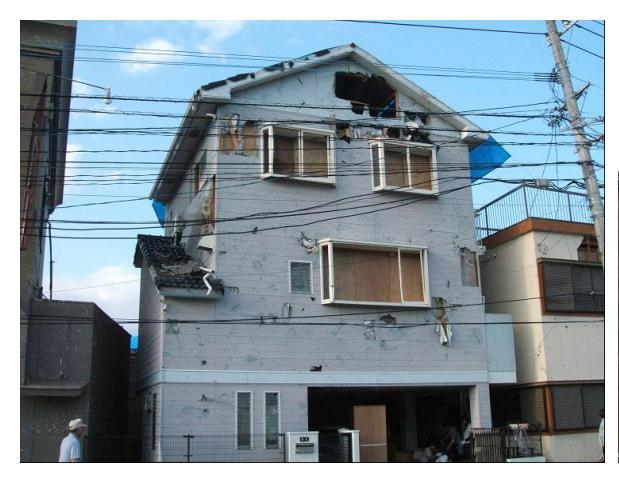
Fig.25 Damage to Wall by Flying Debris

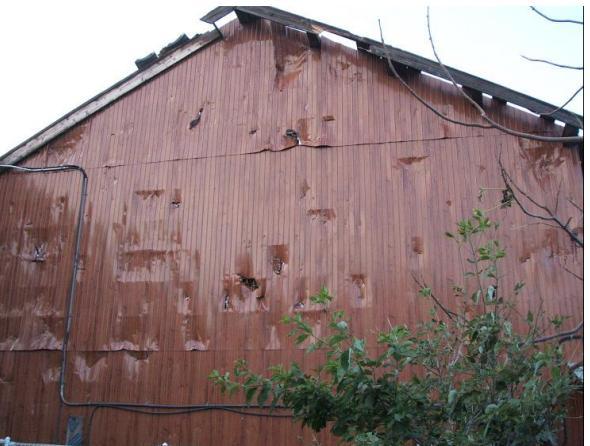
Fig.26 Damage to Wall by Flying Debris

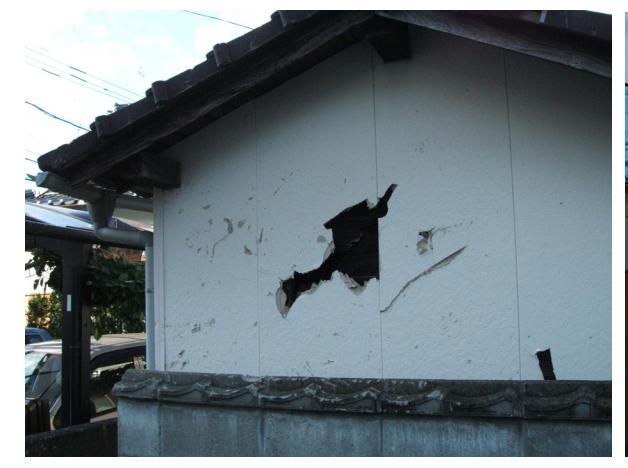
Fig.27 Damage to Wall by Flying Debris

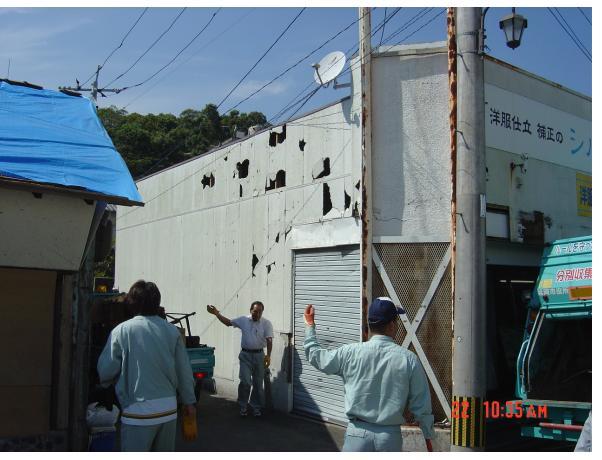
Fig.28 Damage to Wall by Flying Debris

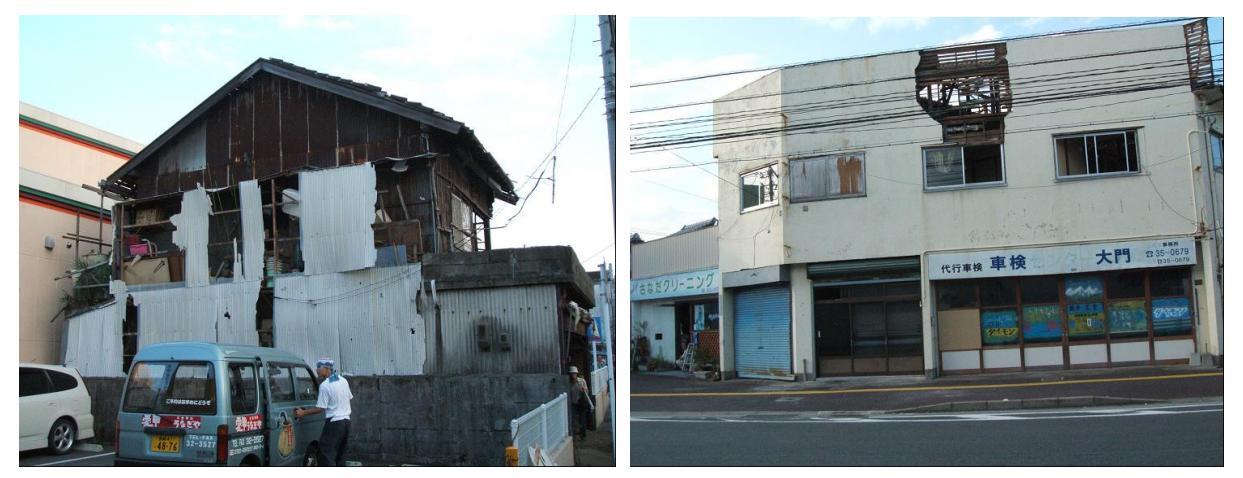
Fig.29 Separation of Wall

Fig.30 Separation of Wall

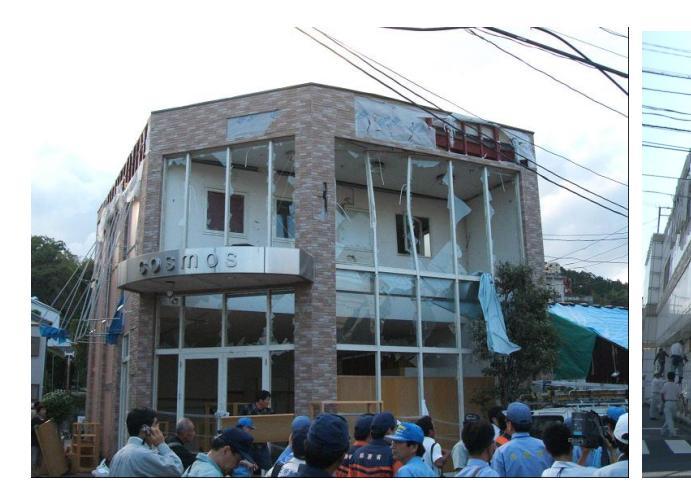
Fig.31 Damage to Windows and Sash

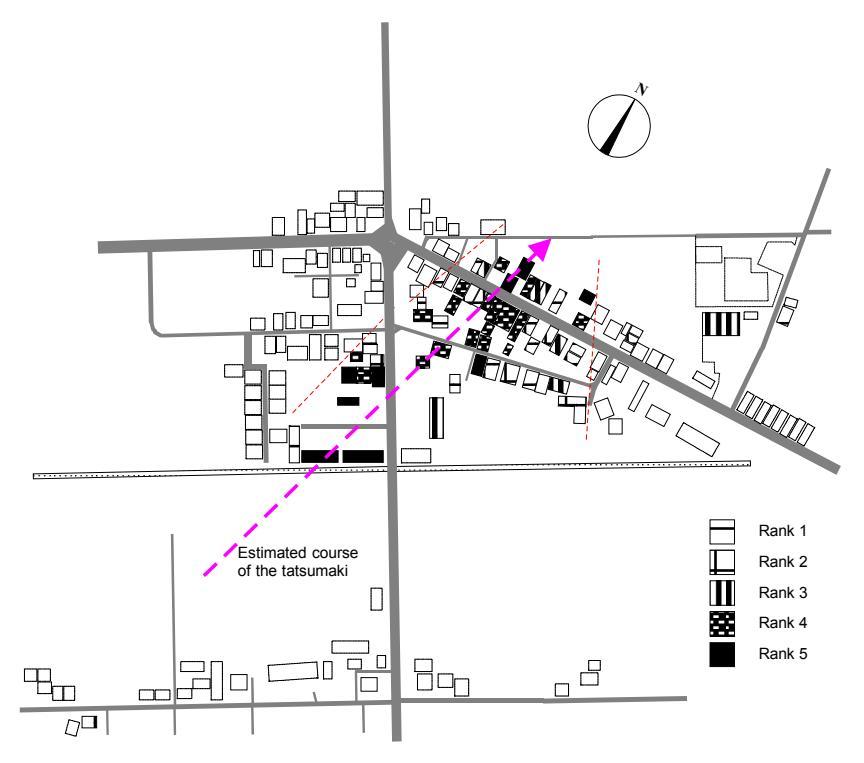
The authors applied observed damage states of each houses in Wakasa of Saroma town to the high wind damage scale shown in Table 1. The result is illustrated in Fig. 30. If the line which covers buildings ranked 4 or 5 is supposed to the route of the tatsumaki, how the tatsumaki

went across the area can be estimated as shown in the figure. The width of disaster area was ranging from 100m to 250m and the damage area may be more extensive in the eastern side of the estimated route of the tatsumaki.

Fig.33 Distribution of Damaged Buildings in Wakasa of Saroma Town

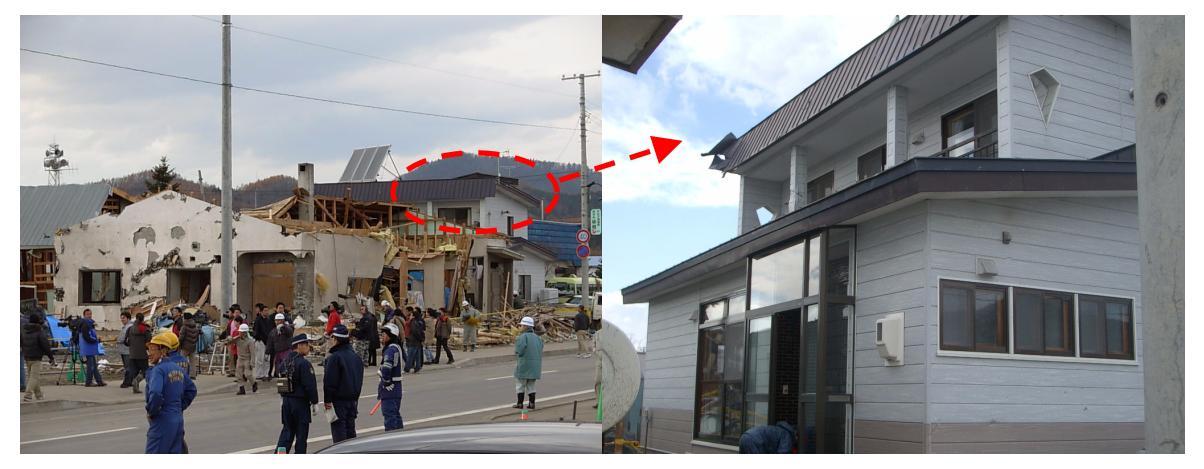
As the typical characteristics of disaster by tatsumaki, it can be pointed out that the width of the disaster area is narrower than that by typhoon and the estimated boundary between damaged area and non-damaged one is very clear. Figs. 34 and 35 are examples of the clear boundary between damaged and non-damaged houses.

Fig.34 House with Collapsed Roofing System and House with Small Damaged Roofing Material

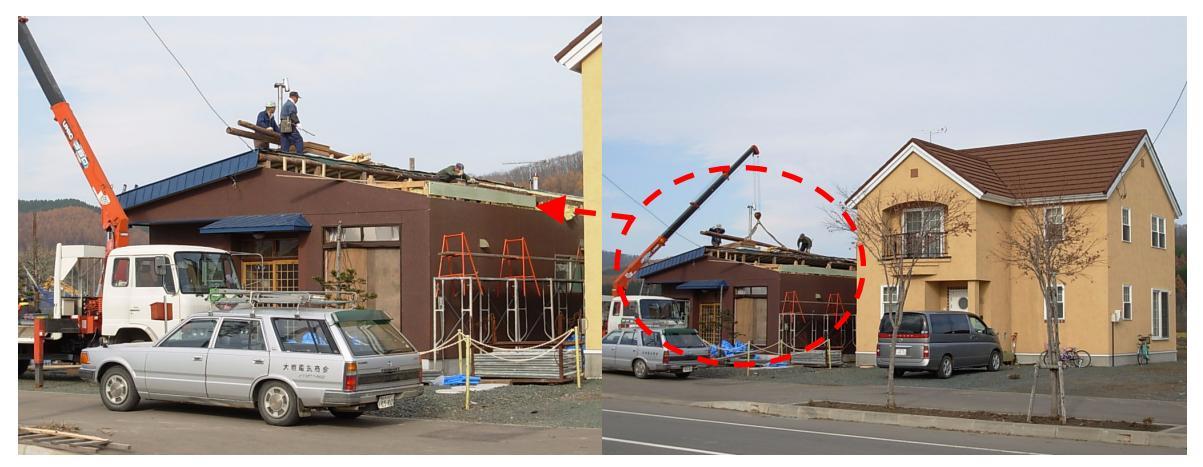
Fig.35 House with Peeled-off Roof and Non-damaged House

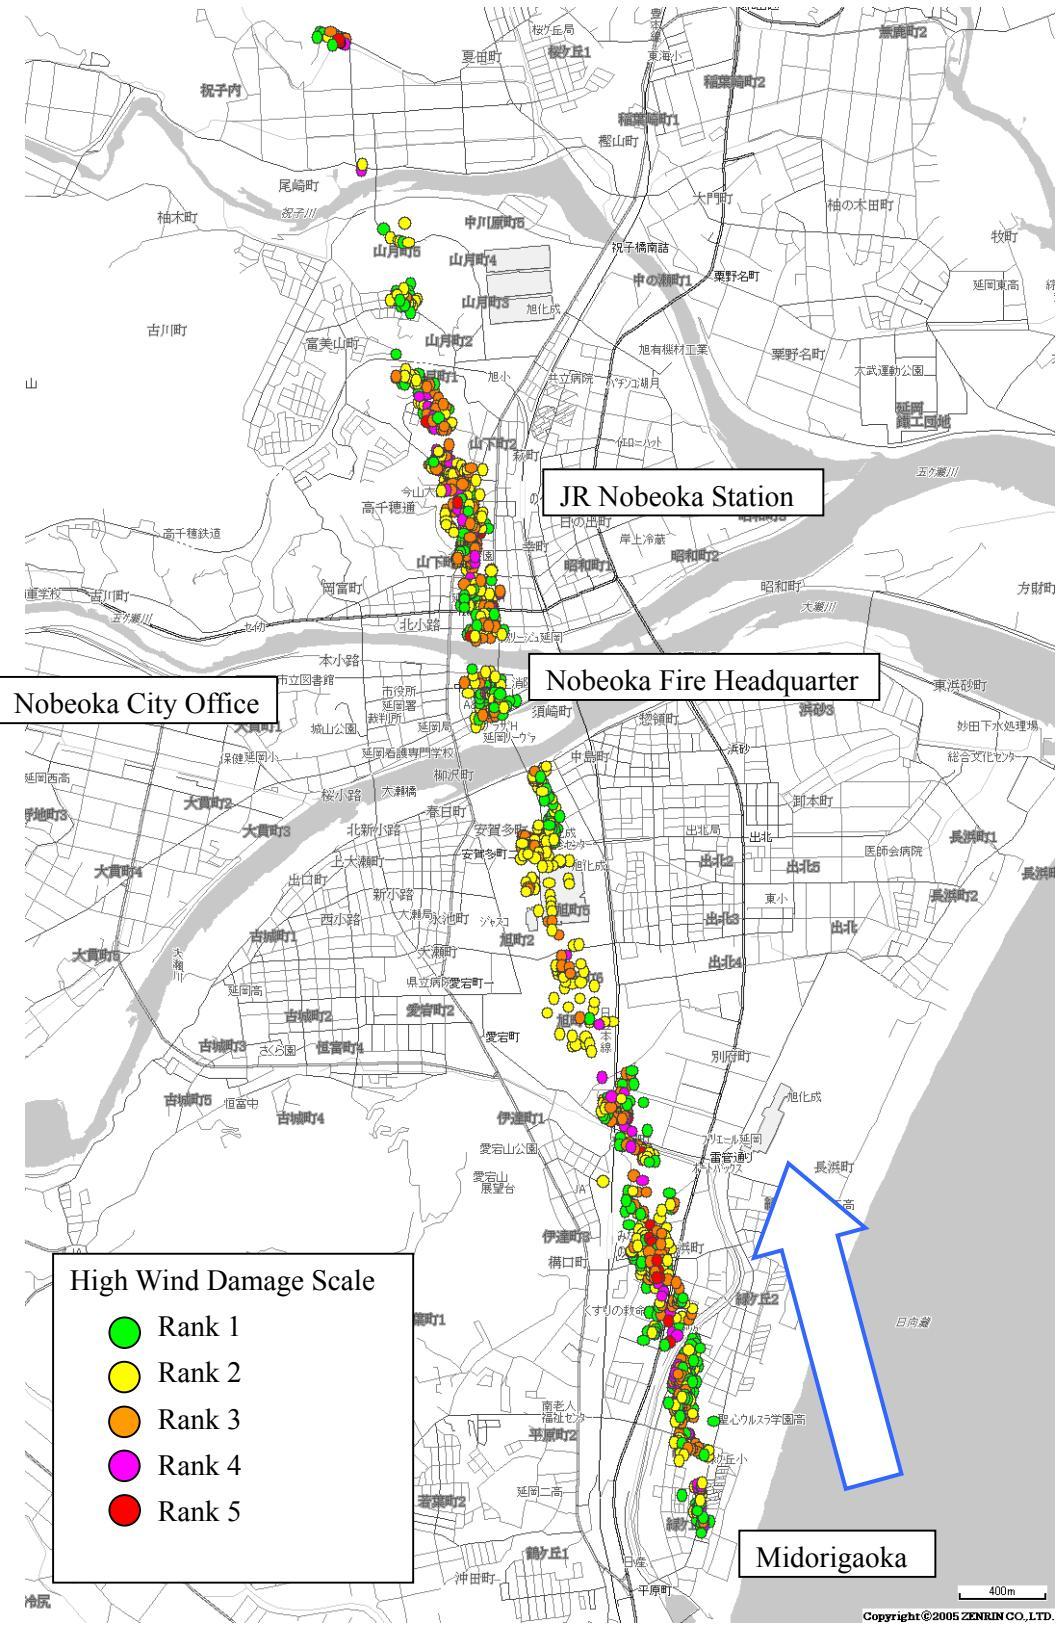
The damage is almost distributed for about

7.5km in a straight line to run through a center of Nobeoka city. A Tatsumaki generated on the sea in the offing of Midorigaoka, Nobeoka city and moved up to the north from the south. According to the Meteorological Agency, movement speed of a tornado estimates it with about 90km/h. A Tatsumaki struck Nobeoka Fire Headquarter and all windows of the building were broken.
