## ASCE/JSCE Tohoku Tsunami Investigation of Structural Damage and Development of the ASCE 7 Tsunami Design Code for Buildings and Other Structures

by Gary Chock<sup>1</sup>

#### ABSTRACT

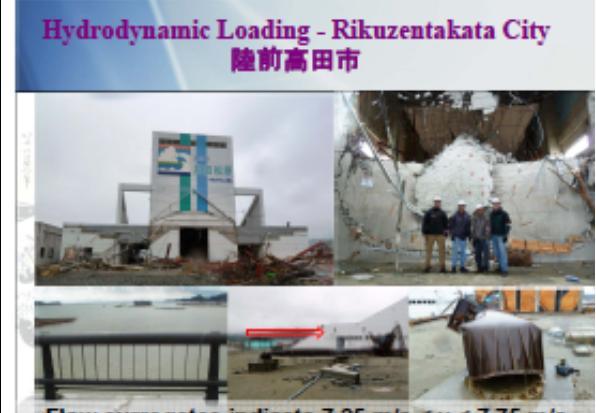
Two large light standards stood on either side of the building. The maximum inundation depth measured by debris on the building was less than the elevation of the light fixture on top of the Based on structural analysis, the pole. pushover of the light standards during the 10 meter deep inflow had following sequence. Under flexural bending, an initial buckling of the thin pipe walls above the base plate stiffeners resulted in rotation of the pipe until the initially dry light fixture frame at the top of the pole was lowered into the flow and captured debris. This debris load at the top of the pole greatly increased the moment at the base and initiated much more rotation until it generated tensile rupture of the anchor bolts. A depthaveraged flow velocity of at least 7.25 m/s was determined from structural analysis of the pole in order to create the initial buckling. The bolt anchorage group had higher moment capacity than the flexural local buckling strength of the pole. In the same vicinity, the undamaged railings of a bridge were analyzed to provide an upper bound for the flow velocity of 7-3/4 m/s at this location. Thus, at this location we have estimates that bracket the estimated flow velocity to be greater than 7-1/4 m/s but less than 7-3/4 m/s.

Flow surrogates indicate 7.25 m/s < v < 7.75 m/s Figure 1 Takada Matsubara Building

The Takada Matsubara Road Station in Rikuzentakata shown in Figure 1 endured a 10.5 meter tsunami inundation depth with flow of about 7-1/2 meters/second, but suffered a failure of its principal transverse shear wall due to unbalanced hydrostatic and hydrodynamic forces of the incoming tsunami. The wall was at the rear face of a three-sided concrete box with the opening in the fourth side being a main entrance into the building at the front. Reinforcing steel was sampled and tested at 510 MPa average yield strength, consistent with JIS G3112 SD 490. The sequence of nonlinearities was found to be:

- 1. Flexural yielding of the base of the wall as soon as when the flow level reached 1.6 meters above grade.
- 2. Bottom half of side edge supports of the wall and the two ends of the horizontal beam yield when the flow level reached 2.2 meters.
- 3. The top and upper portions of the side supports of the wall yield and concrete shear cracks occur at the bottom when the flow reaches 2.7 meters. Shear friction of the double dowels from the

- 4. Side supports and horizontal beam supports reach concrete shear failure cracking when the flow reaches 7.2 meters. The flexurally yielded wall essentially became a membrane pinned at the bottom.
- 5. The top and upper portions of the side supports reach concrete shear failure cracking when the flow reaches 9.5 meters. The top half of the wall is hanging in tension from the top beam.
- 6. At 10.5 meters, the upper portion of the concrete walls hanging in tension drops down and relieves further loading increase; the unbalanced hydrostatic forces are relieved.

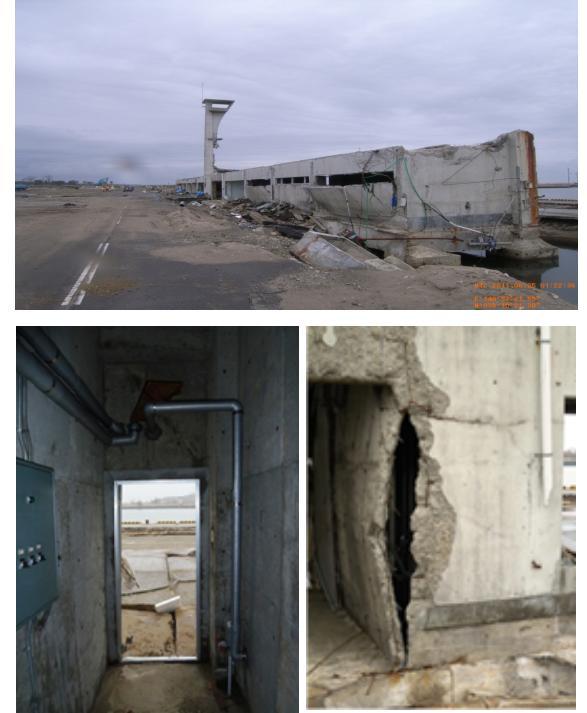
A large morning fish market building was located directly at the wharf area at the harbor of Yuriage. The building consisted of a large 120 m long by 20 m wide steel-truss framed single story high-bay building with a smaller attached one-story single bay of reinforced concrete bearing walls and concrete roof slab. The steel-framed main building was stripped off. A reinforced concrete utility closet for equipment had its sole door opening oriented towards the incoming tsunami, and was thus subjected to the internal pressure resulting from stagnation of the flow. Reinforcing bar samples tested to be equivalent to JIS G3112 SD 390 with 400 MPa average yield strength. In order for the failues shown here to have occurred, flow velocity have been least would at 7 - 1/2meters/second.

**Figure 2:** Wall corner joint and flexural failure by internal hydrodynamic pressurization

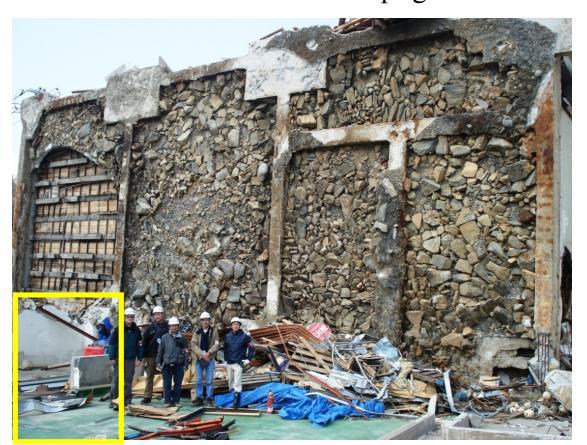
The building shown in Figure 3 was lifted by hydrostatic buoyancy off of its pile foundation, which did not have tensile capacity, and carried over a low wall before being deposited about 15 meters inland from its original location. This building was approximately 22 meters by 8.7 meters by 12 meters tall. Total deadweight of the structure was 8995 kN. The refrigerated space on the ground floor was effectively sealed off from being rapidly inundated with water, leading to a neutrally buoyant condition as soon as the water inundation depth reached 7 meters. The building was lifted off its original site and carried just barely over a short wall (background of photograph on the left), and then was apparently flipped over by contact with the top of the wall that it damaged in the process. Once sideways, the buoyant displaced volume was reduced from when it was upright.

**Figure 3** The ASCE Tohoku Tsunami Reconnaissance Team at the Onagawa uplifted and overturned 2-story reinforced concrete coldstorage building - Note low wall with top edge spalled (Hideyuki Kasano)

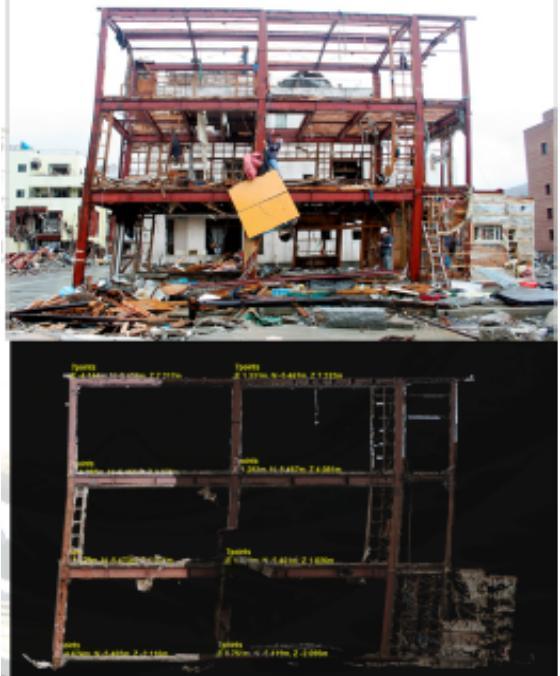
The three-story steel moment-resisting frame in Figure 3 was exposed to flow returning to the ocean which has been estimated from video analysis at about 8 m/s. The beams were stronger than the columns, since our inspection did not indicate any beam damage. With about 67% blockage of the original enclosure, (33% open), the return flow is sufficient to yield the

top and bottom of the second story column but not the third floor columns, nor the second and third story of the exterior columns. At the first yield point of the system, the calculated lateral drift at the third floor would be about 30 cm (and at the second floor it would be about 7 cm). Subsequently sustained flow induced further displacement until loss of all cladding reduced the building's projected area. A subsequent LiDAR scan of the frame shows a third floor drift of up to 50 cm. Without such load shedding, collapse would have occurred.

Figure 4 Onagawa 3-Story Steel Frame Pushover

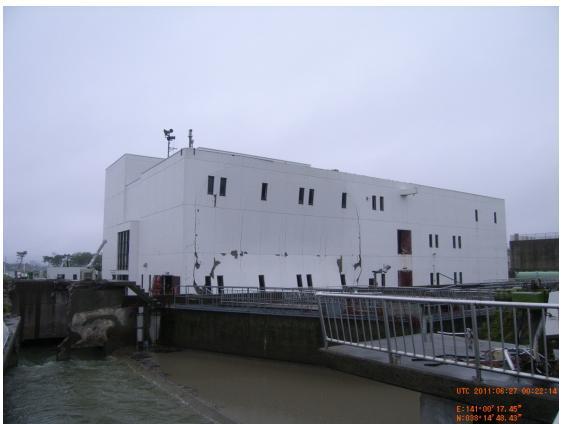
*Minami Gamou Wastewater Treatment Plant* Video of this facility in Sendai showed a soliton bore directly striking the longitudinal walls of buildings at this wastewater treatment plant sited at the shoreline. (Figure 5) Also, structural drawings for the damaged buildings were obtained from the plant management.

Based on loading calculated from the height of bore using the method of Robertson, Paczkowski, and Riggs [2], the bore forces were found to be sufficient to create the midheight and top and bottom flexural yielding. The bore impact forces were also found to exceed the surge and hydrostatic forces resulting from the rising tsunami surge. It is preliminarily concluded that repeated soliton bore impacts were likely to be responsible for the amount of deformation found in this wall and another building nearby.

Figure 5 Minami Gamou Wastewater Treatment Plant Building.
