# **EVOLUTION OF PARALLEL WIRE CABLE CONDITION ASSESSMENT – A CASE STUDY** Barney T. Martin Jr.<sup>1</sup>

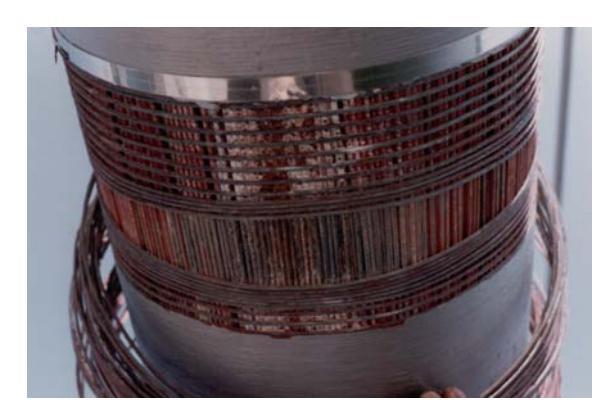
The exposed wires at the selected location near the mid-point of the south cable in the center span (low point) were observed to be more extensively corroded than the wires at the other locations. As shown in Figure 3, a decision was made to unwrap a length of 2.0 m (6-1/2 ft.) at this location and probe with wooden wedges. The cable was probed with hardwood wedges at four positions on the circumference; the top, bottom and sides. The wedges were driven to a depth of 50 to 75 mm (2 to 2-3/4 in.). Extensive corrosion of the zinc coating was observed on the outer wires between the 2:00 o'clock and 9:00 o'clock positions on the cable perimeter. The most significant wire section loss was observed on the underside of the cable at the location of the black residue formed by the corrosion process. The visible surfaces of the outer wires on the upper portions of the cables appeared in good condition; however, the red lead coating on the wires was dry and brittle and could be easily brushed from the cable. White zinc oxidation

FIGURE 2 – PARTIAL REMOVAL OF WRAPPING WIRES – NOTE CORROSION RESIDUE

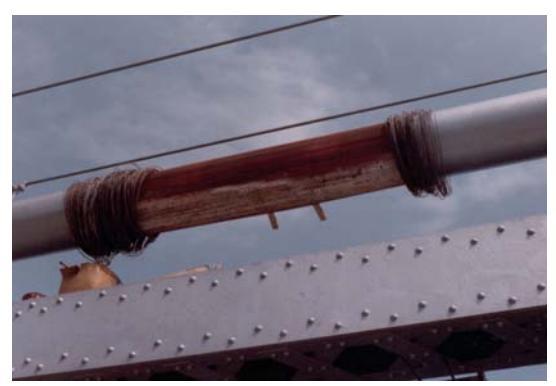
residue from the galvanizing was noted on all visible interior wires at the four positions probed. Some brown steel corrosion residue was noted on interior wires at three of the four positions, but no significant loss of wire section or broken wires was visible.

FIGURE 3 –EXPANDED INSPECTION AREA - NOTE CORROSION RESIDUE

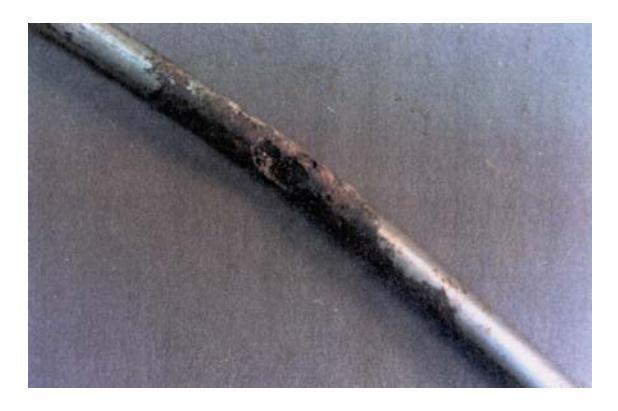
FIGURE 4 – REPRESENTATIVE CORROSION "PIT"

The greatest concentration of localized cavities or pits on inner wires was noted on the upper half of the cable cross-section. These pits appeared to occur on the upper surfaces of the wire at locations that trap moisture between the wires and were located more toward the center of the cable.

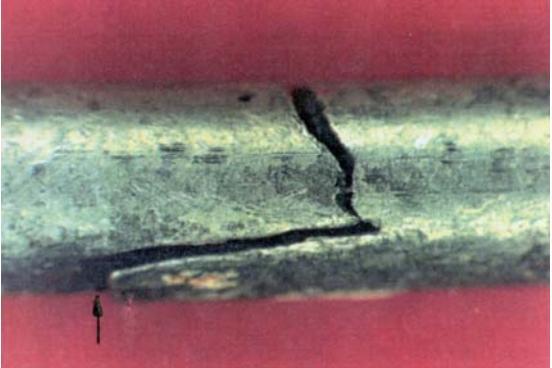
The fracture surfaces of the broken wires were similar to those discovered in the earlier examinations, and were characteristic of stress corrosion cracking (see Figure 5).

FIGURE 5 – TYPICAL FRACTURE

The fractographic examinations performed on the broken cable wires removed from the cable indicated the failures were most likely the result of stress corrosion cracking. Stress corrosion cracking is defined as the formation of a crack due to the combined effects of corrosion and high tensile stress. High-strength steel, such as bridge cable wire, is subject to stress corrosion cracking in an environment of moisture and anions, such as chlorides, sulfates and nitrates. The presence of significant amounts of these anions was found in the corrosion product and/or water samples analyzed in the laboratory. These contaminants were most likely brought into the cable by rainwater penetrating cracks in the paint coating.

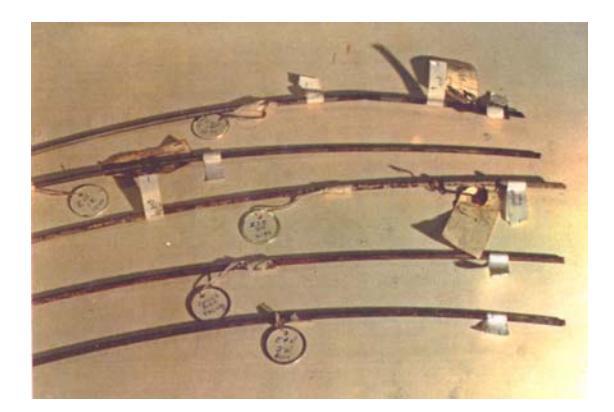
The initiation sites for cracks in the wire were found at locations where the zinc coating was depleted and ferrous corrosion was in progress, but were not found at deep pits or cavities in the wires. All crack initiation sites were located on the inside of the wire residual curvature (See

Figure 6). This is most likely related to the additional tensile stress caused by straightening the wire.

FIGURE 6 – SAMPLES OF REMOVED WIRE (NOTE RESIDUAL CURVATURE)

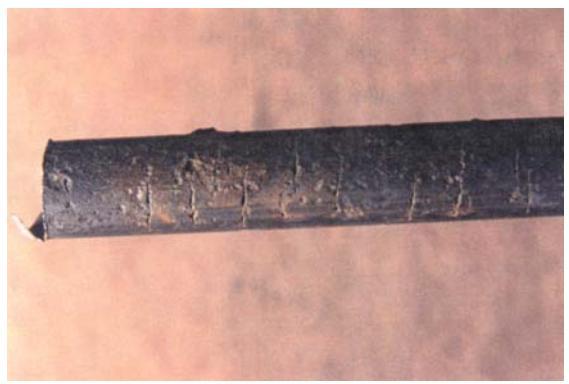
FIGURE 7 – NOTE CRACKS ON INSIDE FACE

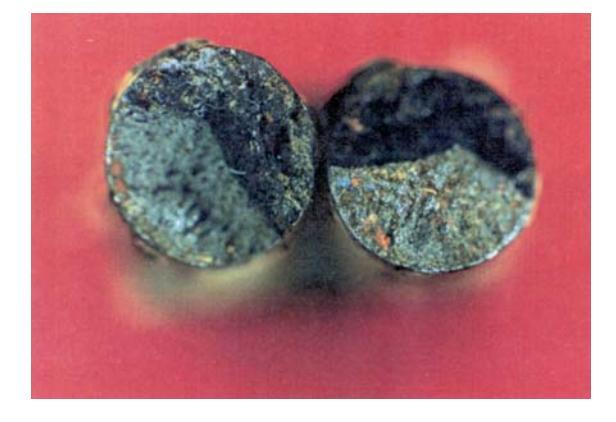
FIGURE 8 – TYPICAL FRACTURE SURFACE

The most probable cause for cracking in the wires is environmentally induced corrosion. A combination of stress corrosion, corrosion fatigue and hydrogen embrittlement mechanisms are involved. Field observations of the fracture surface shapes and the fractographic studies support stress corrosion and/or corrosion fatigue mechanisms for crack propagation. There has been no evidence found to indicate that the chemical composition of the wire and/or metallographic aberrations specifically initiated wire cracking.

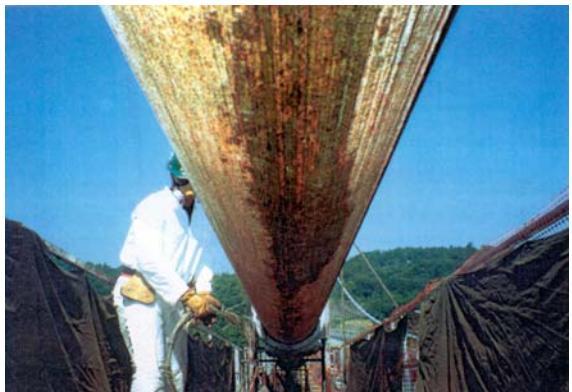
FIGURE 9 – VIEW OF CABLE BOTTOM, NOTE THE PRESENCE OF MOISTURE

Also as found under previous investigations, the greatest concentration of wire corrosion product was found on the bottom surface of the cable between the cable bands. This is the area where moisture has historically collected and remained in contact with the wires for longer periods of time.
