# GROUND MOTION AND TSUNAMI INDUCED DAMAGE OF BRIDGES DURING 2011 GREAT EAST JAPAN EARTHQUAKE

This paper presents damage of road and railway bridges during the Great East Japan earthquake and tsunami on March 11, 2011 based on a JSCE damage investigation. Ground motion induced damage and tsunami induced damage of both road and railways bridges are presented.

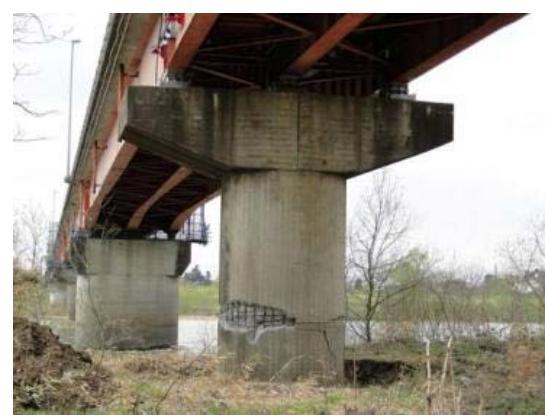
Photo 1 Shear failure of a column due to termination of longitudinal bars with insufficient development (Fuji Bridge) (courtesy of Dr. Hoshikuma, J., PWRI)

Ground motion induced damage of road bridges was generally less significant. However extensive damage occurred at the bridges which were designed according to the pre-1990 design codes (JRA 1990) and were not yet retrofitted in accordance with the post-1990 design codes. For example, Photo 1 shows shear failure of a reinforced concrete column resulted from insufficient development at cut-off of longitudinal bars. This mode of damage occurred extensively in the 1995 Kobe, Japan earthquake [Kawashima and Unjoh 1997]. Extensive investigation was directed to clarify the failure mechanism of such columns [for example, Kawashima, Unjoh and Hoshikuma 2005], including a project consisting of series of large scale shake table experiments using E-Defense [Kawashima et al 2009]. Over 30,000 columns were so far retrofitted since 1995 Kobe earthquake. Consequently, during this earthquake, damage due to this mechanism was not predominant in the bridges which were retrofitted, but damage occurred at the bridges which were not yet appropriately retrofitted.

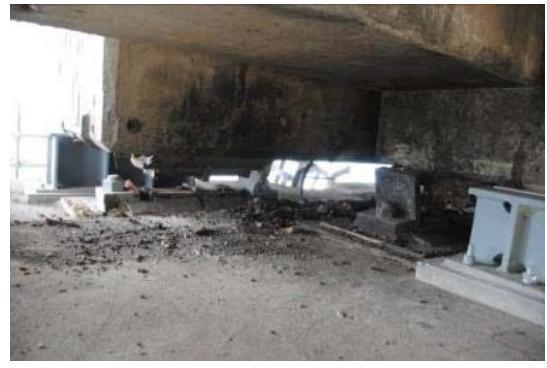
Photo 3 Damage of pin and roller bearings

suffer damage this time. However pin and roller bearings suffered damage again in the similar way as shown in Photo 3. It is obvious that pin and roller bearings are vulnerable to seismic action, because the stress builds up until failure by allowing virtually no relative displacement at pin bearings and relative displacement accommodated in roller bearings is insufficient to realistic relative displacement developed under a strong excitation.

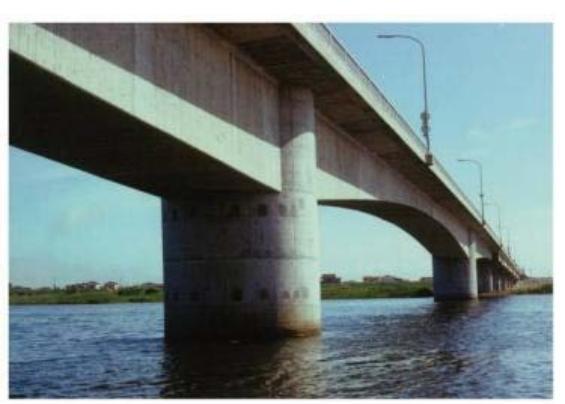
Photo 2 Yuriage Bridge

Yuriage Bridge as shown in Photo 2 suffered extensive damage at reinforced concrete hollow and solid columns, supports of prestressed concrete girders, and steel pin and roller bearings during 1978 Miyagi-ken-oki earthquake. Since the damaged

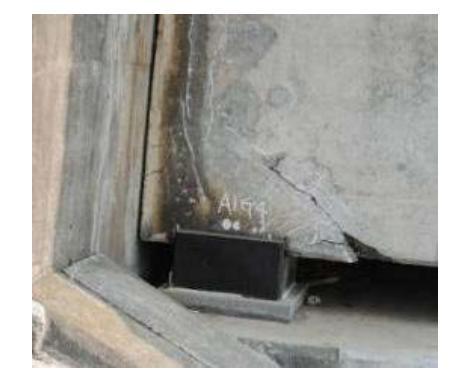
Photo 4 Damage of PC girders near the support

Furthermore, the same supports of prestressed concrete girder which suffered damage in 1978 Miyagi-ken-oki earthquake suffered again as shown in Photo 4. Taking account of likely concentration of seismic force at this region and the importance of anchorage of PC cables, more rigorous repair had have to be conducted after 1978 Miyagi-ken-oki earthquake.

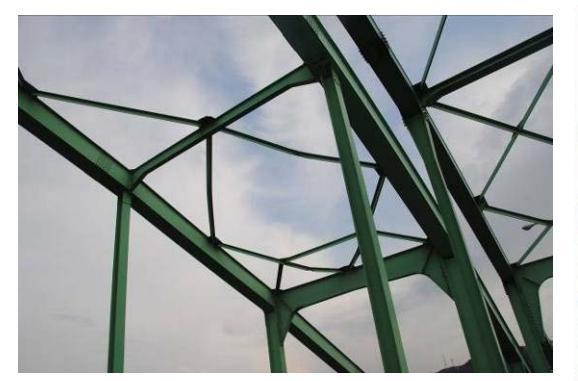
Photo 5 Buckled truss braces

Tennoh Bridge built in 1959 suffered extensive damage during 1978 Miyagi-ken-oki earthquake. This bridge suffered extensive damage again during this earthquake at the same members; truss braces and pin and roller bearings as shown in Photo 5.

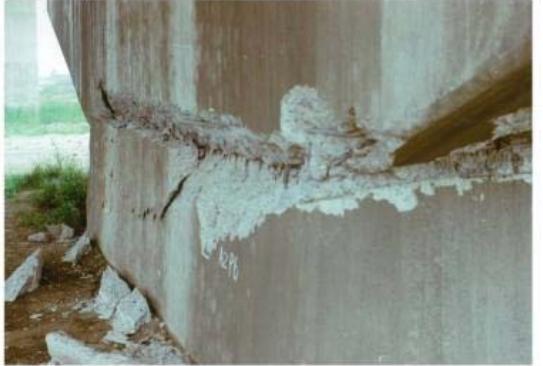
Photo 6 Damage of a pier during 1978 Miyagi-ken-oki earthquake (Sendai Bridge)

On the other hand, damage of bridges which were already retrofitted suffered virtually no damage. For example, Sendai Bridge which is a symbolic bridge in Sendai suffered extensive damage at columns and bearings as shown in Photo 6 during 1978 Miyagi-ken-oki earthquake. However this bridge suffered no damage during this earthquake, because columns were retrofitted as shown in Photo 7 and steel bearings were replaced with elastomeric bearings.

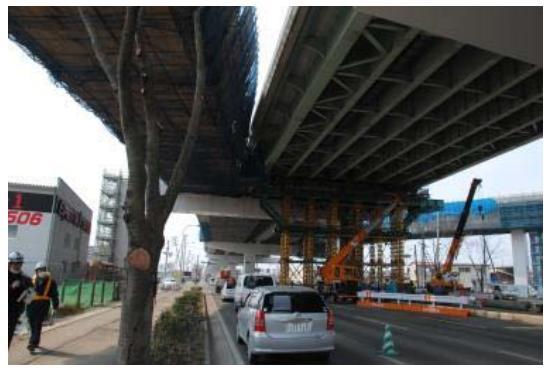
Photo 10 Piers where elastomeric bearings ruptured (Sendai-Tobu viaduct)

Elastomeric bearings including lead rubber bearings and high damping rubber bearings performed much better than vulnerable steel bearings. However it should be noticed that elastomeric bearings ruptured in several bridges. For example, at Sendai-Tobu viaduct as shown in Photo 10, several elastomeric bearings ruptured such that the deck offset in the transverse direction and settled aside the ruptured bearings as shown in Photo11. Rubber layers detached from steel plates as well as rupture inside rubber layers as shown in Photo 12. Since extensive number of elastomeric bearings including high damping rubber bearings and lead rubber bearings are used, the damage should be critically investigated. It is pointed out that one of the possible reasons for the damage is that the interaction between adjacent bridges with different natural periods was not properly considered in design of elastomeric bearings. Since an expansion joint constrained relative displacement between adjacent decks in the transverse direction, it is likely that larger displacement demand of an adjacent deck is imposed to the elastomeric bearings which were designed based on smaller displacement demand [Quan and Kawashima 2009].

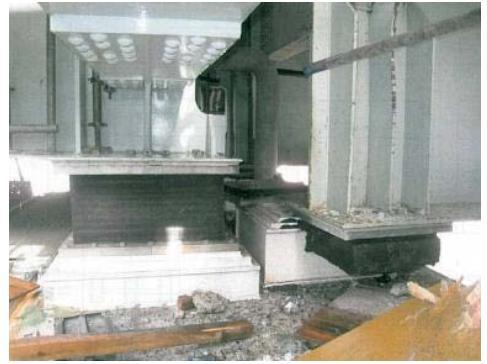
Photo 11 Transverse offset of a girder due to rupture of elastomeric bearings

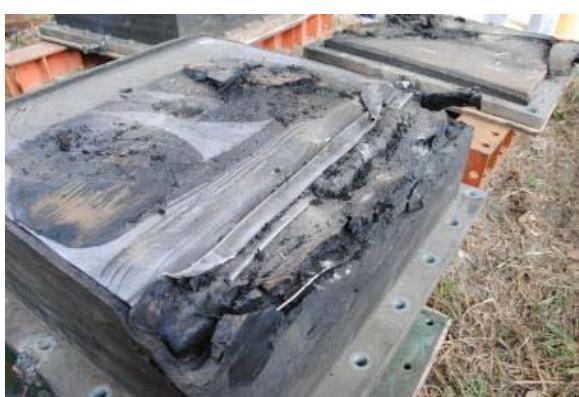
Photo 12 One of elastomeric bearings ruptured

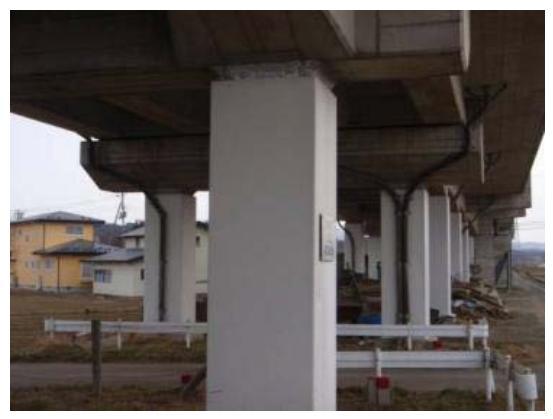
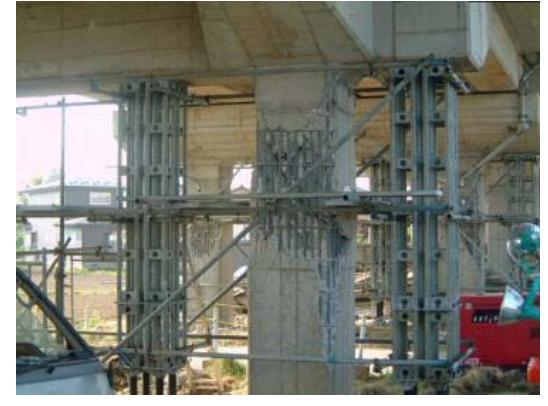
Photo 14 Shear failure of RC columns at Odaki viaducts after 2003 Sanriku-Minami earthquake

No. 3 Odaki viaducts in Iwate-ken failed in shear as shown in Photo 14 during 2003 Sanriku-Minami earthquake. The viaducts were retrofitted so that they had sufficient shear capacity under the first retrofit program after 2004 Niigata-ken Chuetsu earthquake. The retrofitted columns of the viaducts performed well with almost no damage during 2011 Great East Japan earthquake as shown in Photo 15.

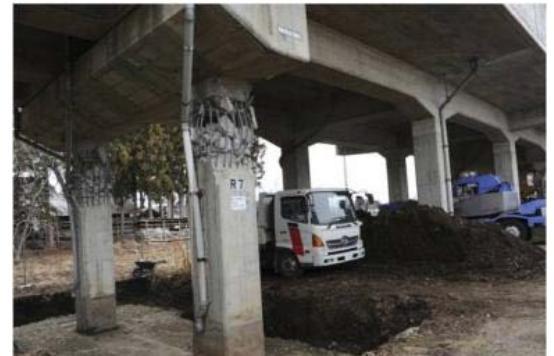
Photo 16 Damage of R7 column, No. 1 Nakasone viaduct during 2011 Great East Japan earthquake

During 2011 Great East Japan earthquake, side columns suffered extensive damage as shown in Photo 16. All columns lost even the bearing capacity for vertical load. It was fortunate enough not to totally collapse because the viaduct was supported by eight columns. Side columns in other viaducts also suffered extensive damage. Shear failure occurred at the upper part of columns as shown in Photo 17. The damage was so extensive that original shear cracks could not be identified because of crash and spill out of the core concrete.

In the JR seismic evaluation, it was evaluated that shear failure occurred if the parameter was smaller than 0.9. From the fact that the columns in No. 1 Nakasone viaducts failed in shear although was not as small as 0.9, it is recommended to revise the criteria of failure mode in the future seismic retrofit program.

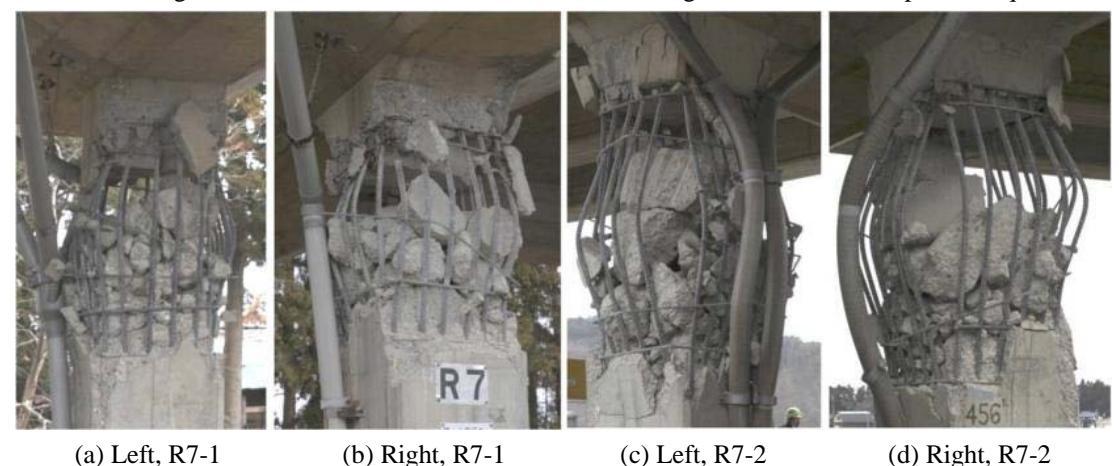
Photo 17 Close view of damage of R7-1 and R7-2 columns

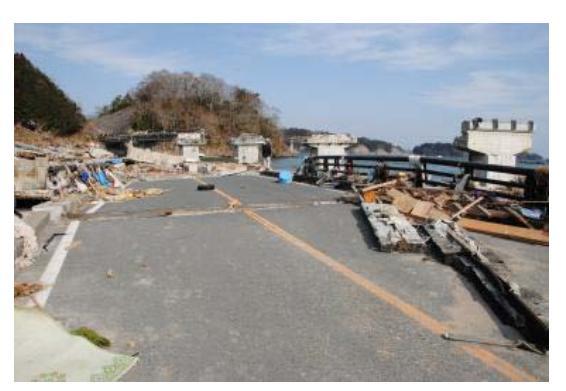
Photo 18 Damage of Utatsu Bridge

Utatsu Bridge at Minami-sanriku Town over Irimae Bay suffered extensive damage by tsunami as shown in Photo 18. It consisted of 3 types of superstructures with spans ranging from 14.4m to 40.7m, as shown in Fig. 6. The superstructures from S3 to S10 were completely washed away from their supports in the transverse direction due to tsunami while the superstructures S1, S2, S11 and S12 were not washed away. The

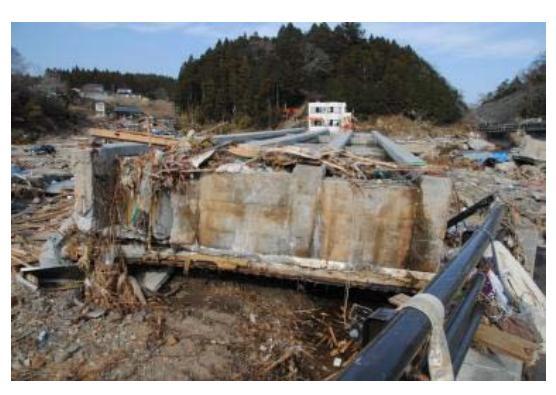
Photo 20 An overturned superstructure

not washed away. It is noted that S3, S4 and S4, and S5, S6 and S7 which flowed out together because they were tied by cable restrainers for preventing excessive superstructure response under a large seismic excitation as shown in Photo 19. S8, S9 and S10 overturned during being floated as shown in Photo 20.

Fig. 8 shows possible mechanism of damage of bridges due to tsunami. As mentioned earlier, overturning of foundation due to scouring did not occur in road bridges. It is likely that damage of decks in Photos 20 and 21 occurred due to mechanism shown in Fig. 8 (b) and (c), respectively.

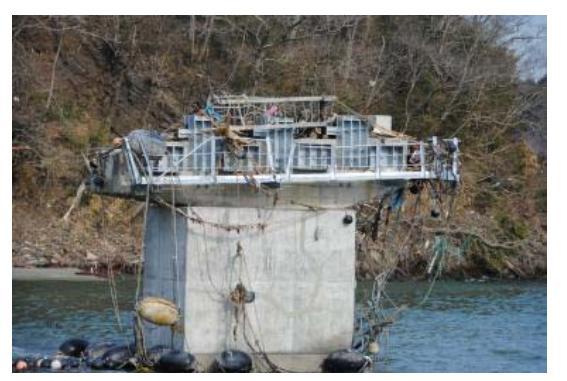
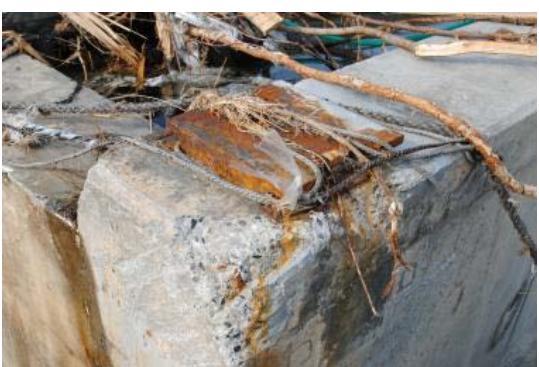
Photo 21 shows the top of a pier after superstructures were washed away. Two types of steel devices were set as an unseating prevention device in this column; one is the devices aiming of increasing seat length required by the recent code, and the other is the devices which were set for preventing excessive deck displacement in the longitudinal direction. It is important to know that none of those devises tilted or were detached from the pier which must have happened if the decks were simply washed away laterally. It is likely that the decks were uplifted by tsunami buoyancy force and then they were washed away. Steel plate bearings used in this bridge was very simple as shown in Photo 22 such that both uplift and lateral force capacities were limited.

Photo 21 Steel devices for extending seat length Photo 22 Failure of a RC side stopper, and four excessive longitudinal deck response due to deck response which were not damaged ground motions (tall device)

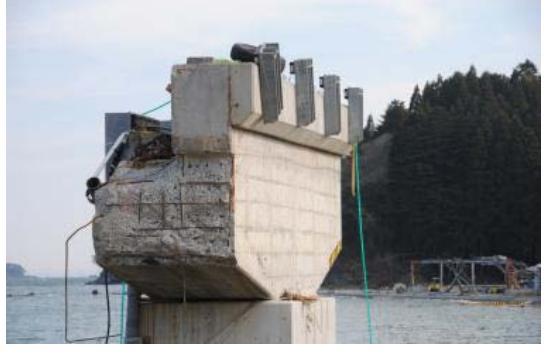
Photo 23 An upper steel bearing after damaged

This is also the case at a column shown in Photo 23 in which four stoppers did not tilt. But a RC side stopper at the land side collapsed probably due to a transverse

force which applied from the deck. It is likely that due to tsunami force the deck uplifted at the sea side first being supported only at the land side, which resulted in larger tsunami force. Thus the side stopper at the land side collapsed due to excessive concentration of tsunami force.
