INVESTIGATION INTO CAUSES OF RUPTURES OF ELASTOMERIC BEARINGS DUE TO THE GREAT EAST JAPAN EARTHQUAKE

Takeshi Hirose¹, Kaneyoshi Yamada²

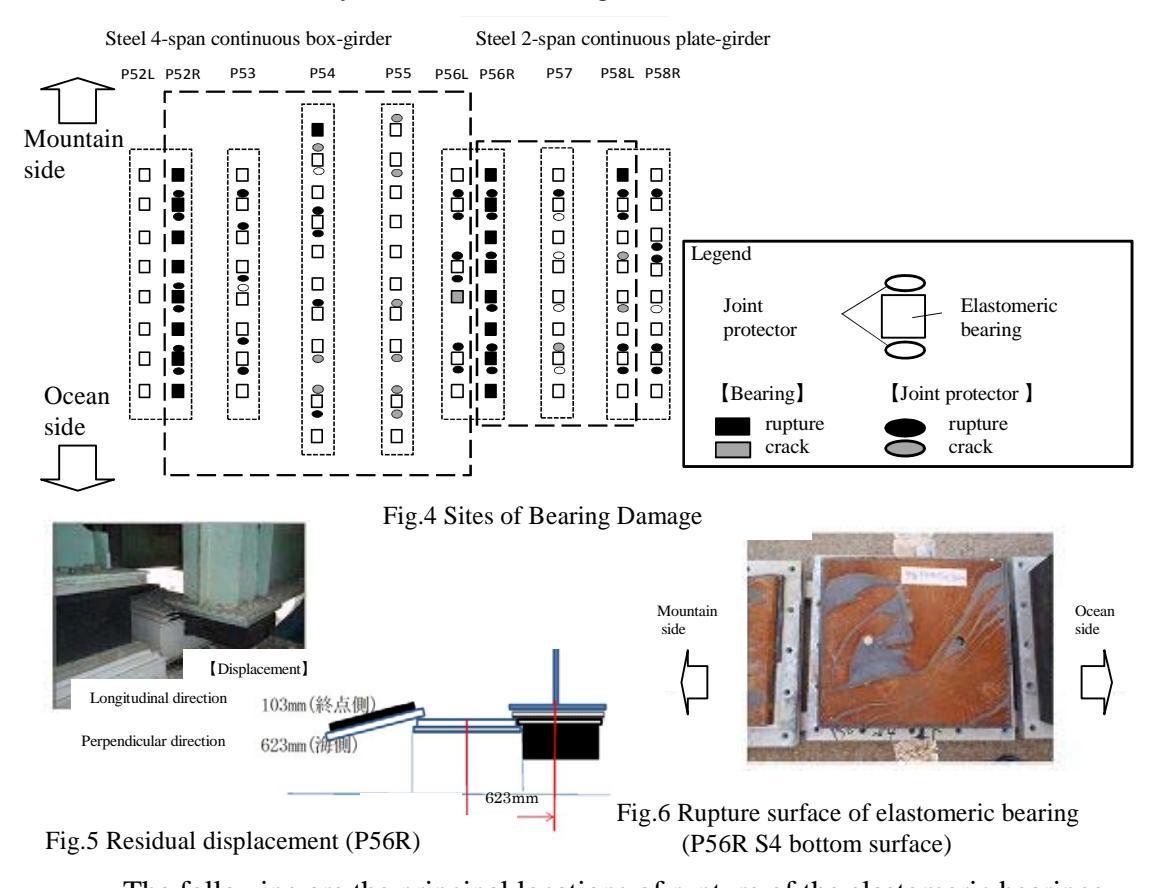
1) On the terminal side of pier P52, (right side at top of P52 in Fig.4, below referred to as "P52R") and on the terminal side of pier P56 (below referred to as "P56R"), all (8) bearings along the bearing support line ruptured.

2) On pier P54 and the terminal side of pier P58 (left side at top of P58 in Fig. 2, below referred to as, "P58L"), only the mountain side bearings ruptured.

There were numbers of joint protectors were installed on each bearing support line (considering the design seismic force of a Level 1 earthquake). Ruptures of the setting bolts of the joint protectors caused many joint protectors to fall out of place. On the other hand, at piers P54 and P55, there was only partial deformation or conditions remained sound.(Fig.4)

The residual displacement at the ruptured elastomeric bearings at P52R was from 9 to 22 mm longitudinally to the bridge axis on the terminal side, and from 144 to 156 mm perpendicularly to the bridge axis on the ocean side. At P56R, the displacement was large, ranging from 0 to 103 mm longitudinally to the bridge axis on the terminal side, and from 562 to 653 mm perpendicularly to the bridge axis on the ocean side. Many had fallen from

their shoe seats (vertically about 400 mm).(Fig.5)

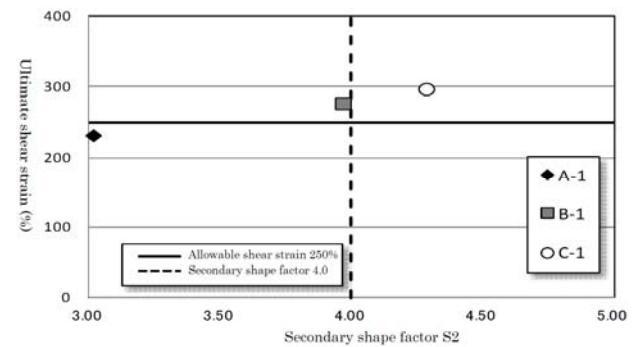
Fig 8. Ultimate strain and the secondary shape factor S2

Figure 8 shows the relationship between the secondary shape factor and ultimate shear strain. The smaller the secondary

shape factor the lower the ultimate shear strain. In accord with the 1996 Standards, the secondary shape factor should be 4 or more.

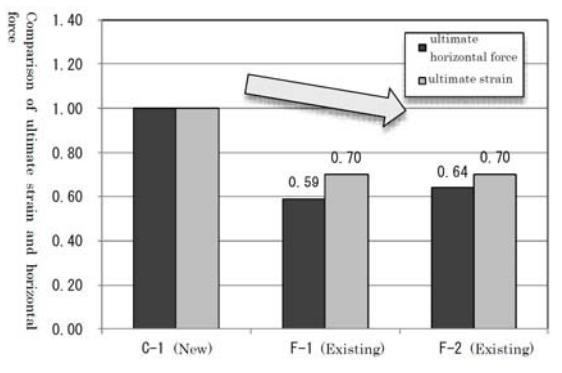
Fig 9. Comparison of Ultimate Shear Strain and Horizontal Force (Same shape)

Figure 9 shows a comparison of the newly made bearings (C1) with existing bearings (F1, F2). These were elastomeric bearings with identical shapes. Figure 10 shows the comparison of newly made bearings with existing bearings from the same company made of the same material and with identical shapes.

These figures reveal that the ultimate shear strain of the existing bearings was about 20 to 30% below that of the newly made bearings, and that the ultimate horizontal force was reduced by between 30% and 40%.

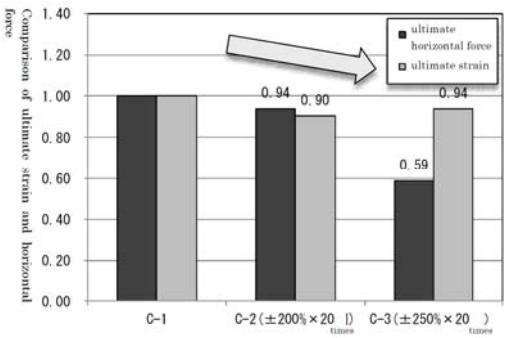
Fig 11. Impact of Large Deformation History

Specimen C3 partly ruptured at the fourth cycle, so as noted earlier, we used its

results as reference values, but a decline in performance was observed (Fig. 11). However, the number of specimens was few, so to clarify the impact of a large deformation history, more data must be sought in the future.

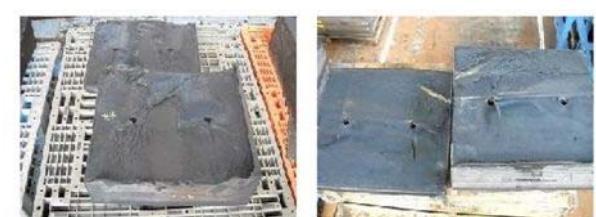
Fig 12. Rupture Surface of Specimens (Left: B1, Right: D1)

The rupture surfaces of the specimens were inside the rubber in 12 of the 13 specimens. However for only specimen C2, which was provided with a large deformation history, the rupture surface was on the steel plate and rubber boundary surface. Figure 12 shows a typical rupture surface.

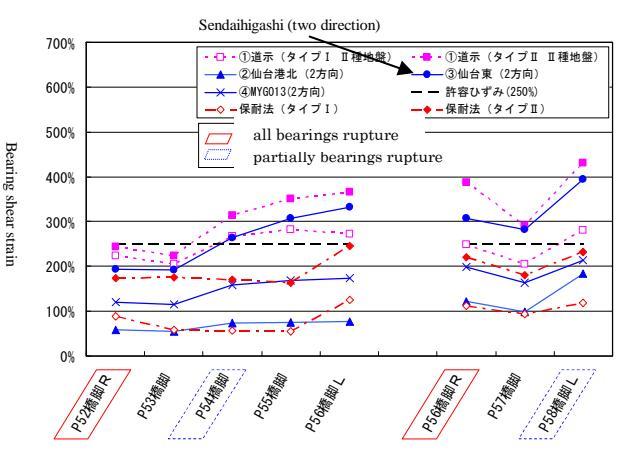
Fig.15 The result of dynamic analysis (perpendicular direction to the bridge axis)

We analyzed using a general model treating the superstructure as a single beam model. The entered earthquake motion ignores vertical earthquake motion, and the impact of accessories such as expansion devices are not modeled. The results of the analysis are shown in Figure 15.

The results of analysis using the general model differed from damage results, because the response of P52R which ruptured was acctually small, and that of P56L which did not rupture, was larger.

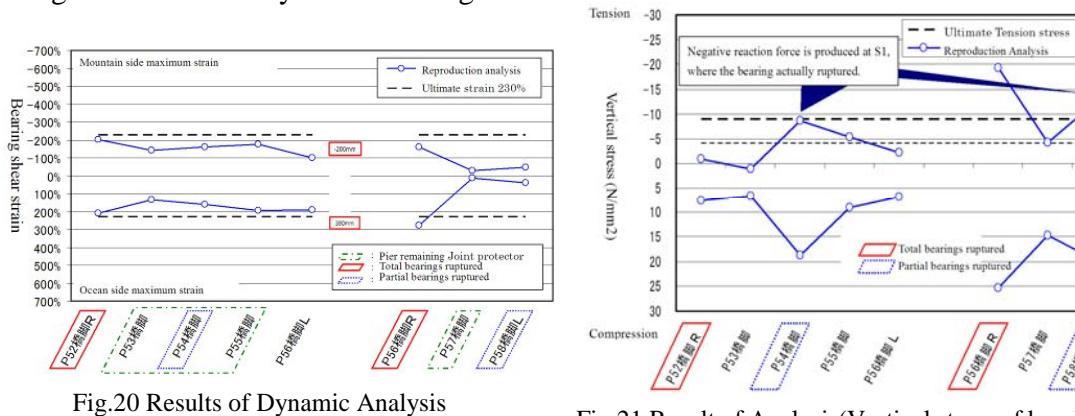
Fig.21 Result of Analysis(Vertical stress of bearings)

Figure 20 shows that the response during the earthquake after modeling to match the results of damage exceeded the ultimate shear strain at P56R, resulted in significant displacement at P52R. Figure 21 shows that at P54 and P58, the response led to a powerful negative reaction force. For these reasons, we decided that the damage results and analysis results are balanced and the modeling is appropriate.

Stress equivalent to the ultimate tensile stress shown in Figure 21 occurred on bearings installed closest to the mountain side at pier without a cantilever beam. Rupture of P58L bearing (S1: ruptured at only 1 location)

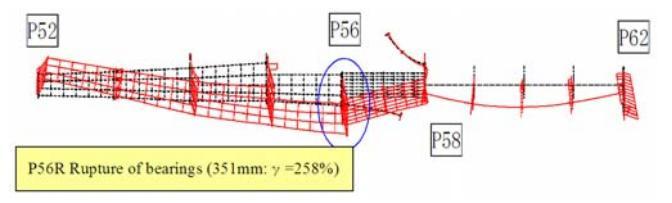
Fig.22 Response Deformation Distribution(T=90.2s)

2) 90.2 seconds after the earthquake Rupture of entire bearing at P56R The 1st series of the superstructure, which has heavy bridge girders, followed the 2nd series of the superstructure, which has light girders, through the finger

joints. This resulted in rupture of its bearings with small bearing thickness.

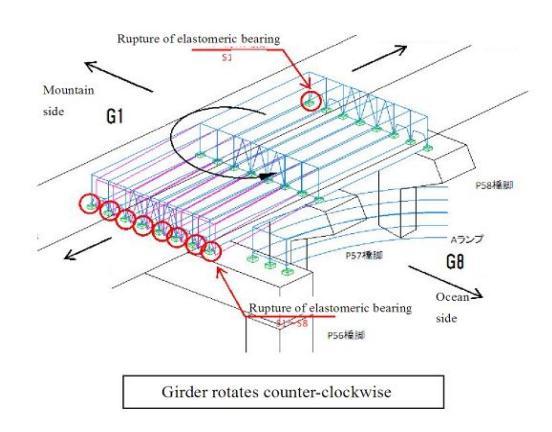
Fig.24 Response Deformation Distribution Diagram (after 90s)

Figure 24 shows that near P56R-S8 bearing on the 2nd series (P56 to P58),

moved horizontally 500 mm to the ocean side and 400 mm downward, and that uplift force affected P58L-S1, which is on a line diagonal to the continuous girders.

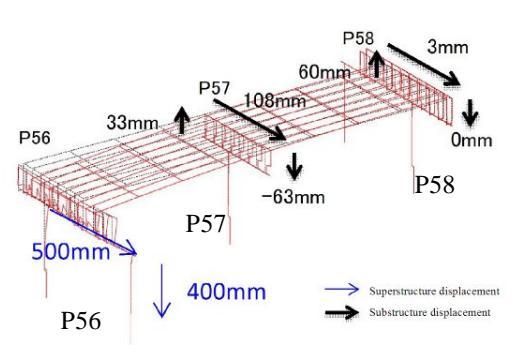
Fig.26 Residual displacement

Because the superstructure is wide and there are mixed pier forms (T-shaped piers, and on the ocean side, portal piers with cantilever beams), torsional rotation deformation mode was seen in the girders, causing stress equivalent to tensile rupture shown in Figure 21, in the bearings without cantilever beams closest to the mountain side. Static analysis performed treating the residual displacement of P56R, P57, and P58L as forced displacement to apply to the superstructure from P56 to P58, confirmed

that tensile stress of -50N/mm was produced in bearings at P58 closest to the mountain side, greatly increasing the stress equivalent to tensile rupture. (Fig. 26)
