# STUDY ON GROUT CONDITIONS OF EXISTING PRESTRESSED CONCRETE BRIDGES

Yoshinori WADA<sup>1</sup>, Yoshitomi KIMURA<sup>1</sup>, Taku HANAI<sup>2</sup>

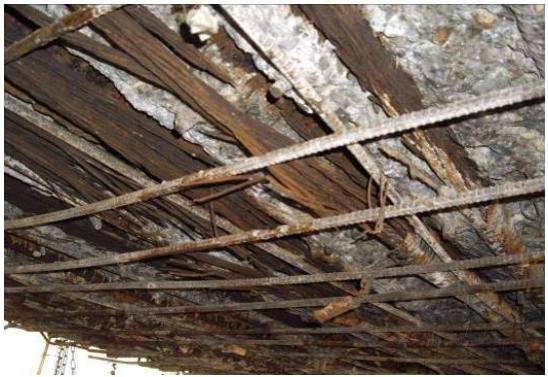
Figure 1 shows corroded prestressing cables in a precast segment box girder bridge. An thorough investigation found that grout was not properly filled in the most of ducts. Many cables were already broken.

Figure 1. Corroded and Broken Cables in Precast Segment Box Girder Bridge

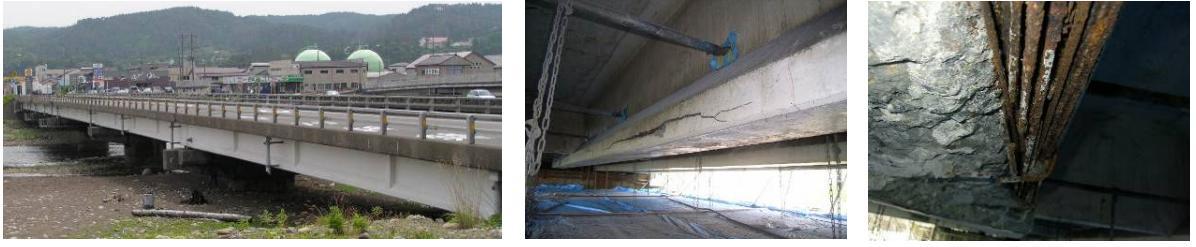
a) C Bridge

b)Pre chipping c)Post chip (A1-P1:Girder-3) the left, Ca

c)Post chipping (Same as on the left, Cable 3 was broken)

In 103 cross sections of ducts at A1-P1, 102 sections were first separated into Level 1 or 2 (Figure 13 and 14). Nevertheless, 1 section was not grouted and classified into Level 4. These grout void ducts were found near girder 3 where Cable 3 was broken as shown in Figure 10c).

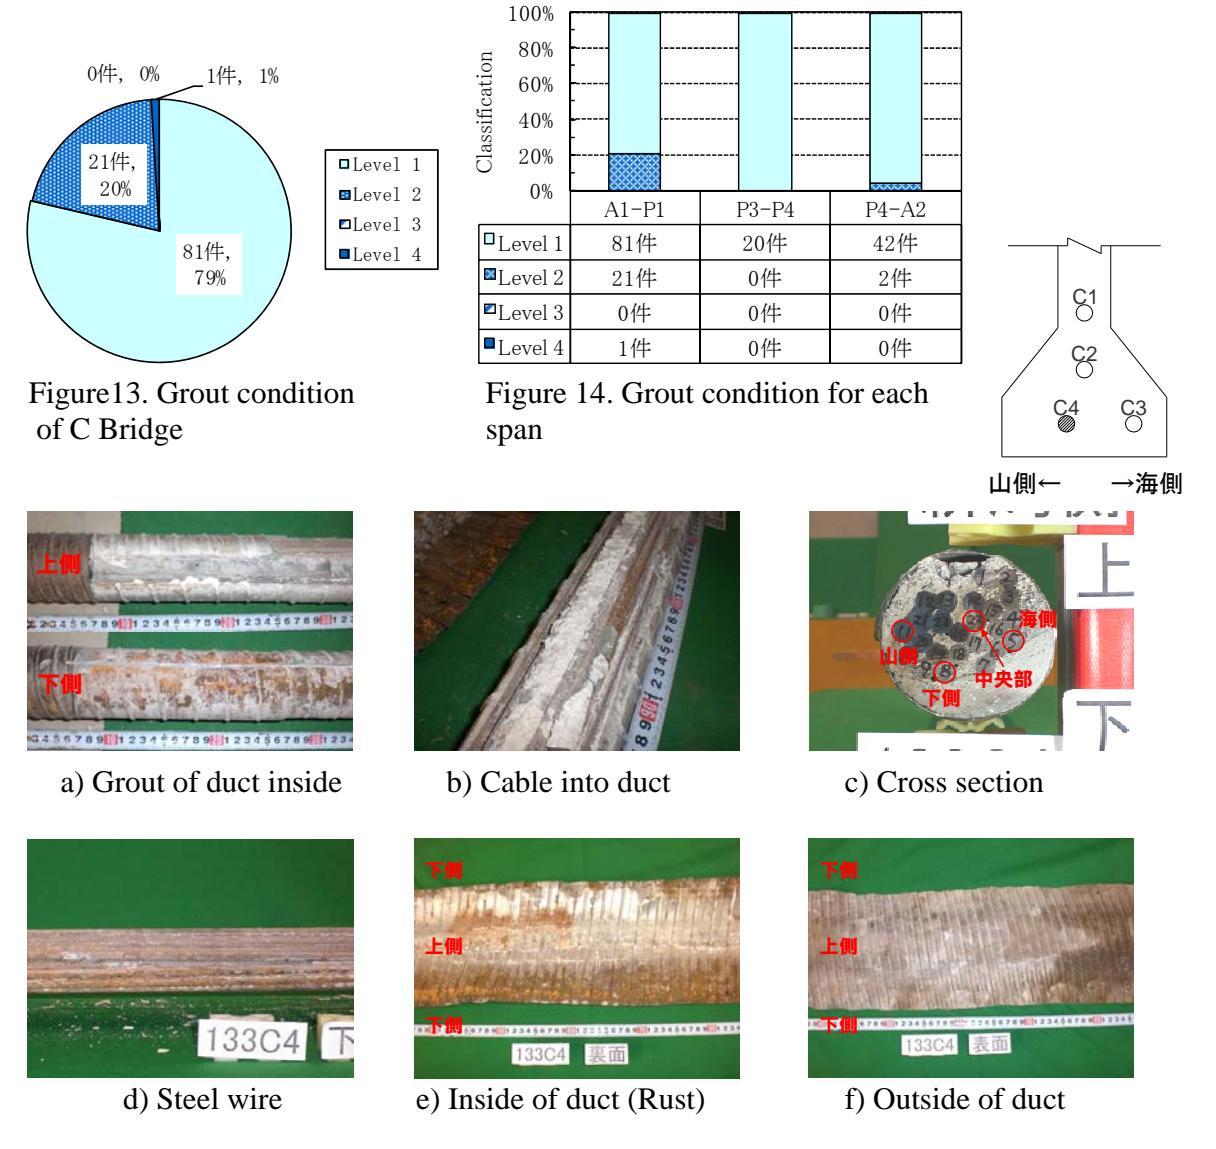
Figure 15. Anatomical investigation of Cable 4, Girder 3 at A1-P1

Figure 15 shows the anatomical investigation of Cable 4 extracted as a whole duct with cable and grout from girder 3. As for the duct, slight corrosion is seen in a part.

Although cables were covered with grout, the grout filled at upper sectional part in the duct is breakable and seem to show remains of air bubbles and bleeding. Nevertheless this Cable 4 was extracted near cable 3 which broke, only a little corrosion was confirmed on the cable. That is, it is considered to be able to suppress the corrosion of cable, if well but not completely grouted in the duct even if under severe environment conditions such as chloride attack from the sea.

In addition, the reason why inside of ducts corroded more than outside is considered to be attributed to remaining water which was used for flushing inside of ducts before grouting, from the fact that a few wires at bottom section of duct were corroded.

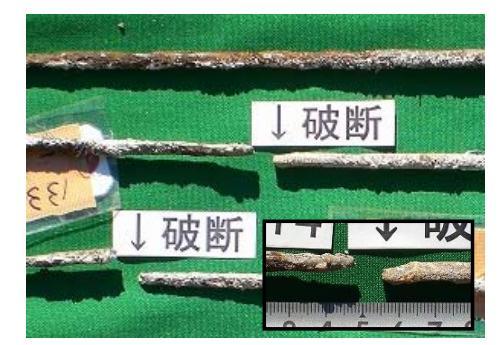
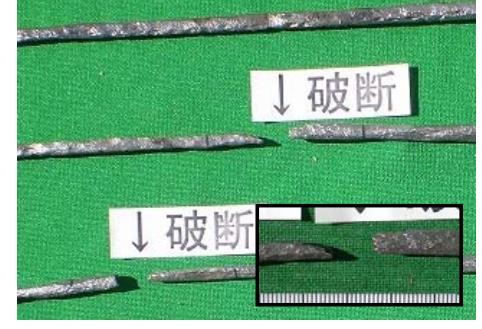
(b) After removal of rust

(a) Before removal of rust

Here too cable corrosion survey was conducted. Figure 16 shows conditions of cable decreased by corrosion. Here, we defined "Decrease ratio of cable weight" as the ratio of decreased weight to nominal weight of wire.

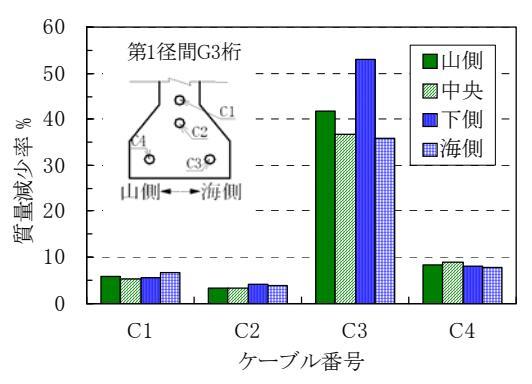
Figure 17 shows "Decrease ratio of cable weight" at cable 1 to 4, girder 3, A1-P1. The ratio of cable 3 in which 13 wires were broken is higher than 35%, however others come to less than 10% and no broken wires.

Figure 17. Decrease ratio of cable weight at cable 1 to 4, girder 3, A1-P1

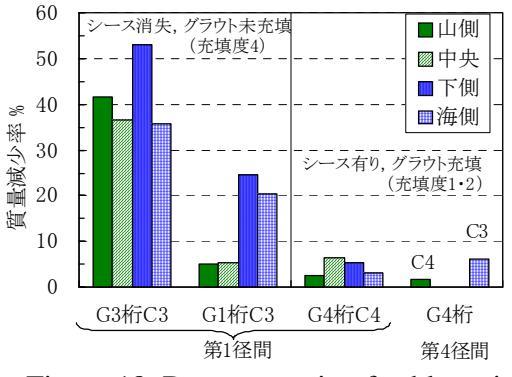
Figure 18 shows "Decrease ratio of cable weight" focused on same cover thickness with cable 3, girder 3, A1-P1. The ratio exceeded 10% only cable 3, girder 3 (the most remarkable damage) and cable 3, girder 1 (the second most noted damage), at which

Figure 18. Decrease ratio of cable weight focused on same cover thickness with cable 3, girder 3, A1-P1

remarkable crack like Figure 10b) was observed. Also the ratios of wires at minor defects like longitudinal cracks of lower flanges shown in Figure 19 were 4% on average.

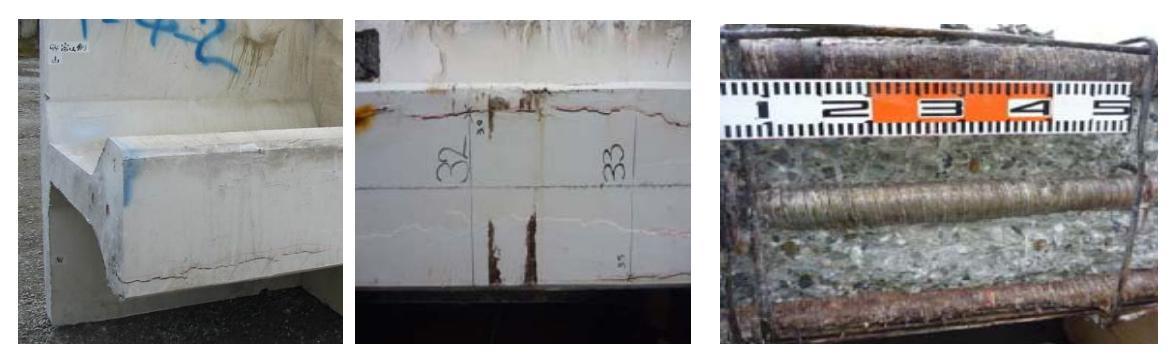
Figure 19. Deterioration of Concrete surface

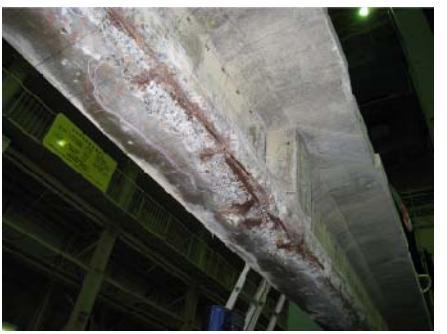
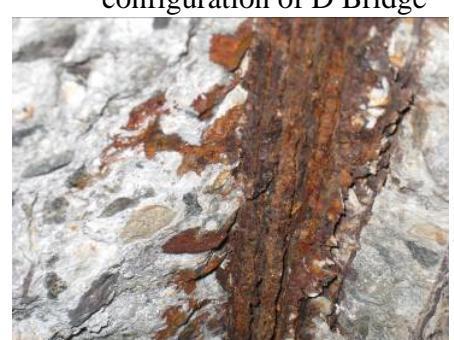
By investigation, some deterioration such as crack, delamination, and spalling appeared over the whole of the girder and 2 in the total of 8 PC steel wires were broken (Figure 22).

Figure 22. Deterioration of lower flange at D Bridge

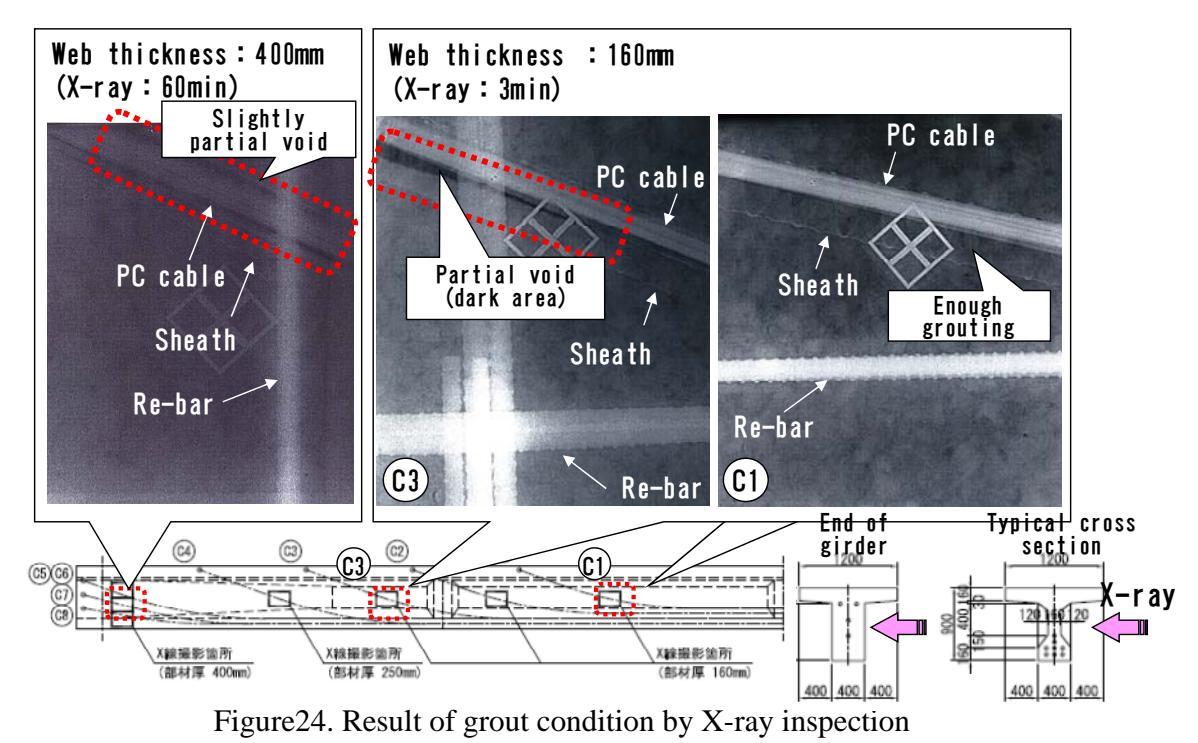
Figure 23 and 24 show X-ray inspection system and results of grout condition by the system, respectively. Although partial voids due to lack of "Consistency flow during grouting as the result of duct inclination" was confirmed, grouting is relatively well done throughout. While on the one hand, we were able to get a clear image by almost 3 minutes of X-ray irradiation if web thickness was around 160mm. On the other hand, it was not possible to get a desired clarity of images at the end of girders where web thickness was 400mm even if X-ray irradiation took place for more than 60 minutes.

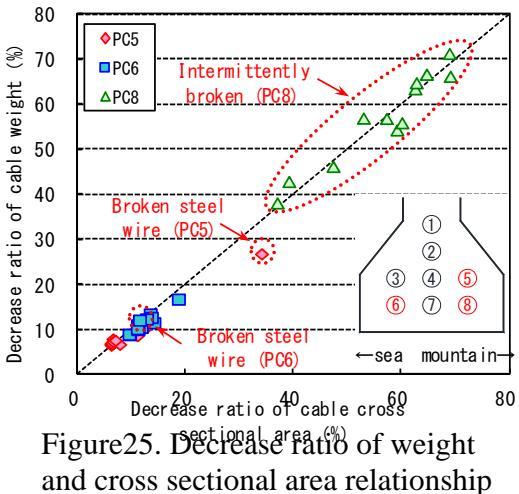
Figure 25 shows relation between decrease ratio of weight and that of cross sectional area for 12 steel wires sampled from the cable in which broken wires were found.

All the broken wires were found in the end of the girder, and limited to PC5, 8 (The mountain side) and PC6 (sea side exposure).

The decrease ratios of PC8 with intermittently broken wires were 40-70%. Except a broken steel wire in PC5, the decrease ratios of PC5 and 6 are approximately 10%.

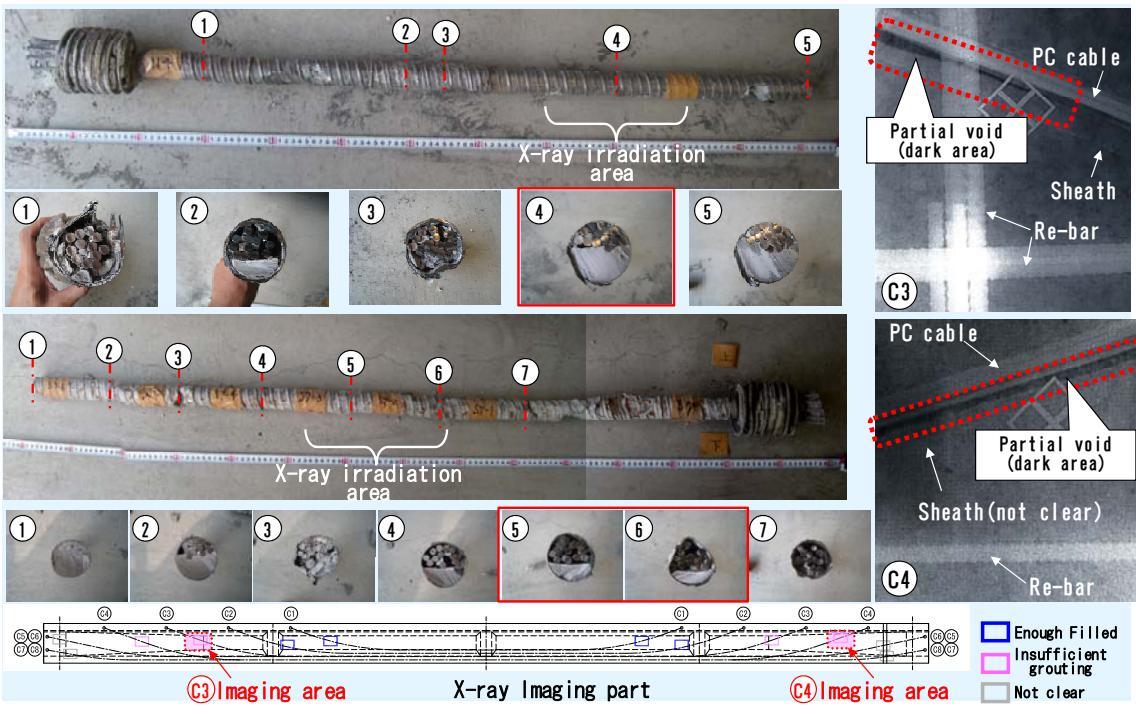
Figure 26 shows relationship between X-ray results and cut section. Compared with 3 sectional area (C3-4, C4-5, C4-6), the result of the X-ray gave good agreement with the actual grout conditions seen in cut sections. It is considered that the X-ray inspection were quite precise.

Void ducts were found only in webs where cables were bent upward to be fixed on the deck, and this is the similar tendency as in Case 1 (Figure 8).

Figure26. X-ray inspection and cut section relationship

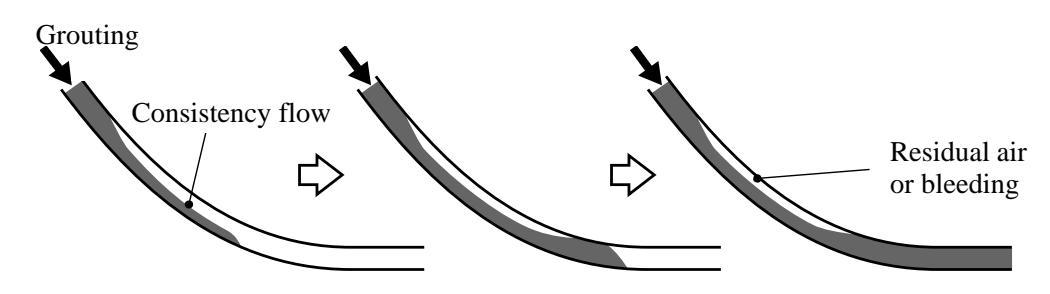
In this study of grout conditions, it was found that most ducts were grouted sufficiently excepting some cables that were placed in web and bent upward to be fixed on the deck. The cause is considered to be, "Consistency flow during grouting occurred by duct inclination" (Figure 27). It may allow residual air in the duct. And if water invades from construction joints or cracks into these voids, it may cause corrosion or breakage of wires.

Figure 27. Image of consistency flow during grouting

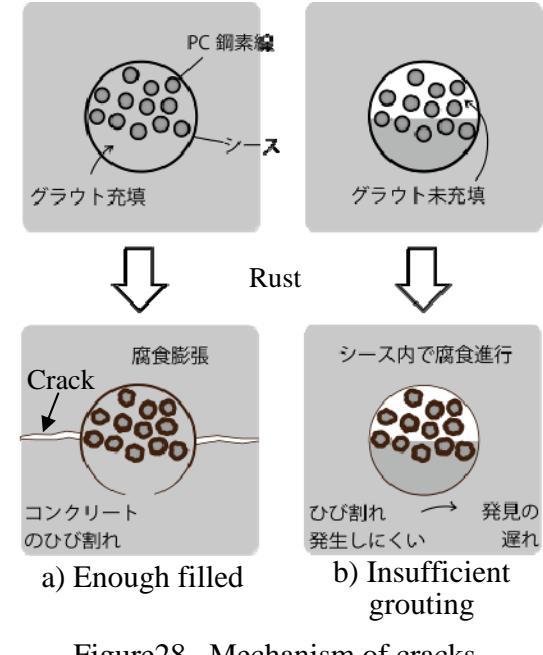
Moreover, while signs of deterioration, such as cracks or leakage of rusty water, may appear on the surface of the concrete in typical chloride-induced deterioration, it is difficult to find signs in this type of deterioration since corroded metal, such as ducts or prestressing cables, can freely expand inside of void ducts and may not damage surrounding concrete.

Figure 28 illustrates the mechanism of cracking due to corrosion in the duct. As the duct corrodes, the volume of corrosion products rises to around 3 times the original duct volume. If fully grouted in the duct (Figure 28a), this increase in volume generates radial expansive pressure on the surrounding concrete and cause cracking. On the other hand, the radial expansive pressure in an insufficiently grouted duct is lower than that in fully grouted ducts, because the voids are present in the ducts (Figure28b)).

Therefore, cracks are observed in a fully grouted duct earlier than in insufficiently grouted ducts. Moreover, it is noteworthy that re-bars adjacent to prestressing cables remained in nearly intact condition.
