# Analytical investigation of damaged tunnel linings by the action of excessive earth pressure

H.Mashimo

*Public Works Research Institute, Tsukuba, Japan*

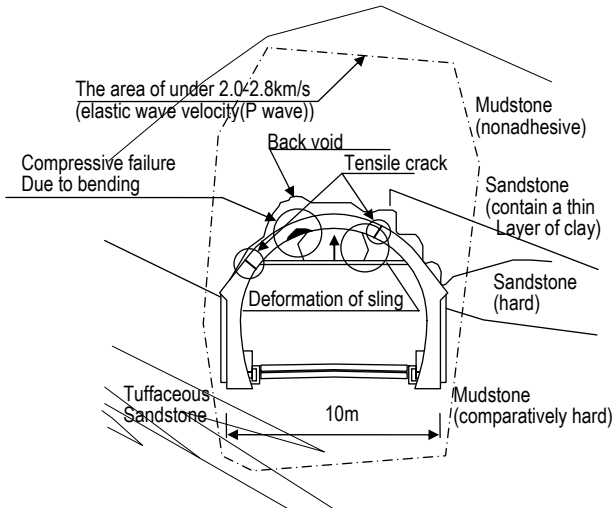
Figure 1. Deformation and geotechnical profile of Tunnel A.

Figure 1 shows the state of the deformation occurred in tunnel lining and geotechnical profile of Tunnel A. Tunnel A with a total length of 2,376m was constructed by steel and logging method about 30 years ago. Tunnel A has a horseshoe shape with a width of 9.7m and a height of 8.0m. Its support structure consists of concrete lining with a thickness of 60 cm.

In Tunnel A, passing-through tensile cracks at the shoulders and compressive failure at the crown due to bending moment were observed at the section with a distance of 800m from portal. The sling that suspended the ceiling boards showed buckling phenomena due to the upheaval of ceiling board. There was void between the ground and concrete lining around the crown. Figure 2 shows the detail of the compressive failure occurred at the crown. The ground at tunnel site and its vicinity, where the tunnel deformation occurred, appeared to be composed of mudstone with the uniaxial compressive strength of approximately 40N/mm<sup>2</sup>. The overburden height at the section where deformation occurred is 320m.

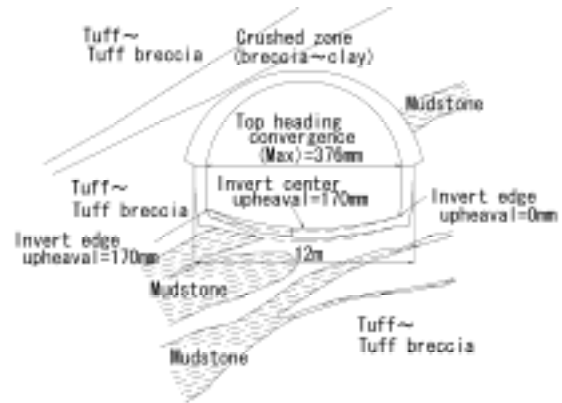
Figure 3. Deformation and geotechnical profile of Tunnel B.

Figure 3 shows the state of the deformation occurred in tunnel lining and geotechnical profile of tunnel B. Tunnel B with a total length of 1,013m was constructed by steel and logging method about 15 years ago. Tunnel B has a horseshoe shape with a width of 11.3m and a height of 8.9m, and its support structure consists of concrete lining with a thickness of 60cm.

In Tunnel B, an upheaval of road surface was observed at the middle of the tunnel after about 10 years had passed since the completion of construction of tunnel. Therefore, the state of invert concrete lining was investigated by taking off the road bed material. As a result, it was found that shear failure had occurred at the junction between the invert and sidewall foot and an upheaval with a height of 170mm had occurred at the invert center. In addition, the top heading arch convergence of 376mm was obtained by measurement on the inner tunnel space, though no slippage at the construction junction between the top heading arch and sidewall was observed. Figure 4 shows the detail of failure occurred at the junction between the invert and sidewall foot. The ground at tunnel site and its vicinity, where the tunnel deformation occurred, appeared to

be composed of mudstone and tuff with the uniaxial compressive strength of  $8.4\text{N/mm}^2$  and  $11.6\text{N/mm}^2$ , respectively. The overburden height at the section where deformation occurred is 120m.

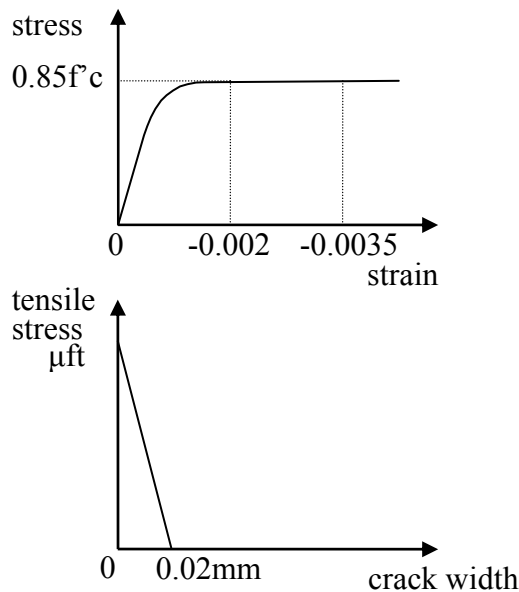
Figure 5. Stress-strain relation adopted in analysis.

Figure 5 shows the stress-strain relation in compression and tension adopted in the analysis. The curve in compression was modified as quadric curve until strain reached the ultimate compressive strain -  $3,500 \times 10^{-6}$ . No stiffness decrease was defined after that. The curve in tension was regulated by tensile-softening curve. The tensile strength  $f_t$  was calculated on the basis of compressive strength  $f_c$  as  $f_t = 0.23f_c^{2/3}$ . Allowable crack width and ratio of resid-

ual strength  $\mu$  in concrete was set as 0.02mm and 1.0, respectively. The interaction between tunnel lining and ground was modeled by a series of spring support outside the tunnel lining, which were assumed to resist only compression and had zero stiffness when subjected to tension. The coefficient  $k$  of subgrade reaction was obtained from the following Eq.(1):

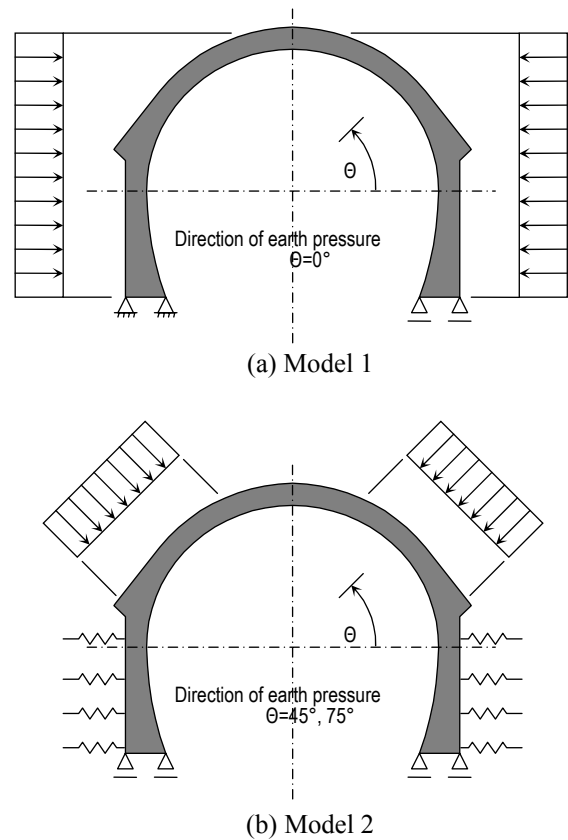
Figure 6. Outline of analysis model of Tunnel A.

Figure 6 shows the outline of analysis model of Tunnel A. In the calculation of Tunnel A, for the purpose of estimating the direction and magnitude of earth pressure acting on the concrete lining, two kinds of load condition and the arrangement of subgrade springs were adopted. In model 1, earth pressure acted on the concrete lining throughout the whole top heading arch and sidewall in the horizontal direction and there was no subgrade spring outside the concrete lining because void was found behind the crown. In model 2, earth pressure acted on the concrete lining throughout the top heading arch partially in the direction at an angle of 45 or 75 de-

gree from the horizontal and the sidewall was supported by subgrade springs. In the calculation, attention was given to tensile cracks at the shoulders and the compressive failure at the crown due to bending moment to evaluate the validity of analysis on the deformation of concrete lining.

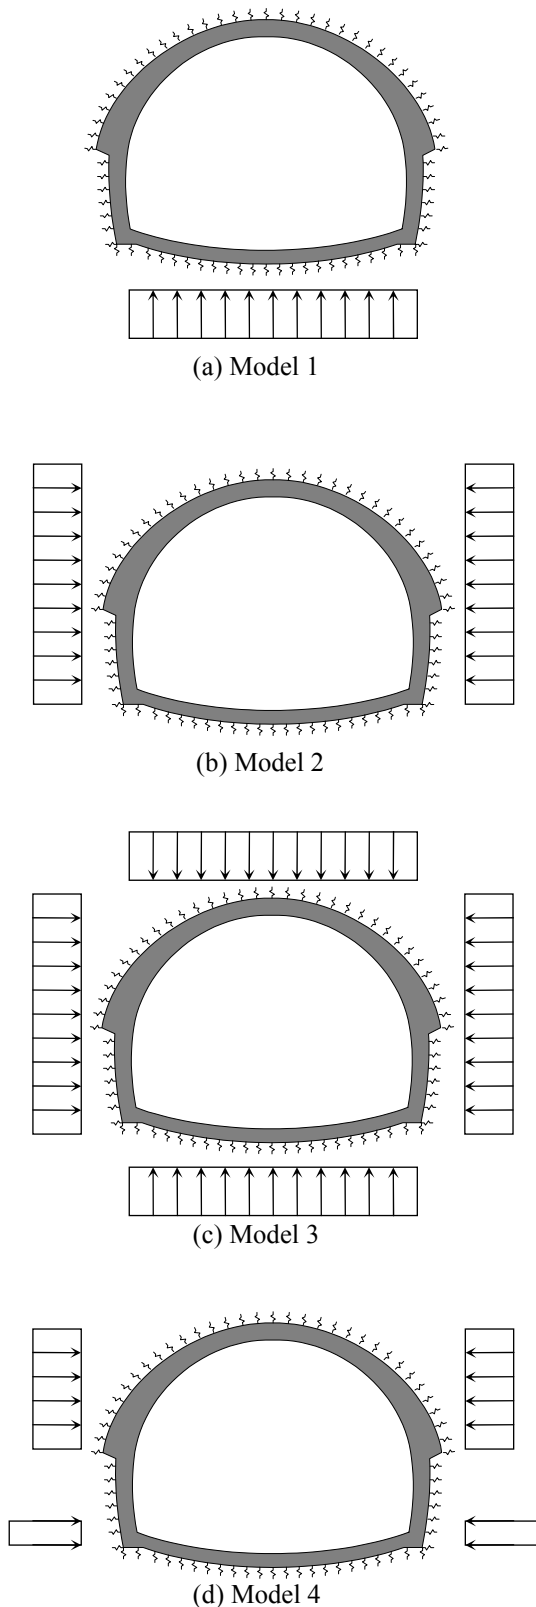
Figure 7. Outline of analysis model of Tunnel B.

Figure 7 shows the outline of analysis model of Tunnel B. In the calculation of Tunnel B, whole concrete lining with invert was supported by subgrade springs. Construction joint between the top heading arch and sidewall was modeled by interface elements, which consisted of spring element in the normal and tangential direction. Four kinds of load conditions were adopted to estimate the direction and magnitude of earth pressure acting on concrete lining. In model 1, earth pressure acted on the invert in the vertical direction. In model 2, earth pressure acted on the concrete lining throughout the top heading arch and sidewall in the horizontal direction. In model 3, earth pressure acted on the concrete lining throughout the top heading arch in both the vertical and horizontal direction, sidewall in the horizontal direction and invert in the vertical direction. In model 4, earth pressure acted on the concrete lining throughout the whole top heading arch in the horizontal direction and the sidewall foot partially in the horizontal direction. In this model, the magnitude of earth pressure acting on the sidewall was assumed to be far larger than that acting on the top heading arch. In the calculation of every model, attention was

given to the shear failure occurred at the joint between the invert and sidewall foot.

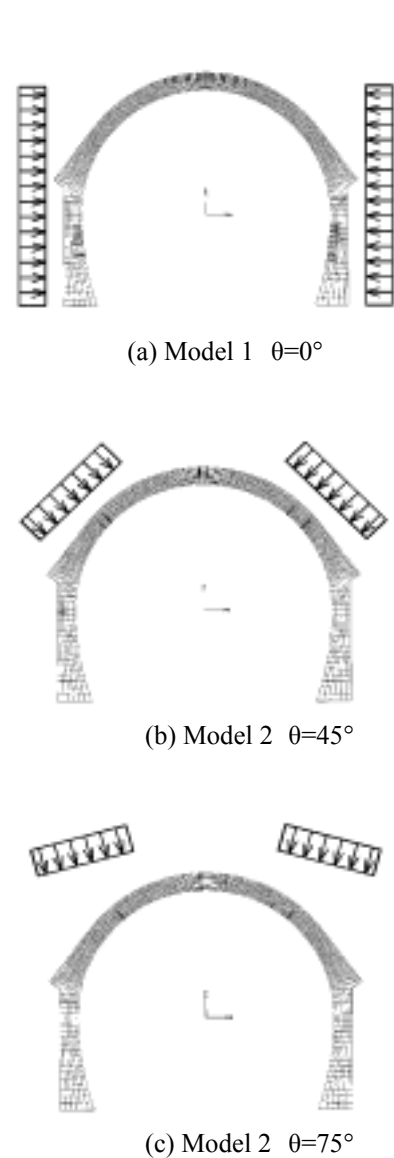
Figure 8. State of cracks obtained by analysis on Tunnel A.

Figure 8 shows the state of the cracks obtained by numerical analysis on Tunnel A. It can be seen that

in the analysis model 1, tensile cracks occurred at the inside of the sidewall and at the outside of the crown. The compressive strains occurred at the inside of the crown showed a value above  $3,000\mu$  and it was assumed that compressive failure occurred at the crown. However, tensile cracks at the shoulders did not occur. On the other hand, in model 2, tensile cracks occurred at the inside of the shoulders and at the outside of the crown in both cases of  $\theta=45$  and  $75^\circ$ . The compressive strain occurred at the inside of the crown also showed a value greater than the ultimate compressive strain of  $-3,500 \times 10^{-6}$  and it was assumed that compressive failure occurred at the crown in both cases. Therefore, it can be assumed that model 2 is more suitable than model 1 for simulating the state of deformation occurred in tunnel A. This means that deformation of Tunnel A was not induced by earth pressure acting on the concrete lining in the horizontal direction, but in the slanting direction.

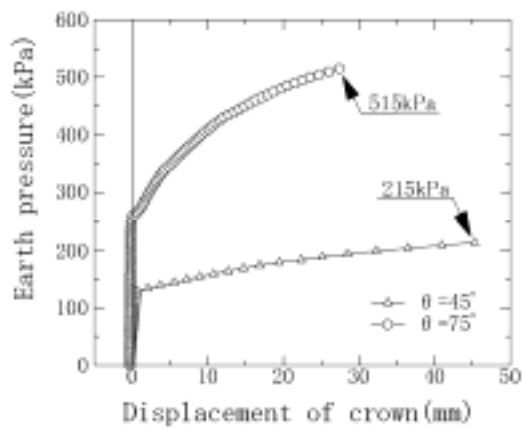
Figure 9. Earth pressure-displacement curve.

Figure 9 shows the relationship between tunnel displacement at crown and earth pressure acting on

concrete lining obtained numerical analysis using model 2 on Tunnel A. Tensile cracks occurred at the inside of the shoulders when the earth pressure reached approximately 130kPa and 250kPa in the case of  $\theta=45^\circ$  and  $75^\circ$ , respectively, and shortly afterward tensile cracks occurred at the outside of the crown. When the earth pressure reached 515 kPa and 215kPa in the case of  $\theta=45^\circ$  and  $75^\circ$ , respectively, the strain of the inside of the crown exceeded the ultimate compressive strain and it was assumed that compressive failure occurred at these earth pressure values. The overburden height corresponding to these earth pressure values were calculated at approximately 9m and 20m by using the unit weight of ground mass  $\gamma=25\text{kN/m}^3$ . Overburden height of 9m in the case of  $\theta=45^\circ$  is almost the same height of loosened area estimated from the elastic wave velocity distribution of the ground.

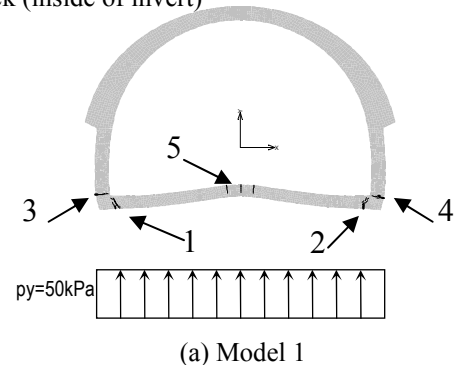
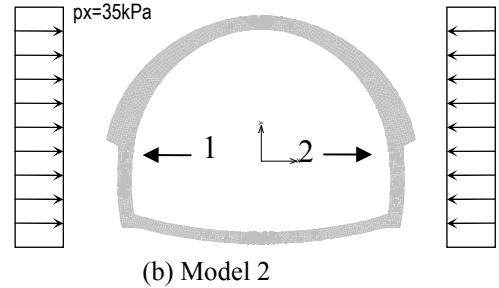
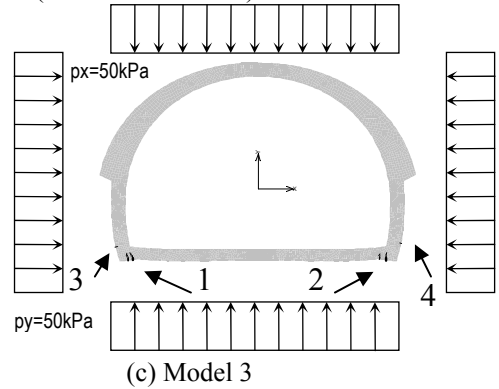
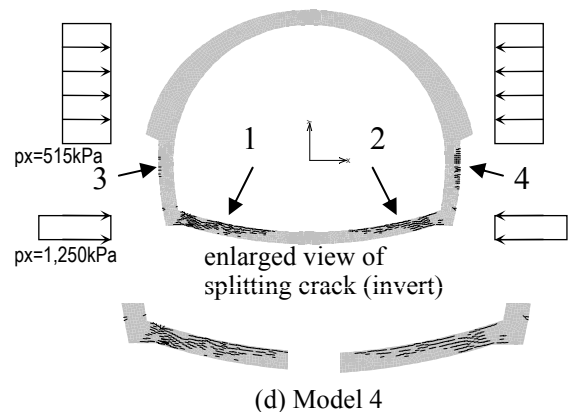
Figure 10. State of cracks obtained by analysis on Tunnel B.

Figure 10 shows the state of the cracks obtained by numerical analysis on Tunnel B. In model 1, tensile cracks occurred at the inside of the invert center and at the outside of the invert edge and sidewall foot when the earth pressure acting on the invert reached 50kPa. In model 2, slippage at the construction joint between the top heading arch and sidewall occurred when the earth pressure acting on the concrete lining in the horizontal direction reached 35kPa, though no tensile crack occurred. In model 3, tensile cracks occurred at the outside of the invert edge and sidewall foot when the earth pressure acting on the concrete lining in both the horizontal and vertical direction reached 50kPa. In model 4, tensile cracks occurred at the outside of the sidewall and splitting cracks occurred at the invert edge, when the earth pressure acting on the top heading arch and sidewall foot in the horizontal direction reached 515kPa and 12,500kPa, respectively. Therefore we can conclude that shear failure occurred at the junction between the invert and sidewall was induced by excessive earth pressure acting on the tunnel sidewall foot in addition to that on the top heading arch in the horizontal direction. However, the earth pressure of 12,500kPa acting on the sidewall foot is far

larger than the overburden earth pressure of 3,000kPa obtained by using the unit weight of ground mass  $\gamma=25\text{kN/m}^3$ .

- 1,2:Crack (outside of invert )
- 3,4.Crack (outside of sidewall)
- 5 :Crack (inside of invert)

- 1,2:Slippage (construction joint) #no crack

- 1,2:Crack(outside of invert )
- 3,4. Crack(outside of sidewall)

- 1,2:Splitting crack (invert )
- 3,4. Crack (outside of sidewall)
