# Impact on Society of a Landslide and Emergency Response taken to Mitigate its Impact

For future reference, we are presenting how Shizuoka Prefecture in Japan acted when a regional arterial road was damaged by a landslide in July 2007.

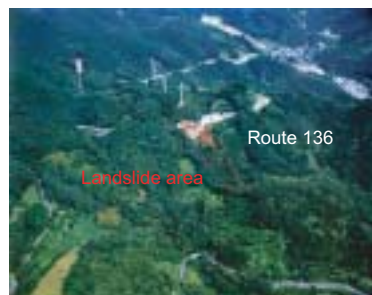
Fig.1 Landslide view from the sky (Photo by Shizuoka prefectural government; August 7, 2007)

- Location : Toi, Izu city, Shizuoka prefecture, Japan (Fig.1, Fig.2)
- Geology and Geomorphology
  - Neogene Tuff and Quaternary Andesite lava
  - Convex slope (angle 25° ~ 30°)
- Size of the landslide : Length: 160m, Width: 40m  
Estimated volume: 28,000m<sup>3</sup>
- Occurred on July 23, 2007
- Landslide features
  - The landslide consists of four sub blocks. (Fig.4)
  - Maximum displacement rate: 230mm/h (Fig.5)
  - 60m in length on July 25
  - 160m in length in mid-September (Fig.6)
  - The upper part of landslide was stabilized following countermeasure application, but the lower part is still moving slowly.
- A part of Route 136 sunk (Fig.3)  
Road closure lasted 19 days (July 23~ August 11)

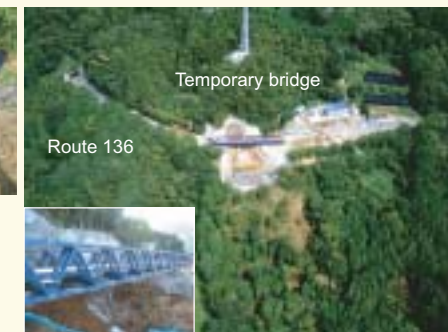
Fig.8 Temporary bridge (Photo by Shizuoka prefectural government; August 7, 2007)

18:00	Landslide displacement : 50mm/h	Slope protection works began (shotcrete, anchor, rockbolt)
Jul. 28		Landslide was still active	
Jul. 29			Temporary bridge started constructing
Jul. 30		Maximum displacement rate of 230mm/h	
Aug. 2		Landslide movement started slowly down	Shizuoka prefectural governor inspected the site
Aug. 6			Coring investigation and borehole inclinometer monitoring started
Aug. 9			First response meeting held
Aug. 11	12:00		One lane traffic opened after completing temporary bridge (Fig.8)
Aug. 23	8:00~10:45		R 136 temporarily closed due to rain
Sep. 6	7:50~16:45		R 136 temporarily closed due to rain
Mid Sept.		The upper part of landslide was confirmed to be stabilized

- Newly designed extensometers enabling to measure long distance was installed.(Fig.7)
- Temporary bridge was built very fast to lessen the economic damage to the tourist industry caused by Route 136 closure.

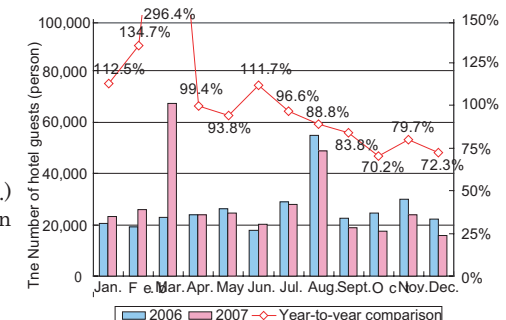
Fig.9 Monthly variation of the number of hotel guests (Data source; Toi hotel association)

- Decrease of the number of hotel guests (estimated from spa tax that visitors have to pay for public authority) (Fig.9)

After landslide: about 20% from August to September about 30% from October to December

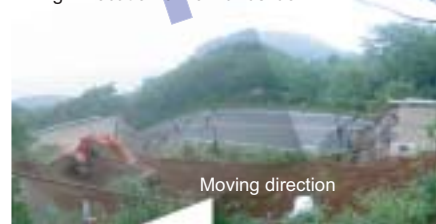
Fig.3 Collapse of Route136 (July 26, 2007)

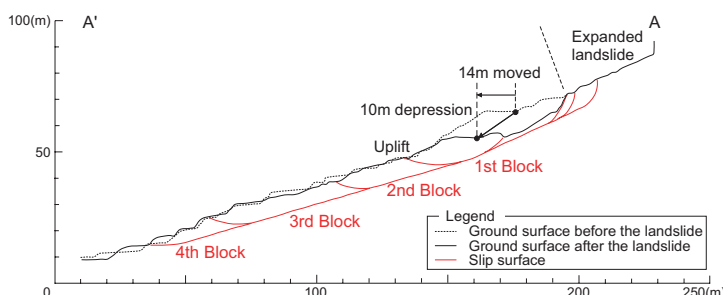
Fig.4 Cross section of Toi landslide

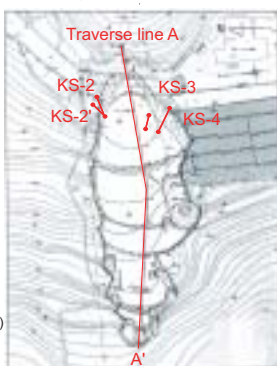
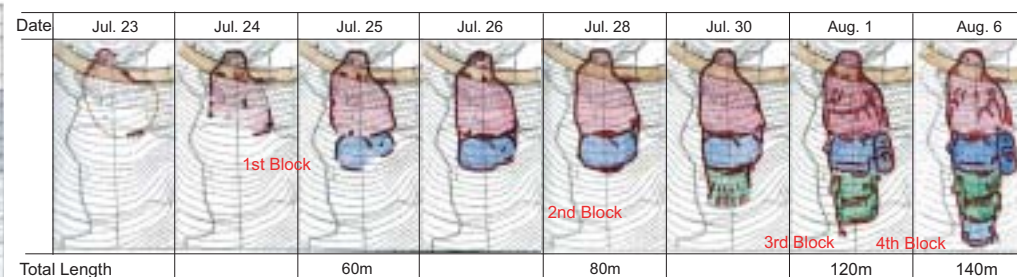
Fig.6 Sequence of landslide growth after July 23

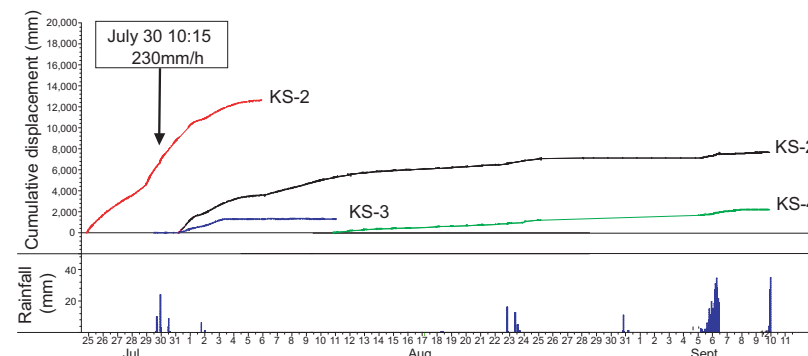
Fig.5 Landslide monitoring by four extensometers (See Fig.4 for the location)

15:30		Monitoring of crack expansion started
Jul. 24	17:30	Landslide displacement : 20mm/h	R136 entirely closed
	22:15		Newly designed extensometers were set (Fig.7)

6:00	Landslide displacement : 50mm/h	
Jul. 25	18:00	Landslide displacement : 100mm/h	Emergency countermeasure works started (cut trees, removed unstable earth from the head part of landslide)

6:00	The toe of the landslide grew downhill	
Jul. 26	6:00	Landslide displacement : 60mm/h	Experts visited the area to coordinate subsequent countermeasures
