Three-dimensional diagnosis of pavement damage using CT scanner

S. Taniguchi & I. Nishizaki

Public Works Research Institute, Tsukuba, Japan

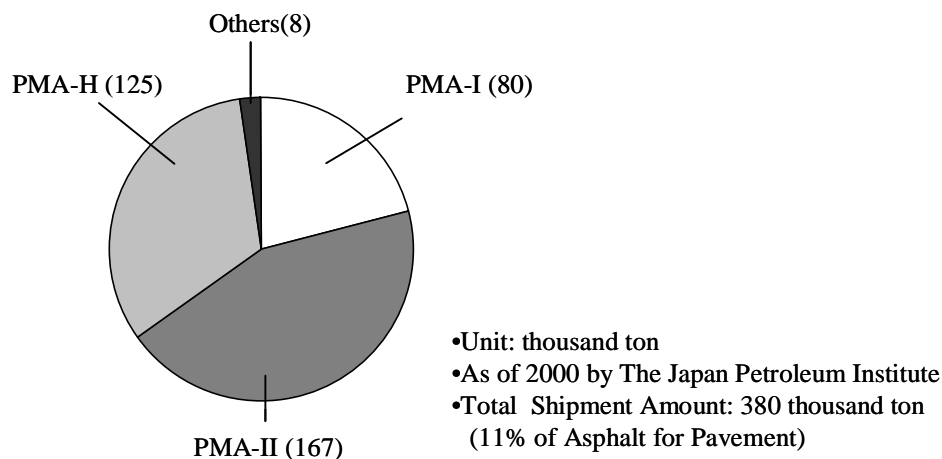
Figure 1. Shipment of modified asphalt in Japan

In Japan, there has been severe flow rutting caused by heavy vehicles and the adoption of the “lane principle” since around 1970. Consequently, polymer modified asphalt (PMA) to reduce wear (PMA-I) and flow rutting (PMA-II) has been developed and standardized in the Manual for Asphalt Pavement (Japan Road Association 1989). In addition, high viscosity PMA (PMA-H), which has higher adhesive strength between aggregate and asphalt than existing asphalt, has spread since the Tokyo Metropolitan Government first constructed porous asphalt concrete pavement (PACP), which drains rain water and reduces noise, in 1987. Figure 1 shows the shipment of PMA in Japan as of 2000.

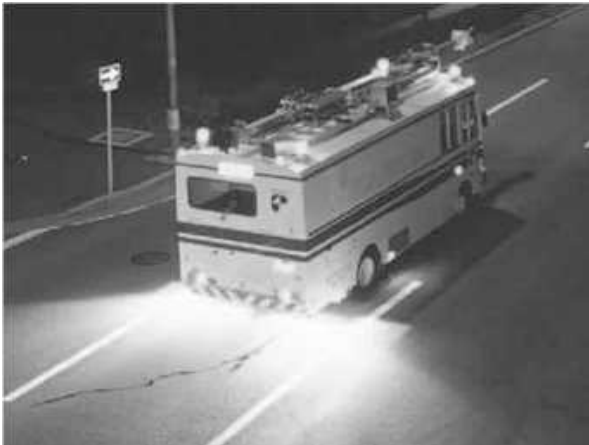
Figure 2 shows a road surface measuring vehicle. It uses non-contact measurement by CCD camera or laser beam, and easily and automatically measures cracks, longitudinal profile and transverse profile under high speed traffic condition. The vehicle can safely and quickly measure the condition of the road surface without traffic lane closures. The automated pavement surface measuring device is also part of the pavement management system (PMS). The length of national highway administered by the Ministry of Land, Infrastructure, Transportation and Tourism (MLIT) is about 22,000 km, of which it surveys about 7,300 km each year. Thus, these vehicles cover all national highways every 3 years. Candidate sections for repair and the construction method are mainly decided considering rutting depth.

Figure 2. Automated pavement surface measuring device

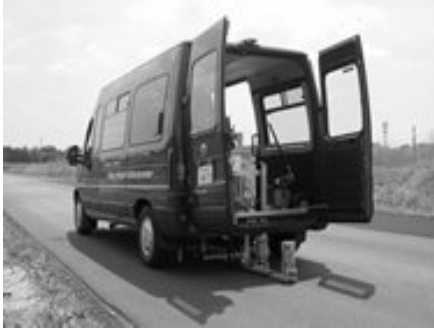
The falling weight deflectometer (FWD) has been developed and researched since 1960 to evaluate the structure and damage of pavement based on dynamic deflections (Bohn 1972). FWD was introduced in 1983 and 30 units for measuring road pavement are in use as of February 2008 in Japan. Figure 3 shows the FWD held by the Public Works Research Institute (PWRI).

Figure 3. FWD held by PWRI

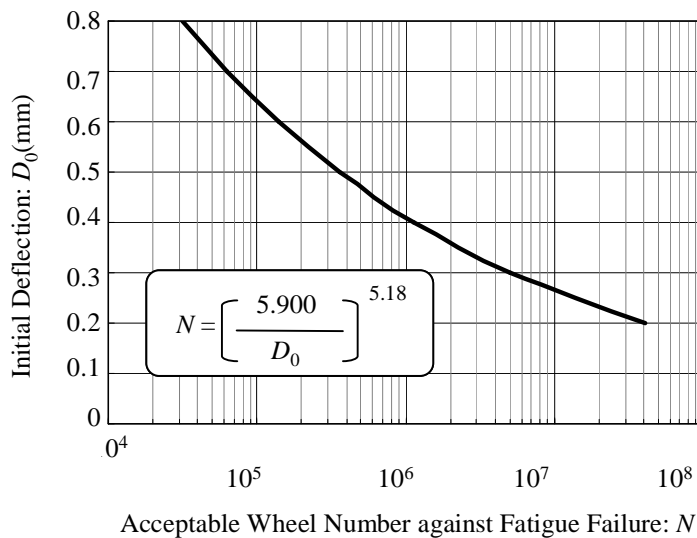
The estimation of elastic modulus from surface deflection measured by FWD has been widely studied and backcalculation programs have been developed to calculate the elastic modulus in each layer. FHWA published the Guideline for Review and Evaluation of Backcalculation Results (Stubstad 2006), and a back-calculation program called GAMES was developed in Japan (Maina 2004). Besides, “Evaluation Method for Pavement Performance” (Japan Road Association 2007) was published, and provides a graph for estimating acceptable number of wheel passes before fatigue failure of the pavement structure based on the initial deflection measured by FWD as shown in Figure 4.

Figure 4. Relationship between acceptable number of wheel passes before fatigue failure and initial deflection

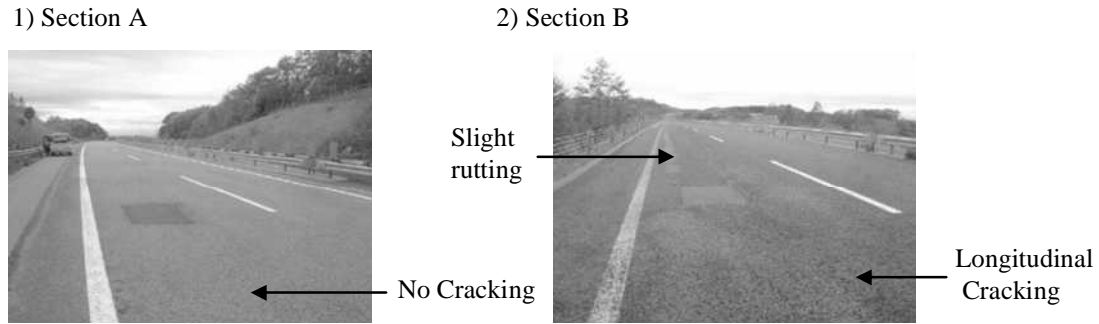
Specimens were collected in 2004 from two different sections on the same expressway (Section A and Section B), which were about 10 km apart and consisted of drainage pavement (surface course) with different asphalt properties (Taniguchi 2008). The sections are in a cold area in Japan, were put into service in 1999, and carry about 2,500 vehicles a day. Figure 5 shows the sections after five years of service. A visual examination shows almost no cracks or rutting on the surface of Section A, but a number of longitudinal cracks and slight rutting can be seen on Section B shown in Figure 5. In an ordinary pavement evaluation, the evaluation score was much higher for Section A than Section B.

Figure 5. Surface condition of section A and section B

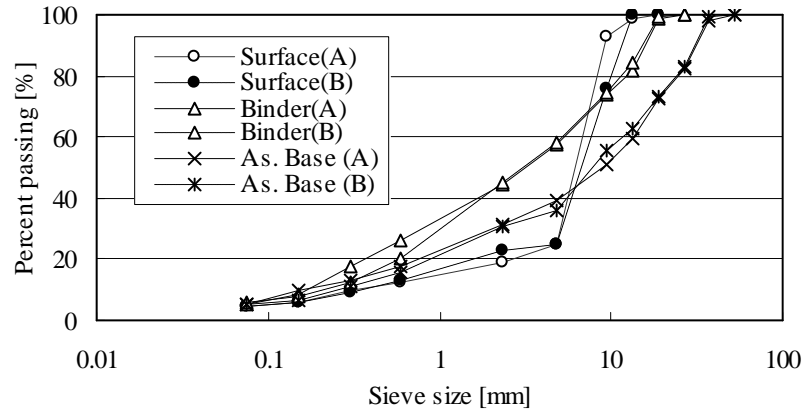
Figure 7. Grain size distribution

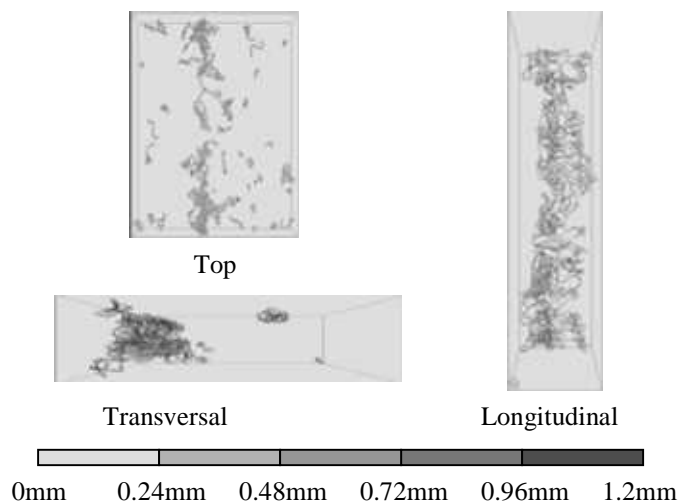
Figure 9 shows the 3-D cracking distribution from the transverse side in the surface course, binder course and asphalt treated base under OWP and BWP at both sections A and B. In addition, Figure 10 shows the 3-D cracking distribution from the top, longitudinal and transverse sides in only the upper binder course at section A since remarkable longitudinal cracking was observed.

Figure 10. 3-D cracking distribution side in upper binder course at section A

As shown in Figure 9, there was almost no cracking and rutting in the surface at section A. However, the three images in Figure 10 show that longitudinal cracking occurred in the upper binder course under OWP at section A. In addition, the longitudinal cracking observed at section B probably originated from the lower binder course since cracking is large in the lower binder course under BWP. Consequently, longitudinal cracking on asphalt concrete pavement occurs not only from the surface but also from within the asphalt concrete. Therefore, it is necessary to survey the inner part of the asphalt concrete layer, as it is impossible to specify the cause of longitudinal cracking from cutting and observing cores.

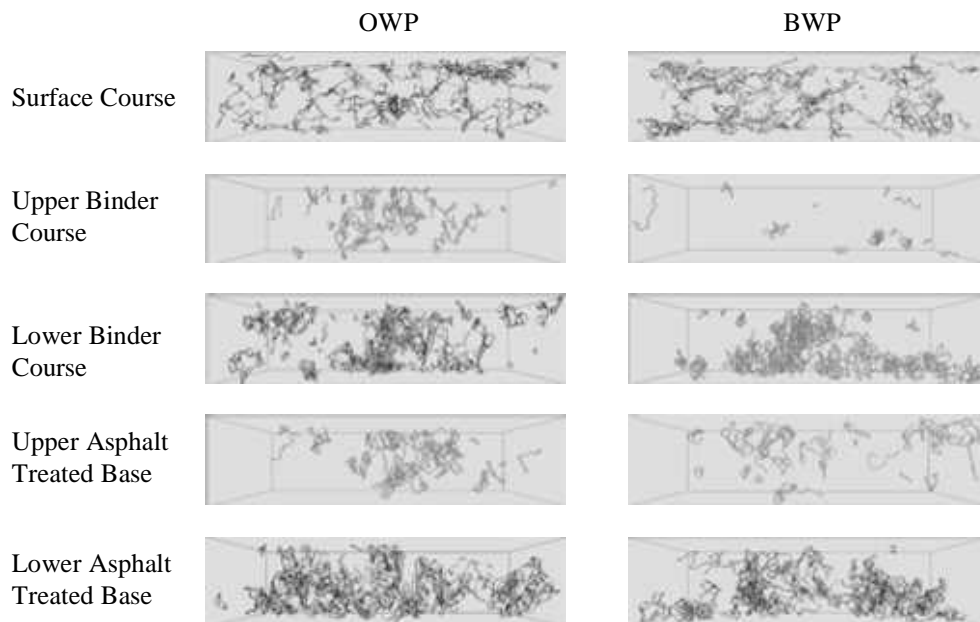
Analysis images usually can be shown in three dimensions and using a 7-color scale. The size of the crack is clearly visible since it is shaded blue for large cracks and red for small cracks. In the gray scale, the brightness is dark for large cracks and light for small cracks.

Figure 9. 3-D void distribution (Transverse side)

In addition, large cracking is revealed by 3-D images in the binder course and asphalt treated base under BWP at both sections. This indicates that longitudinal cracking occurs in not only the wheel path but also the non wheel path sections. This appears to be longitudinal cracking in the non wheel path at LTPP GPS-6 and SPS-5.
