Application of Remote Sensing and Information & Communication Technologies for Disaster Response

ABSTRACT

KEYWORDS: Communication, Damage Detection, High-resolution Satellite, LIDAR, Palmtop

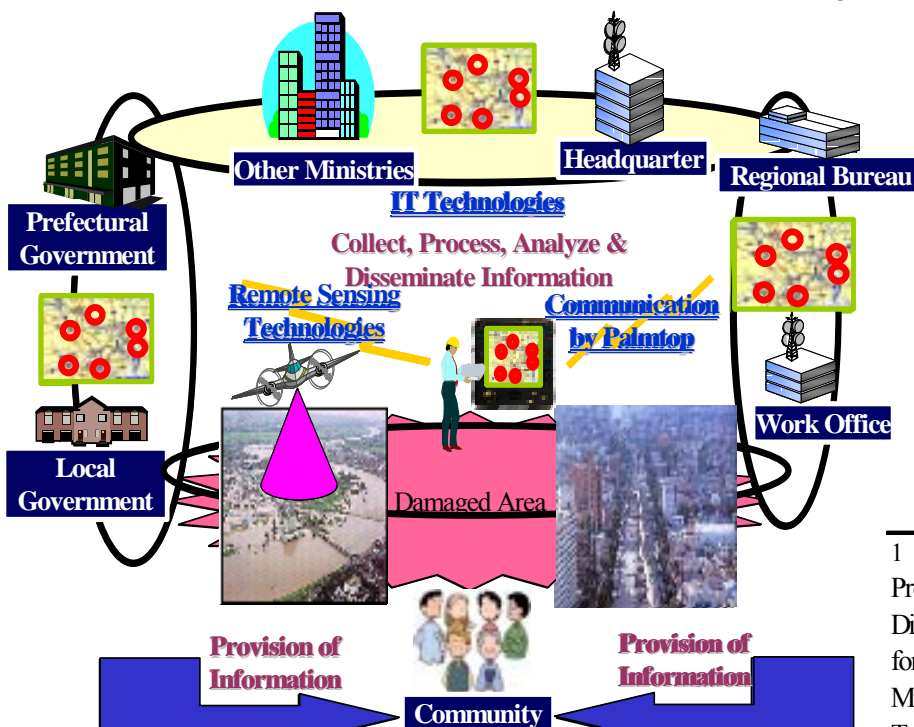
Fig-1 Remote Sensing and Information & Communication Technologies that can support disaster management

The bigger natural disaster becomes, the more rapid response should be executed. In reality, it is more difficult to collect, process, analyze and disseminate information including facility damage information at major disasters. At severe natural disaster, personnel in charge of emergency response and administrating infrastructure likely suffer from disaster damages. It causes shortage of staffs. Under such situations, remote sensing and information & communication technologies can support staffs in fields and headquarters. An example how such technologies can support emergency response is shown in Fig-1. Remote sensing technologies lead to rapid damage detection.

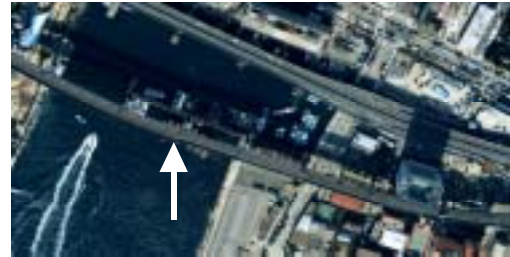
Girder shifted 1.5m in transverse direction to bridge axis.

Fig-2 Shifted Girder at Kobe-Hamate Bypass (Simulated Image with 1m resolution)

1) Kobe-Hamate Bypass, National Highway #2 (Fig-2)

It becomes difficult to detect girder shift at Kobe-Hamate Bypass and subsidence in Daikai Station.

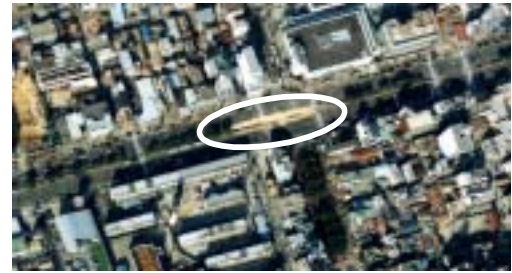
Fig-3 Subsidence at the Daikai Station (Simulated Image with 1m resolution)

The center pillars in Daikai station, which was located in underground, collapsed. This resulted in subsidence at the surface, National highway #28, for 90m long and 28m wide. Depth is maximum 2.5m.

2) Daikai Station of Kobe Rapid Transit Line (Fig-3)

In the case of Daikai Station, it is possible to detect cracks but difficult to understand caving down. Except subsidence at the Daikai Station, it is easy to find out damages of facilities.

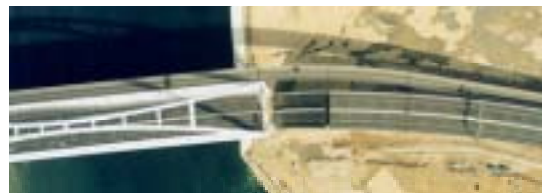
(a) Simulated Raw Image with 1m resolution

(b) Result of Edge-enhancement

Fig-4 Approach Bridge that fell down at Nishinomiya Port Bridge

Approach bridge, 52m span and 6 lanes, fell down about 25m.

3) Approach bridge of Nishinomiya Port Bridge, at Bay Shore Route of Hanshin Expressway (Fig-4(a))

In this experiment, two kinds of image processing, which are edge-enhancement and supervised classification, are applied to the two images: approach bridge of Nishinomiya Port Bridge and Nakatottei Pier. After image processing, possibility to extract damages from the images is estimated on each resolution. Fig-4(b) shows the result of application of edge-enhancement. This indicates that enhanced edges at road side and road center becomes discontinuous in the collapsed parts. In other parts, enhanced edge is continuous and looks clear. Fig-6 shows the result of applying edge-enhancement in 5 different resolutions. It is possible to detect collapsed part in the case of 2m or better resolution images, but impossible in the case of 10m resolution. In addition, results on the application of edge-enhancement to Nakatottei Pier indicate that edge-enhancement is suitable to detect damages of line-shaped facilities and difficult to detect damages which spread widely (Fig-5(b)). Widely spread damage should be detected by classification. In this study, supervised classification is applied. The result is shown in Fig-7. In classification, as training data, three sample pixels inside the liquefaction and outflowing area are chosen and pixels which has similar color with training data are judged as damaged area. The result indicates

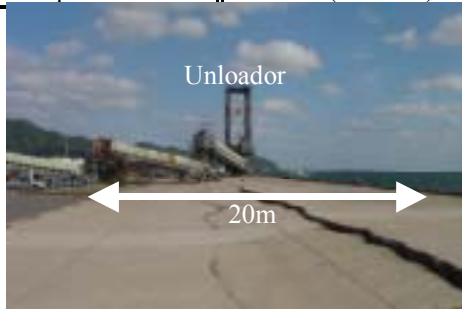
Fig-9 Damaged Quaywall in Sakai Port

Cracks and settlement occurred behind caisson along the face line. Difference in level was 60cm(Fig-9).

Fig-11 is the map of level difference from average height of face line of quaywall. White areas in Fig-11 are ship coming alongside the quaywall and the unloader shown in Fig-9. At the approximately 10m inside from the face line, color changes in Fig-11. This indicates that damage in quaywall can be captured by LIDAR. Fig-12 shows settlement of one cross section across the face line of the quaywall. The solid line is the survey result of LIDAR and broken line is the result of ground measurement. In points of the location and width of inclination, and the volume of height-difference, result measured by LIDAR is in good agreement with ground measurement.

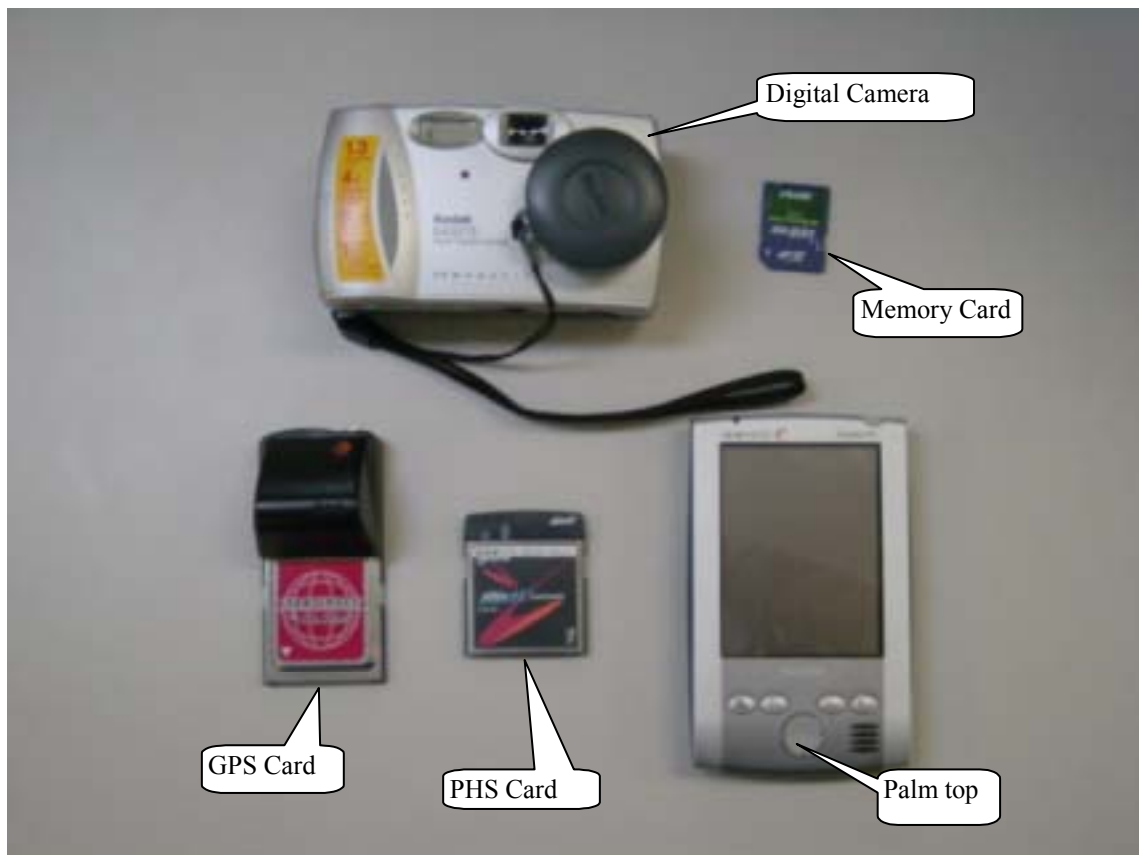
Fig-14 Palmtop and other devices used in the experiment

Based on the discussion in 3.2, these new functions are equipped in palmtop and the availability and efficiency of those functions are checked by the field experiment. The palmtop and related devices used for this experiment are shown in Fig-14.

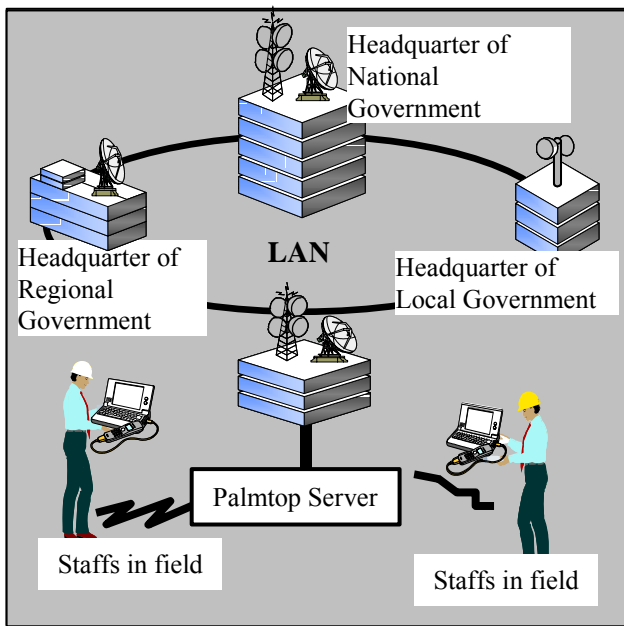
Fig-15 Structure of network in this experiment

In addition to these data, by networking palmtop server and servers of local (municipal), regional (prefectural), and national headquarters, information shearing can be done among not only headquarters but also staffs in fields. Fig-15 indicates the structure of networking in this experiment.

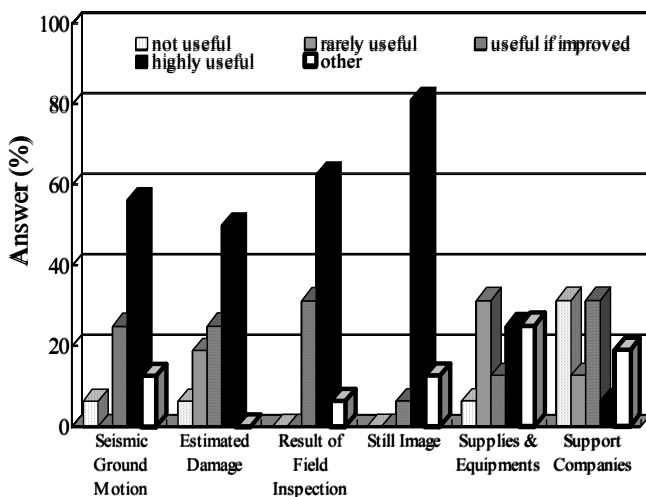
Fig-16 Usefulness of each information

The usefulness of each data in 3.3.2 is shown in Fig-16. This result indicates that information about 1) seismic ground motion, 2) estimated damage, 3) report of field inspection results to headquarter through palmtop, 4) report of situations in field with images, 5) acquiring information from headquarter and other staffs in

fields is efficient for field staffs. On the other hand, it is understood that information about 1) supplies and equipments for recovery and 2) support companies are not effective. Participants as field staffs in the experiment have opinions that it is difficult to input data by pen and voice input or selection from pull-down menu are useful.
