Report on Field Survey of Solomon Islands Earthquake Tsunami in April 2007

ABSTRACT

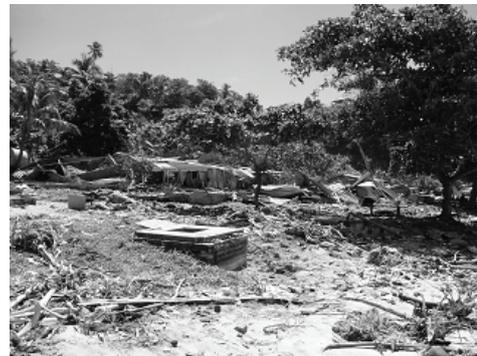
On the southern coasts of Ghizo Island, the tsunami with 4 m approximately struck. At Marakerava on the southern coast, the tsunami climbed up to 5.63 m on a hill surface. According to eyewitness, the first tsunami receded and then the sea water rose in whole, which was not like a water wall. Some inhabitants said that they watched the tsunami coming to the coast and then they evacuated to the hill behind their village. A 14-year-old boy told us that he and his 5-year-old friend were swept by the tsunami in a house, and he helped his friend to escape from a window and then he got out from a breach of a house wall that was made by the tsunami flow. The inundation depth there measured was 1.43 m on the ground. Another person said the first tsunami came a few minutes after the quake and another two tsunamis struck after that. The duration time of three tsunami waves was within 10 minutes. The tsunami destroyed completely houses in the first and second rows from a beach, and the third-row houses remained but suffered severe damage as shown in Picture 1.

Picture 1: Swept and remained houses in Marakerava.

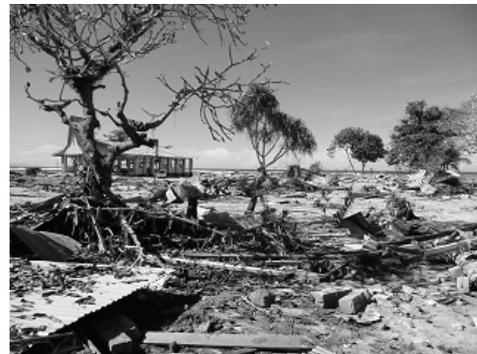
In Titiana Village, almost houses were swept by the tsunami higher than 3 m, as shown in Picture 2. However, some houses on stilts remained in the affected area as shown in Picture 3. When

Picture 2: Tsunami damage in Titiana.

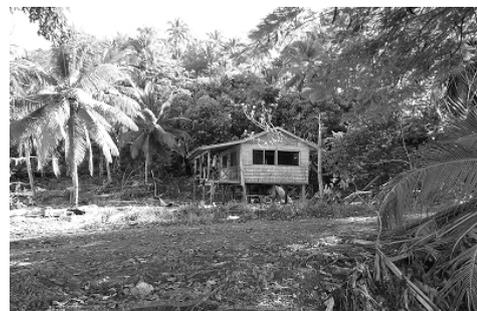
Picture 3: House on stilts remained after the tsunami in Titiana.

Another mitigation of tsunami disaster is traditional houses on stilts. If such a house suffered less damage by the earthquake, almost of them remained. On the other hand, many houses on stilts were broken by the earthquake motion, because such a structure was vulnerable to quake motions. A house on stilts that is strong against quake motion is a good measure against tsunamis as well as earthquakes. Moreover, it is better that such a house is built on a place which is as high as possible.

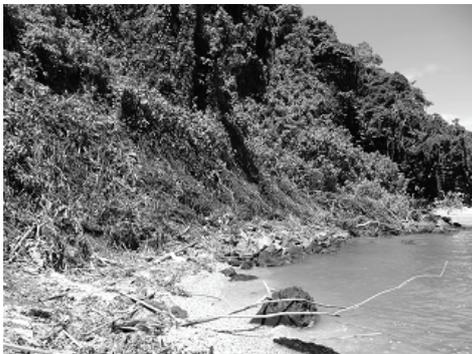
A runup height of 9.03 m was found on a hill slope as a clear border of dead vegetation by salty water, as shown in Picture 4. In Titiana Village, there were more than 100 houses, and the houses were completely swept by the tsunami as shown in Picture 5, but a house on stilts remained at the innermost part of the village along the hill edge. Since many wrecks of destroyed houses were twined around the stilts of the house, the tsunami inundation depth was lower than the length of the stilts. The inundation height there was 5.20 m. Church on a hill also remained.

Picture 4: Tsunami runup in Tapurai.

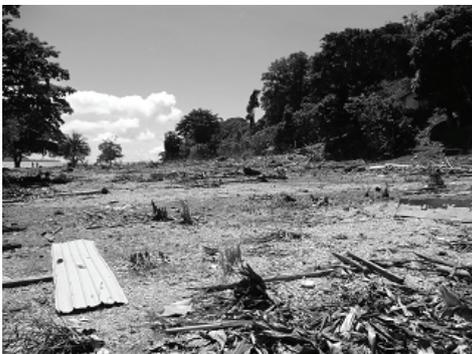
Inhabitants said that the first tsunami came from north and the second tsunami reached from south. They encountered each other in the sea in front of the village and went away from the island. This feature seems the coming of diffracted tsunamis by the island. The diffracted tsunamis by the island encountered each other behind the island resulting in the higher tsunami striking the village.

Picture 5: Tsunami damage in Tapurai.

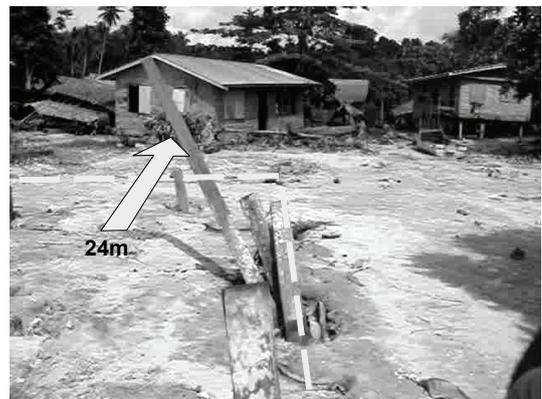
In Vella Lavella Island, four villages were investigated. Especially in Iringgira on the western coast of the island, higher inundation height of 4.46 m was measured. A local area in the village was struck by the higher tsunami and a lot of houses were swept away, as shown in Picture 6. However, other parts of the village were also inundated by the tsunami but many houses remained. According to eyewitness, firstly the sea in front of a beach of the village was separated into right and left. After that the seawater came reversely from the right and left sides into the area that the seawater retreated and then the tsunami struck the village. Part of the tsunami climbed a river and hit the village from behind. The tsunami striking this village seems to be effected highly by bathymetry, topography and geometry. To understand the tsunami feature there, we should conduct the numerical simulation with detailed bathymetry, topography and geometry data.

Picture 6: House floated away in Iringgira.

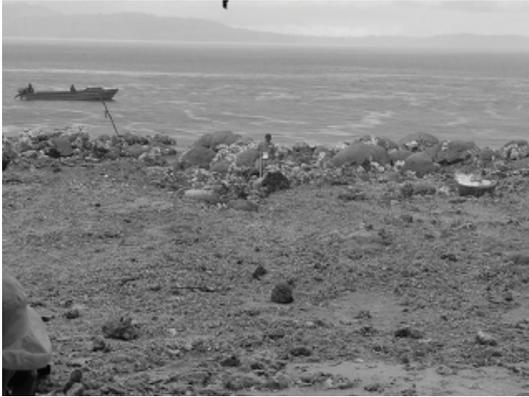
At locations we visited in Ranongga Island there were less damages by the tsunami. Especially, in Pienuna on the eastern cost of the island, the tsunami did not overflow the land, because the land was raised 2m from the original level by the displacement due to the earthquake. As the result, coral reef appeared above the sea surface as shown in Picture 7.

Picture 7: Coral reef appearing above the sea surface in Pienuna.

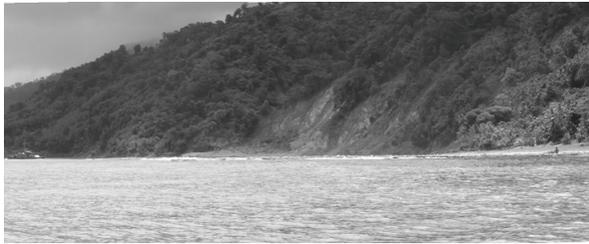
At other places of the island, landslides were caused by the earthquake motion. An example is shown in Picture 8.

Picture 8: Landslide in Ranongga Island.
