OOMORI BRIDGE DAMAGED BY TYPHOON NO.18

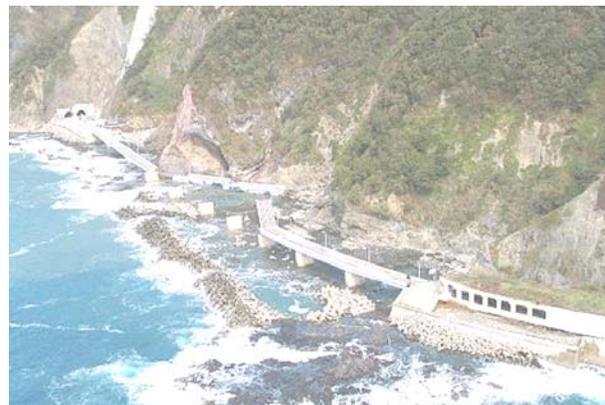
Figure 2. Washout of Four Spans of Oomori Bridge

On September 8, 2004, typhoon No.18 struck Hokkaido. The Oomori Bridge suffered serious damage from storm surge. Two PC girders with total length of 159 m were washed away. Pier No.3 was destroyed and inclined by about 30 cm at the top.

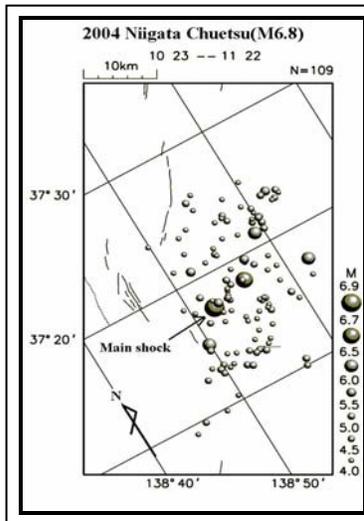
Figure 3. Earthquake Data of 2004 Niigata Chuetsu Earthquake (M6.8)
