SAFETY EVALUATION OF ASAHIBASHI BRIDGE BY USING A MODIFIED DESIGN METHOD TO VERIFY ITS SEISMIC PERFORMANCE

Shin-ya OKADA, Hiroyuki ISHIKAWA and Takashi SATOH

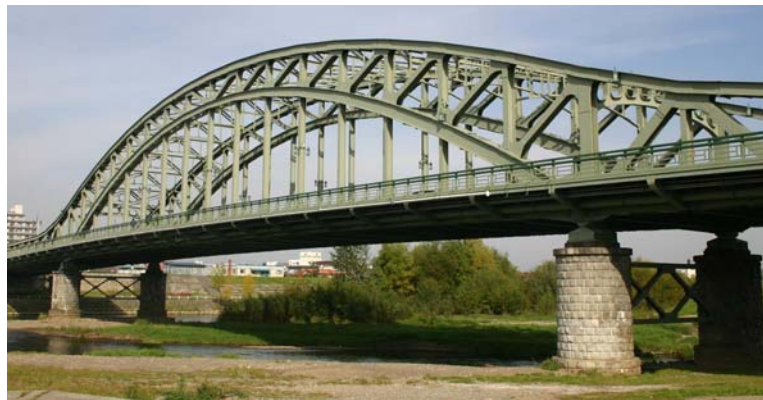
Photo 1 Asahibashi Bridge

Asahibashi Bridge is a beautiful bridge that ranks as one of the three finest in Hokkaido. The superstructure consists of a braced-rib cantilevered tied-arch center span, and a pony warren-truss side span. The substructure is a reinforced concrete (RC) bridge abutment and piers with distinctive granite panels. Photo 1 shows the center span.

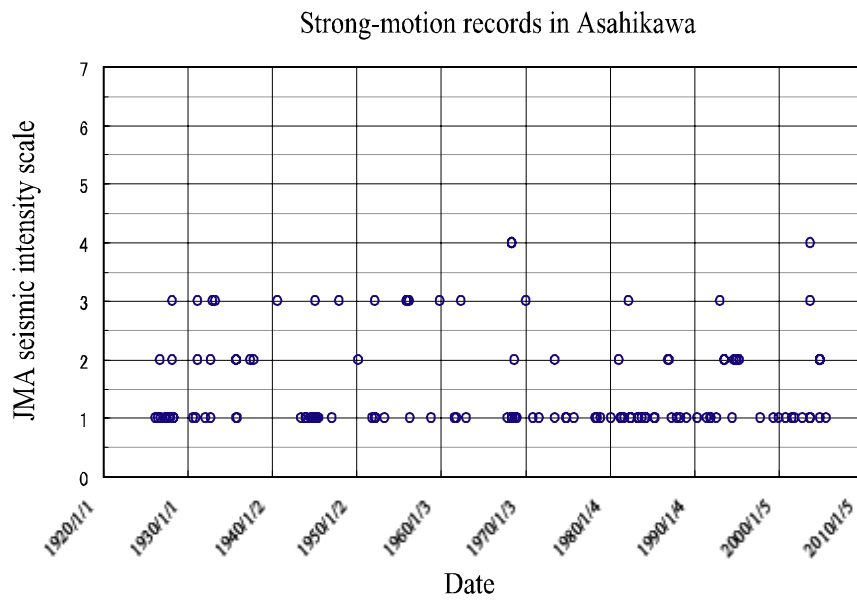
Figure 1 Strong-motion records for Asahikawa, with earthquake occurrences and intensity.

As a first step, a study was performed on the seismic characteristics of the Asahikawa region, where the bridge is located. Figure 1 shows the strong-motion records for that region. Earthquakes in Asahikawa have been monitored for 120 years by the Japan Meteorological Agency. In that period, about 130 earthquakes have been recorded, but intense earthquakes have rarely been recorded. The most intense recorded earthquake was 4 on the Japan Meteorological Agency seismic intensity scale (about VI to VII on the Modified Mercalli Intensity Scale), with a maximum acceleration in the range of 25 to 80 gal.

Based on past observations, the assumed maximum strong-motion has a maximum acceleration of about 60 gal. The strong-motion of this assumed earthquake is about the same as that of the largest earthquake the bridge has experienced.

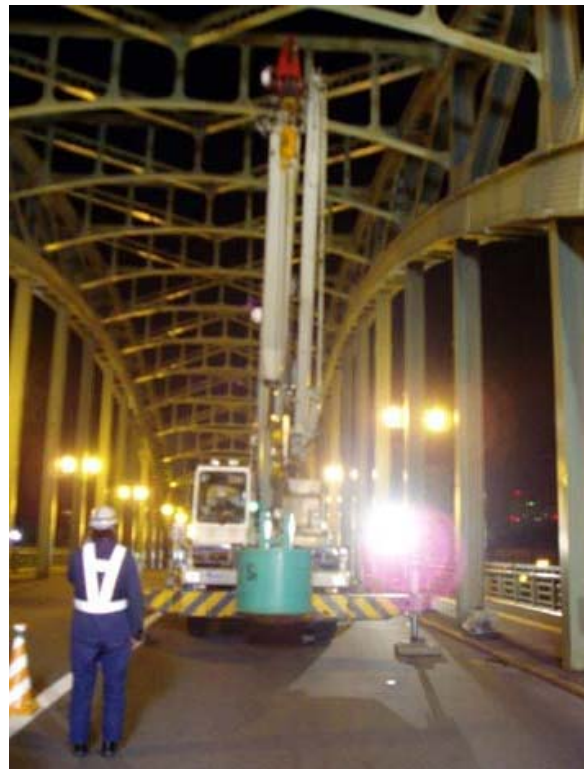
Photo 2 Forced vibration test on the bridge

Photo 2 shows the forced vibration test being performed. Two test methods

were used. One used a truck-mounted crane to apply reaction force and vibrate the bridge by raising and lowering a weight. The other used a truck that applied a force by stopping suddenly on the bridge. For measurement, many accelerometers were installed on the bridge, and the vibration characteristics were estimated by processing the acceleration waveforms.

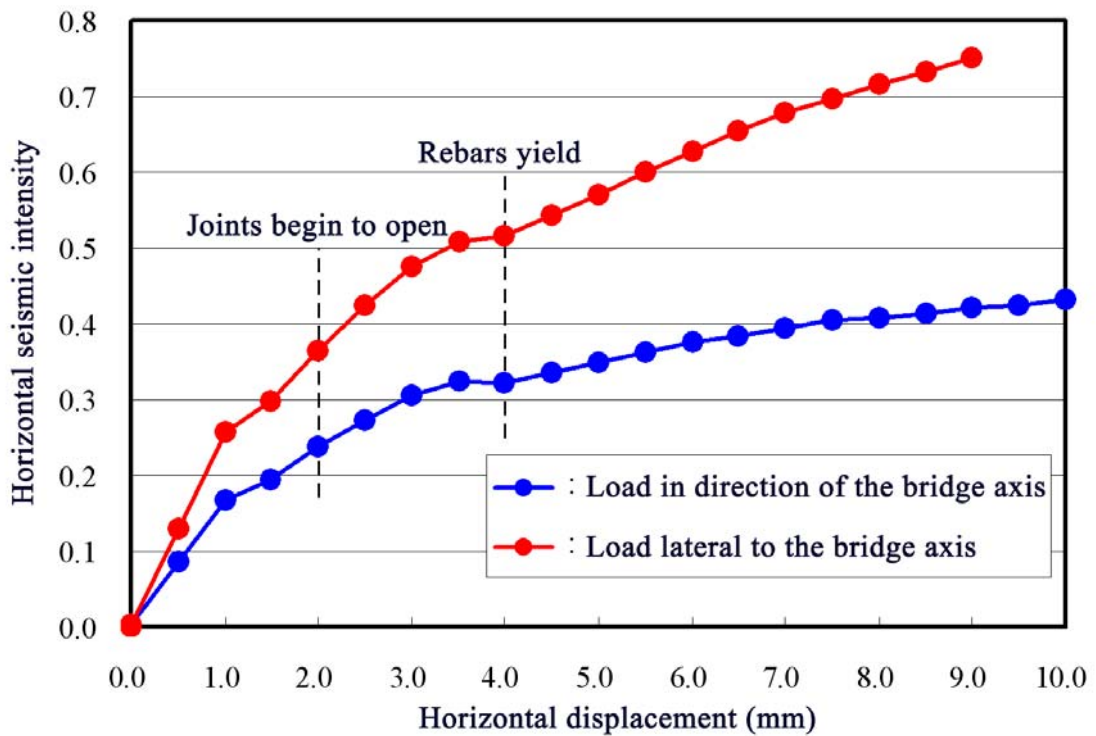
Figure 7 Horizontal seismic intensity - horizontal displacement curve

Figure 7 shows an example of the horizontal reaction - horizontal displacement relation in the analysis. The figure shows that this bridge maintains load capacity but lacks deformation capacity. It was determined that this bridge could withstand forces imposed by the aforementioned strong-motions.
