FATIGUE DESIGN, EVALUATION AND INSPECTOION FOR ORTHOTROPIC STEEL DECKS ON LONG-SPAN BRIDGES

Koichiro Fumoto¹, Ikuo Yamada², Akira Moriyama³ and Yoshiteru Yokoi⁴

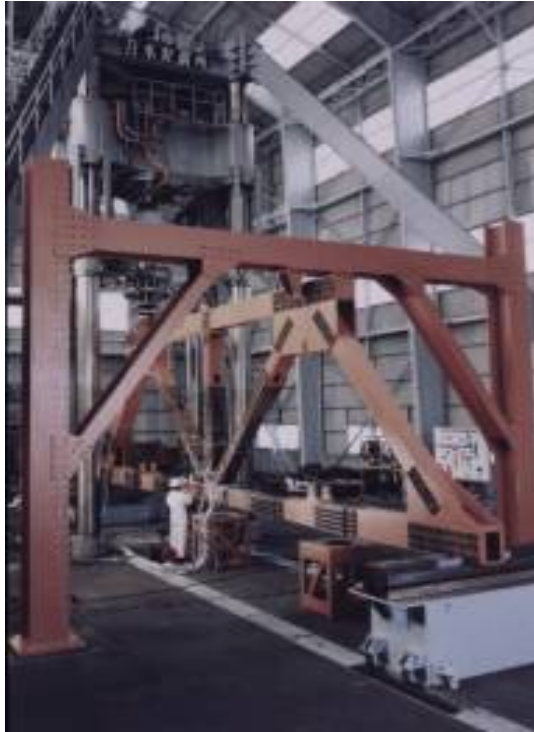
Photo 1: Fatigue test with full-scale specimen of Honshu-Shikoku Bridges

In the design for the HSB, the fatigue tests with full-scale specimens were conducted (Photo.1). Based on test results, the specifications for fatigue durability were made and applied to the design of orthotropic steel decks. Moreover, because the operation period is comparatively short and the traffic is not heavy, the fatigue damage has not yet reported. However, many fatigue damages are reported in similar structure details in other operators, the future safety is not necessarily ensured just because no fatigue damage occurs at present. Therefore, it is necessary to review the inspection methods against fatigue damage.

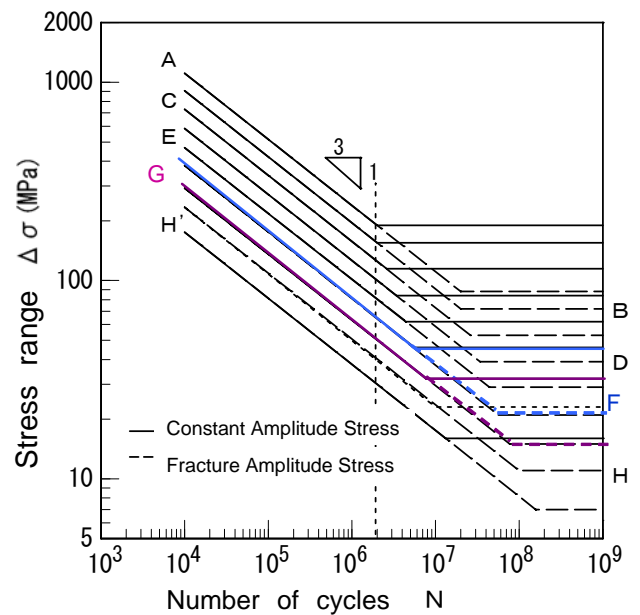
Figure 2: Stress Range versus Number of Cycle

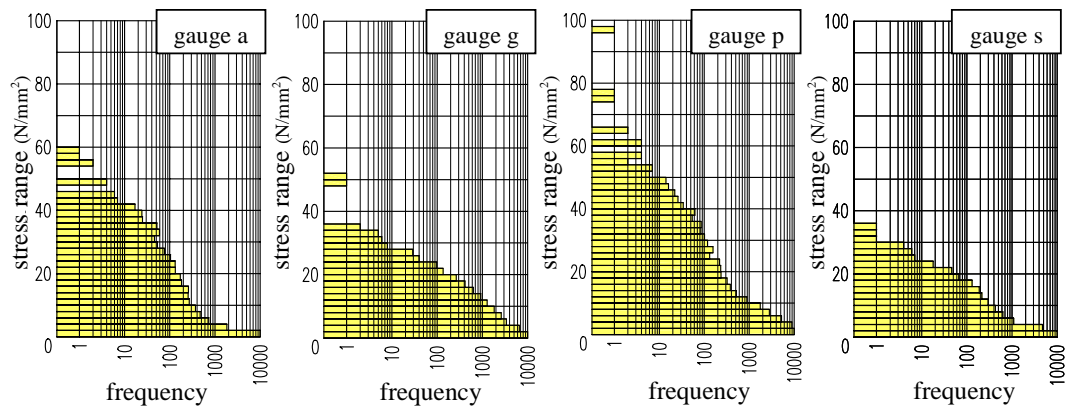
Figure 5: Stress measurement result in the Ohnaruto Bridge

The measurement points were selected just under wheel loads in the left lane for slow traffics, as shown in Figure 4. Stress gauges were attached to the 5 mm-distance point from toes of welded joints. The 24 hour-measurement was carried out for a weekday from 2:00 p.m., Thursday, February 27 through 2:00 p.m., Friday, February 28, 2003. In order to investigate kinds of vehicles or running locations of vehicles, the traffic flow was monitored by a video recorder in 3 hours in the daytime and a special vehicle with the weight of 200 kN passed through the bridge several times during the monitoring. Numbers of stress amplitudes was counted by the rain-flow method and the result was shown in Figure 5.

The aim of local stress measurement, however, is not to evaluate the fatigue lives for details, but to select severe details against fatigue damage in orthotropic steel deck and to reduce the maintenance costs. Figure 5 shows that large stress amplitudes occur in the scallop of the bolt joints for trough ribs (Gauge a and d) as well as in the slit between trough rib and cross rib (Gauge p and q), which means a severe condition against fatigue.

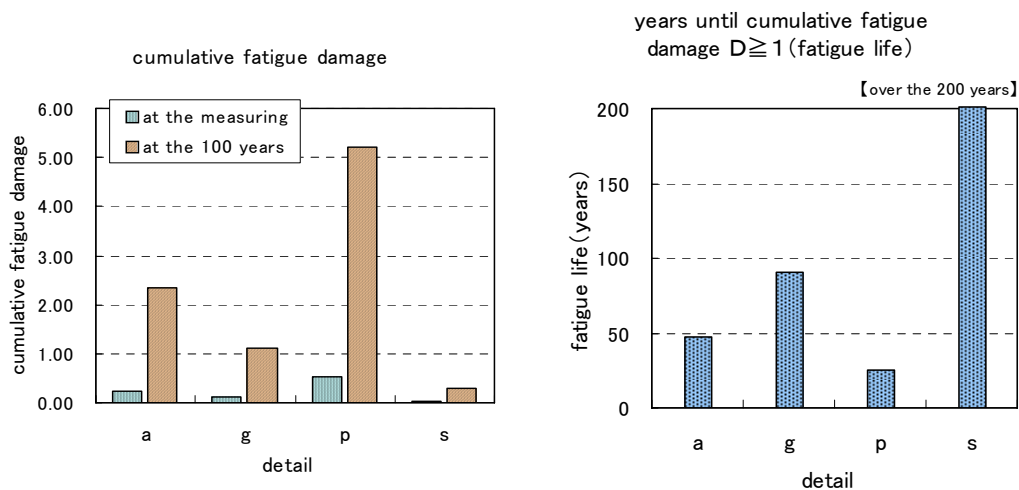
Figure 6: Evaluation of Fatigue damage and fatigue life in the Ohnaruto Bridge

Based on the result of the local stress measurement on the Ohnaruto Bridge, the fatigue life for the scallop of the on-site bolt joints for trough ribs in the orthotropic steel deck were estimated [6]. The result of estimation is shown in Figure 6. The procedure of estimation is outlined as follows.

- 1) The numbers of stress amplitudes, counted by the rain-flow method, is used for fatigue damage estimation.
- 2) Fatigue strength grade for the above-mentioned detail is assumed to be Grade G, which has the allowable fatigue stress range of 65 N/mm^2 against 2 million repetitions.
- 3) Cumulative fatigue damage on the measurement day can be calculated, considering the low amplitude limit of 15 kN against variable stress amplitude for Grade G.
- 4) Cumulative fatigue damage from 1985 to 2005 can be given by multiplying the measurement-day cumulative fatigue damage and the ratio of the cumulative traffic volume of large vehicles to the measurement-day traffic volume of large vehicles.
- 5) Cumulative fatigue damage from 2006 to the future can be given so that the future traffic volume is assumed to be the same as the traffic volume in 2005.

The estimation for the orthotropic steel deck revealed that the cumulative fatigue damage for the scallop of the on-site bolt joints for trough ribs will be equal to 1.0 after 45-year operations, i.e., in 2030. The estimation result of the fatigue life of 45 years has a possibility of several variations, because uncertain factors are assumed in the estimation. For example, the pavement stiffness is relatively large on the measurement day on winter, and the fatigue strength grade for the detail is assumed to be Grade G nevertheless welding qualities. The estimation for the orthotropic steel deck, however, yields to a certain possibility of fatigue damage for evaluation of the structural safety against fatigue damage.

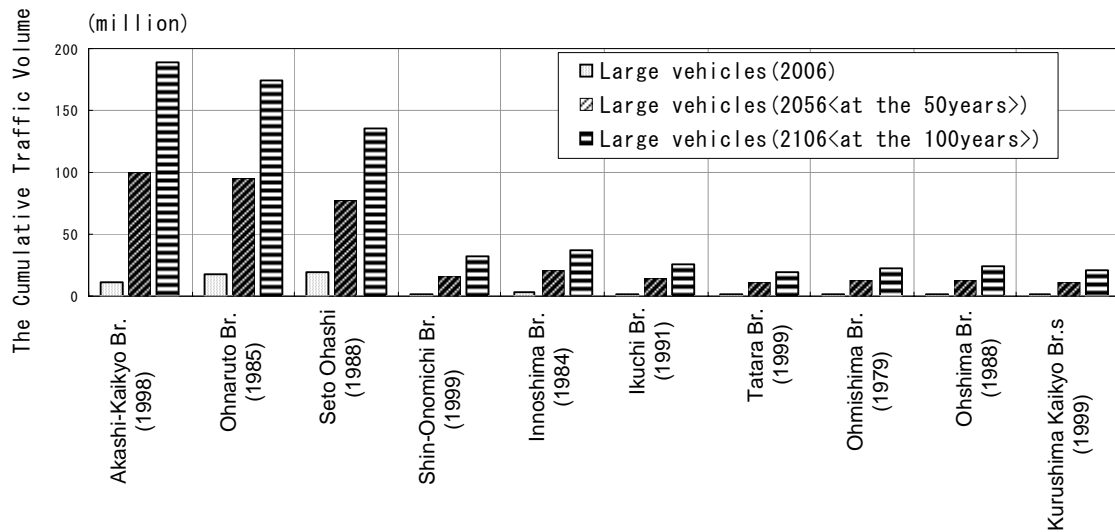
Figure 7: Cumulative traffic volume (completed year) of Honshu-Shikoku Bridges

Considering the above-mentioned estimation results and the cumulative traffic volumes of Honshu-Shikoku Highways (Figure 7), important inspection details in orthotropic steel decks (Table 2) were selected in term of bridges, locations, and detailed structures. The Akashi Kaikyo Bridge, which has a large traffic volume, is excluded because the details of the orthotropic steel decks are partly improved during construction. The fatigue hazard figure for orthotropic steel deck (Figure 8) was made for the Ohnaruto Bridge, which has a large traffic volume and Type-A details in orthotropic steel deck.
