## **FATIGUE DURABILITY OF A REINFORCED CONCRETE DECK SLAB IN A COLD SNOWY REGION**

Takashi Satoh<sup>1</sup>, Hiroshi Mitamura<sup>2</sup>, Yutaka Adachi<sup>3</sup>, Hiroaki Nishi<sup>4</sup>,  
Hiroyuki Ishikawa<sup>5</sup> and Shigeyuki Matsui<sup>6</sup>

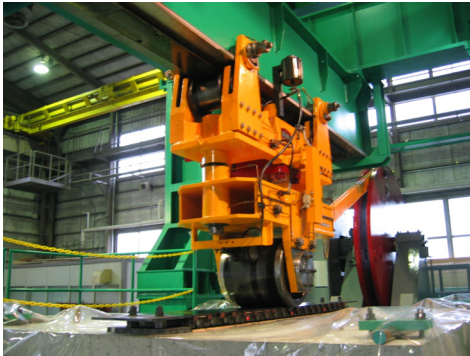
**Photo 1** Wheel loading test machine

It show in the Photo 1, the wheel loading test machine is capable of imposing vertical loads of up to 300 KN. The reciprocating movements of the wheel reproduce punching shear failure (Photo 2), a failure mode that is typical of RC deck slabs. This paper defines failure of an RC deck slab as the point where the curve of the number of wheel loadings vs. displacement turns up sharply (Figure 1).

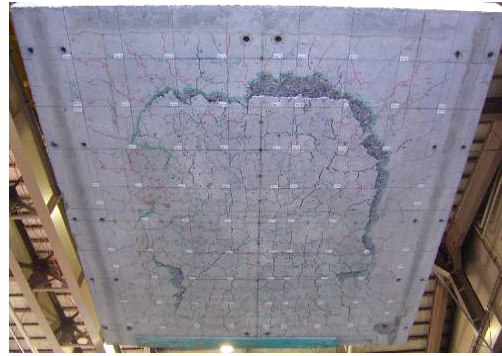
**Photo 2** Punching shear failure at the lower surface of the deck slab

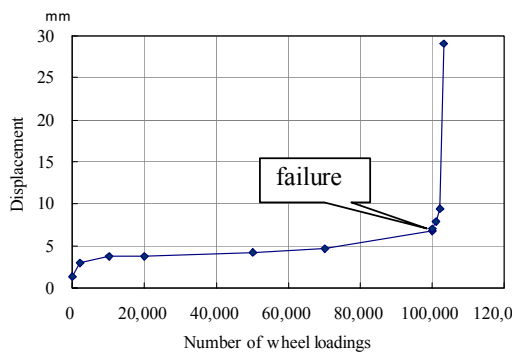
**Figure 1** Wheel loadings vs. displacement

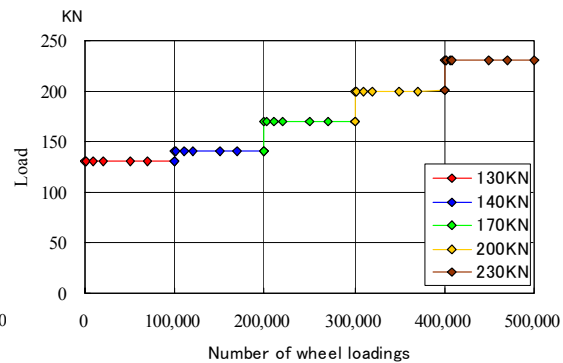
**Figure 2** Loading pattern

The wheel loading test was conducted in the incremental loading pattern shown in Figure 2, which is recommended by the Ministry of Land, Infrastructure and Transport. From the degree of damage to the bridge, early failure of the test specimen was expected, and the initial load was decided to be a relatively light 130 KN. The test specimens were simply supported at both ends and were elastically supported at both sides. To examine changes in deflection, deflection was measured at the numbers of wheel loadings marked with diamond marks in Figure 2, with static wheel loading and without loading.

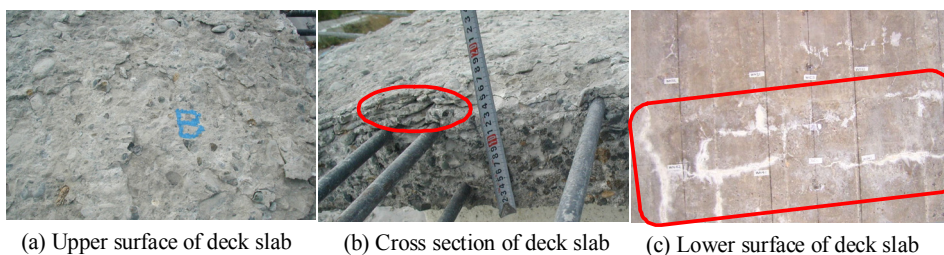
Photo 3 Deterioration of test pieces

The bridge was designed in accordance with the Specification for Steel Highway Bridges (1956), and the test specimens are described in Table 1. The degrees of deterioration of the deck slabs from which the test specimens were cut are shown in Photo 3, and sketches of cracks in the lower surface of the slabs are shown in Figure 5. Wide areas of the slab upper surface show scaling from frost damage. The cross sections show delamination of the upper concrete cover. In the most severe case, the rebars were exposed.

Scaling was observed over the entire upper surface, and delamination had caused the loss of about 25 mm of the concrete cover. The crack density at the lower surface was  $1.9 \text{ m}^2/\text{m}^2$ , and some of the edges there were observed to have broken off.

Scaling was observed on about 20% of the upper surface, and delamination had caused the loss of about 20 mm of the concrete cover. The crack density at the lower surface was  $6.0 \text{ m}^2/\text{m}^2$ .

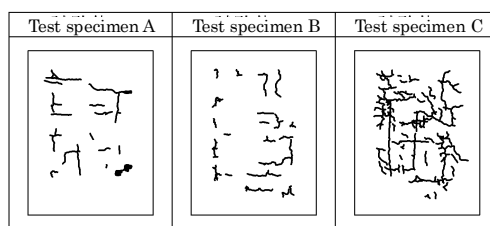
Figure 5 Cracks at the lower surface of deck slabs before the wheel loading test

At the lower surface of the deck slab, the crack widths were about 0.1 mm, and from these cracks, a considerable amount of free lime release was observed. Visual inspection showed deterioration as follows:

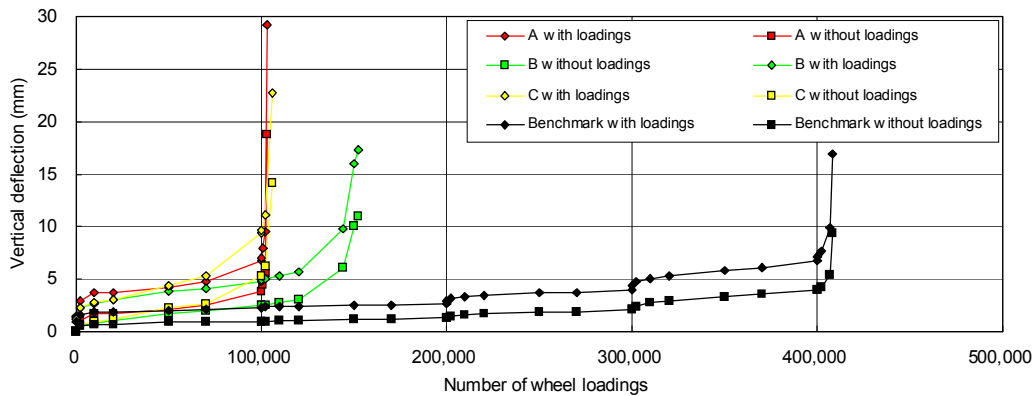
**Figure 6** Wheel loadings (before conversion) vs. deflection

The relationship between the number of wheel loadings and the deflection at the center of the test specimens is shown in Figure 6 for total deflection under load and for residual deflection without load. At failure, the critical deflection can be read as 5 to 10 mm for total deflection and 3 to 5 mm for residual deflection. Then, the number of wheel loadings to the point of failure is obtained, as shown in Table 2, by converting the incremental loadings to a constant load of 150 KN and converting the width of the test wheels to that of standard vehicle wheel. From the number of wheel loadings, it was found that the number of wheel loadings at failure for the three frost-damaged test specimens is 1/167th to 1/366th less than that for the benchmark specimen. This verifies the importance of installing waterproofing layers on deck slabs.

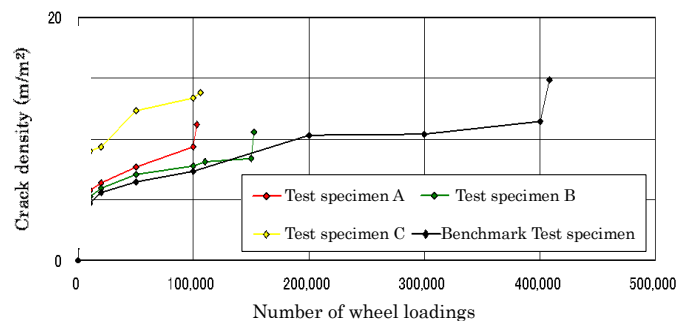
**Figure 8** Wheel loadings (before conversion) vs. crack density

Figure 7 shows cracking at the lower surface of the deck slab at failure. Figure 8 shows the relationship between the number of wheel loadings (before conversion) and the crack density. Similar to deflection, crack density increases proportionally to increases in the number of loadings up to failure; crack density was about 10 m/m<sup>2</sup> at failure for test specimens A and B. This is consistent with the threshold crack density previously reported by the authors<sup>2)</sup> (i.e., the density beyond which the deck slab is no longer sound). On the other hand, test specimen C, which had a high crack density of 6.0 m/m<sup>2</sup> before the wheel loading test, and the benchmark test specimen, which had deteriorated only from fatigue, show relatively high crack densities of 14 to 15 m/m<sup>2</sup>.

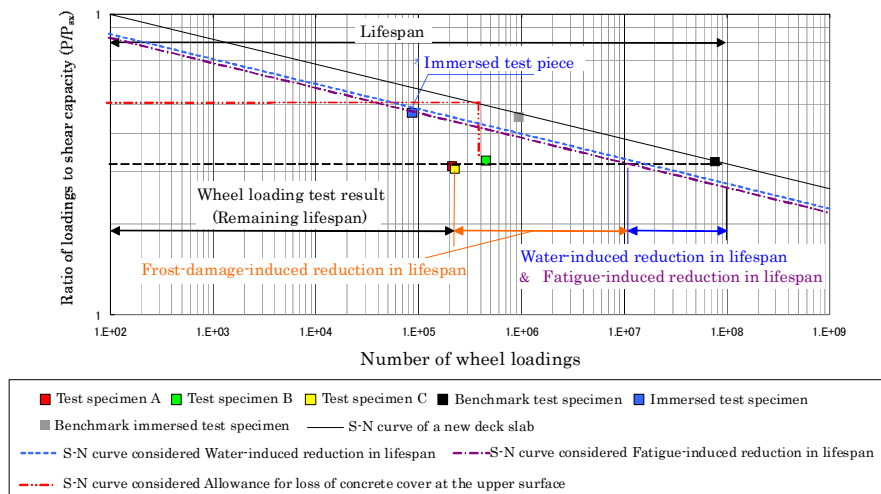
**Figure 9** S-N curve

The curve of stress vs. number of wheel loadings (S-N curve) in Figure 9 is expressed with the ratio of equivalent load ( $P$ ) to shear capacity ( $P_{sx}$ ) on the vertical axis and the number of wheel loadings on the horizontal axis. The chart plots the numbers of

wheel loadings at failure for the three test specimens sampled from the bridge and the one benchmark test specimen, with loadings converted to 150 KN. In 2006, test specimens were immersed in water to determine the effect on fatigue durability. Figure 9 also plots the fatigue durability of the immersed test specimens. Since the test specimens in this previous test had a slab thickness of 17 cm and a compressive strength of about  $28 \text{ N/mm}^2$ , their shear capacities were less than those of the test specimens in the current test.

The benchmark test specimen and the benchmark immersed test specimen were intact at the beginning of the test and were deteriorated by wheel loading. Figure 9 shows S-N curves for the non-immersed test specimen and for the immersed test specimens. These curves indicate the lifespan, in terms of the number of wheel loadings at failure.

From data on the cumulative volume of heavy vehicles on this bridge (the Road Traffic Census (1999)) and a study on the frequency distribution of axle loads<sup>3)</sup>, the number of wheel loadings during the service period was estimated to be 640,000. A curve that shows deterioration from fatigue is plotted parallel to the S-N curve in Figure 9.

From the above, the shear capacity ( $P_{sx}$ ) that ignores the 4 cm of concrete cover was calculated, and it is plotted in Figure 9 as the red dashed line. The number of wheel loadings at failure (i.e., the lifespan) of a deck slab without concrete cover is roughly the same as that of the test specimens from the bridge. This can serve as a reference in estimating the remaining lifespan of frost-damaged concrete deck slabs in cold regions.

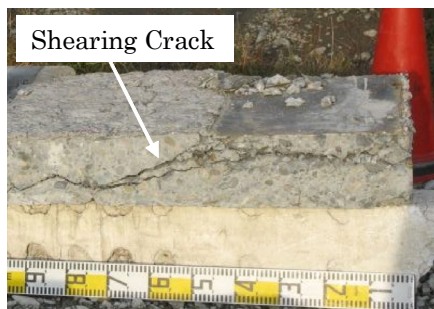
**Photo 4** Cut section of the bridge deck slab (transverse direction)

After the tests, the test specimens from the bridge were cut to examine the deterioration. Photo 4 shows a transverse section of the deck slab, and Photo 5 shows a longitudinal section of the deck slab at the line of wheel travel. As observed in Photo 4, the failure mode of the frost-damaged deck slab was punching shear failure. In Photo 5, the concrete has crumbled in the surface layer and in the layer of the upper reinforcements, and it is assumed that the shear resistance of this portion of concrete has been reduced.

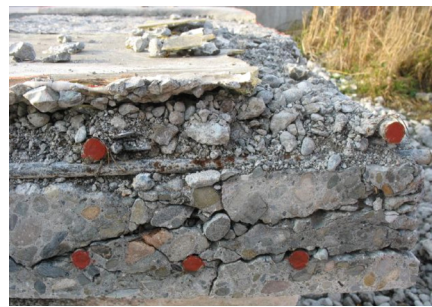
**Photo 5** Cut section of the bridge deck slab (directly below the wheel travel position)
