SEISMIC RETROFIT OF LARGE CABLE-SUPPORTED BRIDGES ON TOKYO METROPOLITAN EXPRESSWAYS

Abstract

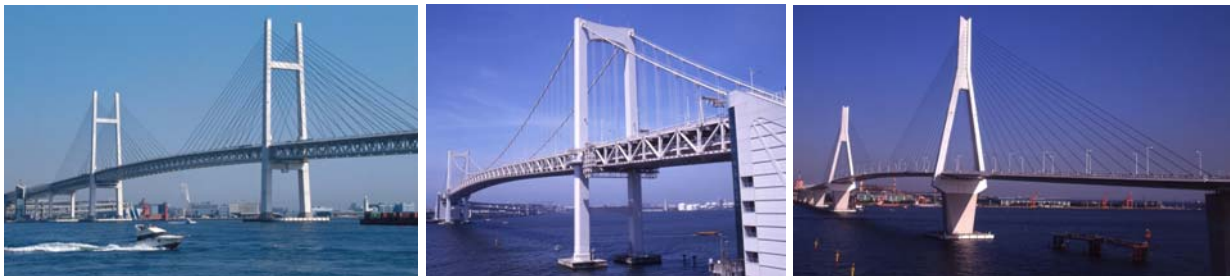
Photos-1 Long Span Cable-supported Bridges on Metropolitan Expressways

Yokohama Bay Bridge is a three-span suspension bridge with a continuous steel stiffening truss. Its total length is 860m and the central span is 460m. The Daikoku wharf located at the entrance of the Yokohama port and the Honmoku wharf are directly connected to this bridge. The stiffening truss of the bridge is hanged by cables in a double-fan type layout which has a Metropolitan Expressway route on its top layer and the national route No.375 on the bottom. The national route No.357 has two traffic lanes and opened on April 4th, 2004. The multi pillar type was chosen as the substructure of the bridge, because the bed rock was located in deep down beneath unevenly. Short pendulum type links connect the towers and the girder. Its swinging motion in the longitudinal direction releases the thermal stress and isolates the girder seismically by stretching out the length of natural period of the bridge. This also reduces the seismic force on main towers and side piers while limiting the movement of the girder in the longitudinal direction (MEPC, 1994) (JSCE, 1999).

Rainbow Bridge, the total length is 798m, is a suspension bridge with steel stiffening trusses. It is located beyond a sea route between Shibaura and Daiba in the Tokyo bay with its center span of 570m and side spans of 114m. Its stiffening truss has

Tsurumi Tsubasa Bridge is located over the Tsurumi sea route in Yokohama area. This cable-stayed bridge has three continuous spans of which the total length is 1020m and the center span length is 510m. Its upside-down Y shaped main towers hang the flat box girder with cables in single faced fan-type layout. This center span length is the world longest among those types of cable-stayed bridges, so far. The main tower consists of two segments, the upper portion is made of steel and the bottom is from steel framed reinforced concrete. The substructure was constructed using the pneumatic caisson method on the bed rock which consists of diluvial deposits. Main towers and the box girder are connected each other in the longitudinal direction using steel cables. These cables elastically connect main towers and the box girder and vane-type dampers which have the pressure controlling system and work together to enhance the damping performance in case of a large scaled earthquake (MEPC, 1994, JSCE, 1999). The lengths of natural periods of those three bridges in main vibration mode are fairly long as shown in Table-1.

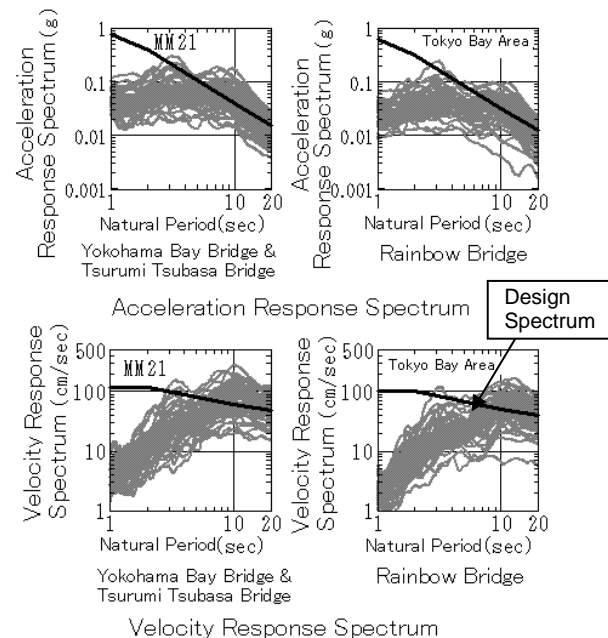
Figure-4 Response Spectrum of Formed Level-2 Seismic Wave based on Kanto Earthquake

Figure-4 shows the response spectrum of the bedrock wave obtained using an epicenter fault model. The damping factor of 5% is used in the calculation. It is seen that the response level over 3 seconds is larger than other spectrums made for buildings located
