HURRICANES KATRINA AND RITA – LOUISIANA’S RESPONSE AND RECOVERY

Ray A. Mumphrey, P.E., Louisiana Department of Transportation and Development,
Baton Rouge, Louisiana, and Hossein Ghara, P.E., MBA, Louisiana Department of
Transportation and Development, Baton Rouge, Louisiana

ABSTRACT: Louisiana’s transportation and hurricane protection system took a
tremendous blow from two major hurricanes that struck the coast of Louisiana in 2005,
hurricanes Katrina and Rita. This presentation will introduce the audience to the
transportation infrastructure damage Louisiana experienced as a result of these two
storms and will describe how Louisiana is responding to the disasters and our road to
recovery.

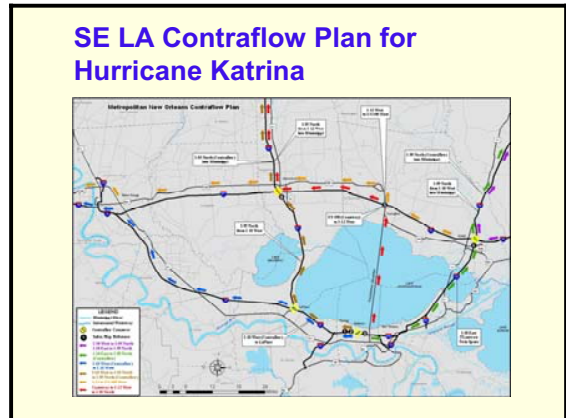
Figure 5 – LaDOTD Contra flow Plan

The contra flow plan shown in figure 5 for Hurricane Katrina was very successful. Our contra flow techniques were so successful that other states such as Florida and Texas are studying our model to determine how this may be used in their states. Contra flow activities were in operation for 25 hours and approximately 1 million people were evacuated from the potential landfall area.

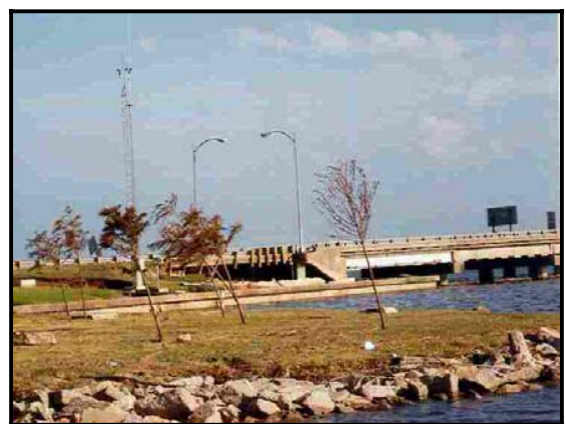
Figure 6 – Bridge Abutment Scour

Abutment scour and undermining of approach slabs essentially closes bridges to traffic, however this is one of the easiest damages to correct. Figures 6 and 7 depict typical bridge end damage and repairs. The portion of the approach slab to the left of the light stand in figure 6 does not have any soil to support it after the storm. Temporary repairs are usually accomplished through demolition of the approach slab, installation of base course material and a roadway aggregate surface. The bridge can then be reopened to traffic. If the approach slab only has minor undermining, the soil support is re-established through mud jacking. The key to these types of recovery efforts is to have contractors and materials lined up prior to landfall of the hurricane. During these extreme events, most contractors will go above and beyond the call of duty to assist the state in re-establishing transportation routes. This type of partnership benefits the state's recovery tremendously.

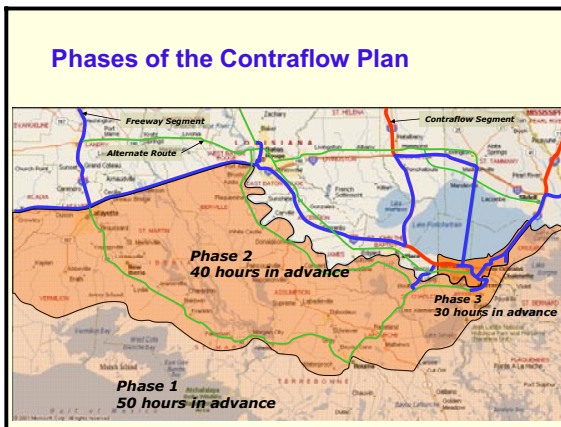
Figure 4 – LaDOTD Contra flow Plan

Contra flow procedures are set up to evacuate coastal areas in phases to minimize congestion on highways and produce a consistent flow of traffic away from these vulnerable areas. As you can see in figure 4, the phases are based on the relative location to the coast.

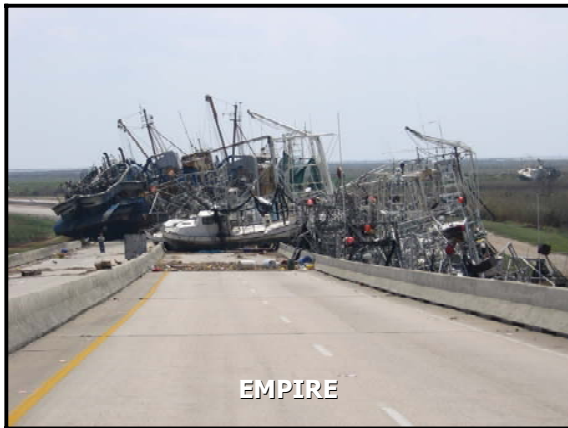
Figure 8 – Debris

Sometimes debris build up on our bridges can be extensive. Figure 8 demonstrates one of the largest debris piles on any bridge we encountered during our bridge assessments. There is a large harbor facility for the seafood industry near this bridge site. A large number of the vessels stored at this site landed on the bridge approaches. The US Coast Guard assisted with the removal of some of the larger vessels.

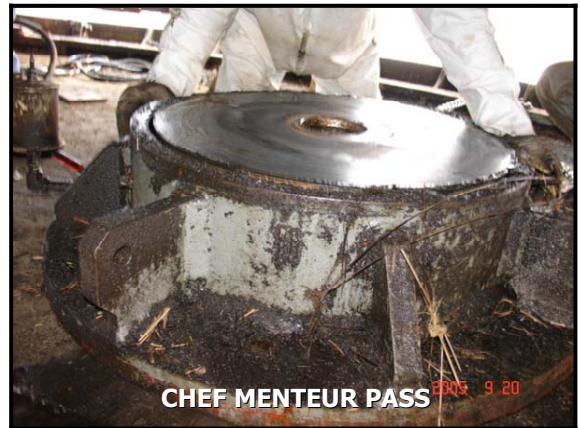
Figure 11 – Removal and Reconditioning of the Pivot Bearing

When swing span bridges are inundated the pivot bearing must be jacked, inspected, cleaned and reconditioned prior to operation of the bridge. In some instances after Hurricane Katrina, bridges were forced open by mariners to allow work forces passage into the New Orleans area for dewatering the city prior to the Department reconditioning these bearings.

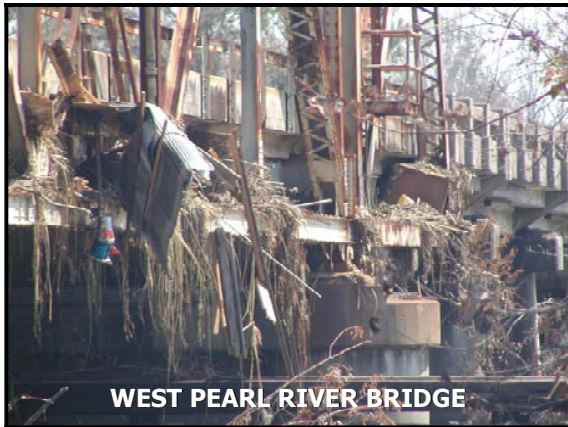
Figure 9 – Debris Buildup

Debris buildup on structures is a big problem after a storm. Debris must be removed in order to properly assess the damage to the structure. Refer to figures 9 and 10.

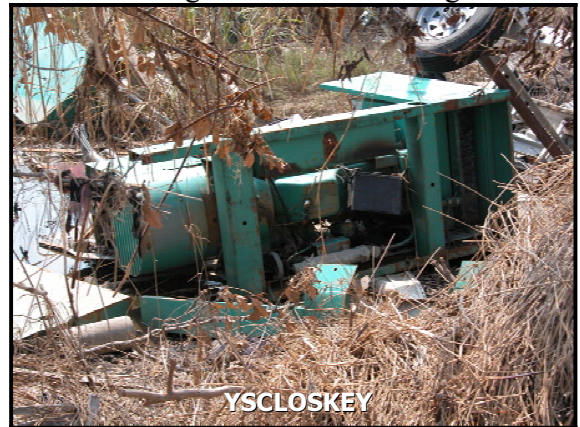
Figure 12 – Destroyed Generator

Alternate power supplies for movable bridges are particularly susceptible to storm surge and often lost or damaged during hurricane events. Refer to figure 12. Generators are usually placed close to grade for ease of access and servicing. In some installations these units were elevated above the storm surge elevation and survived the storm. A storm hardening of these installations is a good design improvement that should be considered in future designs.

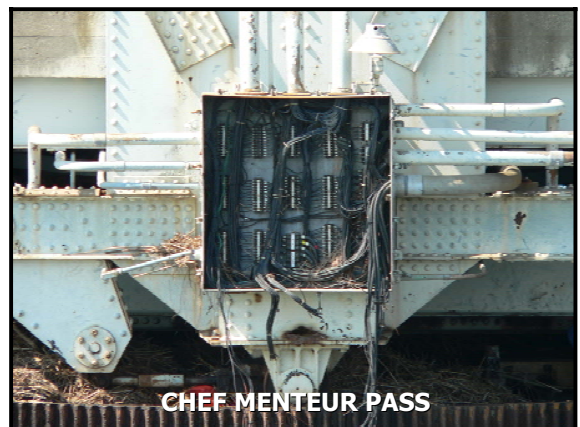
Figure 13 – Electrical Systems

Electrical systems as shown in figure 13 usually require full replacement after inundation with salt water.

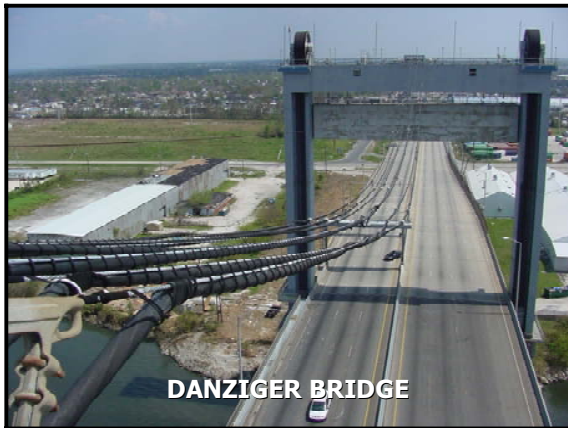
Figure 14 – Droop Cables on Vertical Lift Bridges

Droop cables are aerial electrical and communication cables that connect the towers on vertical lift bridges. In many cases, droop cables sustained wind damage. These cables were twisted and sometimes pulled from the service box. When these cables are damaged they must be replaced for safety and operational reasons. Refer to figure 14.

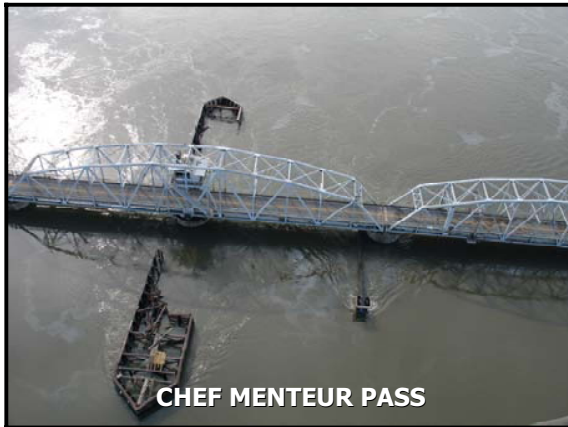
Figure 15 – Pier Protection Systems

In several instances, pier protection systems sustained damage from storm surge. In figure 15 the pivot pier protection system is severely damaged and the rest pier protection systems are missing.

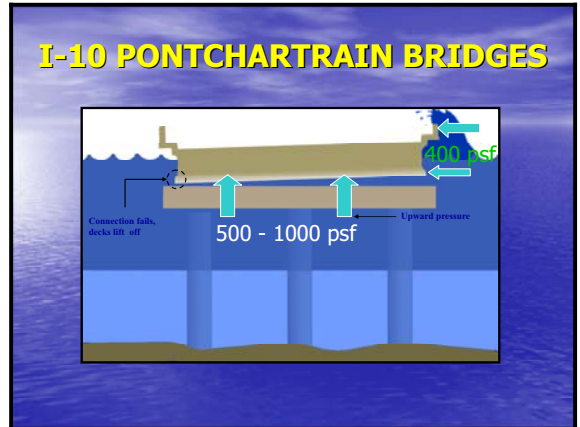
Figure 18 – Wave forces

Open water bridges are particularly susceptible to damage from storm surge and wave action. The damage to the I-10 Twin Span Bridges across Lake Pontchartrain is a good example of the vulnerability of these types of structures. When the water surface elevation due to storm surge, tides and wind reaches an elevation just below the low chord of the structure and remains there for an extended period of time, wave forces continuously impact the structure. Wave forces have two components, a vertical impulse force acting on the bottom of the structure from the rolling motion of the wave and the horizontal force from the forward motion of the wave. Refer to figure 18 for illustration and order of magnitude of these loads.

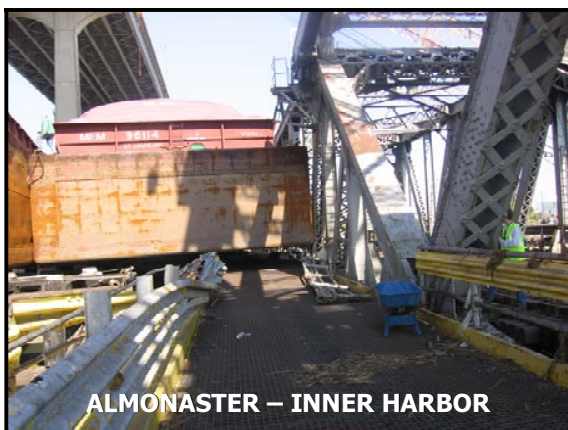
Figure 16 – Debris on Structures

When a bridge resides in an industrial area, floating often barges break free and drift with the storm surge until they meet up with a bridge structure and come to rest. In figure 16 two such barges came to rest on the cantilevered roadway and fender system of this bascule bridge on the Inner Harbor Navigational Canal.

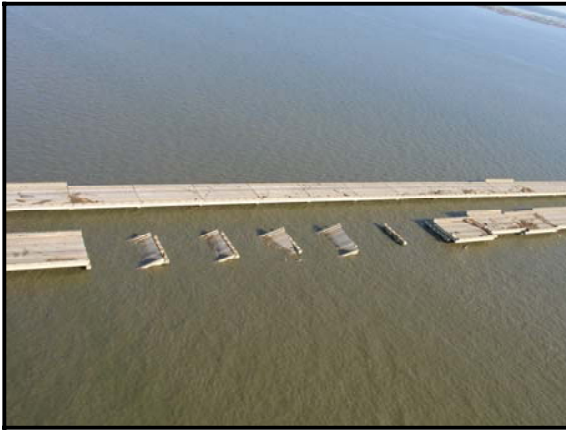
Figure 20 – Damage due to diagonal wave action

In the case of the I-10 bridges, the bridge bearings failed due to continuous wave forces acting on the structure and then the waves lifted and pushed the structure off of its supports. We were very fortunate that many of the spans were temporarily restrained by the substructure risers for a sufficient length of time to allow the water to recede before these spans fell into the water. Wave forces applied transverse to the structure, moved spans uniformly transversely and in many cases they fell off of the ends of the caps. Refer to figure 19. Waves acting diagonally to the structure place enough drag on the superstructure to displace the substructure and the spans simply fell off of the sides of the caps. Refer to figures 20 and 21.

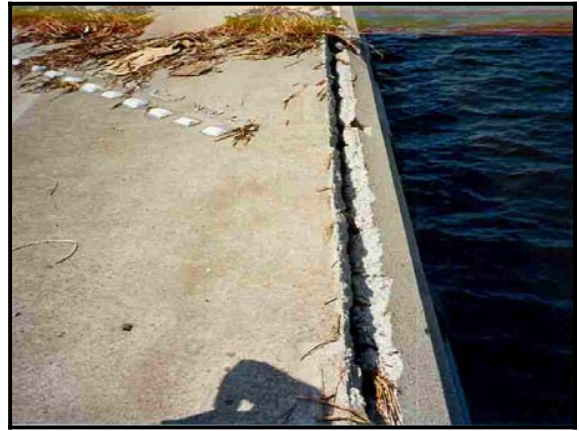
Figure 23 – Damage to bridge railing

In figure 23, it can be seen that earlier designs of bridge rails did not consider loads that may act on the back side of bridge rails, opposite to the primary traffic loading. Because of this type of design, large sections of bridge rail must be replaced because of severe damage from the storms.

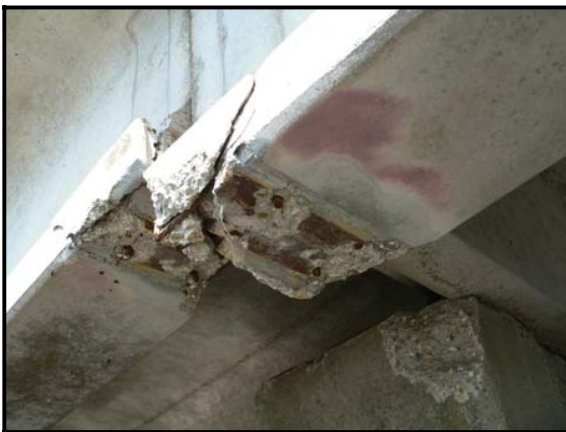
Figure 22 – Damage to girder ends

In figure 22, it is evident that the attachment of the superstructure to substructure was marginal and the bridge sustained severe damage to the ends of the concrete girders. This provided a difficult situation during the emergency repair, since we could no longer depend on these ends for support. In many cases support was re-established away from the damaged area. These girder ends are one of the reasons the structure could not be salvaged. Any spans that were completely removed from the substructure were deemed un-salvageable. This lesson was learned from Florida's Escambia Bay project.
