## **INSTRUMENTATION AND MONITORING OF I35W ST. ANTHONY FALLS BRIDGE**

### **Abstract**

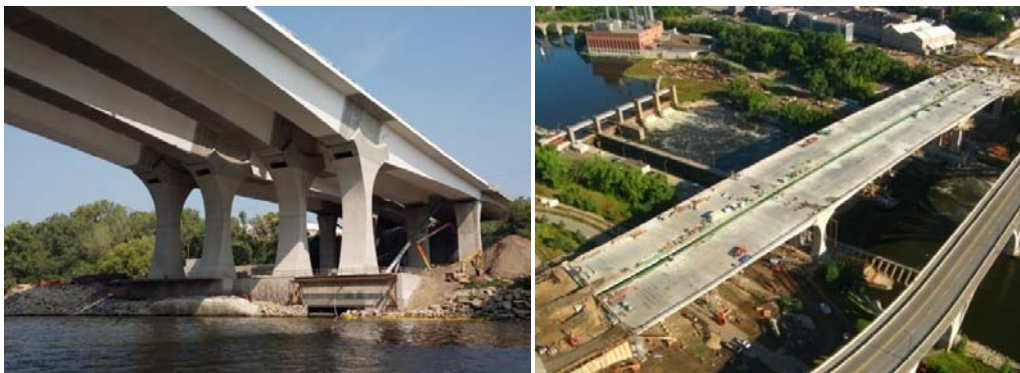
FIGURE 1: PHOTOS OF THE I35W ST. ANTHONY FALLS BRIDGE DURING CONSTRUCTION

The I35W St. Anthony Falls Bridge, constructed to replace the steel truss bridge that collapsed in 2007, consists of two parallel bridges to carry northbound and southbound traffic. The four-span bridges consist of prestressed concrete box girders. Three of the spans were fabricated with cast-in-place concrete. The fourth span, the river span (i.e., Span 2), was fabricated with match-cast precast segmental construction. To accelerate the construction of the replacement bridge, the design-build approach was used. The proposal from the design-build team of Flatiron-Manson in conjunction with Figg Bridge Engineers featured the incorporation of a “smart-bridge” system. This system included instruments to monitor the structural behavior of the bridge, as well as instruments to control the anti-icing and lighting systems. Photographs of the bridge nearing completion of construction are shown in Figure 1. Figure 2 shows elevation views of the bridge which indicate the primary instrumented sections of the bridge and the variation in the cross-sectional shape of the boxes along the length of the bridge.

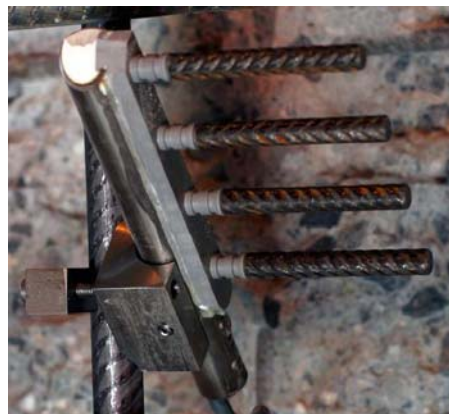
FIGURE 3: EXAMPLE OF CORSENSYS CORROSION SENSOR INSTALLATION

This section contains a brief description of the types of sensors installed in the bridge followed by the quantities of each instrument in parentheses. Sensors include a CorSenSys system (4), an example of which is shown in Figure 3, to monitor the corrosion susceptibility of the reinforcement within the deck. Information from this system can be used to determine when the deck needs to be resurfaced to prevent the chlorides from reaching the reinforcement layer and initiating corrosion. Additional instrumentation includes: strain gages to measure the deformations of the bridge (24 resistive, 195 vibrating wire [VW], 12 fiber optic); accelerometers to measure the vibrations of the bridge and to relate those measurements to structural deformations if possible (26); linear potentiometers to measure displacements of the expansion joints in the structure (12), and thermistors to measure the thermal gradients through the bridge cross section (243, including the thermistors associated with the VW gages). The vibrating wire strain gages and thermistor data are recorded statically at four to twenty-four times per day; whereas the accelerometer, resistive gage, and linear potentiometer data are recorded at up to 200 Hz continuously during the day, and then processed daily to save a shorter period of data coincident with the VW data, and the asynchronous major events of the day.

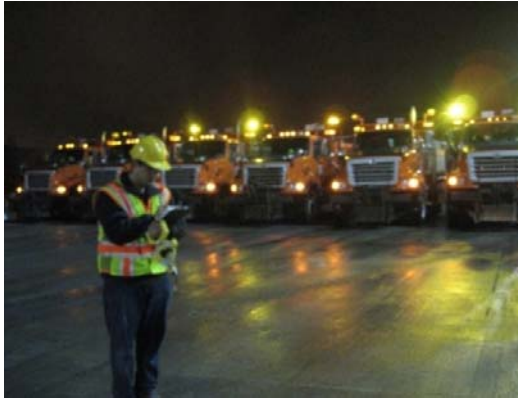
FIGURE 7: TRUCK ORIENTATION ST I

Prior to opening the bridge to traffic, a series of static and dynamic truck load tests were conducted on the evenings of September 14 and 17, 2008. The loads were provided by a series of eight heavily loaded sand trucks which were carefully weighed and measured before the tests. The vehicles each weighed approximately the same and had a combined weight of approximately 400 kips (1,800 kN). The trucks were positioned in a series of different pre-established configurations on the bridge. For the static tests, the trucks were stationed at each of the pre-established locations long enough to typically capture three readings. Several of these tests were also repeated over the course of the evening as time permitted. One of the configurations (ST I) is shown in Figure 7, for which case the eight trucks were positioned across the width of the bridge.

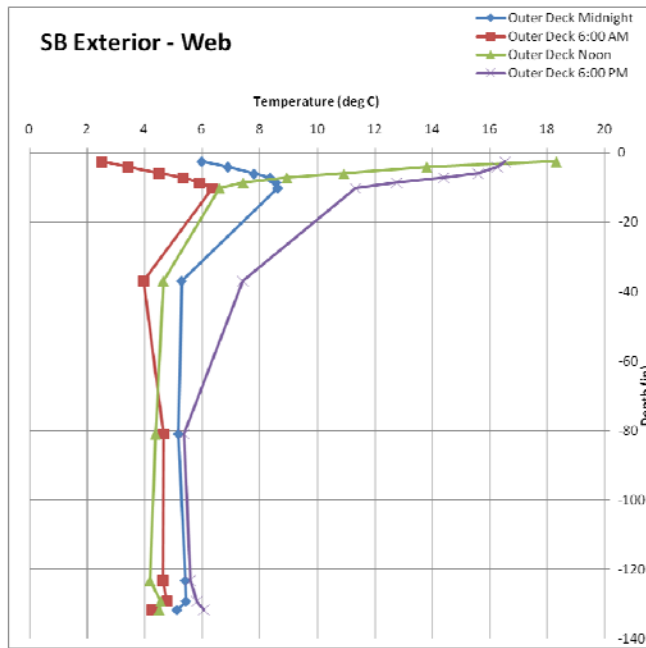
FIGURE 11: MEASURED THERMAL GRADIENTS THROUGH THE SECTION DEPTH OF WEB (MIDSPAN OF SB SPAN 2) 4/9/2009

In addition to calibrating the FEM model with the truck load tests, studies are underway to calibrate the model with the measured results due to environmental effects including the effect of the thermal gradient on the structure. Figure 11 shows thermal gradients measured through the cross section of the bridge obtained at four times over an 18 hour period. The effect of solar radiation has a dramatic effect on the thermal gradient through the section particularly in the April to late June time frame.

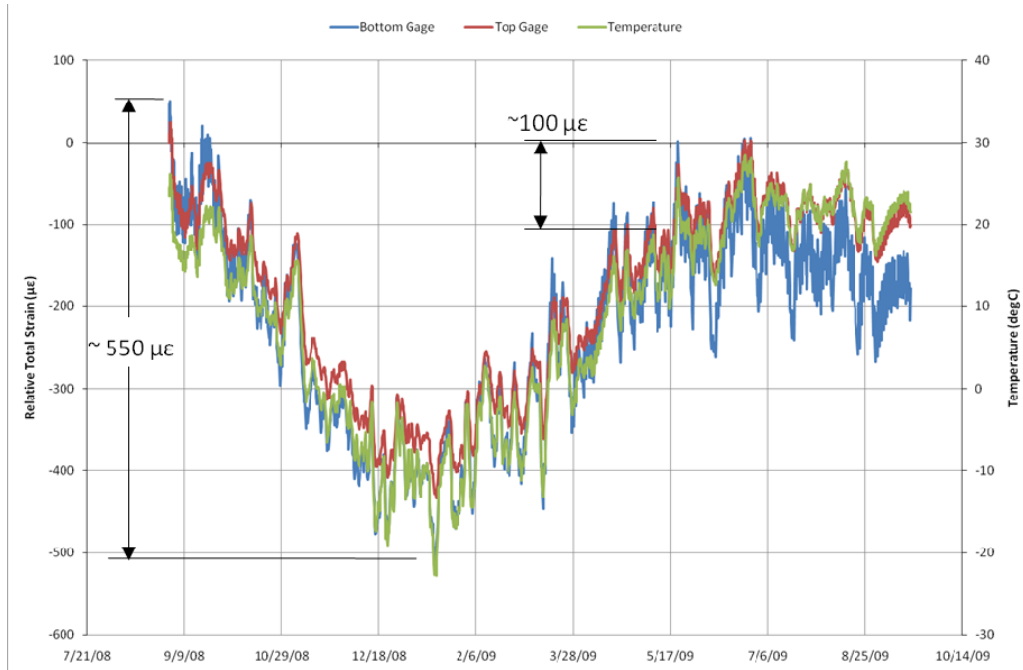
FIGURE 13: MEASURED TOP AND BOTTOM TOTAL STRAINS (MIDSPAN OF SB SPAN 2) VS. TIME (OVER 12 MONTH PERIOD)

Figure 13 shows the data from the same strain gages (i.e., in the top and bottom of the box section near midspan of SB Span 2) that were measured four times a day (i.e., midnight, 6:00 am, noon and 6:00 pm) over a ten month period (arbitrarily zeroed on September 1, 2008). As evident in the figure, the daily changes in total strain of the top gages ( $\sim 100\mu\epsilon$ ) due to the thermal gradient and temperature changes were nearly five times the magnitudes of those obtained during the truck load test with the eight trucks stationed across the bridge at this section (i.e.,  $\sim 20\mu\epsilon$ ). The seasonal changes in total strain were more than  $500\mu\epsilon$  for the same gages.

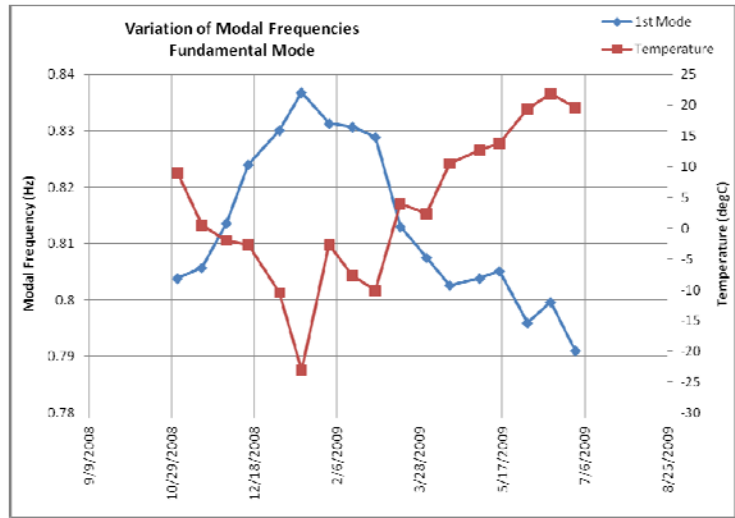
FIGURE 15: MODAL FREQUENCIES OF SPAN 2 (OVER EIGHT MONTH PERIOD)

Besides having a significant effect on the strain measurements, the temperature changes also appear to affect other bridge properties including the modal frequencies. Preliminary data obtained from the accelerometer at midspan of Span 2 was used to determine the modal frequencies. To obtain this data, input averaging of 20 points was used on the dynamic data collected at 200 Hz over an approximately half hour period to obtain greater resolution in the frequencies in the 0 to 5 Hz range where the structural frequencies were expected to reside. The resulting Fast Fourier Transform (FFT) applied to the data showed three strong peaks at approximately 0.8 Hz, 1.5 Hz, and 2.3 Hz as shown in Figure 14, which compared reasonably well with the data obtained from the FEM model. In the FEM model, the frequencies around 0.8 Hz and 1.5 Hz represented bending modes, while the mode at 2.3 Hz was associated with a torsional mode. The FFTs were then applied to the data bimonthly, to investigate the consistency in the three noted frequencies over time. Figure 15 shows a sample of these results. The variation of the modal frequencies for the first mode is shown compared with the bridge temperature at the time of measurements. Data obtained for the other modes showed similar variations with respect to temperature. It appears that there is some correlation between temperature and bridge modal frequencies. As the temperature increased, all modal frequencies were observed to decrease. Further studies regarding this behavior are currently underway.

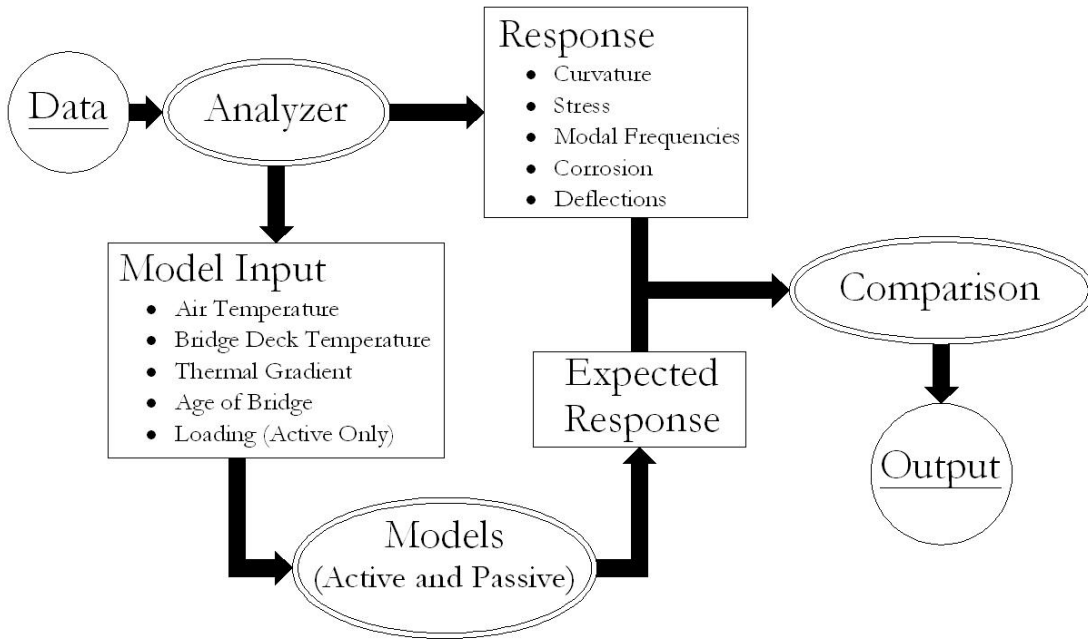
FIGURE 16: SCHEMATIC FOR DEVELOPMENT OF STRUCTURAL MONITORING SYSTEM

Figure 16 shows a schematic that illustrates the plan for the structural monitoring system under development. In the schematic, the raw *data* from the multiple dynamic and static acquisition systems is collected and *analyzed* or processed. The outputs of the processed data are then considered either *model input* (e.g., thermal effects) or *response* (i.e., measured responses of the bridge associated with the measured model inputs). The *model input* is used to determine *expected response* (e.g., expected bridge curvatures, deflections, etc.), by means of a “*passive*” or “*active model*.” A “look-up” table, as described above, is an example of a “*passive*” *model*. An example of an “*active*” *model* would be a study with the calibrated FEM model to investigate an intermittent load test of the bridge. The *expected responses* from the *active* or *passive models* would be *compared* to the measured “*response*” of the bridge. The system would then *output* the results of the comparison to the bridge management engineer. Example outputs include notifications when the measured *responses* are out of range of the *expected responses* which may warrant further examination.
