RAPID BRIDGE REPAIR / REHABILITATION IN WASHINGTON STATE

US 2 Ebey Slough Viaduct – Repair with Carbon Fiber Reinforced Polymer (CFRP)

I-90 Homer Hadley Floating Bridge – Replacement of Modular Expansion Joints

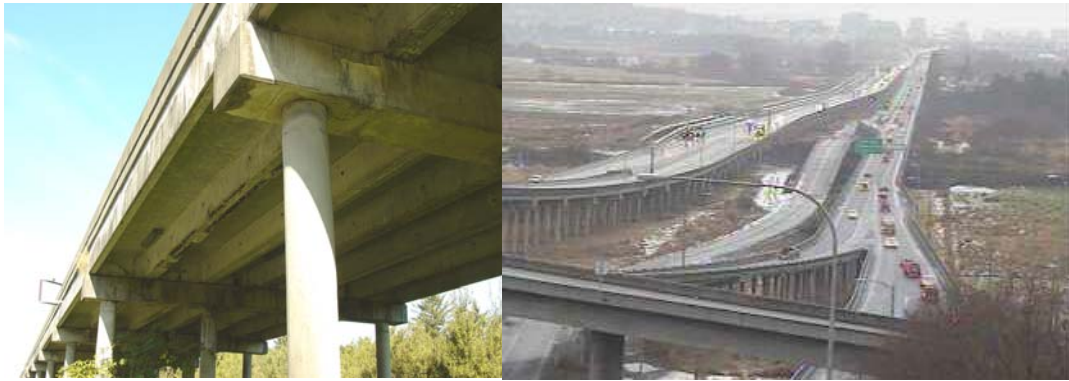
EBEY SLOUGH VIADUCT

The Ebey Slough Viaduct was constructed during the late 1960's and opened to traffic in 1968. The bridge carries nearly 35,000 vehicles per day and provides a vital link between western and eastern Washington. The bridge spans a river and slough area that floods every year. The bridge has several different superstructure types and is 11,909 feet (3630 meters) in length with a total of 256 spans.

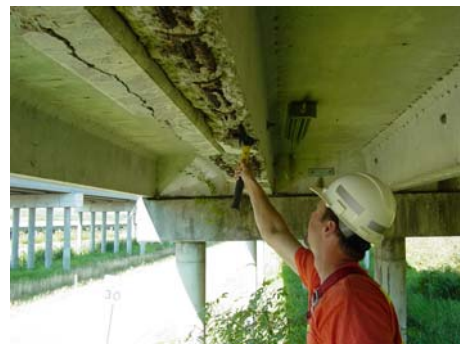
Each individual unit has a bundle of four #11 reinforcing bars at the bottom of each web covered with 1 inch of concrete. The precast concrete units also have grouted keyways between them. Over the years the grout in the keyways had deteriorated allowing water and deicing salt to penetrate between the precast units which caused the main longitudinal steel reinforcing bars to corrode and spall off the concrete cover. Areas of exposed and corroded reinforcing steel are scattered, but mostly predominant in the exterior units.

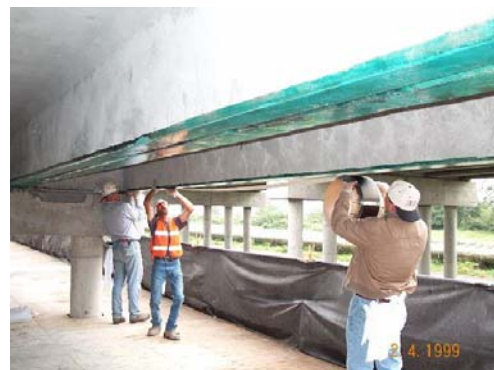
CFRP composites have positive attributes including high strength-to-weight ratios. Additionally, the designer is afforded the flexibility of orienting stiffness and strength in the directions required. FRP composites have high resistance to fatigue and corrosion. Compared to other rehabilitation methods, FRP composites minimize handling difficulties and can be installed in limited access situations, often with minimal disruption to traffic.

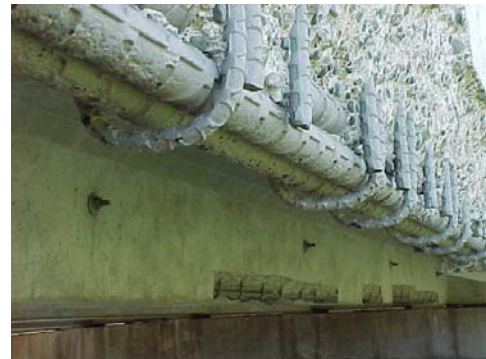
Prior to structural design of the Ebey Viaduct repairs, a field survey was conducted to estimate steel corrosion losses at various locations. Based upon these estimates, a stress-strain compatibility analyses was performed to establish the carbon fiber ply cross sectional area required to regain structural moment capacity. This was done for varying levels of steel reinforcement bar corrosion loss.

Carbon fiber ply application plans specifying carbon fiber ply tensile capacity requirements were developed for each span for the contract documents. Multiple longitudinal plies were required by the design calculations. In areas where very severe spalling had occurred, transversely oriented carbon fiber plies were specified to resist horizontal shear across the existing concrete-to-repair mortar interface.

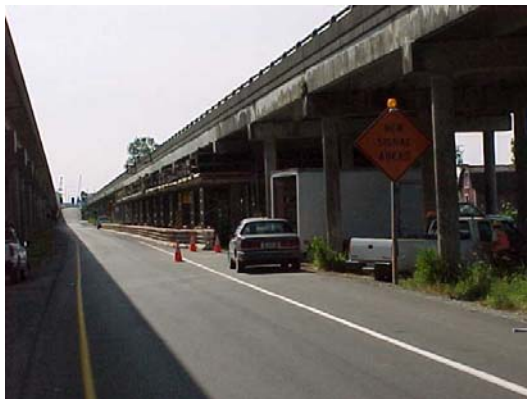
Pilot Project on eight spans

WSDOT bridge engineers selected a 304 feet (92.7 meters) long eight span section of the bridge for a pilot project. The objective of this pilot project was to assess the feasibility of rehabilitating all the precast concrete tub units on the entire bridge using advanced composite CFRP materials, both from an economic and a durability perspective. The use of CFRP would provide a way to repair and strengthen the bridge with minimal disruptions to traffic.

The overall scope of work included setting up a containment and work platform. Removal of the existing ACP overlay to allow repair of deck delaminations and to inspect and repair the longitudinal keyway joints between adjacent concrete units. To repair the grouted keyways, the contractor sawcut 9 inches (23 cm) deep to the mid-depth of the keyways and cleaned and filled the resulting 1 inch wide gap with low modulus epoxy. A new deck membrane and ACP overlay was then placed on the roadway deck side of these eight spans. Upon completion of the overlay repairs, the spalled concrete web surfaces were prepared for placement of repair mortar. After repair mortar placement, carbon fiber plies were bonded to the web bottoms.

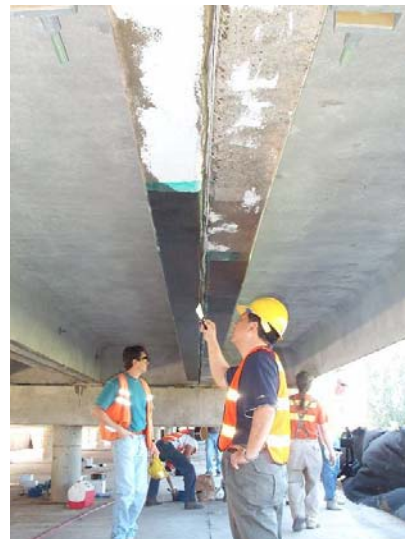
The carbon fiber supplier's willingness to be on the jobsite to provide technical guidance and train to the contractor was directly related to the success of the project. The supplier and contractor's work crew had a meeting prior to the carbon fiber application. Previous projects nationally have demonstrated that CFRP can be bonded under full traffic conditions to strengthen bridge superstructures. In order to evaluate several construction staging options, span-specific traffic control requirements with respect to placement of repair mortar and CFRP strip bonding were specified. Two traffic control conditions were imposed during construction: full traffic closure and a restricted traffic condition with vehicle weights limited to five tons at a maximum speed of 25 miles (40 km) per hour. Durability and performance of spans repaired under the two different traffic control scenarios will be examined and taken into consideration in developing a long-term repair strategy for the entire bridge.

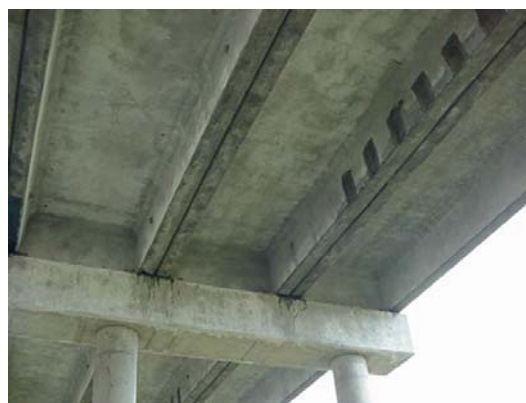
Ten years following construction, all CFRP repaired concrete areas have been inspected with the longitudinal joint repairs and carbon fiber reinforcement performing as originally designed with no visible deterioration. It is anticipated that this repair will provide 25 years or more of service.

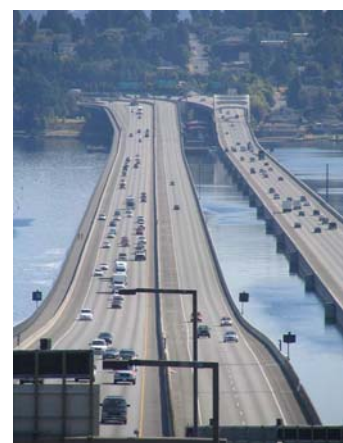
The Interstate 90 “Homer M. Hadley” bridge is the third floating bridge to be constructed across Lake Washington between Mercer Island and Seattle and carries five lanes of traffic (three for westbound and two reversible). This bridge was officially opened on June 4, 1989 and is 5,811 feet (1771 meters) in length with eighteen floating

The bridge has transition spans at both ends that allow traffic to move from the approaches to the floating sections and to allow boats to go under the bridge. The longitudinal movement, which represents a combination of wind and wave loading, seasonal water level fluctuations, and thermal variations in the bridge are accomplished through the steel modular expansion joints.

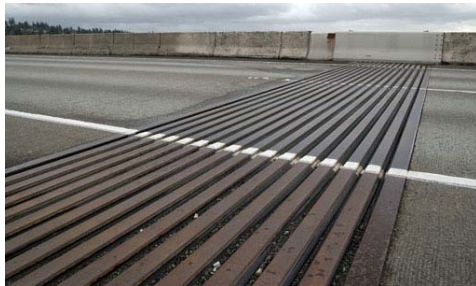
ORIGINAL MODULAR EXPANSION JOINTS

The section of the bridge with the three westbound lanes has two large movement modular joints (48 inch, 122 cm) that are 63 feet (19.2 meters) in length and the section with two reversible lanes has two large movement modular joints (48 inch, 122 cm) that are 40 feet (12.2 meters) in length. Thus there are a total of four of these sizes of joints

The original modular joints were designed, fabricated, and installed prior to the advent of fatigue-based design and manufacturing criteria for modular expansion joints. The joint manufacturer chose to use a hollow tube shape for the main transverse center beams.

Fatigue cracking initiated in the hollow tube and the welded support bar connection within 18 months after the Homer Hadley Bridge opened to traffic.

A decision was made in 2007 that all four of the 48 inch (122 cm) movement steel modular joints needed to be replaced due to the amount of fatigue cracking in the transverse center beams and the high risk associated with a potential failure. In order to meet the fatigue resistant design criteria, the new center beams are solid and one inch wider than the center beams in the original modular expansion joint.

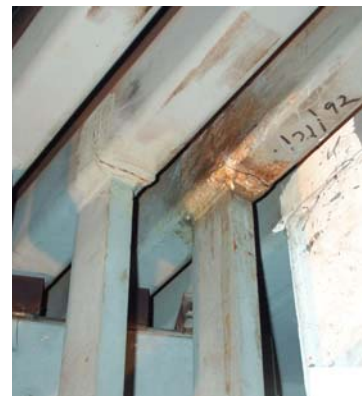
WSDOT developed some research projects with the University of Washington to investigate the cause of the cracking. The university performed field measurements of the dynamic wheel loads. The location and extent of the cracks were also carefully monitored. Repairs were made in several instances by welding the cracks but nearly all of these locations cracked again.

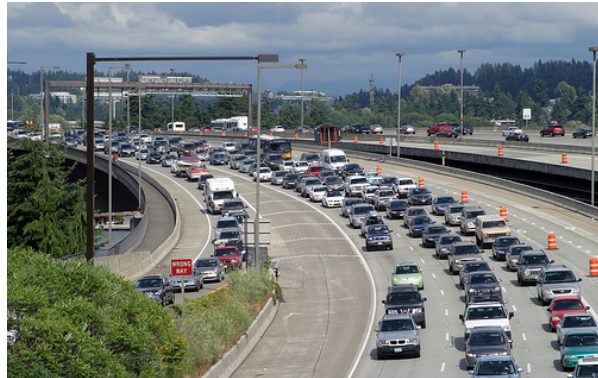
Stage 1 replaced the two 40 foot long joints located in the reversible lane roadway. All traffic used only the three westbound lanes. The first closure began on May 4, 2009 and was completed on May 16, 2009. The contract allowed 19 days with the contractor completing the work in 12 days. For the first closure, the contract had a provision to pay the contractor an extra \$40,000 for each 24 hour period completed early. Total was not to exceed \$160,000.

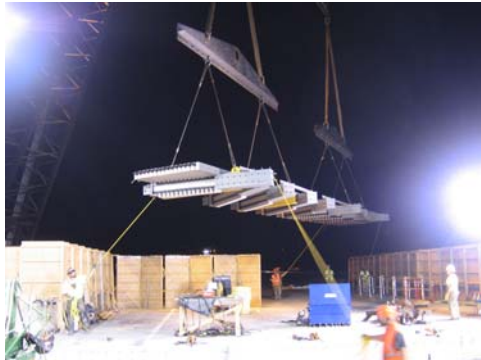
Our Special Provisions required that the contractor submit structural analyses verifying the load carrying capacity of the bridge for the specific cranes that would be used. Given the weight of each joint being installed and the boom radii that would be required to position these joints in their respective blockouts, we realized that the contractor would need some pretty substantial lifting equipment. Additionally, we required that the contractor operate all cranes on a

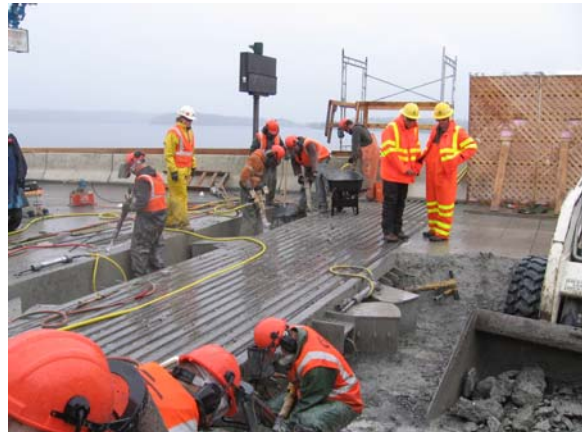
The contractor developed a good method to remove the concrete in the header area on both sides of the existing expansion joint and removal of the existing joint. A large concrete saw was used to cut a line across the bridge at the removal limits. Workers then used chipping hammers to remove the concrete.
