DEVELOPMENT OF AN EXPANSION DEVICE FOR COLD REGIONS

- TEST INSTALLATION OF AN EXPANSION DEVICE ON A NATIONAL ROUTE 274 INTERCHANGE VIADUCT -

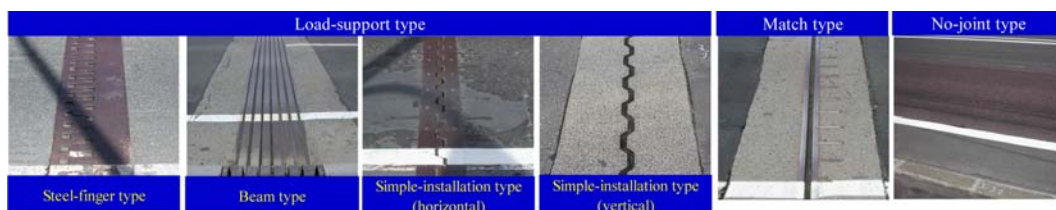
Figure 1.3 shows the types of target expansion devices, of which 60% were the load-support types, 20% were the no-joint type and the other 20% were the match type.

FIG. 1.3 TYPES OF EXPANSION DEVICE

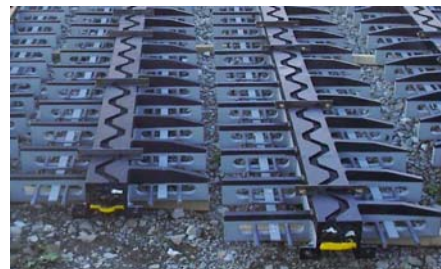
PHOTO 3 IMPROVED EXPANSION

- (1) Safety against snowplow-related impact must be ensured.
- (2) The cutoff structure must be strong enough to resist damage from sediment accumulation and compacted snow in expansion gaps where wheel loads are transmitted.
- (3) Resistance to corrosion resulting from the spreading of antifreeze agent, etc. must be improved. Examination of the internal structure of expansion devices Figure 3.1 presents the examined part, and Photo 3.1 shows the improved expansion device.

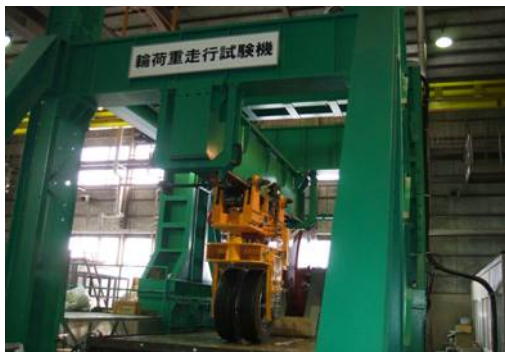
In the fatigue experiment, the method of using a crank-type wheel running machine (owned by the Civil Engineering Research Institute for Cold Region) was adopted. This technique has been established as a method of testing fatigue durability acceleration for road bridge slabs. The experiment is currently under way using a machine with rubber tires rather than the conventional iron wheels (as shown in Photos 4.1 and 4.2) to simulate actual running conditions.

PHOTO 4.1 WHEEL RUNNING MACHINE (FULL VIEW)

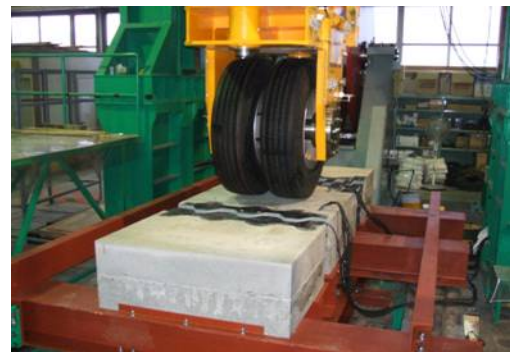
PHOTO 4.2 WHEEL RUNNING MACHINE

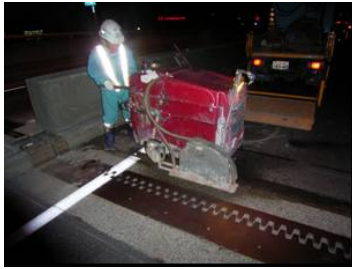
PHOTO 4.3 CUTTING

- 1) Cutting: Cutting was conducted by marking the predetermined positions (Photo 4.3).
- 2) Removal of the existing expansion device and concrete: Existing concrete was removed using a breaker. The existing expansion device was removed by gas-cutting the finger parts of the face plates (Photo 4.4).
- 3) Installation of the expansion device: The expansion device was installed in the rectangular opening by setting a hanging angle after temporary assembly (Photo 4.5).

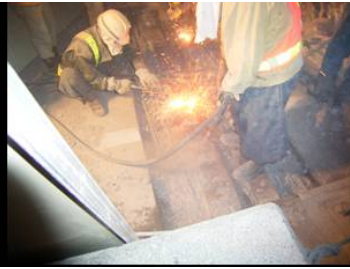
PHOTO 4.4 REMOVAL OF EXISTING DEVICE

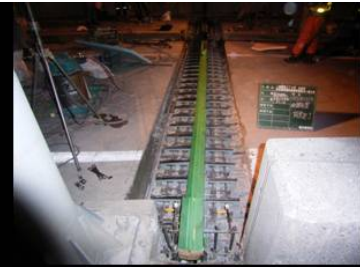
PHOTO 4.5 INSTALLATION OF NEW DEVICE

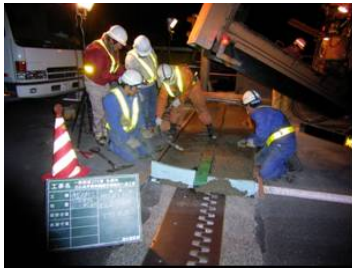
PHOTO 4.6 CONCRETE PLACEMENT

- 4) Placement of ultra-rapid hardening concrete: Ultra-rapid hardening concrete was placed after installation of the expansion device was complete. The concrete was blended and mixed on site using a jet mixer truck. After placement, a curing time of three hours was observed in principle (Photo 4.6).
- 5) Asphalt pavement: After the ultra-rapid hardening concrete had cured, its top surface was paved with asphalt. While concrete is usually placed up to the installation surface in repair work due to time constraints, asphalt pavement was used in this case in consideration of preventing damage to the surrounding pavement (Photos 4.7 and 4.8).

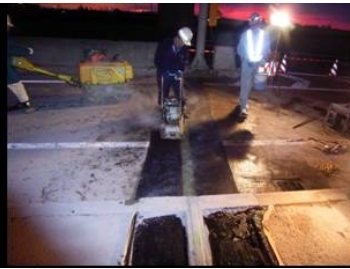
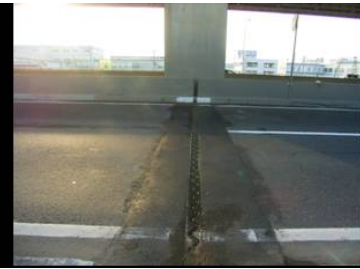
PHOTO 4.7 PAVEMENT

PHOTO 4.8 AFTER COMPLETION
