## FATIGUE AND CORROSION IN CONCRETE DECKS WITH ASPHALT SURFACING

### **Abstract**

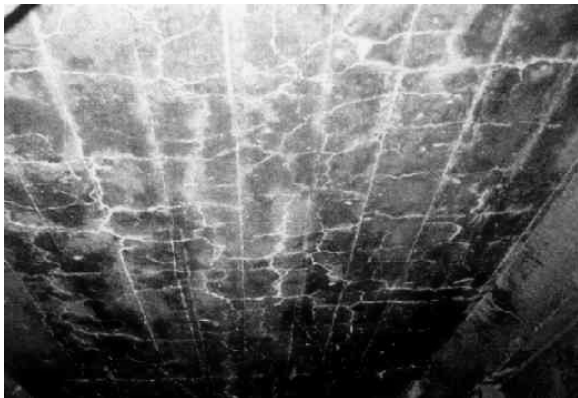
(a) Grid cracks

(b) Through hole

Fig. 2 Deterioration due to fatigue in reinforced concrete decks

In Japan, fatigue due to cyclic loading of heavy trucks is major deterioration of concrete decks shown in Fig. 2 to date. Currently, however, attention should be paid not to only fatigue, but also chloride-induced deterioration on the concrete decks, because salt use have been increasing since spike tires were prohibited in 1990s as shown in Fig. 3.<sup>2, 3</sup> Figure 4 shows chloride-induced deterioration observed on a bridge deck in Japan the late 1990s. While corrosion due to deicing salt is not often observed in national roads and rural roads, significant corrosion on bridge decks in expressway was reported.<sup>4</sup> In addition, most of existing bridges were built from the mid-1950s to the mid-1970s, having lower potential for fatigue durability than current bridges (Fig. 5, 6). The possibility of combined deterioration from fatigue and corrosion should be taken into account in maintenance of existing highway bridges.

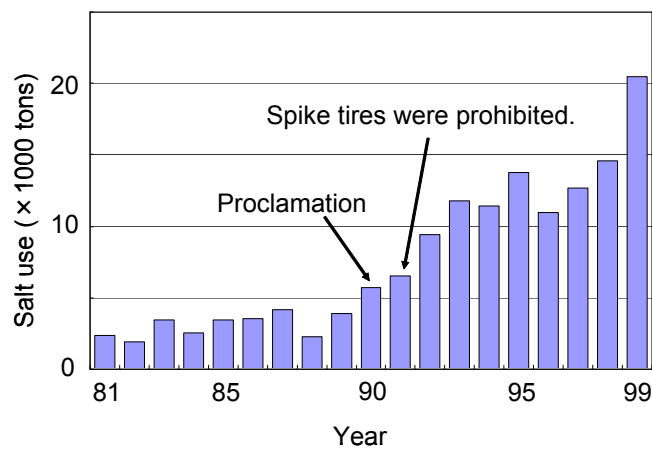
Fig. 3 Trends in deicing salt use in Tohoku region in Japan

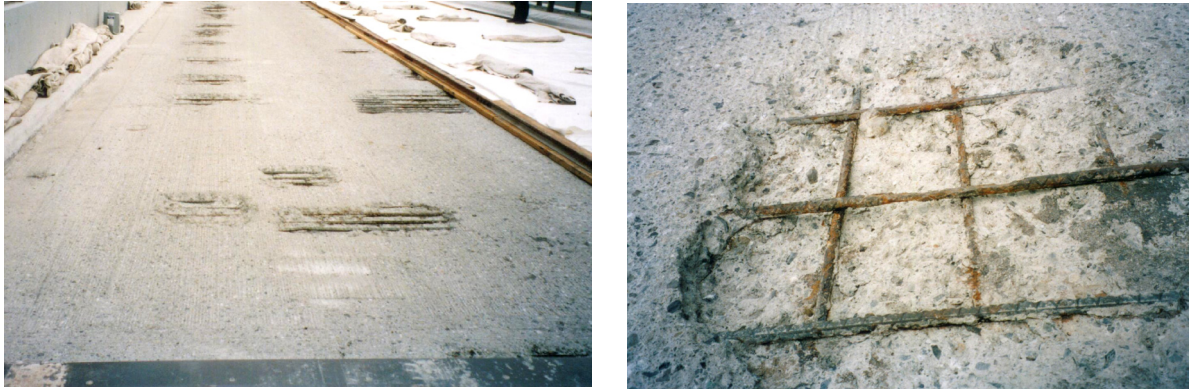
Fig. 4 Corrosion of top mat reinforcement due to salt use in reinforced concrete decks  
Both photo shows top of decks after asphalt and spalled concrete cover were removed.

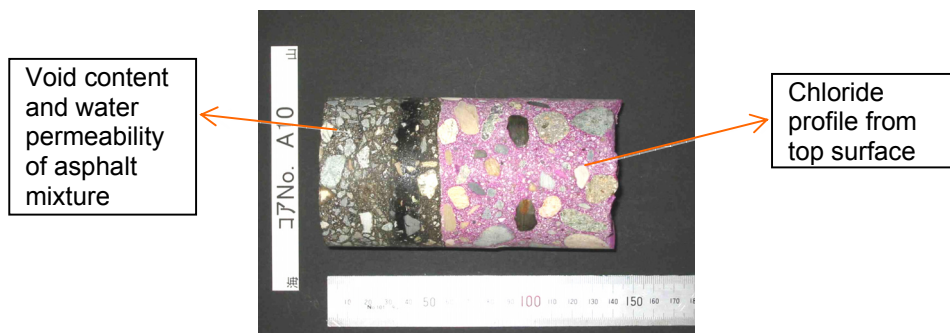
Fig. 8 A core with 70 mm dia. taken from the road surface of a closed prestressed concrete bridge at coastal area and purposes of the core

Test cores consisting of asphalt mixtures and portland cement concrete of decks were taken from the closed bridges before removing asphalt surfacing (Fig. 8). Content of acid-soluble chloride ions in each slice with 10 mm depth of concrete cores was determined. A percentage of void content of asphalt mixture cores  $V_v$  was determined as described below.

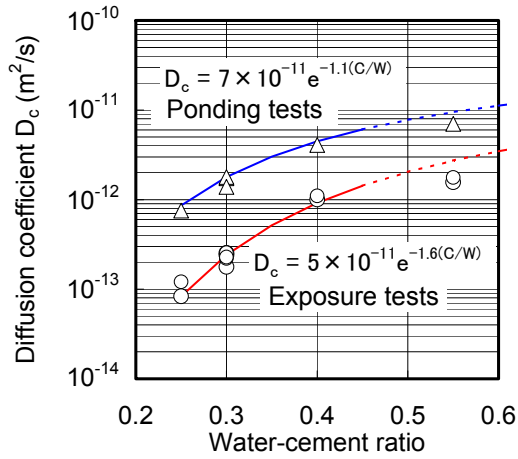
Fig. 12 Difference in diffusion coefficients of chloride ions in concretes between exposure test at coastal area and ponding test in salt water<sup>8</sup>

As shown in Fig. 12, the diffusion coefficient obtained from ponding tests in salt water significantly differs from that obtained from exposure tests in airborne chloride environment at coast.<sup>8</sup> Consider the diffusion coefficient of top cover concrete in decks, while the condition of bare concrete of curbs corresponds to that of the exposure tests, the condition of concrete decks covered with chloride-contaminated water under asphalt mixtures is probably close to that of the ponding tests indicating rapid chloride penetration. In addition, water ingress accelerates disbonding between asphalt surfacing and concrete, providing a fine soil layer in the boundary. The soil layer keeps the surface of concrete wet for long time, forming the condition closer to the ponding tests.

As an attempt, the exposure time is estimated using the diffusion coefficient predicted from Fig. 12. Since water-cement ratios of old structures are not exactly predictable, average values of reinforced concrete and post-tensioned concrete are roughly assumed as 0.55 and 0.43, respectively. Fig. 13 shows the estimated exposure time of the concrete decks under asphalt surfacing. With regard to the results of wet condition, the estimated exposure time of decks on ATG bridge is only 0.2 to 1 year despite the severe chloride environment at coast and the lifetime of 34 years. In cores taken from TYD bridge, obvious chloride profile was obtained from only core T-9 at a joint of asphalt, while deicing salt was applied for long years. The estimated exposure time at T-9 is 8 years. It cannot be determined whether chloride ingress took place after installing a waterproof layer or before.

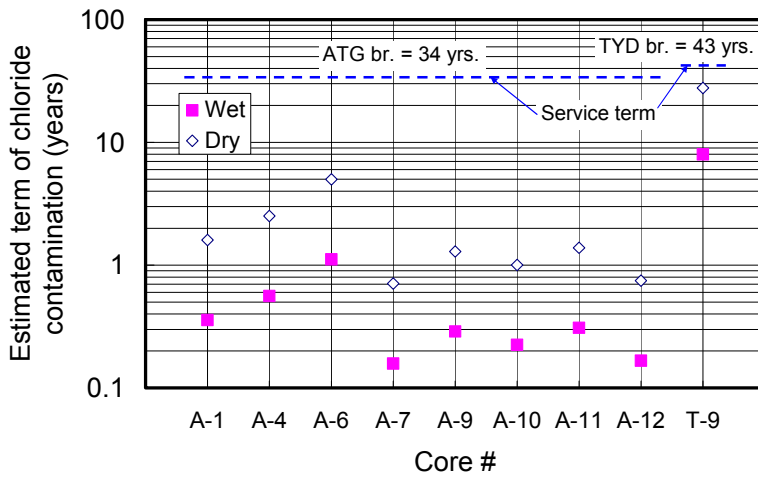
Fig. 13 The estimated terms of chloride contamination at top of decks

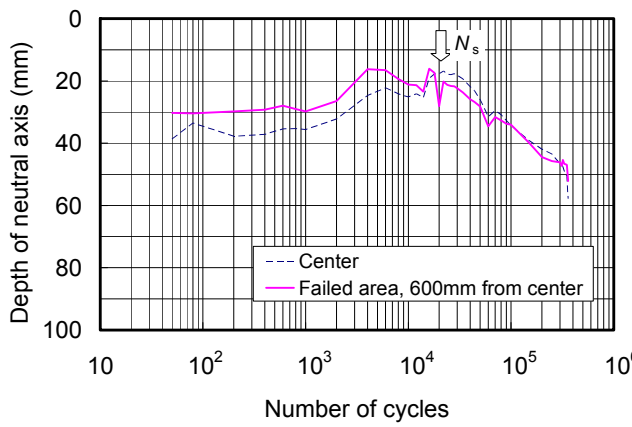
Fig. 17 Relation of depth of the apparent neutral axis from the top surface with cycles

As shown in Fig. 15, cracks were observed in a deck specimen after the truck wheel traveling test. For showing one of the behavior indicating arch action, distributions of axial forces acting on a main tensile reinforcement at the center of the deck are shown in Fig. 16, being measured using strain gages. The distribution at 50 cycles shows typical flexural behavior of a slab. As the number of cycles increases, the distributions changed even through the bar, indicating the behavior of the tie bar. The change was recognized at early stage corresponding to the cycles  $N_s$  that an apparent neutral axis calculated using measured strains of upper and lower steel bars turned to increase as shown in Fig. 17.

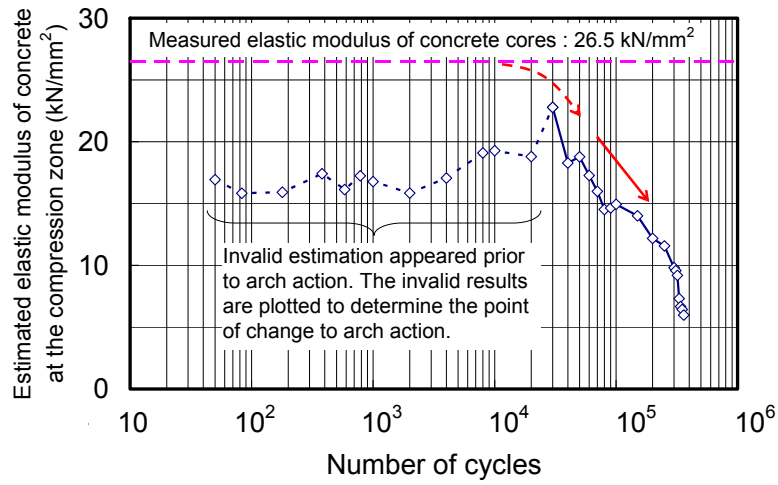
Fig. 20 Decrease in elastic modulus of concrete due to fatigue under arch action

It is known that an elastic modulus of concrete decreases with cycles in fatigue tests. To estimate the elastic modulus of concrete in the deck specimen N, each share of concrete and main compressive reinforcing bars in the internal compressive resultant force under arch action was calculated using measured strains of upper and lower reinforcing bars as shown in Fig. 19. Subsequently, assuming that the share equals to the ratio of concrete area to steel area considering young's modulus ratio, the elastic modulus of concrete in the internal compression zone of arch action was estimated. The result is shown in Fig. 20. It can be recognized that the elastic modulus of concrete in the compression zone rapidly decreased after developing arch action. The turn to increase of the apparent neutral axis observed after arch action was caused by the increase of strains in the upper main reinforcing bars due to the decrease of elastic modulus of concrete in the compression zone.
