REPLACING THE SUSPENDER ROPES OF A TIED ARCH BRIDGE USING SUSPENSION BRIDGE METHODS

BARNEY T. MARTIN, JR., Ph.D., P.E.¹, AND BLAISE A. BLABAC, P.E.²

ABSTRACT:

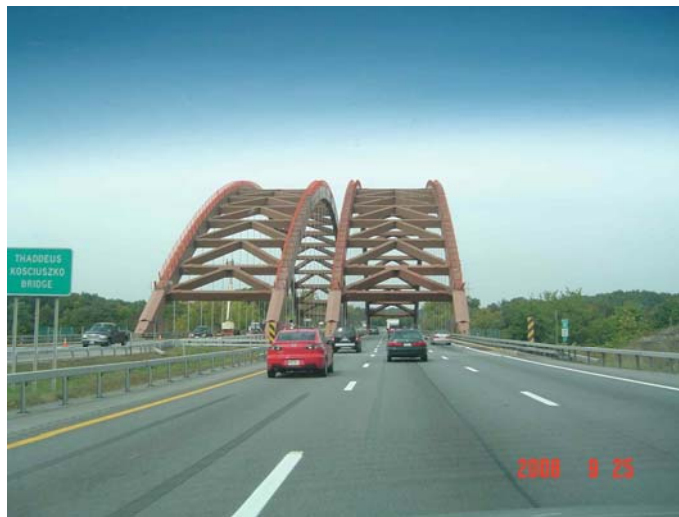
Figure 1 – Northway Twin Arch Bridges (Thaddeus Kosciuszko Bridge), Albany, NY

The Thaddeus Kosciuszko Bridge consists of twin through-arch structures located in the State of New York which span the Mohawk River between the towns of Colonie in Albany County (on the South) and Halfmoon in Saratoga County (on the North). The bridges were built in 1959 and each carries three lanes of traffic in a single direction on the Northway (Interstate 87) – one bridge is for Northbound traffic and the other for Southbound. The bridges carry a high traffic volume of approximately 110,000 vehicles per day.

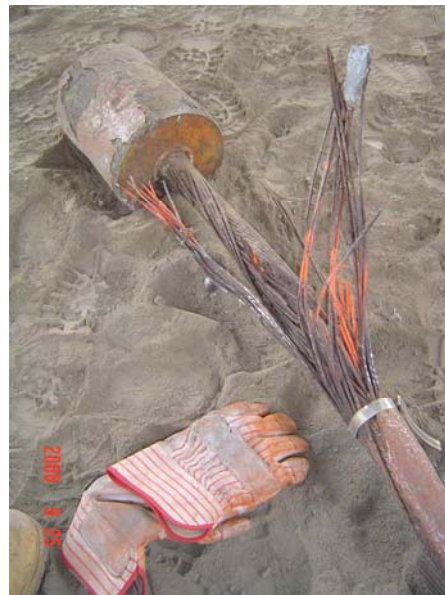
Figure 3 – Photo of Deteriorated Suspender Strand with Broken Wires (After Removal)

In recent years, the condition of the suspender strands had rapidly degraded due to a combination of age and exposure. Salt spray from the adjacent roadway had run down the suspenders over the years, concentrating the damage at the area where the suspender connects to the floorbeam. The suspender strand in the vicinity of the seat angle began to suffer from corrosion related section loss, eventually leading to failure of the individual wires. As the wires began to break, they would splay outward, eventually resulting in a rather dramatic display of deterioration (see Figure 3). In the most extreme cases, section losses of up to 50% were reported. As a result, the decision was made to undertake an immediate replacement of all 168 suspenders on both bridges. Of these, a total of 22 suspenders were identified as requiring emergency replacement.

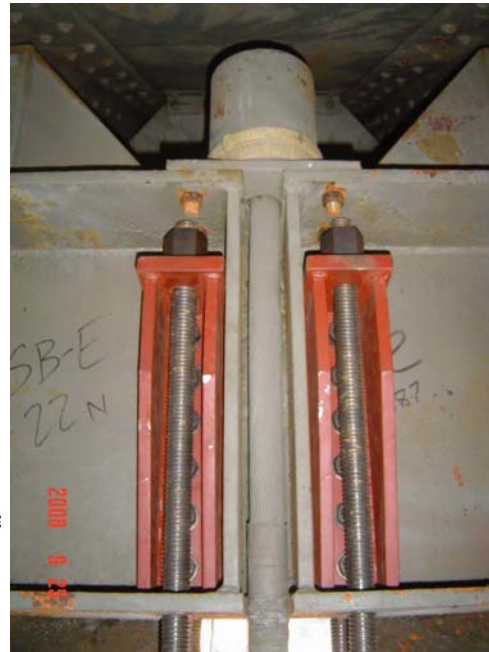
Figure 6 – Connection at Transverse Beam Inside Arch Box

- With the alternative method, there is no change in load path during the removal and replacement of the suspender. The jacking system is attached to both the arch and the floorbeam in a way that is structurally equivalent to the existing suspenders (see Figures 6 and 7).

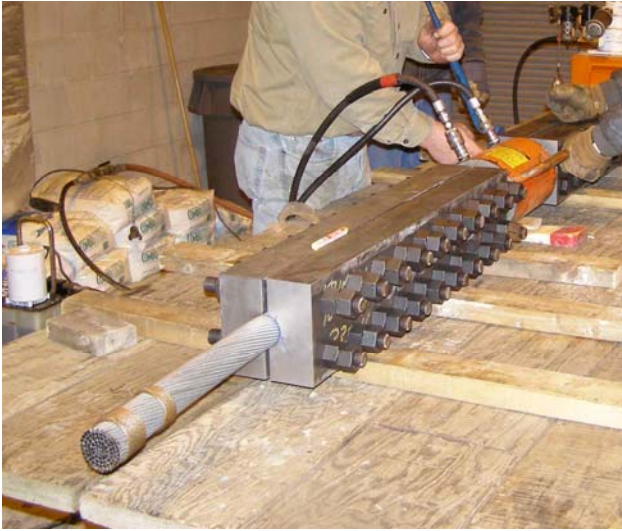
Figure 8 – Friction Clamp During Load Test

The contractor fabricated two friction clamps for the load test based on a preliminary design performed by Modjeski and Masters (see Figure 8). Assuming a friction coefficient of 0.15, the clamps were designed for the required structural lifting load of 445 kN (per suspender) with a safety factor of 1.5 against slip (ultimate capacity of 668 kN). This resulted in a clamp utilizing 20 – 25 mm diameter A325 bolts fully tensioned to a minimum load of 227 kN each (total clamping force of 4,536 kN, min.). For the initial test, the ram was operated to its maximum capacity (890 kN), but no slip occurred in either clamp. This proved the design was adequate; however, in order to determine the coefficient of friction, it was necessary to determine the load at which slip would occur. Therefore, the test was repeated, removing two bolts each time, until slip was achieved. Slip finally occurred at a load of 890 kNs after eight bolts had been removed (12 bolts remaining). Assuming an average bolt tension of 271kN per bolt (227 kN min., 316 kN, max.) with a total clamping force of 3,256 kN, the actual coefficient of friction coefficient was calculated to be 0.27. This meant that the actual capacity of the clamp was 1,223 kN (ultimate) vs. the required capacity of 445 kN, resulting in a safety factor of 2.75 for the design jacking load.

Upon the conclusion of the test, the clamps were opened and the rope was visually inspected by NYSDOT personnel. The load test demonstrated that the galvanized coating was in satisfactory condition – there was localized deformation of the coating due to the high bearing stress on the surface of the outer wires, but the integrity of the coating was not compromised.

FRICITION CLAMP – Rope removal and installation was performed using a friction clamp, similar to those used on previous suspension bridge suspender rope replacement projects. According to the contract specifications, the clamp had to be load tested to determine the friction factor of the suspender strands for use in the design of the clamp. Due to the proposal to use the friction clamp for the installation of the new ropes, the load test was also required to demonstrate that there would be no damage to the galvanized coating of the suspenders as a result of the applied clamping force.

For this project, it was elected not to use a zinc liner at the contact surface between the clamp and the suspender. Previous experience with installing clamps on wire rope suspenders indicated that there would be no damage to the surface of the ropes. The contractor pointed out that clamping devices are used during the manufacturing of both ropes and strands (as part of the stressing beds used to pretension the strands to remove the initial elastic stretch) which do not utilize zinc liners.
