DEVELOPMENT AND PERFORMANCE ASSESSMENT OF A FRP STRENGTHENED Balsa-WOOD BRIDGE DECK FOR ACCELERATED CONSTRUCTION

C.S. Cai¹, Archana Nair², Miao Xia³ and Shuang Hou⁴

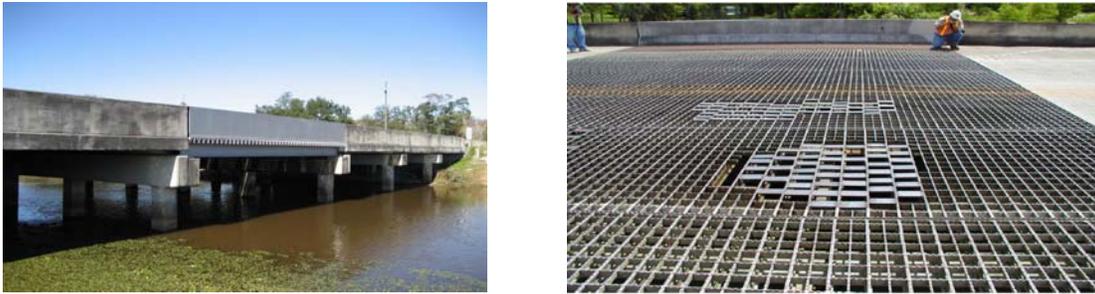
Figure 1 CORIBM bridge

The bridge selected for this study is the CORIBM Bridge on route LA 70 in District 61, Assumption Parish, Louisiana. The bridge was built in 1988, with a design load of HS20-44 and ADT about 6000. The bridge, with a total length of 145 ft (44.2m) and a roadway width of 46 ft (14m), consists of six 20 ft (6.1m) spans and a 25 ft (7.6m) span. The 20 ft (6.1m) spans are concrete structures and the 25 ft (7.6m) span consists of a steel grid deck supported on steel girders. The height of the superstructure from the top of concrete pedestal to the top of roadway is about 20in (0.51m). The 25 ft (7.6m) steel span is designed for being lifted for river navigation when needed. **Error! Reference source not found.** shows the damaged grid deck that needs to be replaced in the 25 ft (7.6m) span. The requirement of being movable, the appropriate span length, and the existing height of the superstructure 20 inches (508mm) makes this steel span a good candidate to be replaced with a FRP slab system.

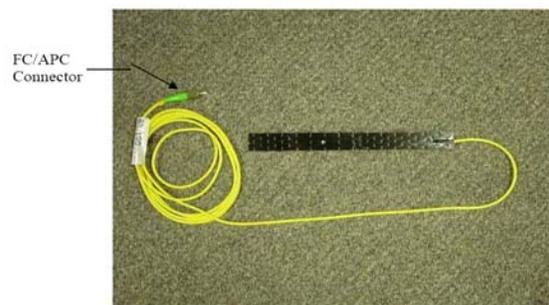
Figure 2 Composite deck mountable packaged sensor

requires customization. The type of application, material surfaces on which the sensors need to be attached, etc play a vital role in deciding the appropriate gauge packaging. To attain realistic strain values, the gauges attached on the deck were packaged with a strip of carbon fiber (Fig. 2) while steel shims with shallow grooves (Fig. 3) were chosen for the steel girder gauges. All packaged gauges were tested in the laboratory before installation to ensure their functionality.

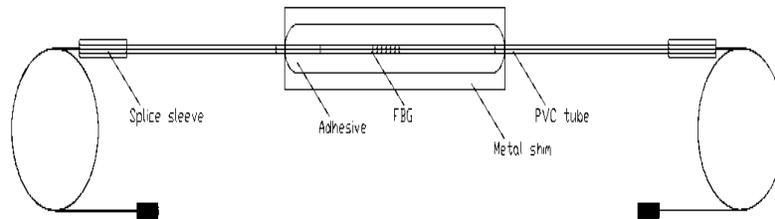
Figure 3 Steel girder mountable packaged sensor

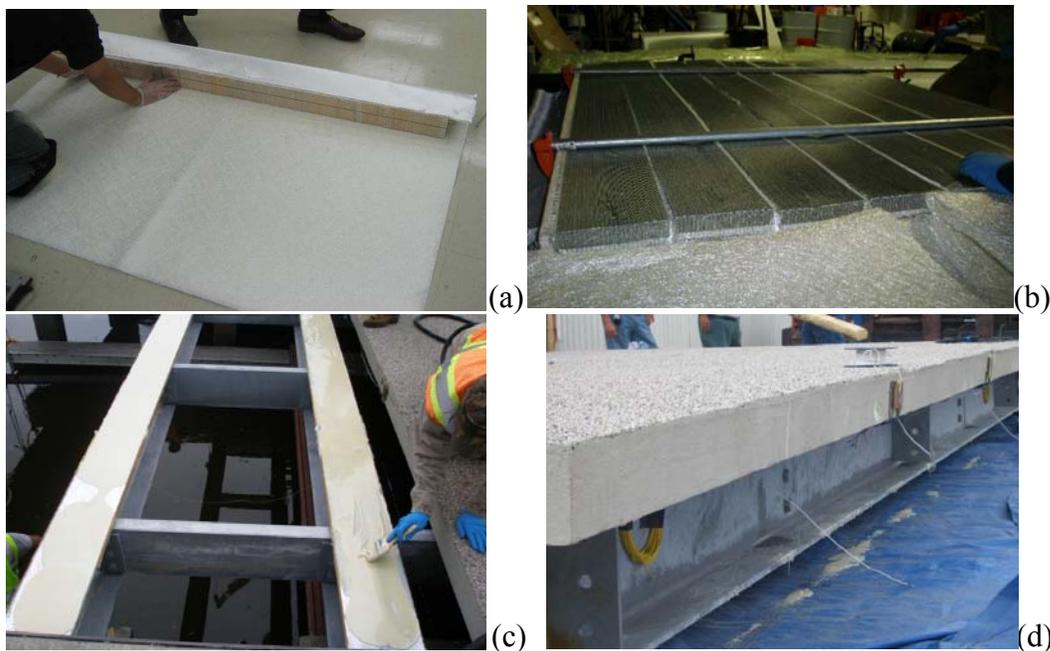
Figure 4 FRP-wrapped Balsa wood bridge deck installation: a) Balsa wood beam wrapped with FRP material b) FRP deck assembly c) Application of bonding agent on girder d) Finished FRP deck attached to steel girder.

The new bridge deck consists of pre-fabricated FRP-wrapped balsa wood units. The fabrication sequence of the bridge deck units and final installation are illustrated in Fig. 4(a) that shows the balsa wood beam being wrapped with GFRP sheet. In Fig. 4(b) a single panel is being assembled using several of the wrapped balsa wood beams and hardware layers. The deck was adhesively bonded to the steel girder using customized

epoxy (Fig. 4(c)) and a bonded panel is shown in Fig. 4 (d).

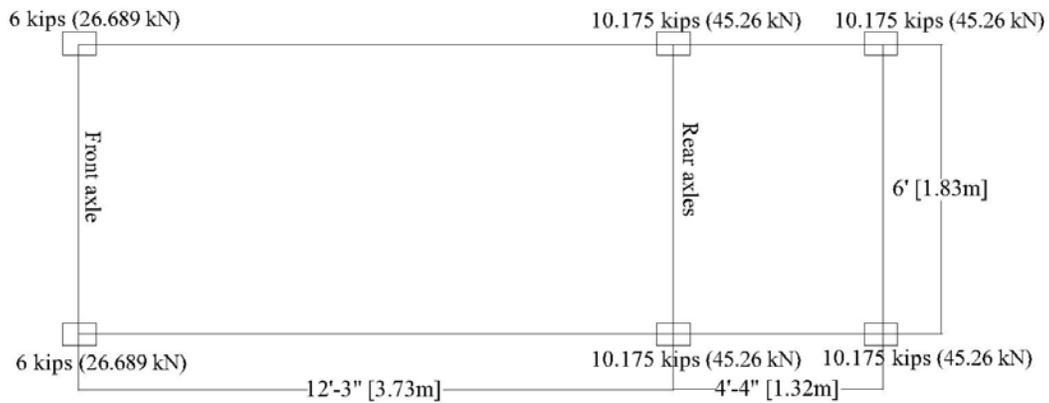
Figure 5 Test truck axle configuration

In this study, the truck loading used in the model was of the actual truck used during live load testing (see Fig. 5). To make a close comparison with the field strain data, the strain data from the FE model was collected from nodes that were located approximately at the same location as the field measurement points. Since strain data comparisons includes data collected from both deck and girder, the FE strain results were correspondingly collected in both the transverse (X) and longitudinal directions (Z).

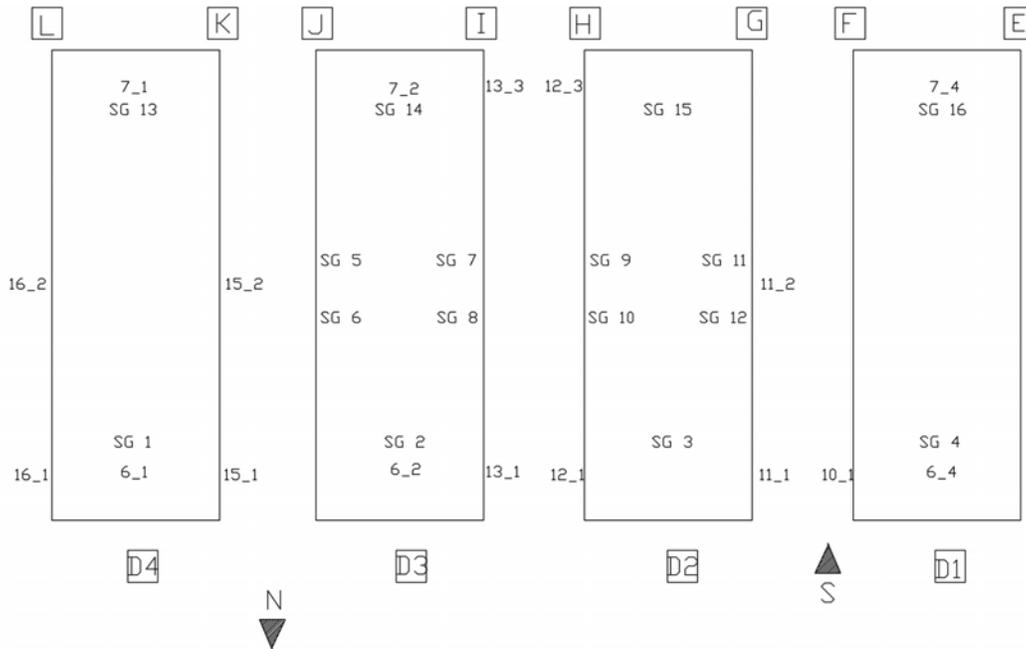
Figure 6 Plan view of all functional strain sensors attached to decks and girders during short-term test (E-L: Girders; D1 – D4: Deck panels; SG: Traditional Strain Gauge; X-1, 2, 3, 4- FBG sensors)

Traditional strain data analysis: The measured static live load strain changes in micro strain ($\mu\epsilon$) at each of the 16 gauge locations were plotted versus time/position along the bridge for all load cases. Fig. 6 is a sensor layout plan for all functional strain gauges installed on the central four panels of the bridge during the live load test. The observations made from only the south bound-lane testing will be discussed in this section. The general trends observed from Fig. 7 to Fig. 8 are: (i) Maximum strains of up to $350 \mu\epsilon$ are observed from the gauges located on the deck for most static rolling load cases. Strain peaks were generally seen to decrease under dynamic test cases from

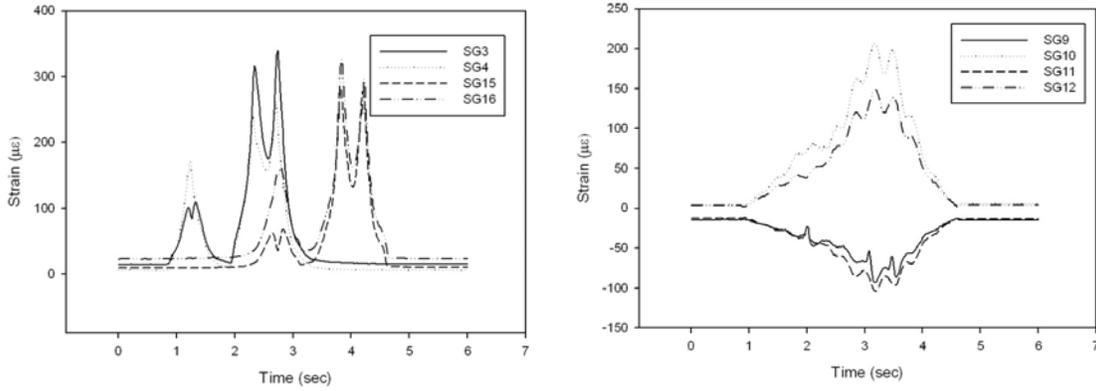
(a) BDI deck strain plot for load case S_SR1

(b) BDI girder strain plot for load case S_SR1

Figure 7 Strain plots of sensors on deck panels (a) and girders (b) for static rolling load cases

sensors attached on the deck; and (ii) The maximum recorded strains on the girders for all load cases fall in the range of 150-200 $\mu\epsilon$. Differences are observed in strain readings at the same location from the top and bottom flanges of the girder implying the presence of composite action between the girder and deck.

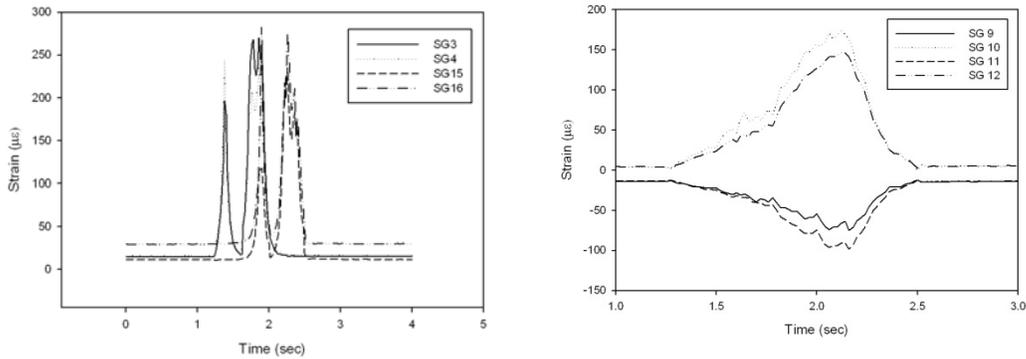
(a) BDI deck strain plot for load case S_D1-30

(b)BDI girder strain plot for load case S_D1-30

Figure 8 Strain plots of sensors on deck panels (a) and girders(b) for dynamic load cases

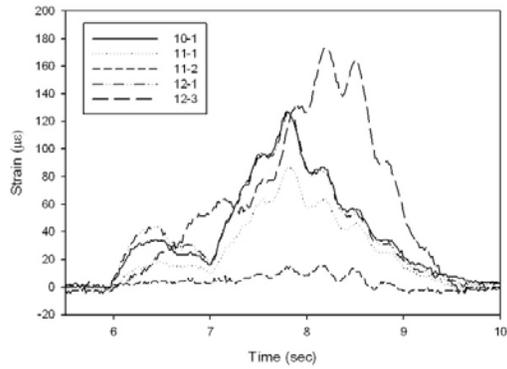
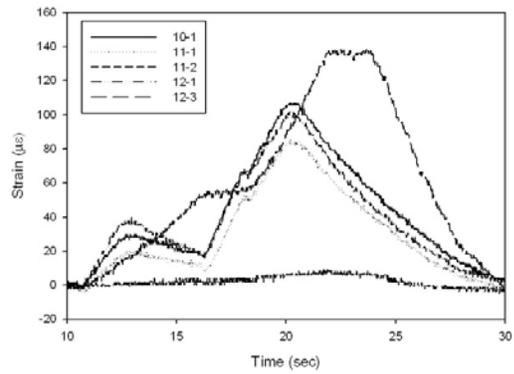
(a) FBG strain plot for load case S_SR1

(b) FBG strain plot for load case S_SR2

Figure 9 Strain plots of girder sensors

FBG strain data analysis: The strain plots for girders (Fig. 9) and decks (Fig. 10) are separately presented here. Again, only south bound lane results are discussed here. Although maximum girder strains range from 150-200 $\mu\epsilon$ (Fig. 9) and strain profile indicates load sensitivity, they do not match up exactly with strain readings from the traditional gauge (Fig. 11). This could be attributed to the lack of direct adhesion of the gauges on the structural surface and thus influence of sensor backing material behavior. Strains from the deck sensors are shown in Fig. 10. Compared to the traditional strain gauge records, the data peaks collected from the FBG sensors for similar load cases seem to show a 25% decrease on average.

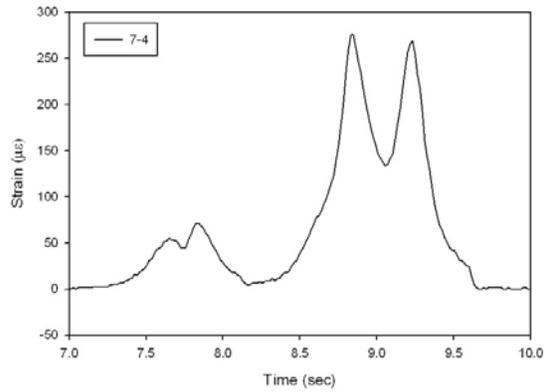
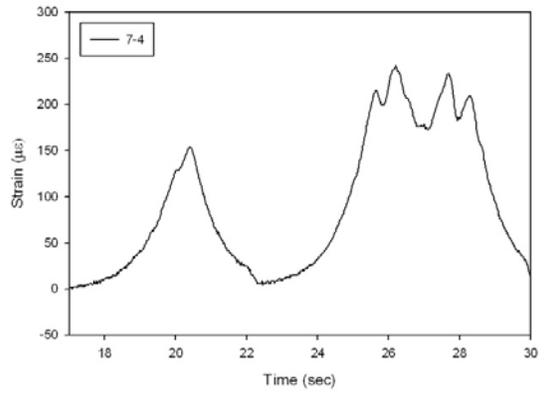
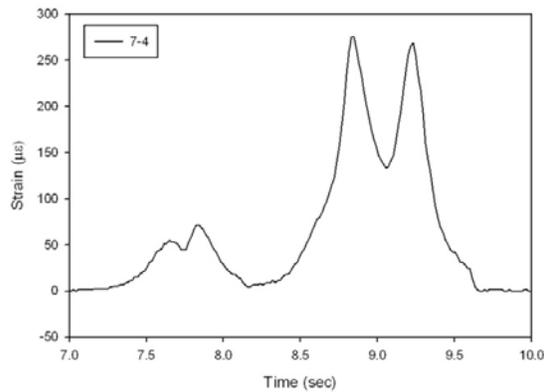
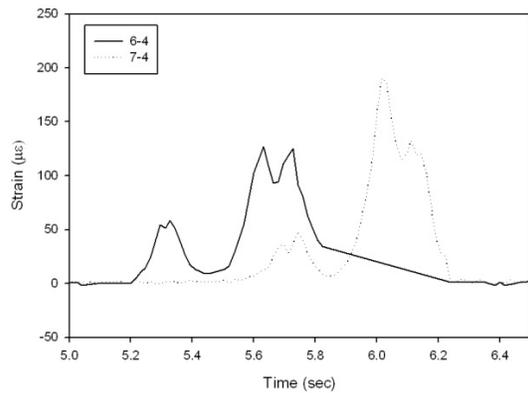
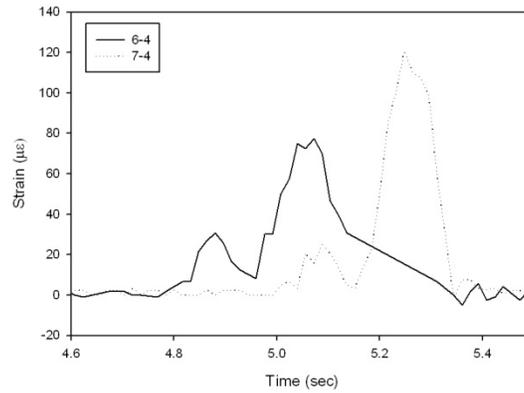
(a) FBG strain plot for load case S_SR1

(b) FBG strain plot for load case S_SR2

(c) FBG Strain plot for load case S_D1-30

(d) FBG Strain plot for load case S_D2-30

(e) FBG Strain plot for load case S_D1-55
 Figure 10 Strain plots of deck panel sensors for all load cases

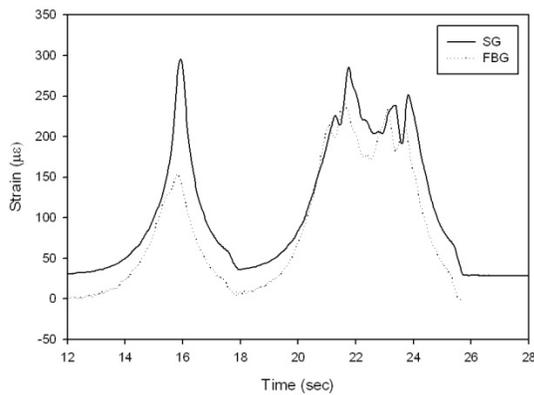
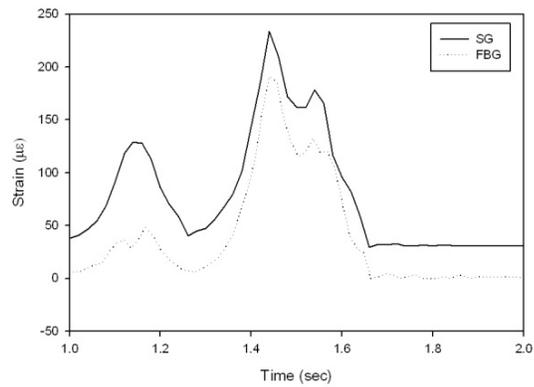
(a) Deck 1(north end) for load case S_SR3

(b) Deck 1(north end) for load case S_D2-30

Figure 11 SG and FBG strain comparison for deck

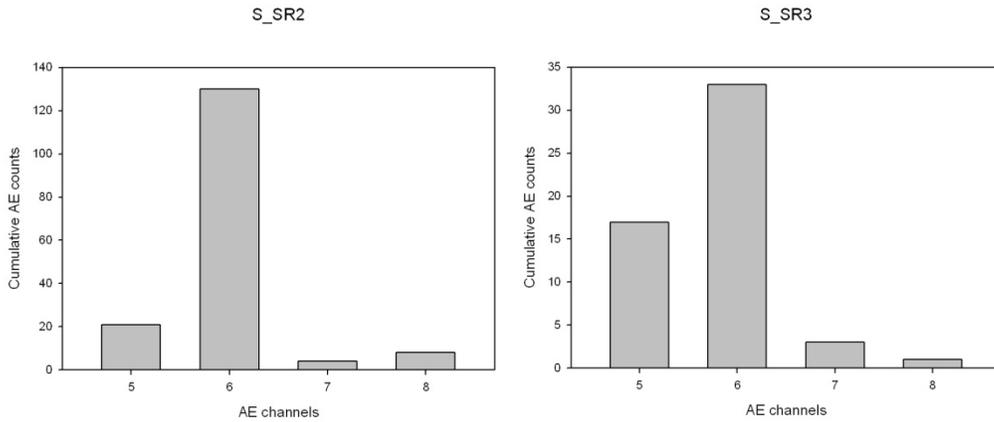
Figure 12 Cumulative AE hits observed by active channels for live load test cases in south bound lane

The results discussed here are for AE data collected when the south-bound lane was tested. When the vehicles moved at a crawling speed of 3-5 mph (1.34-2.23 m/s) the cumulative AE hits collected by each sensor along the tested lane is shown in Fig. 12 (typical). It is observed that the most active channel was channel 6 located close to the midspan of the bridge. The same sensors are observed to collect significantly lower number of AE hits when the static loading case is repeated implying the structures stability under the same load. The AE activity is comparatively higher when the truck enters the bridge than when it exits indicating an impact load induced activity at entry end of the bridge.

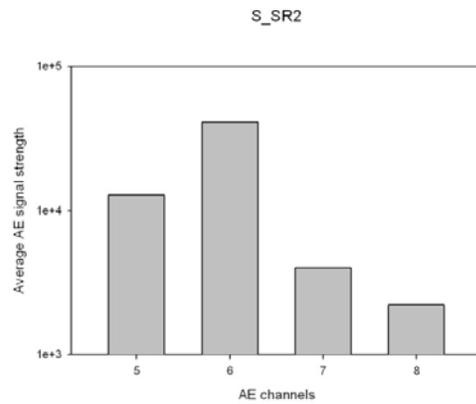
To ensure genuity of the AE data collected the AE signal strength parameter is also assessed and represented in Fig. 13 for the same load cases previously mentioned. As is clear from Fig. 13 the trends observed are similar to the AE counts distribution. The general trend is for signal strengths in all load cases to lie below 105 pVs. Similar trends were observed for the north-bound lane. Although the source of AE hits generated during this test cannot be individually identified, a baseline AE data activity trend has been collected. Any changes to this activity trend in future testing can reveal the

Figure 13 Average AE signal strengths observed

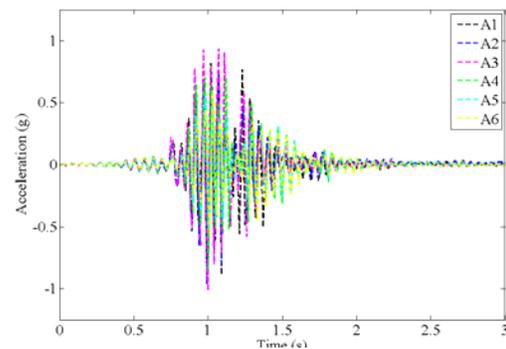
Figure 14 Acceleration at all girder and deck sensors for S D1-55 load case (South bound)

Accelerometer data analysis: Typical acceleration information obtained from dynamic load test cases is plotted in Fig. 14. Gauges A2 and A5 were located on the midspan of the deck while all other sensors were on the bottom flange girder midspan.
