# RESEARCH ACTIVITY UTILIZING DECOMMISSIONED CONCRETE BRIDGES IN CAESAR

One of the pillars of research activities of Center for Advanced Engineering Structural Assessment and Research (CAESAR) is a “clinical study.” And the research utilizing decommissioned bridges is a component of it. The final goal of the study is to establish evaluation methods for deteriorated bridges. In this paper, recent cases of concrete bridge deficiencies and CAESAR’s activity utilizing decommissioned concrete bridges are presented.

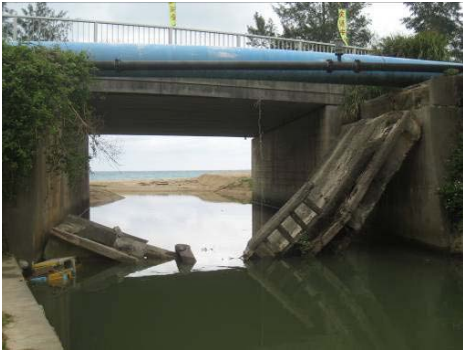
**Photo 1** Collapsed Concrete Bridge in Okinawa

Chloride-induced deterioration is a major issue in the maintenance of concrete bridges. Although the sea salt prone area is limited to small parts of Japan, deterioration is very severe since it will reduce the sectional area of steel members inside of concrete which play important role in terms of strength of bridges. Photo 1 shows a recent collapse of a

concrete bridge in Okinawa, which is the southernmost part and one of the most severe sea salt environment in Japan. The bridge had been closed to traffic at the time of collapse since most of the rebars were lost because of the corrosion. Photo 2 is a bridge severely damaged by chloride-induced deterioration. In the large portion of the girders, cover concrete fell off because of the expansion pressure by corroded reinforcing bars. The bridge will be demolished in a short while.

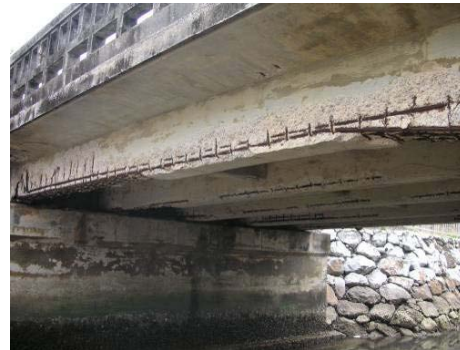
**Photo 2** Concrete Bridge with Cover Concrete Fell Off

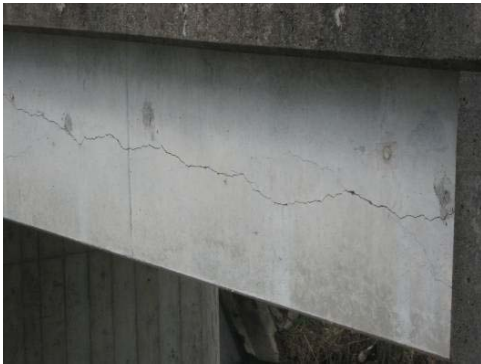
**Photo 3** Horizontal Crack on Precast Hollow Girder

Deterioration caused by alkali silica reaction (ASR) became major problems since 1980's. Through many studies about this phenomenon, it was found that structural strength may not degrade very much despite its stunning appearance, such as wide cracks on the surface of the concrete. However, in some cases of ASR, breakages of rebars because of the expanding pressure of concrete were found. This may have a significant effect against structural integrity. Photo 3 shows a horizontal crack found on the side of the precast hollow girder. Similar cracks were found on the side of the other girders of the bridge. Especially they concentrate at the end of girders. For the prestressed structures suffering ASR, it is known that longitudinal cracks along prestressing direction may appear. Also, ASR may be accelerated when water is supplied. The end of girder is a portion where wrongly drained water from road surface may supply a lot of moisture. From these observations, this bridge is considered to suffer ASR. Photo 4 is a PC hollow bridge with similar cracks.

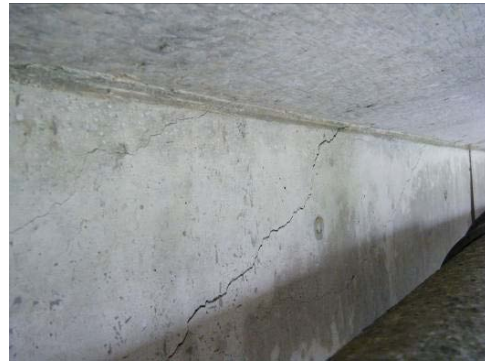
**Photo 4** Diagonal Crack at the End of PC Hollow Bridge Girder

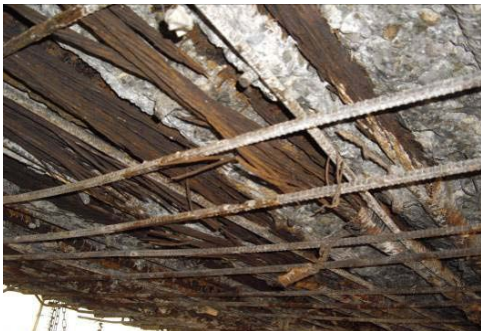
**Photo 5** Corroded and Broken PC Cables in Precast Segment Box Girder Bridge

The number of cases with insufficient grouting in prestressed concrete bridges is increasing nowadays. For those bridges, water including sea salt or deicing salt may seep into sheathes and cause corrosion of PC cables. While signs of deterioration, such as cracks or leakage of rusty water, may appear on the surface of the concrete in typical chloride-induced deterioration, no signs may appear in this type of deterioration since corroded metal, such as sheathes or PC cables, can freely expand inside of void sheathes and may not damage surrounding concrete. Photo 5 shows a corroded PC cables in a precast segment box girder bridge. Through investigation, it was found that grout was not properly filled in the most of the sheathes. Many cables were already broken. It is noteworthy that rebars adjacent to PC cables are almost intact condition. Photo 6 shows a

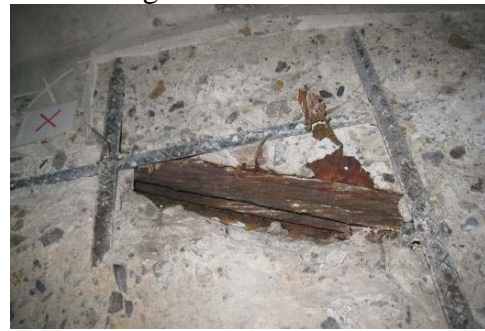
**Photo 6** Corroded PC Cables in T-Shape Girder Bridge

similar damage found on the webs of a T-shape girder bridge. Also some PC cables were found broken in this bridge.

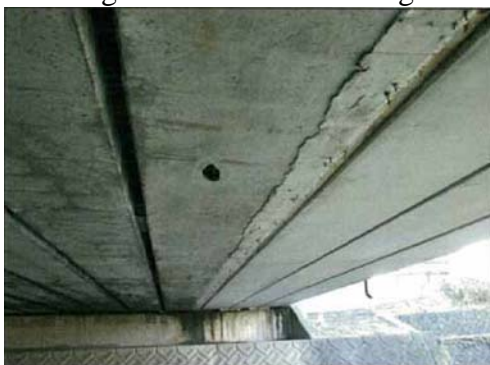
**Photo 7** Void in Bottom Flange of Precast Hollow Girder

Precast PC girders were considered to have reliable quality since they are manufactured inside factories where level of quality control is much higher than in-situ manufacturing sites. Photo 7 shows a recent defect found in a bridge with precast hollow girders. A large void was found in the bottom flange of the girder. The size of the void was 100cm long and 30cm wide. The void was created by faulty workmanship at the time of manufacturing. After finding this problem, the operator surveyed bridges with same type girders constructed at the same period and found some more bridges with similar defects.

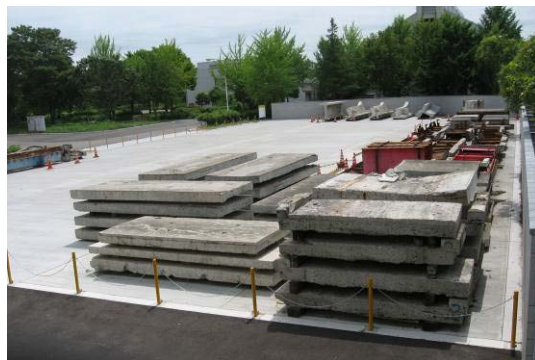
**Photo 8** CAESAR's Stock Yard for Decommissioned Bridges

CAESAR already owns testing facilities for its research, such as 30 MN large-scale universal testing machine, wheel-load test run machine, and so forth. CAESAR also constructed a stock yard of 1,700 m<sup>2</sup> for members of decommissioned bridges (Photo 8) in 2009. The yard is used not only as a stock yard of members until they are tested but also as a display ground for visitors.

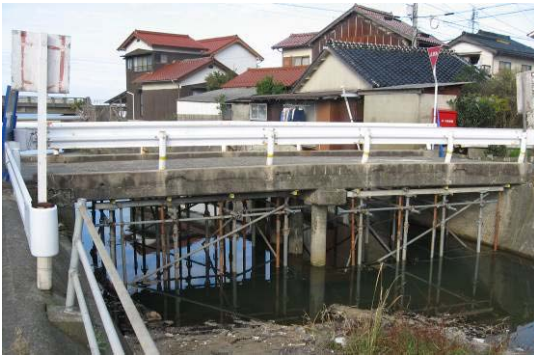
**Photo 9** RC Slab Bridge Before Demolition

In order to evaluate the remaining strength of bridges with chloride-induced deterioration, several loading tests using decommissioned bridges are now being prepared. Photo 9 is a RC slab deck bridge with heavily corroded rebars. The bridge was already removed and transferred to CAESAR’s stock yard. Photo 10 is a RC T-shaped girder bridge. The bridge went through multiple repair works, such as concrete coating, attachment of reinforcing plates under the lower flanges, and so forth. But finally, the operator decided to replace the bridge since the chloride contents already intruded inside concrete caused further deterioration even after the coating. Two girders will be transferred to CAESAR for

loading test. For both bridges, chloride contents will be measured to obtain the relation between chloride concentration and corrosion level of rebars.

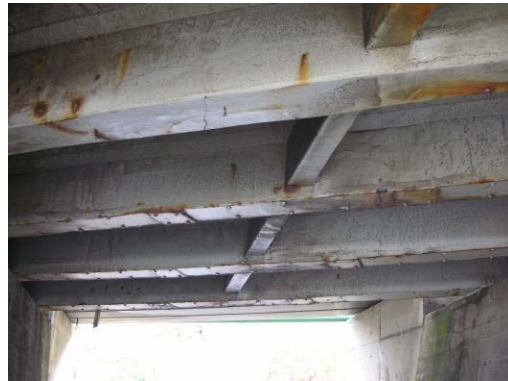
**Photo 10** RC T-Shaped Girder Bridge with Multiple Repair Works

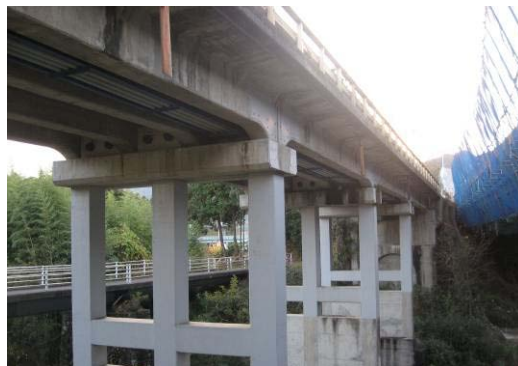
**Photo 11** RC T-Shaped Girder Bridge Served about 80 Years

In order to obtain the relation between the visible external condition of concrete members and internal steel condition, CAESAR is planning to sample some concrete bridges. Photo 11 shows a RC bridge that served about 80 years and will be demolished soon. Close visual inspection was conducted and precise defect map including width and length of cracks was made. Condition of steel members under the cracks will be investigated in CAESAR's laboratory. In spite of its long service, the surface condition was relatively fair.
