STAY CABLE REPLACEMENT OF THE HALE BOGGS BRIDGE

Armin B. Mehrabi¹

Abstract

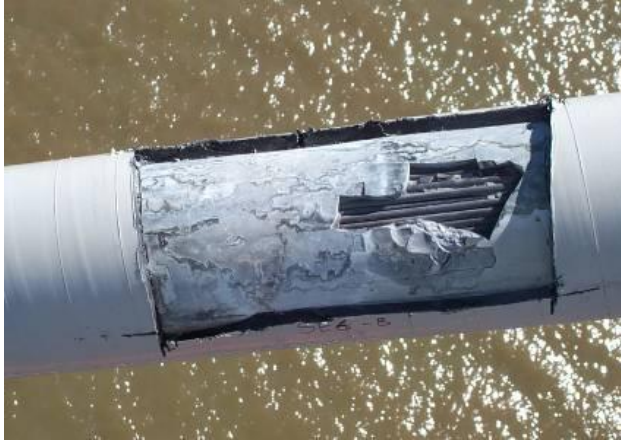
The stay cables are arranged in two planes and are grouped by pairs or fours. There are 24 such cable groupings and a total of 72 cables. Original stay cables that are being replaced are composed of parallel 1/4 in.-diameter wire bundles consisting of 103, 211, 271, or 307 wires. The wire bundle is encased in a black polyethylene (PE) pipe, and the space between is grouted. An Ultraviolet (UV) protection tape is helically wound around the PE pipe with 50 percent overlap. Figures 2 and 3 show a dissection of an existing cable and an anchorage socket, respectively. The replacement cables will have parallel individually sheathed strands encased in PE sheathing pipe without grout infill.

FIGURE 2- DISSECTION OF EXISTING CABLE

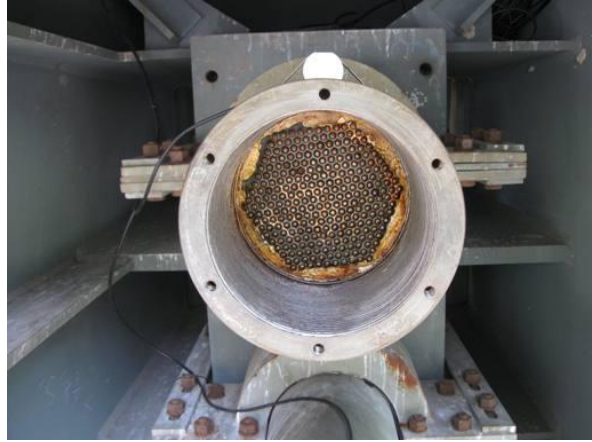
FIGURE 3- AN EXISTING ANCHORAGE SOCKET

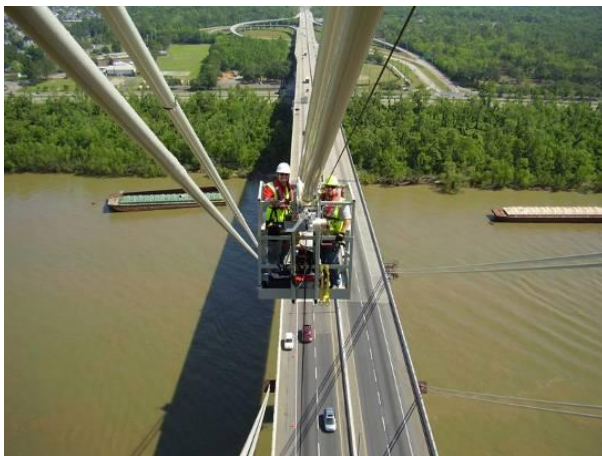
The scope of the cable inspection included visual examination of the bearing plates, shim plates, and exterior and interior of the anchorage sockets in lower and upper anchorage zones, visual inspection of the anchorage boxes behind the bearing plates, and hands-on inspection and non-destructive testing of the cables free length. Damages observed in the anchorage zones were in the form of corrosion of sockets and button heads, missing or broken seals at the joint between the transition pipe and PE pipe, and open grout ports. Inspection of the cables free length (see Figures 4 and 5) discovered a variety of damages and anomalies including longitudinal and transverse split of the PE pipe, exposure and degradation/corrosion of grout filler and steel wires (Figures 6 and 7), bulges and holes in the PE pipe, tape damages, and grout voids and delamination. Most mechanisms causing these damages still existed and were active. It was verified later through subsequent inspections that the initiation and progression of damages will continue in time with an increasing rate. With the exception of locations where the steel wires were visible through splits, the inspections focused on damages related to the protective elements where a high probability for corrosion of steel wires exists at damaged locations and beyond.

FIGURE 4- INSPECTION ALONG CABLE FREE LENGTH

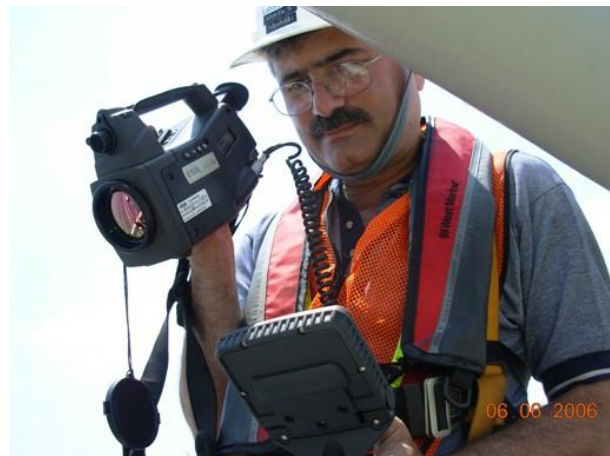
FIGURE 5- NDT USING THERMOGRAPHY

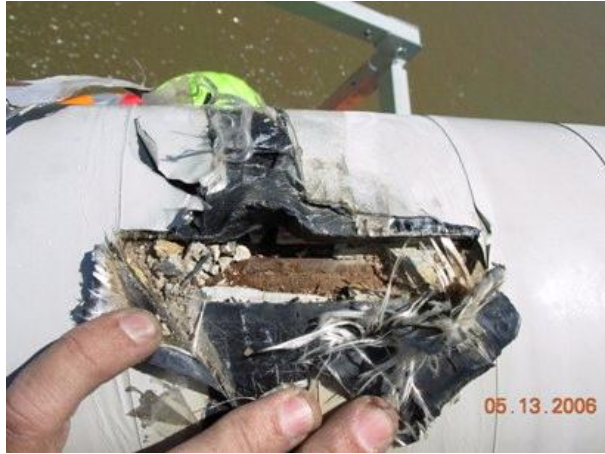
FIGURE 6- CORROSION OF WIRES AT PE SPLIT

These levels pertain to the barrier elements, namely the UV protection tape, PE pipe, and cement grout, and their ability to protect the main tension element, and the condition of the steel wires based on the condition within the anchorage sockets, and the need for action. All cables contained damage and anomalies with severity level of 2 and higher. Thirty-nine out of 72 cables were rated as critical and the remaining cables as poor.

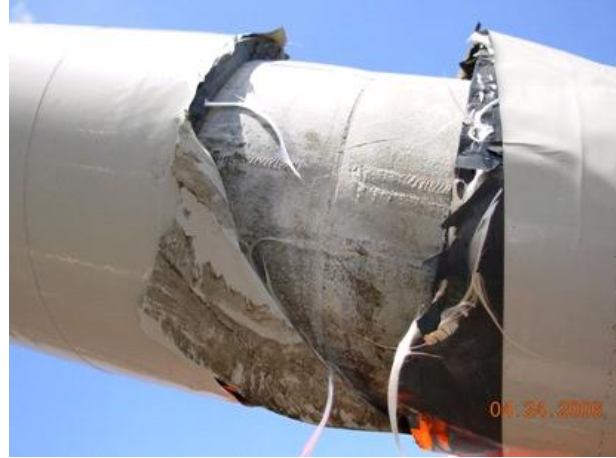
FIGURE 7- PE JOINT SEPARATION

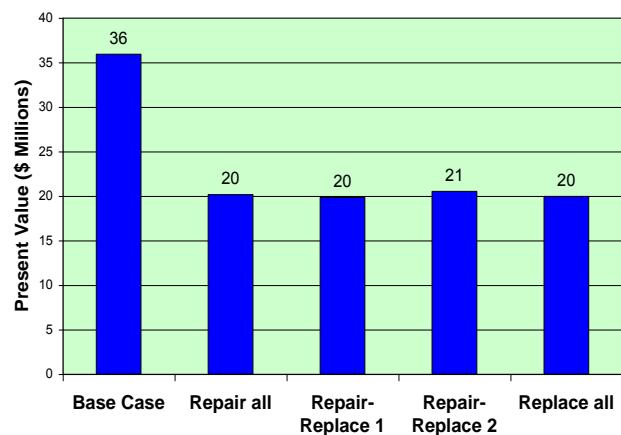
Costs addressed in this investigation are direct (cable repair, replacement, inspection, etc.) and indirect (structural damage to superstructure from cable failure) costs related only to actions undertaken for cables. Costs associated with various activities were estimated based on previous experiences and relevant estimates obtained from repair contractors. Figure 8 shows a comparison among present value of costs associated with 5 different strategies when only initial agency and users' costs are considered. Clearly, cost of "doing nothing" is negligible compared to others, replacing all cables is the costliest strategy. However, as shown in Figure 9, when distributed, periodic, and vulnerability costs are added, the Base Case is almost twice as costly as the other strategies, and cost of the other four are comparable. Considering the LCCA results along with uncertainties in the level of potential damages, the effect of costs not included in the analysis, and more importantly, concerns related to highway network system and public safety, LADOTD decided to replace all cables.

FIGURE 9- COMPARING ALL COSTS

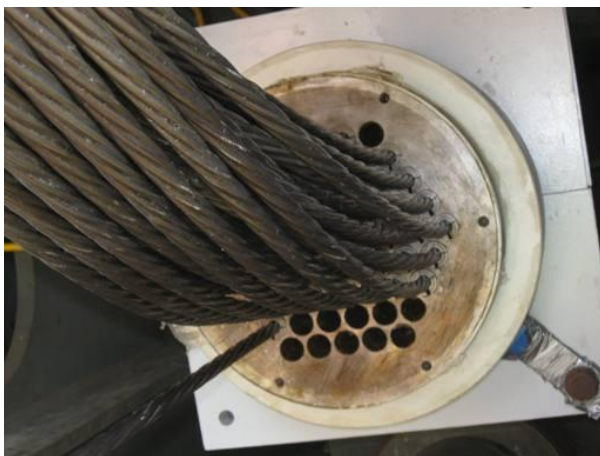
FIGURE 10- A NEW CABLE ANCHORAGE

With an equivalent stiffness design, the existing cables are being replaced by 23, 45, 57 and 67- 0.62-in nominal diameter strand cables. Twenty four additional strands will be installed in various cables as reference strands for inspection purposes. Figures 10 and 11 show a lower anchor and strand bundle in a new cable being installed. Due to susceptibility to wind-induced vibrations, the new cables will be installed with external helical ribs, dampers, and spacers.

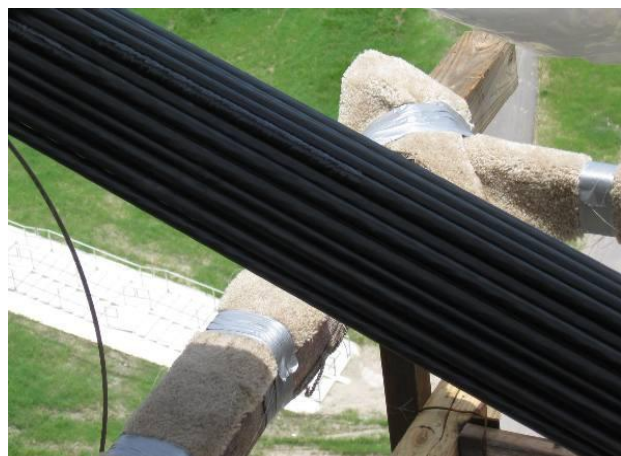
FIGURE 11- STRAND BUNDLE IN A NEW CABLE

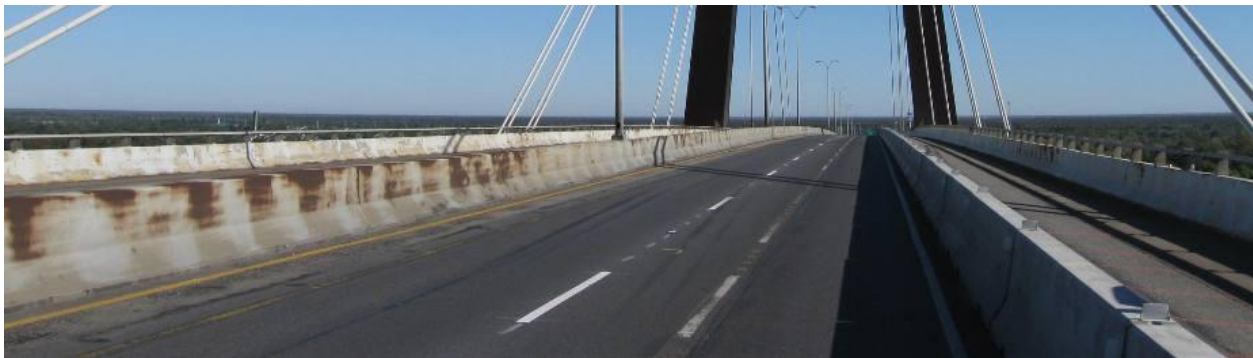
FIGURE 16- MAINTENANCE OF TRAFFIC FOR CONSTRUCTION SIDE FOR PEAK TRAFFIC OPERATION SEQUENCE

The Luling Bridge carries two lanes of traffic on each bound with a 10-ft right shoulder and 4.25-ft left shoulder on each bound. It was determined that most of the cable replacement operation can be carried out within a 12.25-ft space separated on the right side of the deck by concrete barriers (2 ft wider than the existing shoulder). During Peak Traffic, this pattern allows two lanes of traffic, 11-ft each, on the construction side of the bridge without shoulders, and normal traffic pattern on the other side. Figure 16 shows Peak Traffic Operation sequence for the construction side of the bridge. When necessary, during Off-Peak Traffic in the evenings or weekends, the construction space is widened from 12.25 to 23.25 ft using plastic cones allowing operation of heavier and wider equipment and other activities. This pattern allows one 11-ft lane of traffic lane without shoulder on the construction side while traffic on the other side of the bridge flows normally. These patterns have been working smoothly without significant interruptions to traffic since the start of the construction activities on the bridge.
