NON-DESTRUCTIVE MONITORING AND ACTIVE PREVENTION OF CORROSION IN SUSPENSION BRIDGE MAIN CABLES

Deeble Sloane, M.J.¹, Gatti, C.¹, Brugger, A.², Betti, R.³ and Khazem, D.H.⁴

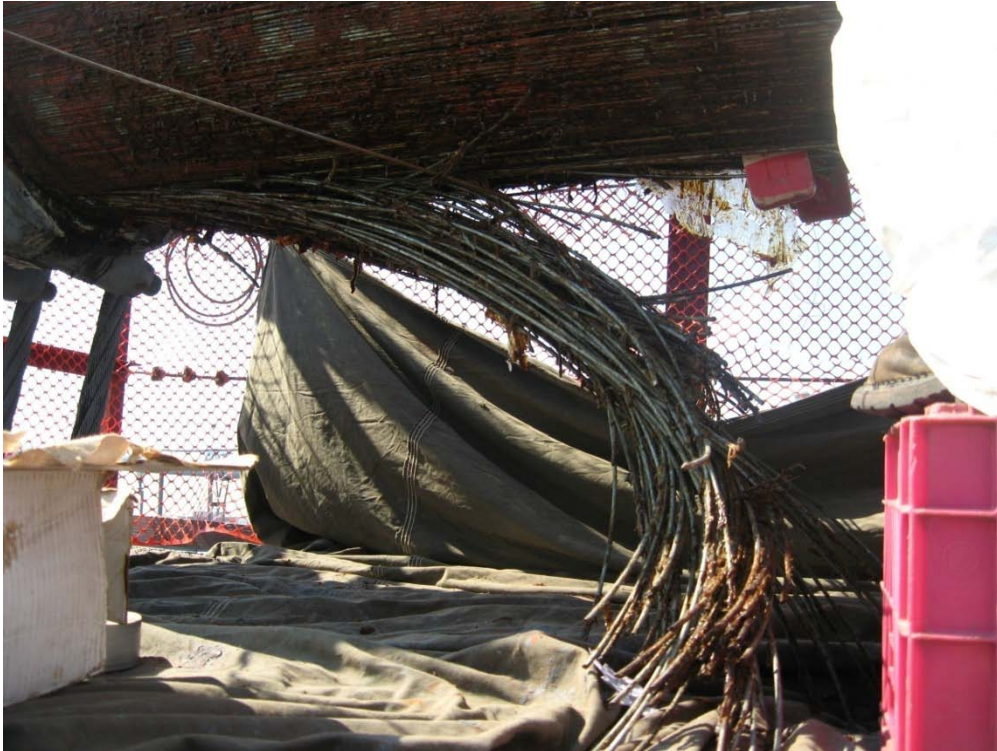
Figure 1: Broken wires in a suspension bridge main cable

In-depth inspections of cable systems in aging suspension bridges in the New York metropolitan area and in the North-East of the United States have shown that 1) there is often water trapped inside the cable, with a pH as low as 4, and 2) there are broken wires (in some cases up to 300 broken wires in between two cable bands) inside the cables and at the anchorages (Betti and Yanev, 1999), indicating brittle fractures and extensive corrosion (see Figure 1). These alarming findings are inexplicable and the reason of the presence of such broken wires must be found in the complex deterioration process within a main cable. In fact, while the effects of corrosion on ordinary structural steel can be mainly characterized by the loss of material and by the ensuing reduction of the cross sectional areas of members, the

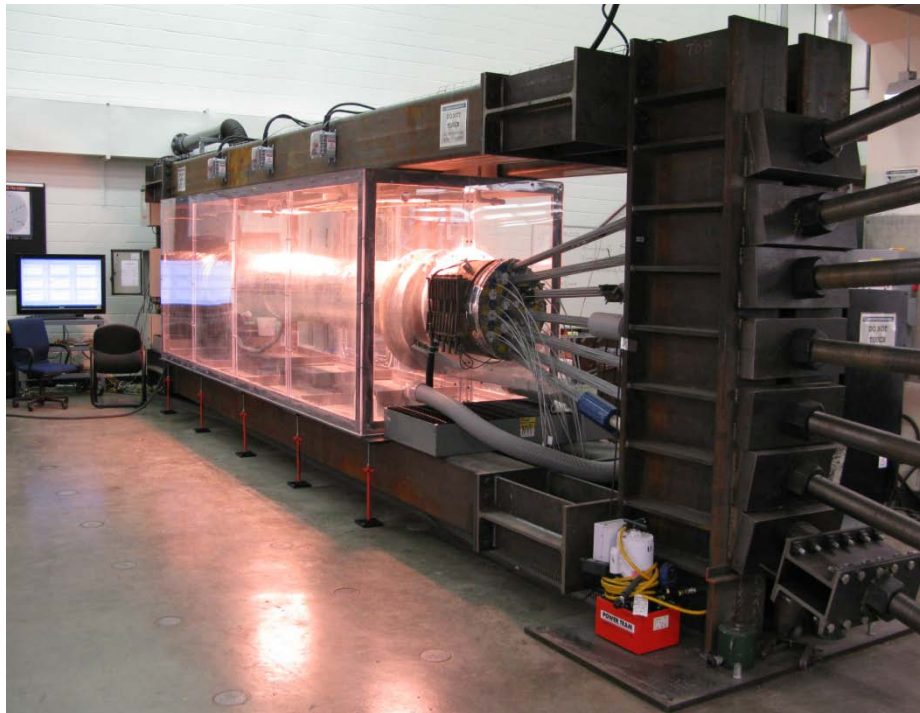
Figure 3: Cable mock up and environmental chamber

In order to test the effectiveness of the monitoring system, a full-size mock-up cable specimen was built and exposed to varying, controlled environmental conditions. The mock-up specimen was made with 73 hexagonally shaped strands, each consisting of 127-high strength steel wires, thus creating a cable with a 50.8 cm

diameter and a cross-sectional area composed of 9,271 wires. Of the 73 strands, 66 measured 6.10 m in length while the remaining 7 were 10.67 m long; these long strands were subjected to a tensile load that induced stresses in the wires up to 700 MPa so to highlight and eventually accelerate the phenomenon of stress-corrosion cracking. An environmental chamber was built around the mock-up cable specimen so to expose the cable to controlled environmental conditions (simulated rain, heating and cooling) in order to assess the functionality of the sensor network. Figure 3 shows the full-scale cable specimen with the environmental chamber.

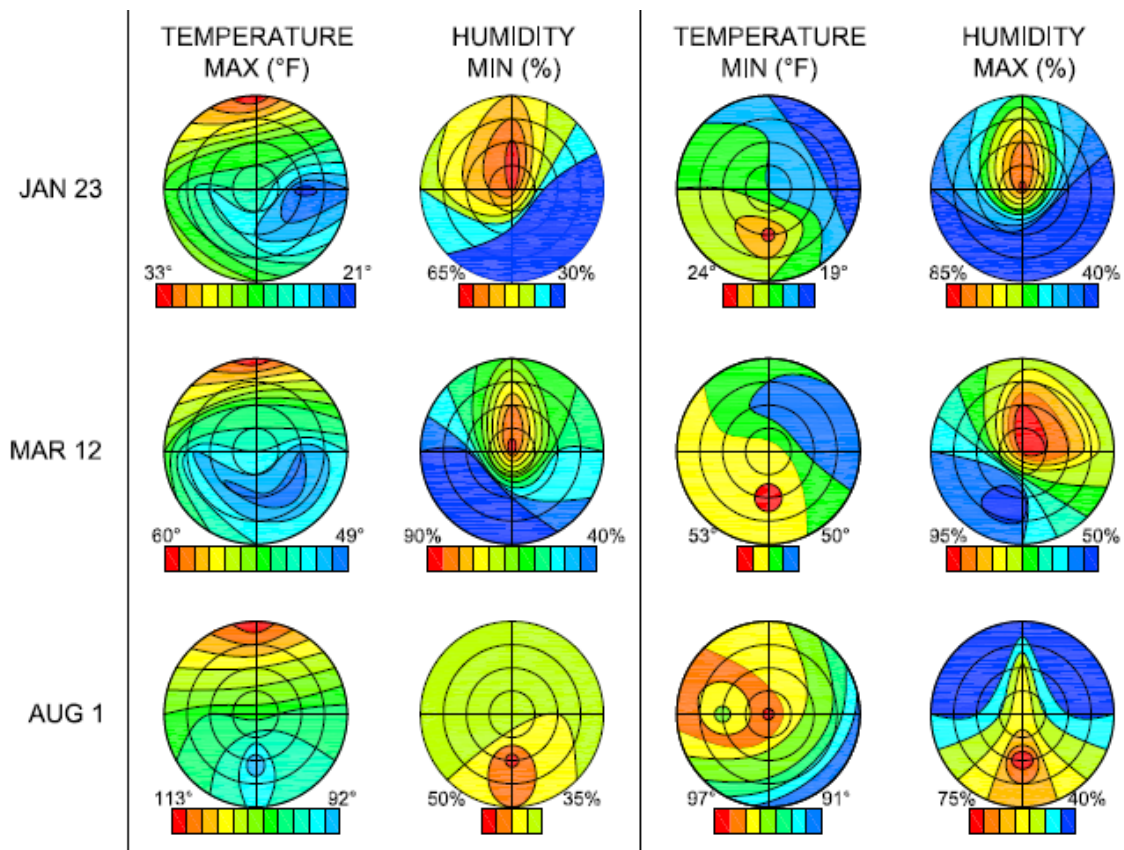
Figure 5: Distribution of Temperature and Relative Humidity inside a Main Cable

The data collected by the 38 sensor network provided a quite unique, real time picture of the internal environment of the cable, which is an important key to understanding corrosion in suspension bridge cables and can help develop a cost effective mitigation strategies. For example, it was extremely interested to see the variation of the temperature and relative humidity inside the cross-section of the cable in service conditions. Figure 5 shows the distribution of the maximum and minimum temperature and relative humidity over the entire cable cross section recorded on different days during the year. These maps show clearly that the distribution of temperature and humidity is not uniform across the cable cross section and that the bottom and shaded side portions of cable are likely to retain higher levels of humidity than the upper portion. Moreover, there are higher temperature and lower humidity during the day. In addition, when comparing the humidity levels between summer (August) and winter (January), it confirms that the internal relative humidity level is higher in the winter months than during summer months. An interesting observation is that, during the spring months when the temperature range is between 49°F and 60°F and the relative humidity between 40% - 95%, the internal cable environment is the most conducive to corrosion, with high level of humidity and with daily temperature cycles between day and night.

Having a monitoring system that can measure the distribution of temperature and relative humidity inside a cable allows us to test how effective the current practice of cable dehumidification is. Today, there is a trend of installing dehumidification systems that, when needed, inject dry air inside the cable, with the goal in mind to keep the humidity level inside the cable below 40%. The need for the system’s activation is regulated by measuring the humidity of the outflow air at some specific locations along the length of the cable: such a measurement, based on the results obtained from the field investigation presented before, could be misleading. In fact, this measurement could not be representative of the complex humidity pattern inside the cable (see Figure 5).

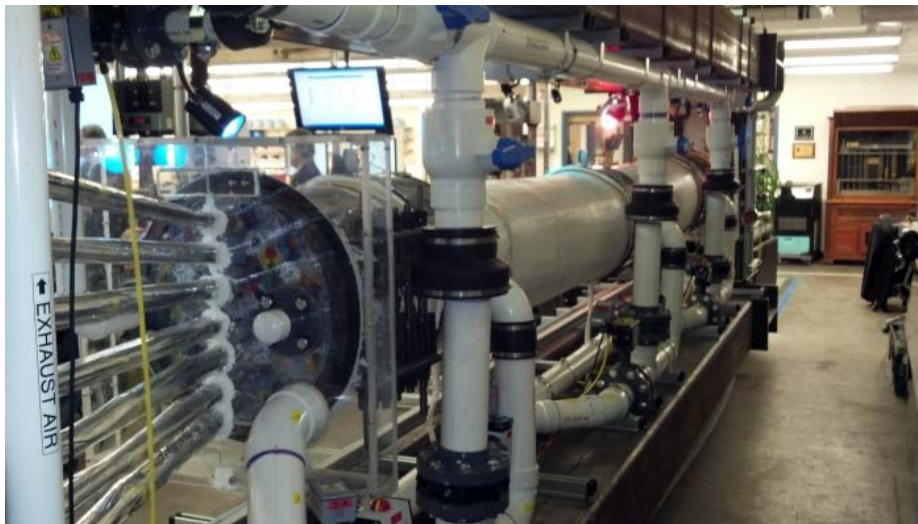
Figure 6: Front and Back View of the Cable Mock-up with Dehumidification System

To study how effective the dehumidification system is, the full-scale cable mock-up has been redesigned (Figure 6) so to accommodate a cable dehumidification system and a new series of tests have been planned.

The cable specimen has been enclosed through a combination of D.S. Brown's Cableguard[®] Elastomeric Cable Wrap System and custom made PLEXIGLAS ports and end boxes manufactured in the Carleton Laboratory at Columbia University. Inlet/outlet ports have been placed at the center as well as at each end of the cable specimen so to allow for different injection-exhaustion configurations. The cable system has been humidified by two Nortec RH2 Space humidifiers, blowing humid air through Direct-Drive Corrosion-Resistant 10" duct fans with airflow 620 cfm @ 1/8" static pressure and 565 cfm @ 3/8" static pressure, and dehumidified by pumping dry air from a Honeywell DH150 Dehumidifier (with the flow also boosted by the Direct-Drive Corrosion Resistant 10" duct fans). Figure 7 shows a schematic representation of the humidification/dehumidification system set up.

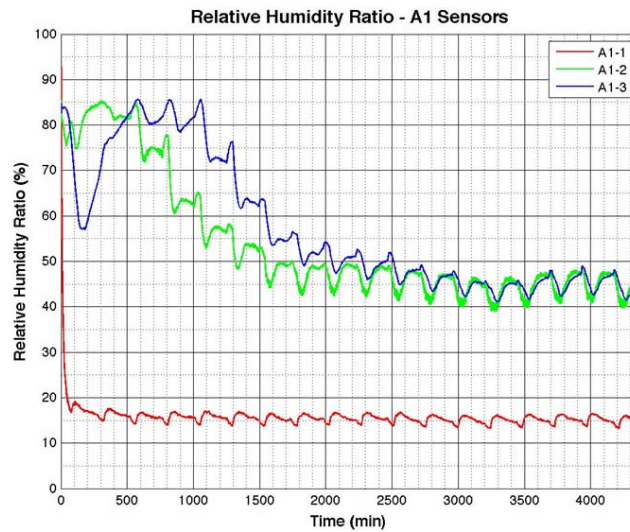
Figure 9: Relative humidity vs time at the injection port during a low temperature test.

Another interesting aspect that needs further attention is concerning about the effectiveness of the dehumidification practice at low temperatures. When the system operates at much lower temperatures, the effectiveness seems to be drastically reduced. Figure 9 shows the same relative humidity-time diagram for same test conditions as in Figure 8(a) but conducted at a lower temperature (around 0°C).

Here, the plots of the relative humidity vs time recorded at the top sensors along the length of the cable specimen are presented and a puzzling result appears. From a preliminary analysis, it seems that the dehumidification system is not capable of bringing the relative humidity level down below 40% for cross-sections different from the injection one. While the system is very effective, as expected, in decreasing the level of relative humidity at the injection location, the dry air cools off when moving along the length of the cable and is not as effective as before in reducing the level of humidity away from the injection point. This could have implication on how to run a dehumidification system during the winter season. However, these are just preliminary results of a test program that is currently ongoing and general recommendations will be provided at a later time.
