The Skagit River Bridge Collapse and Recovery Plan

Abstract

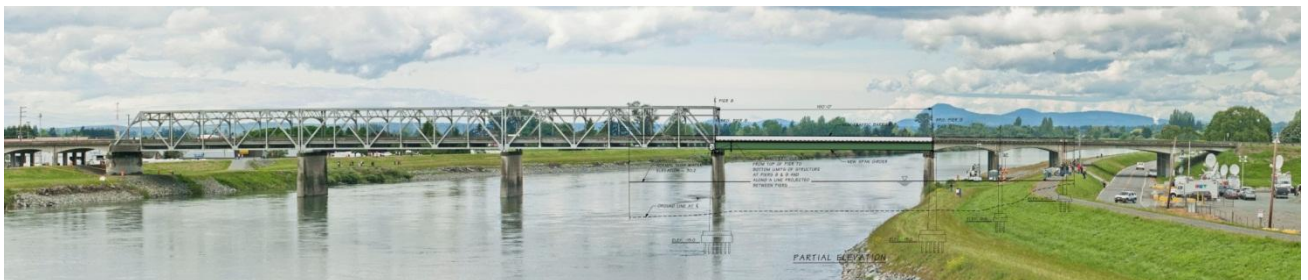
Figure 1. Conceptual Truss Span Replacement with Prestressed Concrete Girders

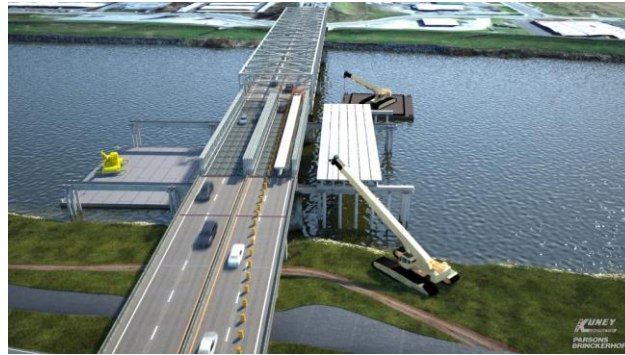
Figure 2. Conceptual Temporary Bridge and Setup for Span Replacement

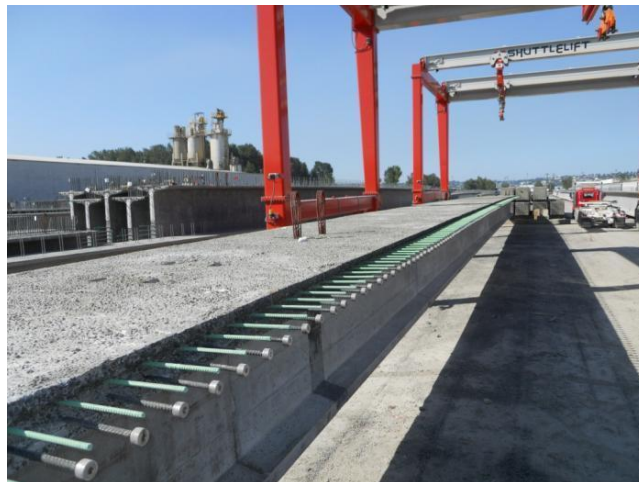
In order to limit the weight of superstructure, the girder spacing of 2.316 m was considered to keep the replacement structure as light as possible. Using 2.316 m girder spacing eliminated one line of girders to reduce the total superstructure weight. The total weight of new superstructure including the lightweight concrete traffic barriers and concrete overlay was 915 tons, within the limit required by the contract. Figure 3 shows the headed bars of deck bulb tee girders at the fabrication plant.

Figure 3: Headed bars at closures

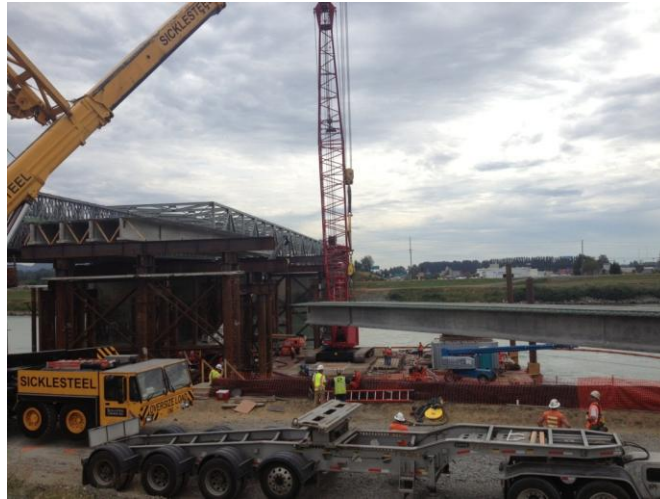
The permanent superstructure was constructed on a steel piling and bents, just downstream of the temporary spans as shown in Figure 5.

Figure 5: Permanent superstructure constructed on a steel piling and bents downstream of the temporary spans

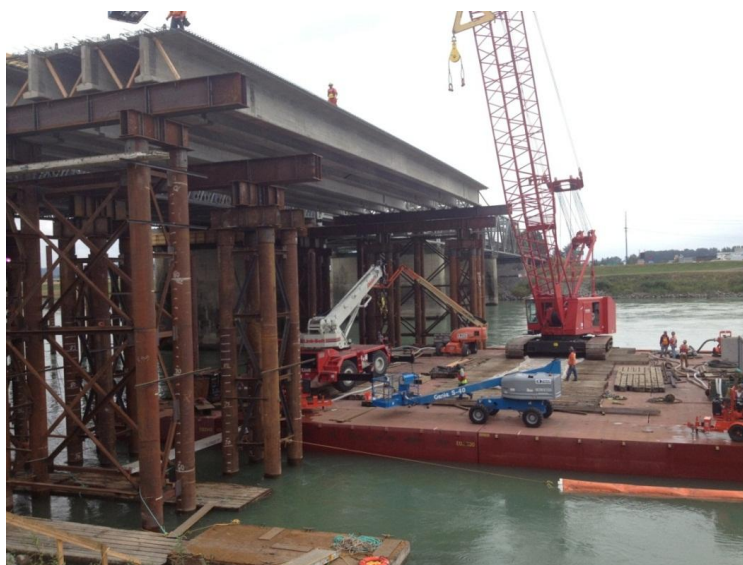
A separate row of piling and bents were built to support a rail system that would be used to slide the temporary spans out, and slide the new span into place as shown in Figure 6.

Figure 6: Supports for slide of the new span into place

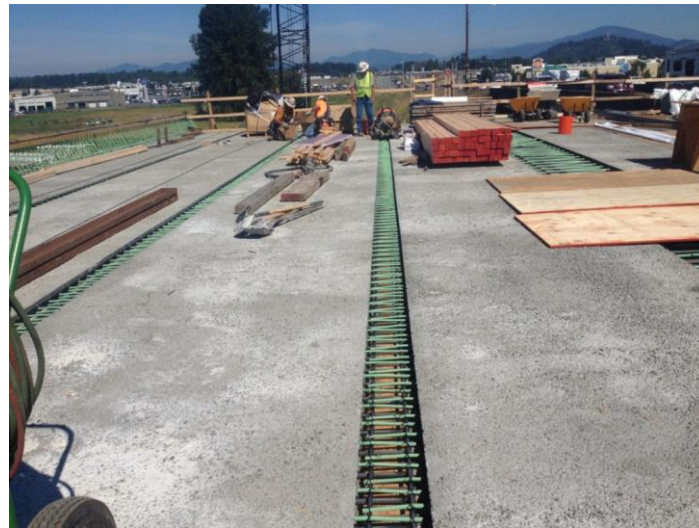
To complete the bridge, the girders were tied together with closure pours between the girders and end diaphragms. This was followed by pouring the traffic barrier and a 38 mm micro silica deck overlay. A separate intermediate set of diaphragms or jacking beams were also installed using reinforced cast-in-place concrete. Figure 7 shows the placement of deck bulb tee girders.

Figure 7: Placement of deck bulb tee girders

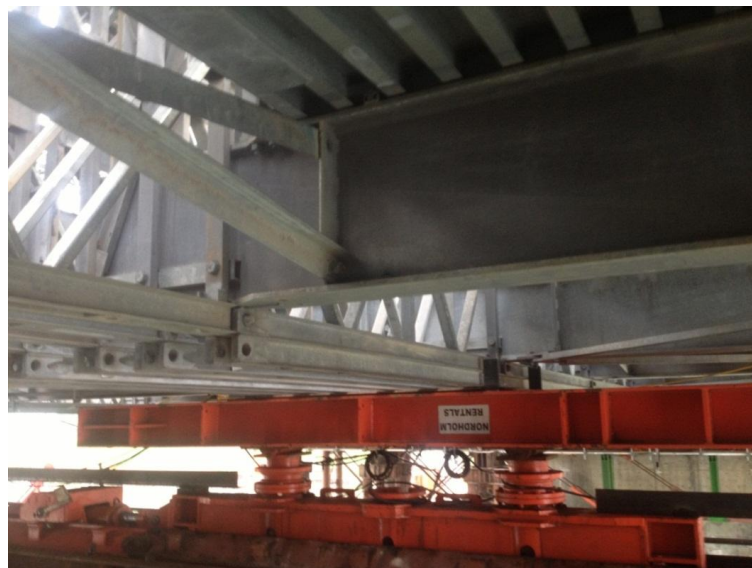
A vertical and horizontal jacking system was concurrently installed using a rail system supported by temporary piling and bents as shown in Figure 8.

Figure 8: Jacking system for Bridge Slide

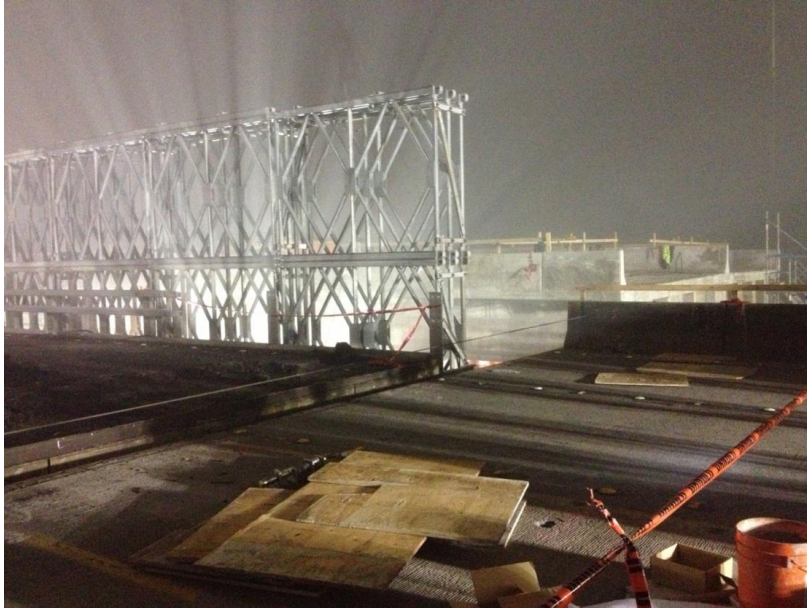
To complete the installation of the new span, first the temporary spans were lifted off the existing substructure and slid off onto the temporary bents upstream of the bridge. The new span was moved in a similar fashion, with the exception that it needed to be shifted a half inch to fit into place. Figure 9 shows the slide of the temporary Bridge.

Figure 9: Temporary Bridge Being Slide Out

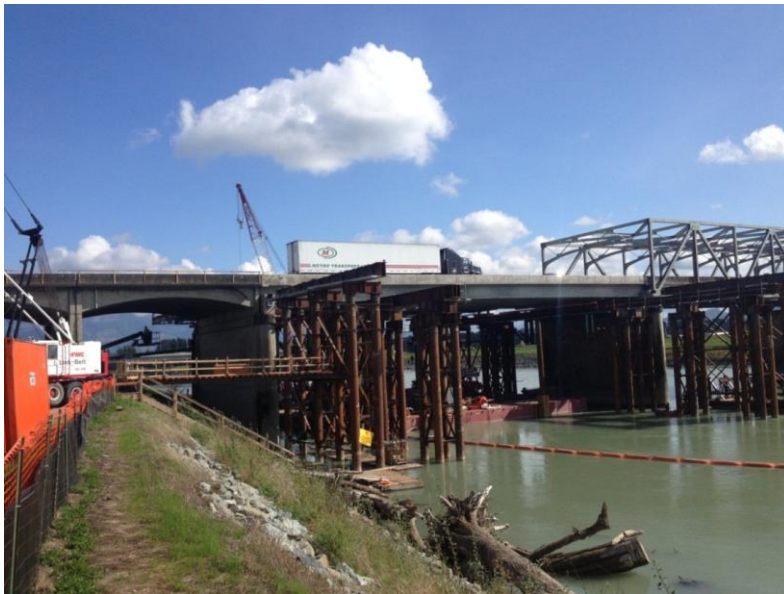
The overall construction started on July 12 and the new span was opened to traffic on September 15. It took just under 19 hours to swap the spans and open the freeway to traffic as shown in Figure 10.

Figure 10: Completion of Span Replacement

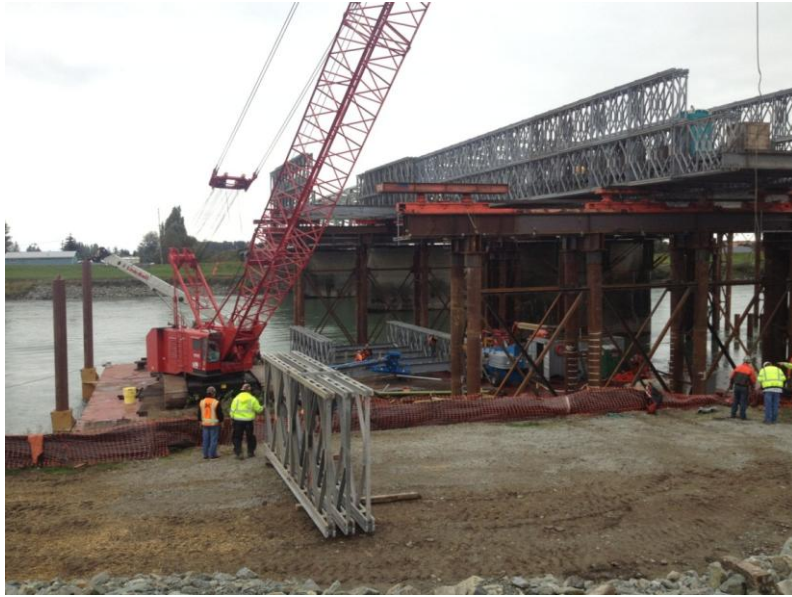
To finish up the work, the temporary spans were disassembled onto the Flexifloat barge system and all of the piling was removed from the river as shown in Figure 11.

Figure 11: Dismantling of Temporary Bridge on Flexifloat Barge and Removal of piling
