Influence of Joints between Steel Plates on Load-Carrying Capacity of Reinforced Concrete Girders Strengthened with Externally Bonded Steel Plates

Eiji Yoshida¹, Jun Murakoshi¹, Yoshitomi Kimura², Yoshiki Tanaka¹

Abstract

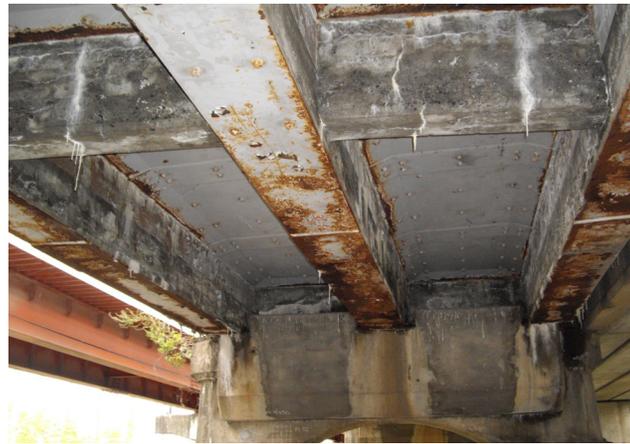
Photo 1 Steel plates bonded to the soffit of girders in a concrete bridge

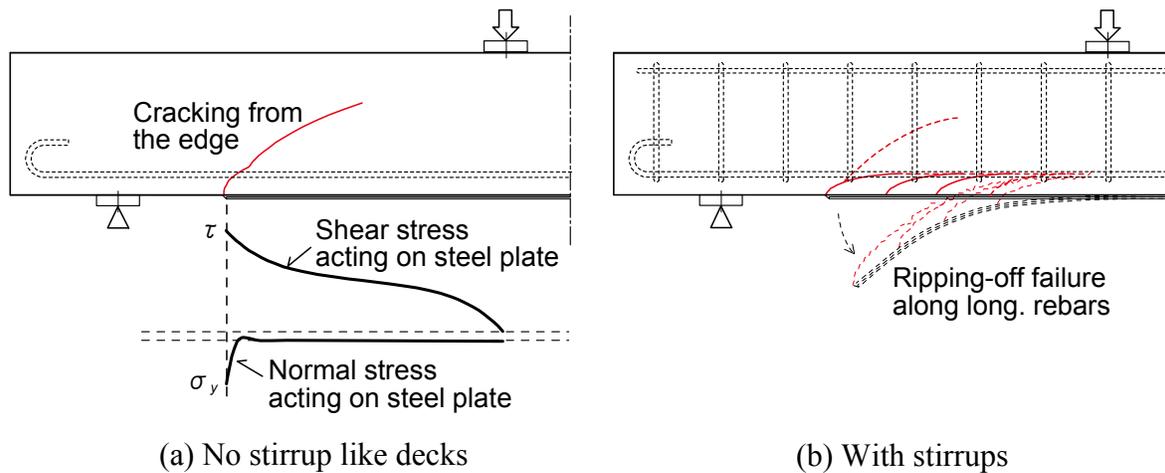
Figure 1 Types of Failure of Plated Beam

While strengthening by use of FRP sheets has spread in recent years, there are still currently many structures bonded with steel plates, so a precise grasp of the effect from strengthening by steel plate bonding as well as FRP bonding is required. There have been numerous reports of studies that are primarily experimental studies, on the steel plate bonding method^[1]). In studies focusing on problems of reinforced concrete girders strengthened with steel plates bonded to their soffit, there are cases where the specified strengthening effect cannot be obtained due to plate end debonding failure occurring from the effects of highly localized vertical stress and shear stress(Figure 1 (a)).

On specimen S4, stripping off the steel plate to observe the bonded surface revealed that delamination of cover concrete had occurred despite rust formation on its main section. Such a failure is often observed in loading tests on steel plate reinforced concrete girders which have shear reinforcing bars (Figure 1 (b)). The reason why delamination of cover concrete occurred is considered to be the effect of cracks along the main reinforcing bar observed before loading.

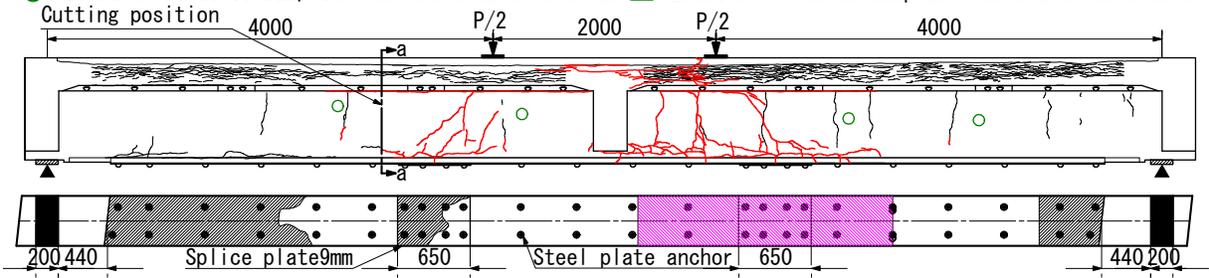
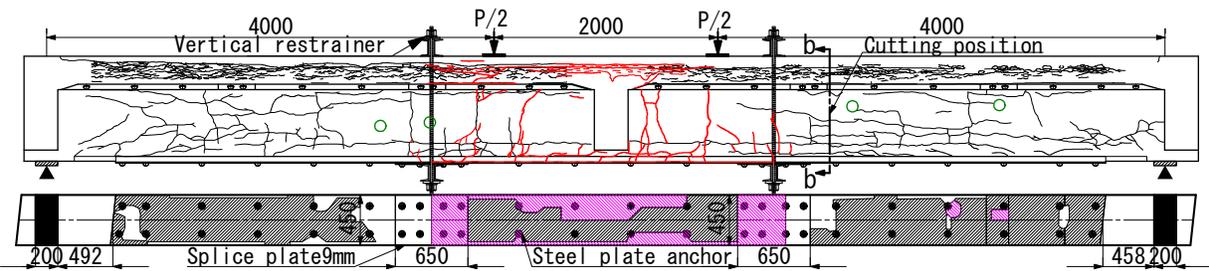
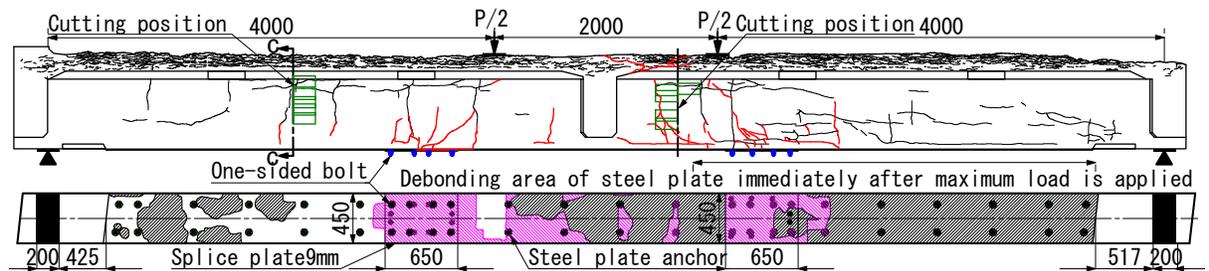
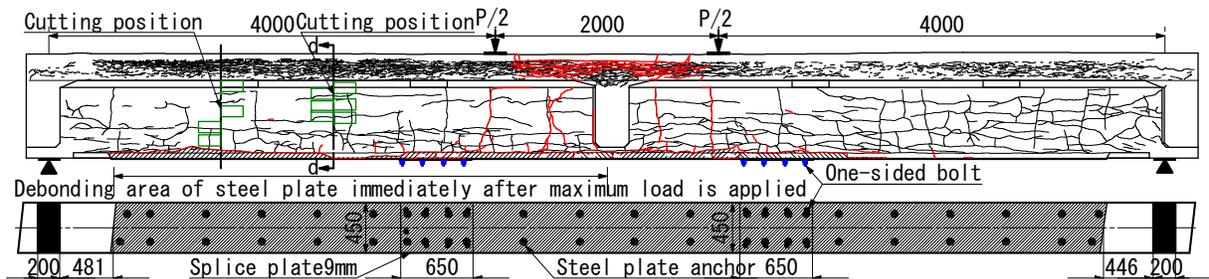
(a) Specimen S1

(b) Specimen S2

(c) Specimen S3

(d) Specimen S4

Figure 2 Appearance before and after loading test

Table 1 is the list of specimens. Figures 2 and 3 respectively show the appearance of specimens S1 to S4 before and after the loading test and cross sections of specimens S3 and S4 after the test. Since the webs of the four reinforced concrete beams were partially covered with coating, this was removed before inspection. Extensive cracks on the sides of the webs of specimens S2 and S4 were found compared with those of specimens S1 and S3; and cracks along the lower main reinforcing bar were confirmed on the sides of the webs of specimens S2 and S4.

Innumerable horizontal cracks were found on the sides of the specimens S1 through S4 decks. In addition, inspection of their cross section after the loading test revealed significant cracks on the deck section. A hammer sounding survey to test for debonding revealed it occurred across all of specimen S4 and extensively on specimens S2 and S3. A dissection survey found two 8 mm diameter stirrups at intervals of approximately 200 mm.

Two-point loading was applied to beams having a span length of 10 m and the shear span of 2 m, corresponding to the support points of the original bridge (Figure 2, Photo 2). Steel plates 200 mm long span-wise and with a thickness of 20 mm were respectively installed at the loading point and the supporting point.

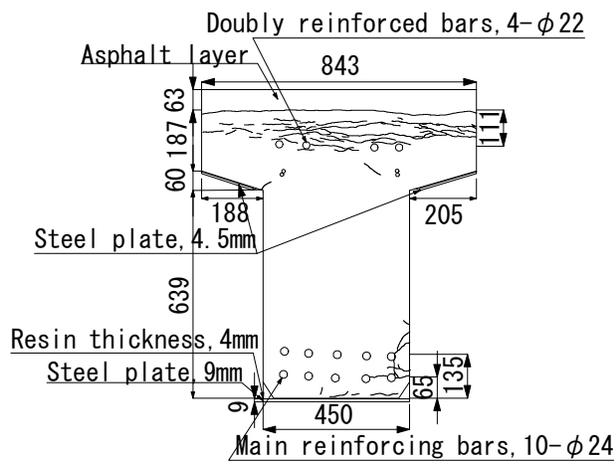
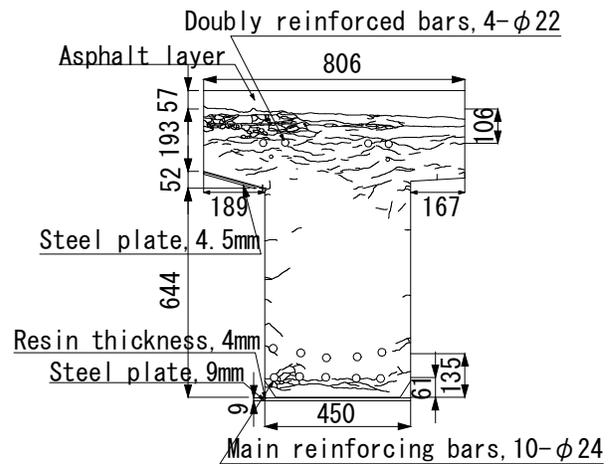
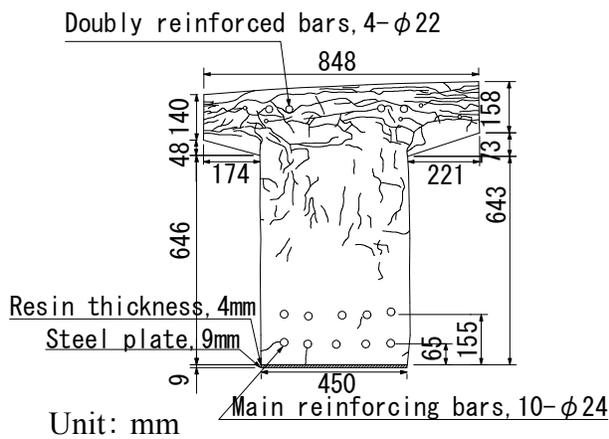
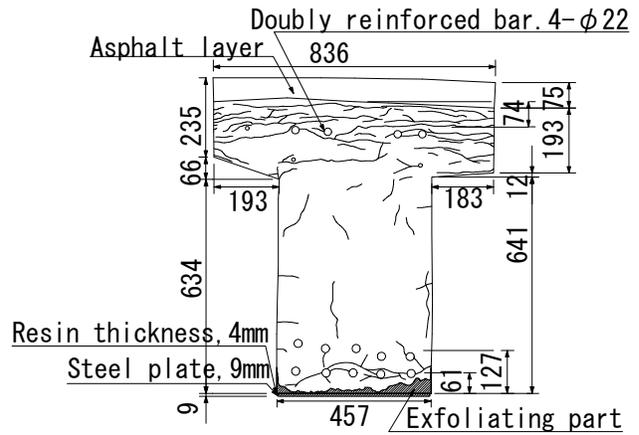
Figure 3 Cross section after loading test

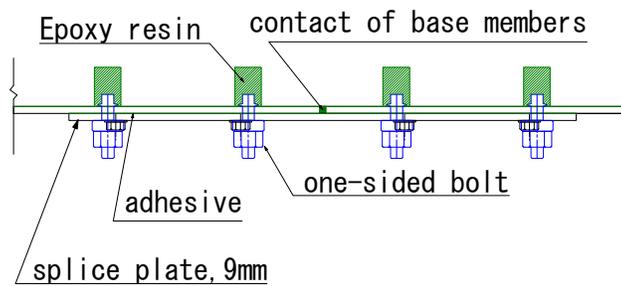
Figure 4 Detailed drawing of joint after bolt insertion

Two joints are single-sided adhesive joints using adhesive. In specimens S3 and S4, one-sided bolts (hereinafter "bolts") were inserted in this area and an axial force (axial force is equivalent to 131kN, F8T by catalog specifications) was applied to them (Figure 4). Bolts were located near the anchor where they did not interfere with the main reinforcing bar. After an axial force was applied to the bolts, epoxy resin adhesive was injected into the bolt holes from the drilled web side (diameter: 6 mm). The temporal change in bolt axial tension was measured by the strain at the end of bolt shank which has a proportional relation to the axial force. The average axial tension of the bolts on the specimens S3 and S4 on the day before the test was 125 kN and 107 kN each.

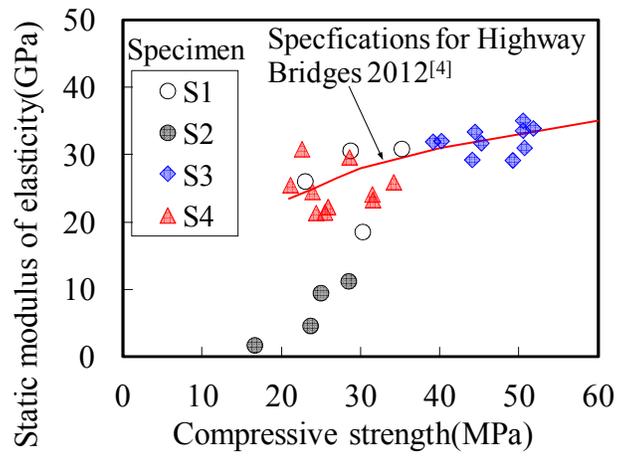
Figure 5 Result of concrete core compressive strength test

Figure 5 shows results of the compressive strength test of the concrete cores. Concrete cores were sampled from the web side of the beam of specimens S1 and S2 and the cross section of specimens S3 and S4 in the axial direction.

The results of the test for specimen S2 were plotted lower than the corresponding relation indicated in the Specifications for Highway Bridges I (General)^[4]. Symptoms of an alkali aggregate reaction were thought to have appeared on part of the beam of specimen S2 due to a significant decline in the modulus of elasticity.

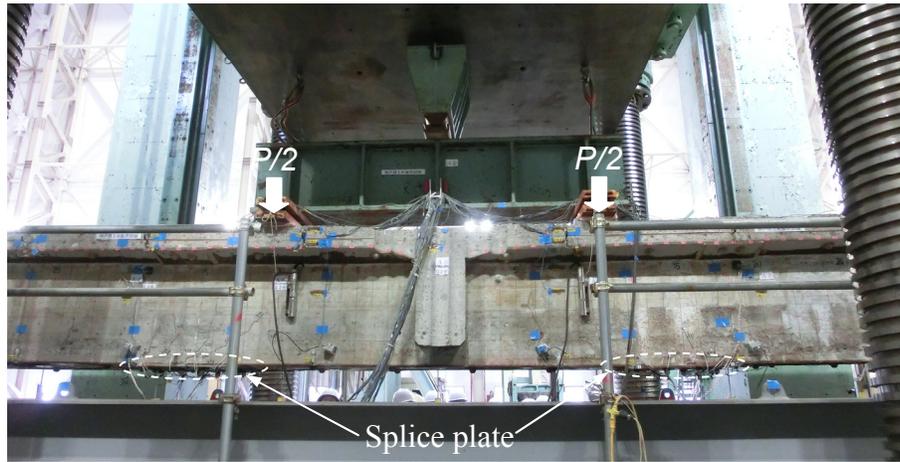
Photo 2 Bending Status of the test

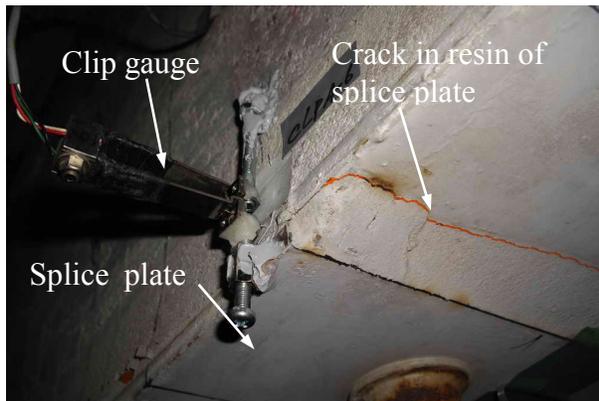
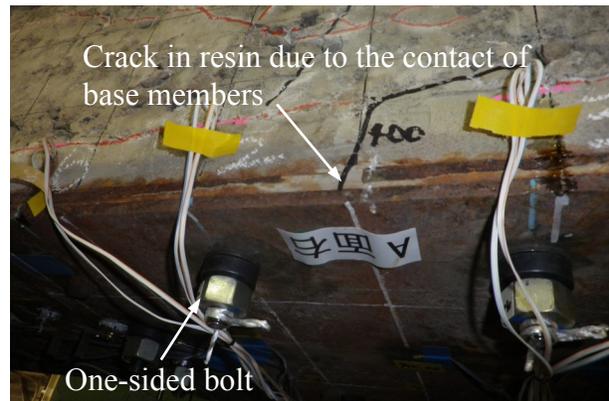
Photo 3 Resin cracks on joint (specimens S1 and S3)

Since no bolts were added to joints in specimens S1 and S2, taking specimen S1 as an example, the state of the resin cracks in the joints and the splice plate failure are shown in Photo 3(a) and Photo 4. In specimens S1 and S2, resin cracks started at the end of the splice plate for joints. (Such resin cracking is hereinafter referred to as partial splice plate end debonding) In both specimens S1 and S2, the resin cracks subsequently progressed between the splice plate and base members, and more than a half of the splice plate on one side completely debonded from the base members. (This state is called debonding failure of the splice plate, Figure 6(a))

Photo 3(b) shows the state of resin cracks in joints taking specimen S3 as an example. In specimens S3 and S4 where whose joints bolts are added, resin cracks started at the contact between base members. (Such resin cracking is hereinafter referred to as partial debonding due to the contact of base members, Figure 6(b)) Resin cracking subsequently progressed between the splice plate and base members but did not result in debonding failure of the splice plate as in specimens S1 and S2.

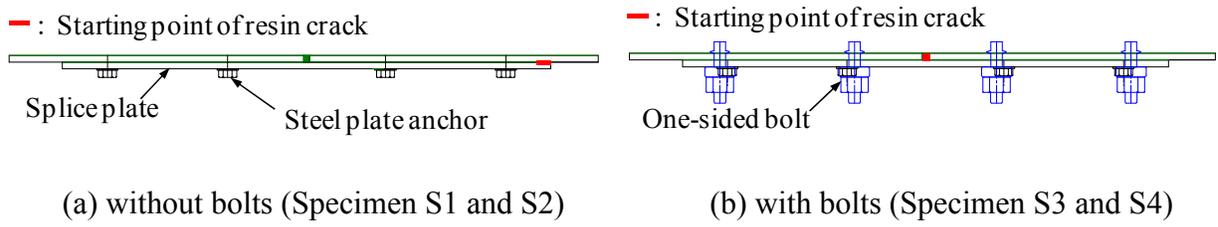
Figure 6 Resin cracks on joint

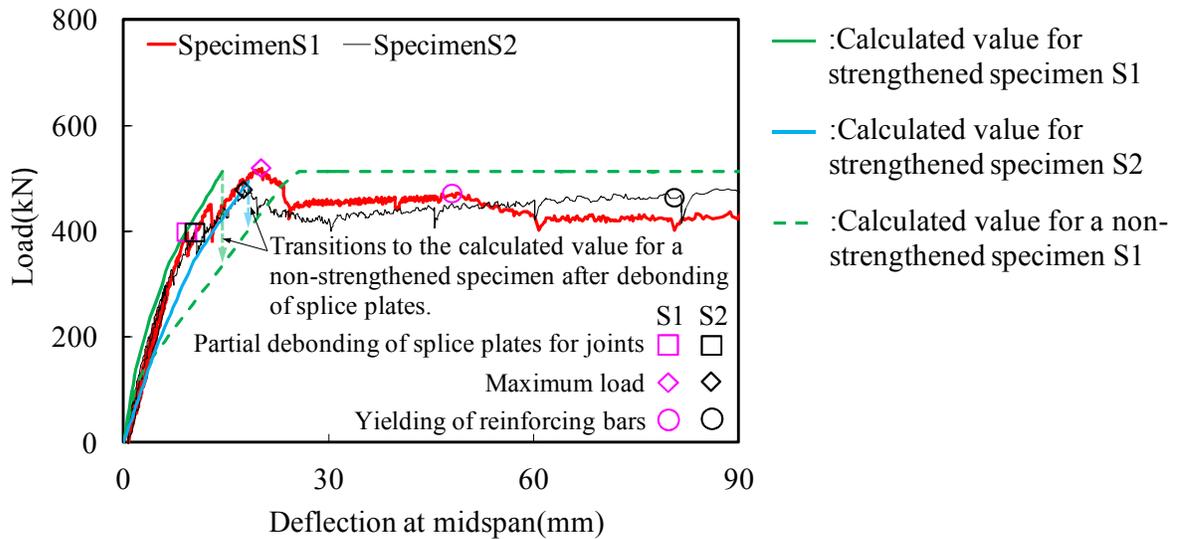
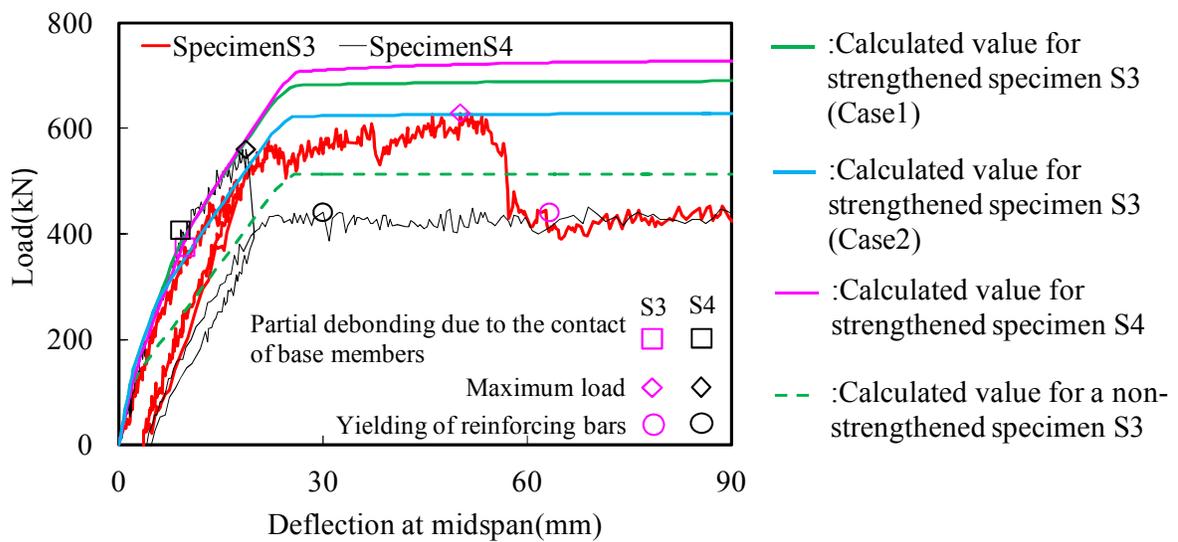
Figure 7 Relationship between load and deflection at midspan

Table 1 is a list of the maximum load and the failure type of each specimen, and Figure 7 shows the relation between the load and deflection at midspan. Figure 7 also shows values calculated by the multi-cross section method (detailed below) for a non-strengthened specimen.

Almost identical loads caused partial plate end debonding of the splice plates of joints of specimen S1 and S2 (confirmed by clip gauges). The debonding failure of the splice plate did not occur immediately after partial debonding, and the load on specimens S1 and S2 increased while the rigidity of their girders declined. When debonding failure of the splice plate occurred, the maximum load was reached at a value approximately close to the value calculated value for a non-strengthened specimen. Subsequently, the load on specimens S1 and S2 gradually declined and their deflections increased while a load somewhat lower than the values calculated for a non-strengthened specimen was maintained.

In specimen S3, after partial debonding due to the contact of base members occurring at 374 kN (visually confirmed), the rigidity of its girder gradually declined due to bending cracking of concrete occurring at the partial debonding point. Subsequently, the steel plate near a joint began to gradually debond. At 637 kN, significant debonding occurred at the end of the steel plate as well and the load reached the maximum.

Figure 7 shows the result of applying the proposed model of stress-strain relation for the joint section into the numerical calculation by the multi-cross section method (Figure 9) and performing the calculation.

The values calculated for specimens S1 and S2 transition to those for a non-strengthened specimen due to total loss of the strengthening effect of the steel plates resulting from total debonding of splice plates in the joint section. Values calculated for

specimens S1 and S2 mostly exhibited behavior similar to that corresponding to experimental values for the period from occurrence of partial debonding on splice plates to a decline in girder rigidity.

Values calculated for girder rigidity and the maximum load for specimen S3 (Case 1) were greater than the corresponding experimental values. While partial debonding due to the contact of base members was visually confirmed during the experiment, symptoms of partial debonding might have actually appeared at an earlier stage. Therefore, in order to examine the impact of such partial debonding, the calculation was made on the basis of a model using unit stress (measured value) calculated by multiplying the strain of the center of one of two joint sections in specimen S3 shown in Figure 8(b) in which partial debonding occurred earlier (shown on the left in the figure), by the modulus of elasticity of the steel plate. The result of this calculation mostly coincided with experimental values up to the clear occurrence of debonding from the ends of the steel plates. Though we were unable to visually confirm the difference between calculated and measured values at and after the deflection of 20 mm, that this might be the result of gradual debonding.

Values calculated for specimen S4 generally coincided with experimental values up to the peak value. Experimental values for specimen S4 did not reach the calculated peak value due to a drastic gradual progression of debonding from the ends of steel plates.

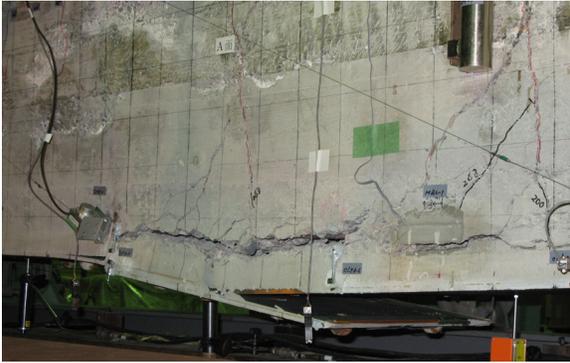
Photo 4 Debonding failure of splice plates on specimen S1

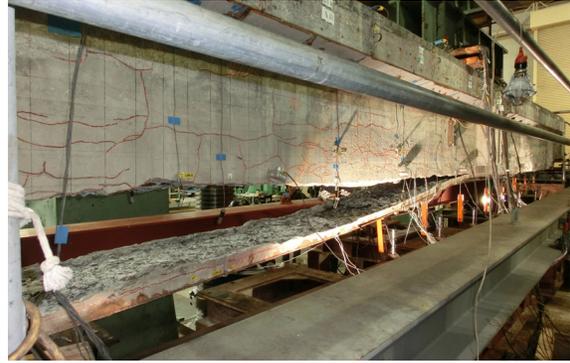
Photo 5 Debonding failure from ends of steel plate (near side in the photo) of specimen S4 (immediately after maximum load is applied)

Specimen S4 (visually confirmed). At 568 kN, the steel plate drastically debonded from the cover concrete, from its end to the vicinity of the center of the specimen along the crack at the location of the lower main reinforcing bar (Photo 5), with the load sharply declining to about 400 kN. The specimen was then unloaded and loaded again with the cover concrete delaminated. After reaching the maximum load, specimens S3 and S4 exhibited behavior mostly similar to that corresponding to the value calculated for a non-strengthened specimen just the same as for specimens S1 and S2. In both specimens S3 and S4, yielding on the main reinforcing bar was observed after the maximum load was reached. On specimens S3 and S4, the addition of bolts reduced the debonding failure of the splice plate.

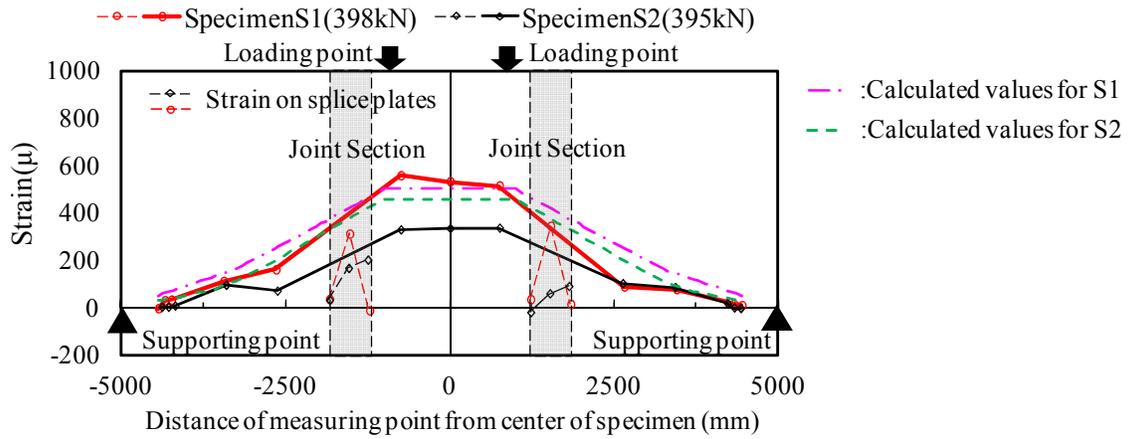
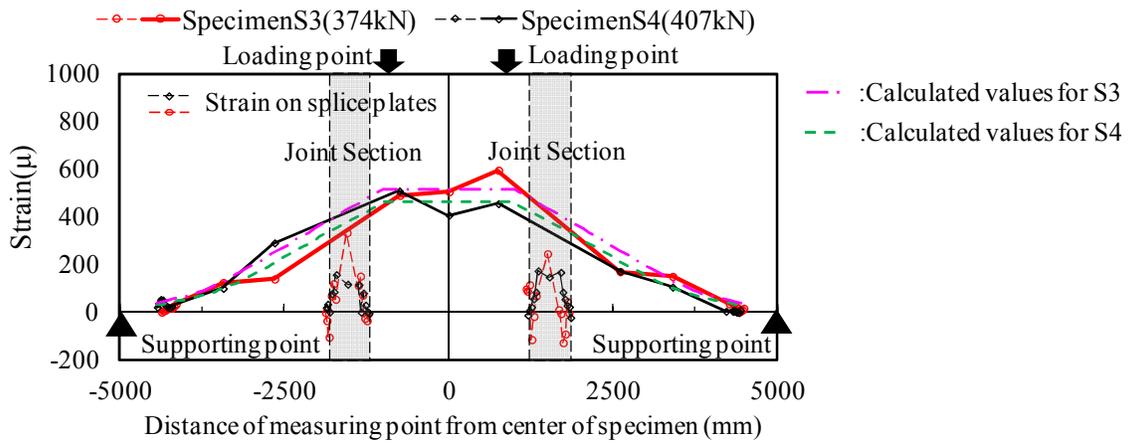
Figure 8 Distribution of axial strain of the steel plate

Figure 8 shows the axial strain distribution on steel plate immediately before the partial debonding of the splice plates of joints on specimens S1 and S2 and immediately before partial debonding due to the contact of base members in specimens S3 and S4. Values calculated by the multi-cross section method for specimens strengthened by an integrated steel plate over its full length are also shown in the figure.

While measured strains of specimens S1, S3, and S4 generally tended to coincide with calculated values except for joints, the measured strain on specimen S2 were generally lower than the calculated values.

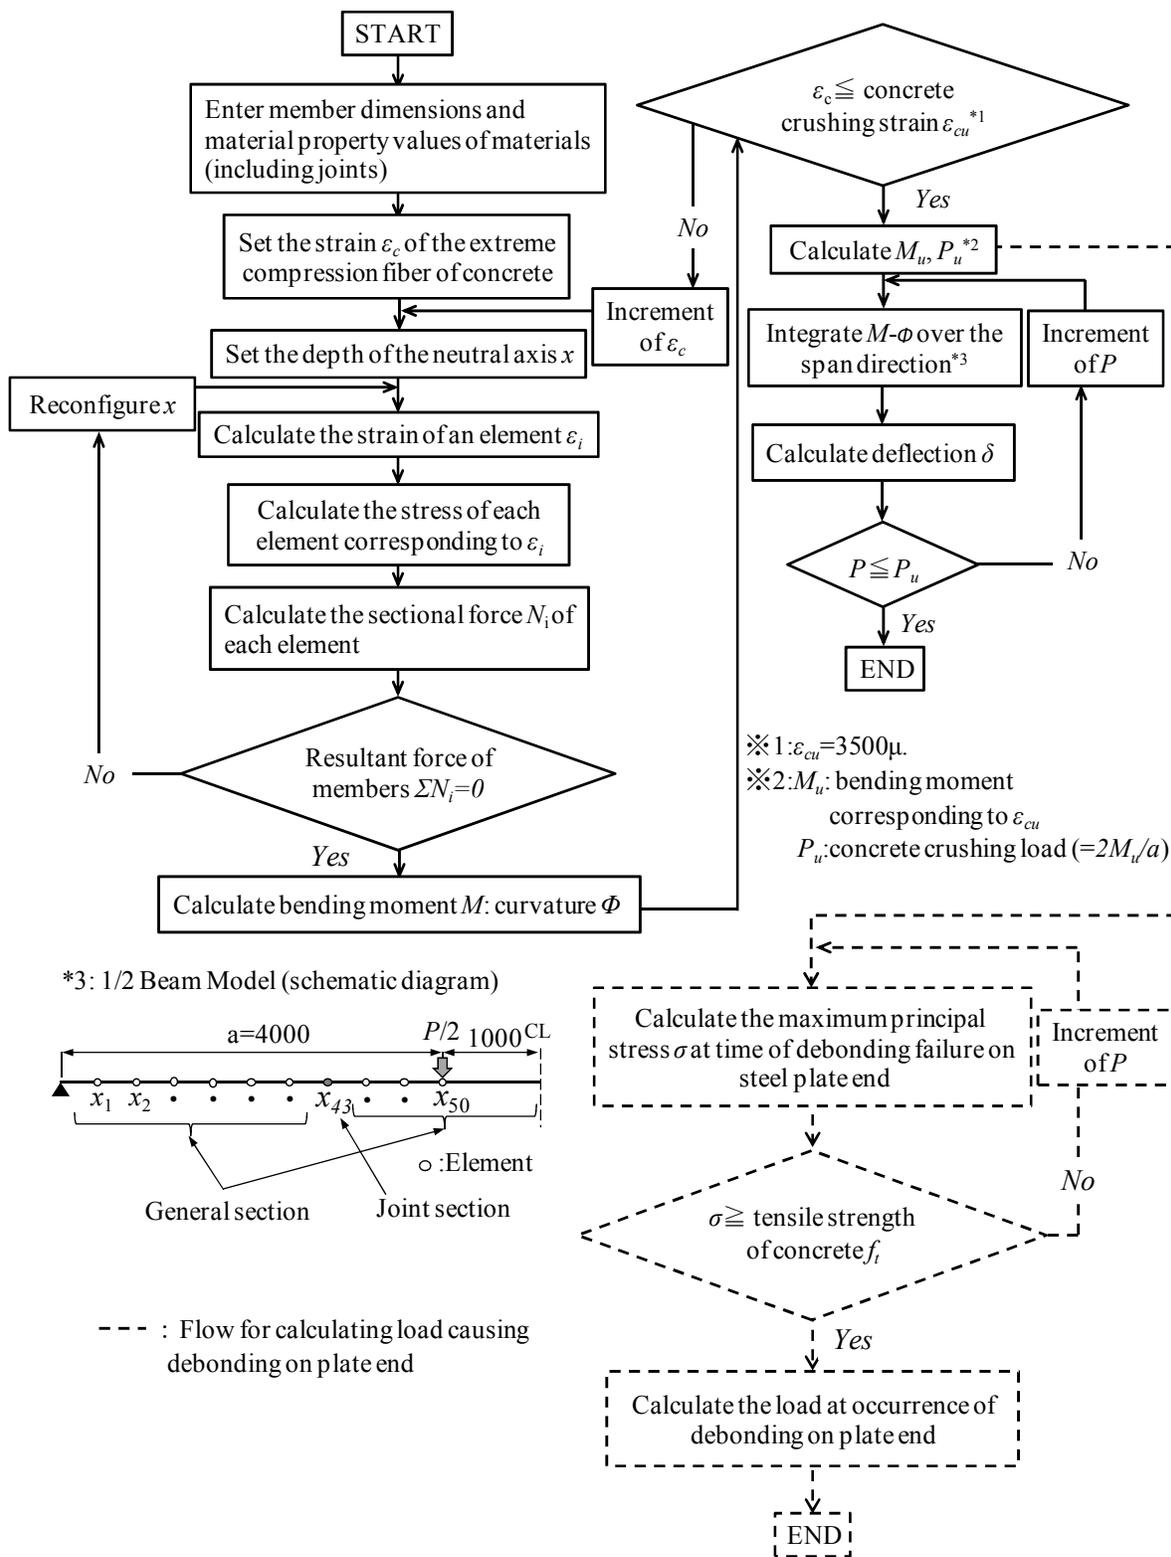
Figure 9 Flow chart for calculation

Figure 9 shows the flow chart for calculation. In order to evaluate load-carrying properties in terms of the effect on joints of reinforced concrete girders strengthened with externally bonded steel plates, numerical calculation was conducted by the multi-cross section method while taking the effects on steel plate joints into account.

The result of the material test was used as the material model in this calculation. The stress-strain relation from results of the compressive strength test was utilized on the compressive side as the stress-strain relation for concrete. The Okamura-Maekawa model^[5]) was used for tension stiffening after the initiation of cracks on the tensile side. A bilinear model disregarding the strain hardening area was used for the stress-strain relation of reinforcing bars. The stress-strain relation from the compressive strength test was used on the As layers. The steel plate was modeled by dividing into general and joint sections. The stress-strain relation from the tensile test of steel plates was utilized for the general section, and the stress-strain relation of the center of the joint section (detailed below) was used for the joint section. The 1/2 Beam Model which axially divides the modeled object into two parts is used as the calculation model. To obtain a stable solution for element breakdown, the cross section of a specimen was divided into 50 elements and the support point to the loading point into 50 elements.

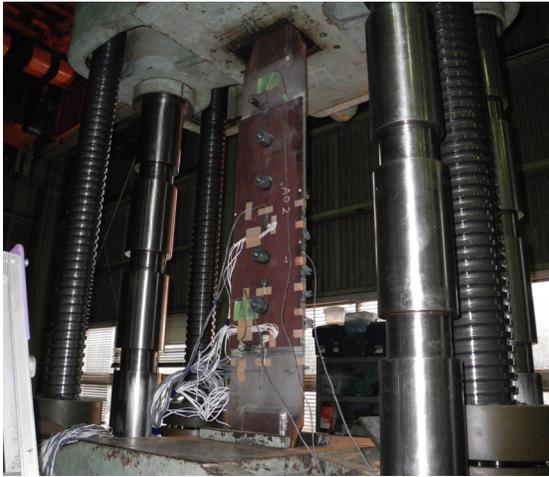
Photo 6 Static tensile test of single-spliced bolted adhesive joints⁶⁾

In the static tensile test of single-spliced bolted adhesive joints having physical details equivalent to those of steel joints on reinforced concrete girders used in the bending loading test (Photo 6)^[6], bending deformation occurred due to an eccentricity specific to a single-sided splice. Partial debonding (peeling or delaminating) occurred at a relatively early stage at the contact of abutting base members and the splice plate ends (Figure 10). At that time, the load did not decrease immediately and a significant increase in deflection was observed. In the static tensile test of unbolted adhesive joints, the initiation of partial debonding of the splice plate in the joint section did not immediately result in whole surface debonding and the load was held despite partial debonding occurring three or four times.

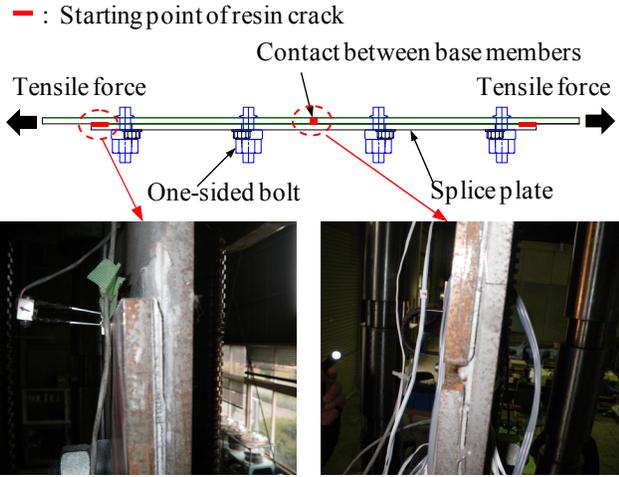
Figure 10 Failures observed in static tensile test of single-spliced bolted adhesive joints

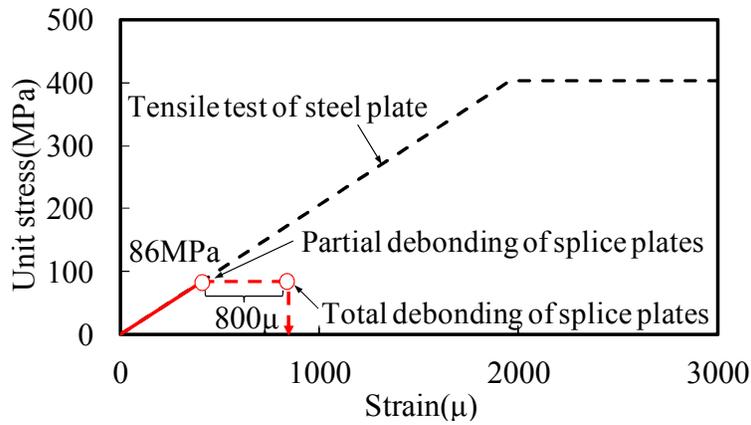
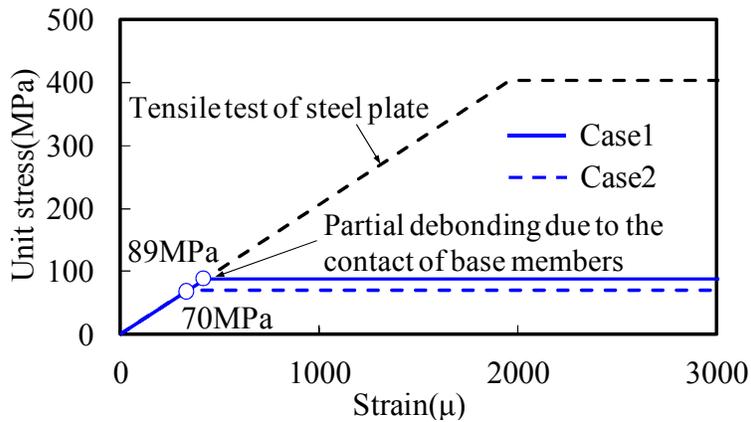
Figure 11 Schematic diagram of the stress-strain relationship in the center of joints

Figure 11 represents these behaviors in terms of a stress-strain relation. Specimens S1 and S3 in the figure as examples, in calculating the unit stress of the steel plate upon the occurrence of partial debonding, the unit stress acting on the center of the joint section was calculated on the basis of the load at the occurrence of partial debonding by using the beam bending theory. The upper strain limit during the period from the occurrence of partial debonding of splice plates to their total debonding in the joint section was tentatively set at 800μ so that it generally coincides with the experimental value of the maximum load (Figure 11(a)).
