# CYCLIC LOADING TEST FOR EXISTING PRECAST PRESTRESSED CONCRETE BRIDGE COLUMN

## Abstract

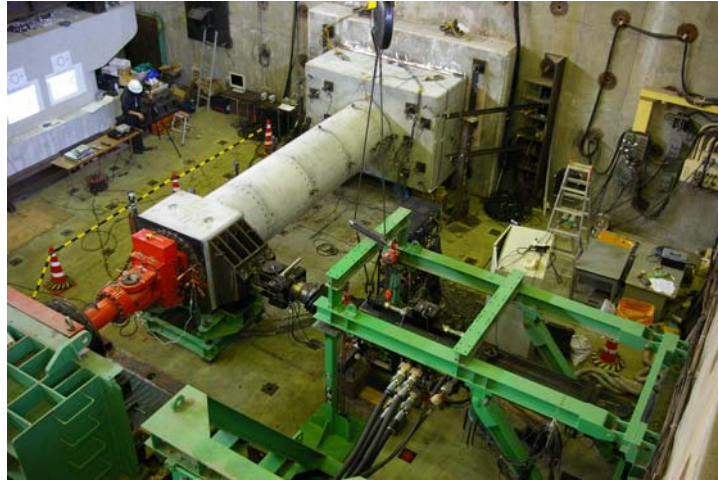
Photo 1 Test setup

A specimen of the precast segmental PC column is shown in Figure 4. The specimen was designed based on the existing segmental PC columns designed and constructed in Japan. The specimen is a 1/3 scale model and consists of 5 precast ring segments. The dimension of the section is 1000mm and thickness of the wall is 100mm. Photo 1 shows the test setup. The specimen was laid horizontally and the footing was mounted to the reaction wall thorough the base concrete. A lateral load was provided by a large stroke actuator at 4350 mm height from the footing, and a vertical load was applied at the top of column by an axial loading apparatus.

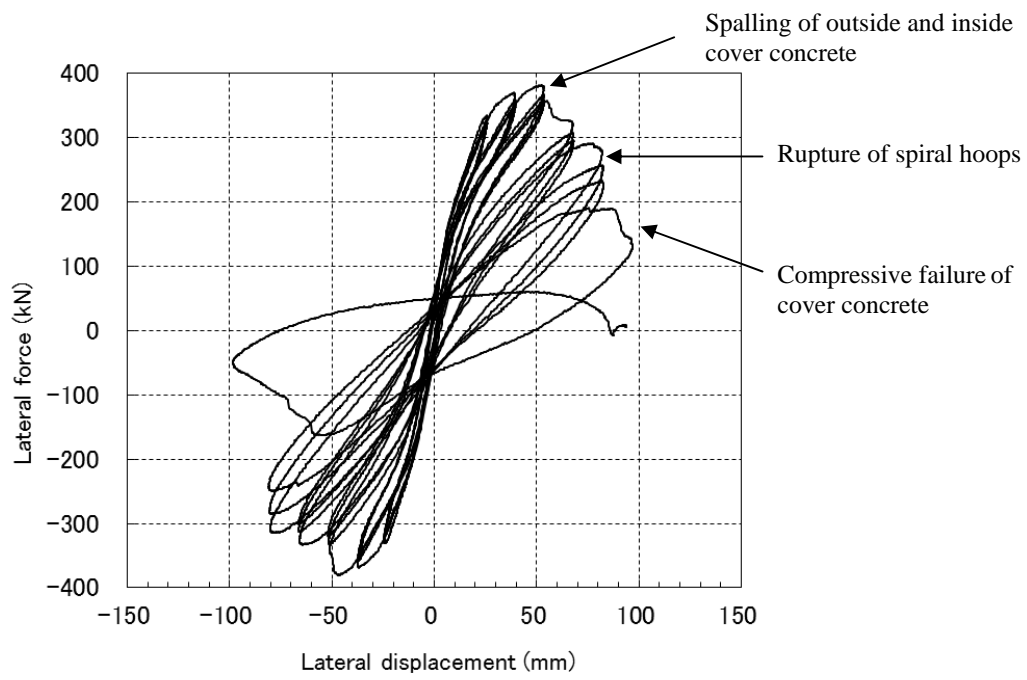
Figure 5 Lateral force vs lateral displacement

Figure 5 shows the lateral force - lateral displacement relationship. The lateral displacement was modified by removing the displacement caused by strain penetration of longitudinal PC bar into the footing. The spalling of outside and inside cover concrete was occurred when the displacement was  $2.0\delta$  as shown in Figure 6. The deterioration of lateral force was observed in the loading step of  $2.5\delta$ . The lateral force in the loading step of  $3.0\delta$  decreased with each loading reputation. The observed spalling of outside and inside cover concrete progressed. However, the longitudinal PC bar didn't yield. The observed spalling of outside and inside cover concrete and the deterioration of lateral force progressed and the some spiral hoops were ruptured in the loading step of  $3.0\delta$  as shown in Figure 7. The cover concrete was crushed around the segment joint between No.1 and No.2 and the many more spiral hoops were ruptured in the loading step of  $3.5\delta$  as shown in Figure 8. The axial load was constantly kept before the cover concrete was crushed. Figure 9 shows the strain where is measured at longitudinal PC bar No.1. The initial value of strain is  $3770\mu$  before testing. The yield strain of PC bars is  $6135\mu$ . The longitudinal PC bars didn't yield during testing. The PC bar's strain at upper of segment No.2 is smaller than the lower one before the lateral displacement is  $1.0\delta$ . However, the both strain values are similar after the lateral displacement is  $1.0\delta$ . It was highly possible that the PC bars were not bonded with grout, because the yield of PC bars didn't occurred and the strain spread upward in segment No.2.

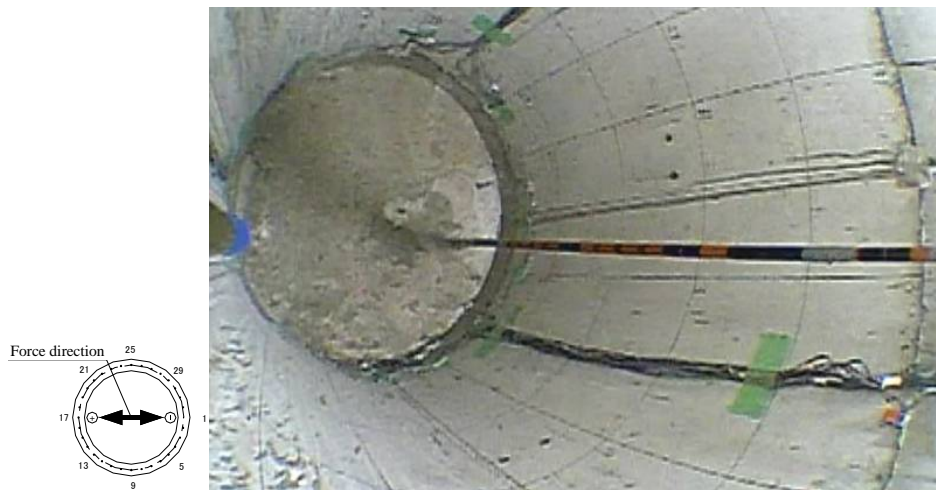
(a) Damage observed at outside face

(b) Damage observed at inside face

Figure 6 Observed damage in the displacement  $2.0\delta$

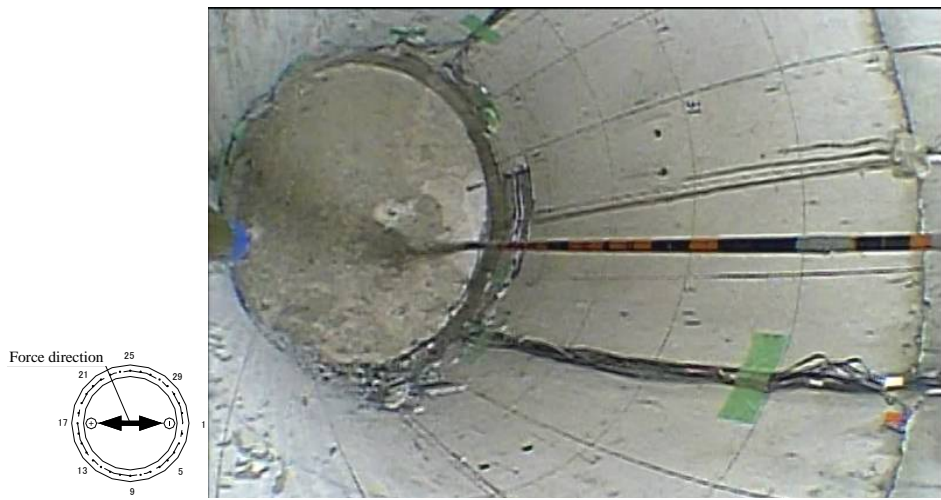
(a) Damage observed at outside face

(b) Damage observed at inside face

Figure 7 Observed damage in the displacement  $3.0\delta$

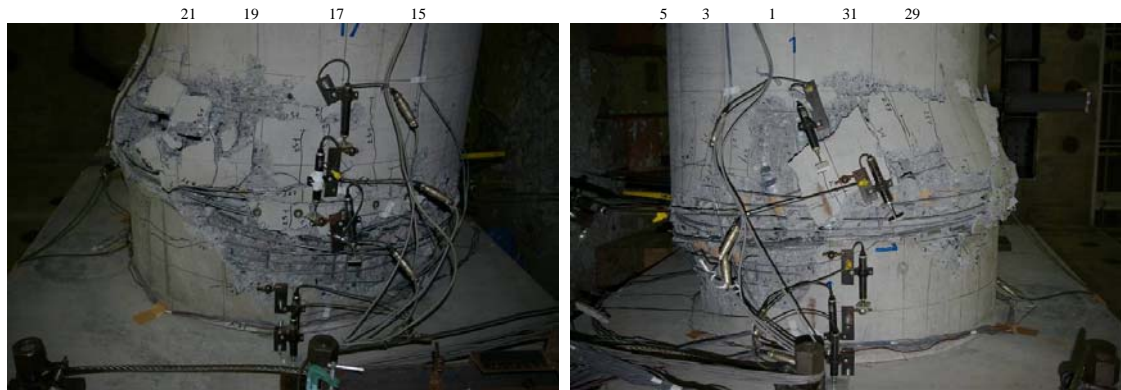
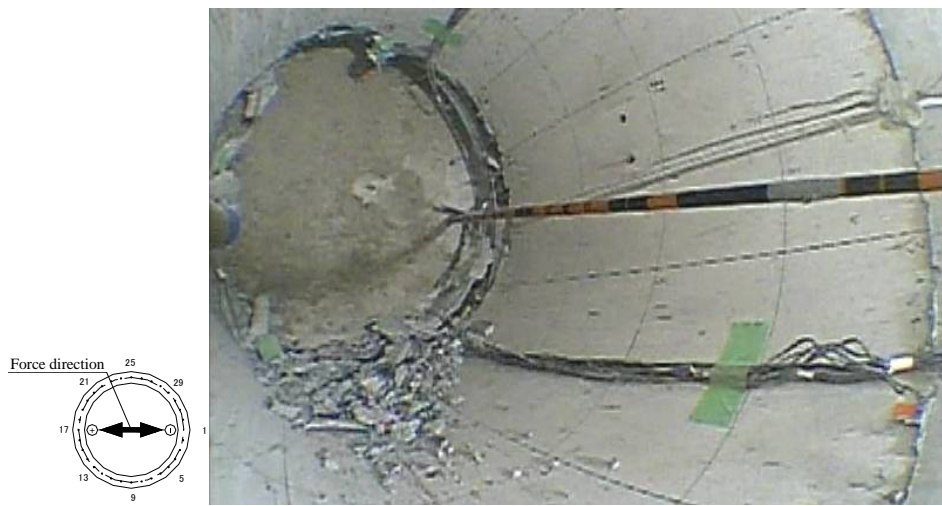
(a) Damage observed at outside face

(b) Damage observed at inside face

Figure 8 Observed damage in the displacement 3.5δ

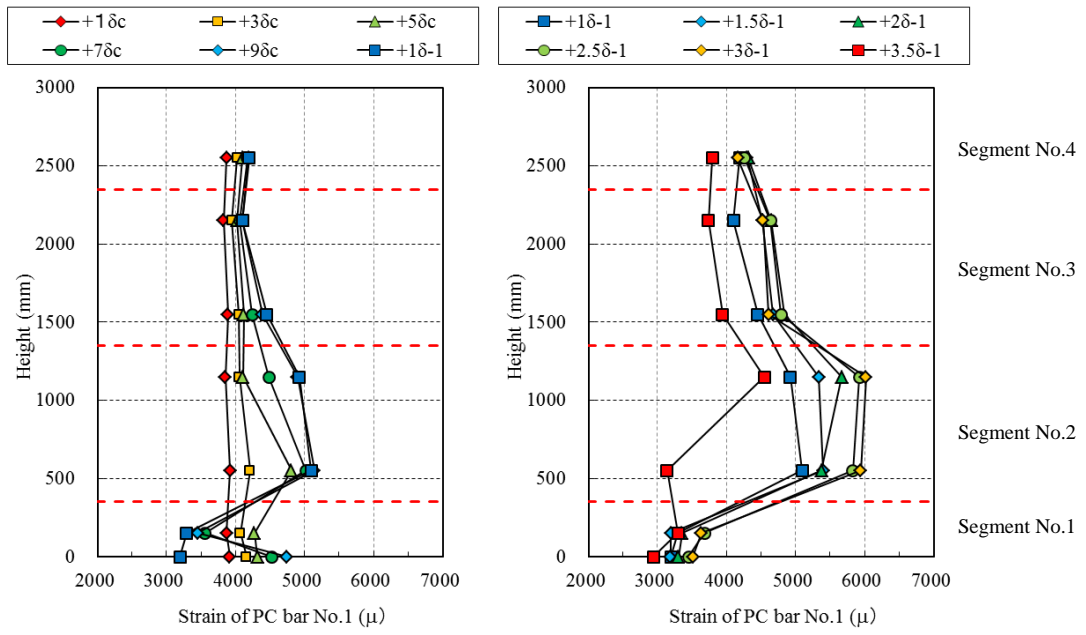
Figure 9 Strain of PC bar No.1
